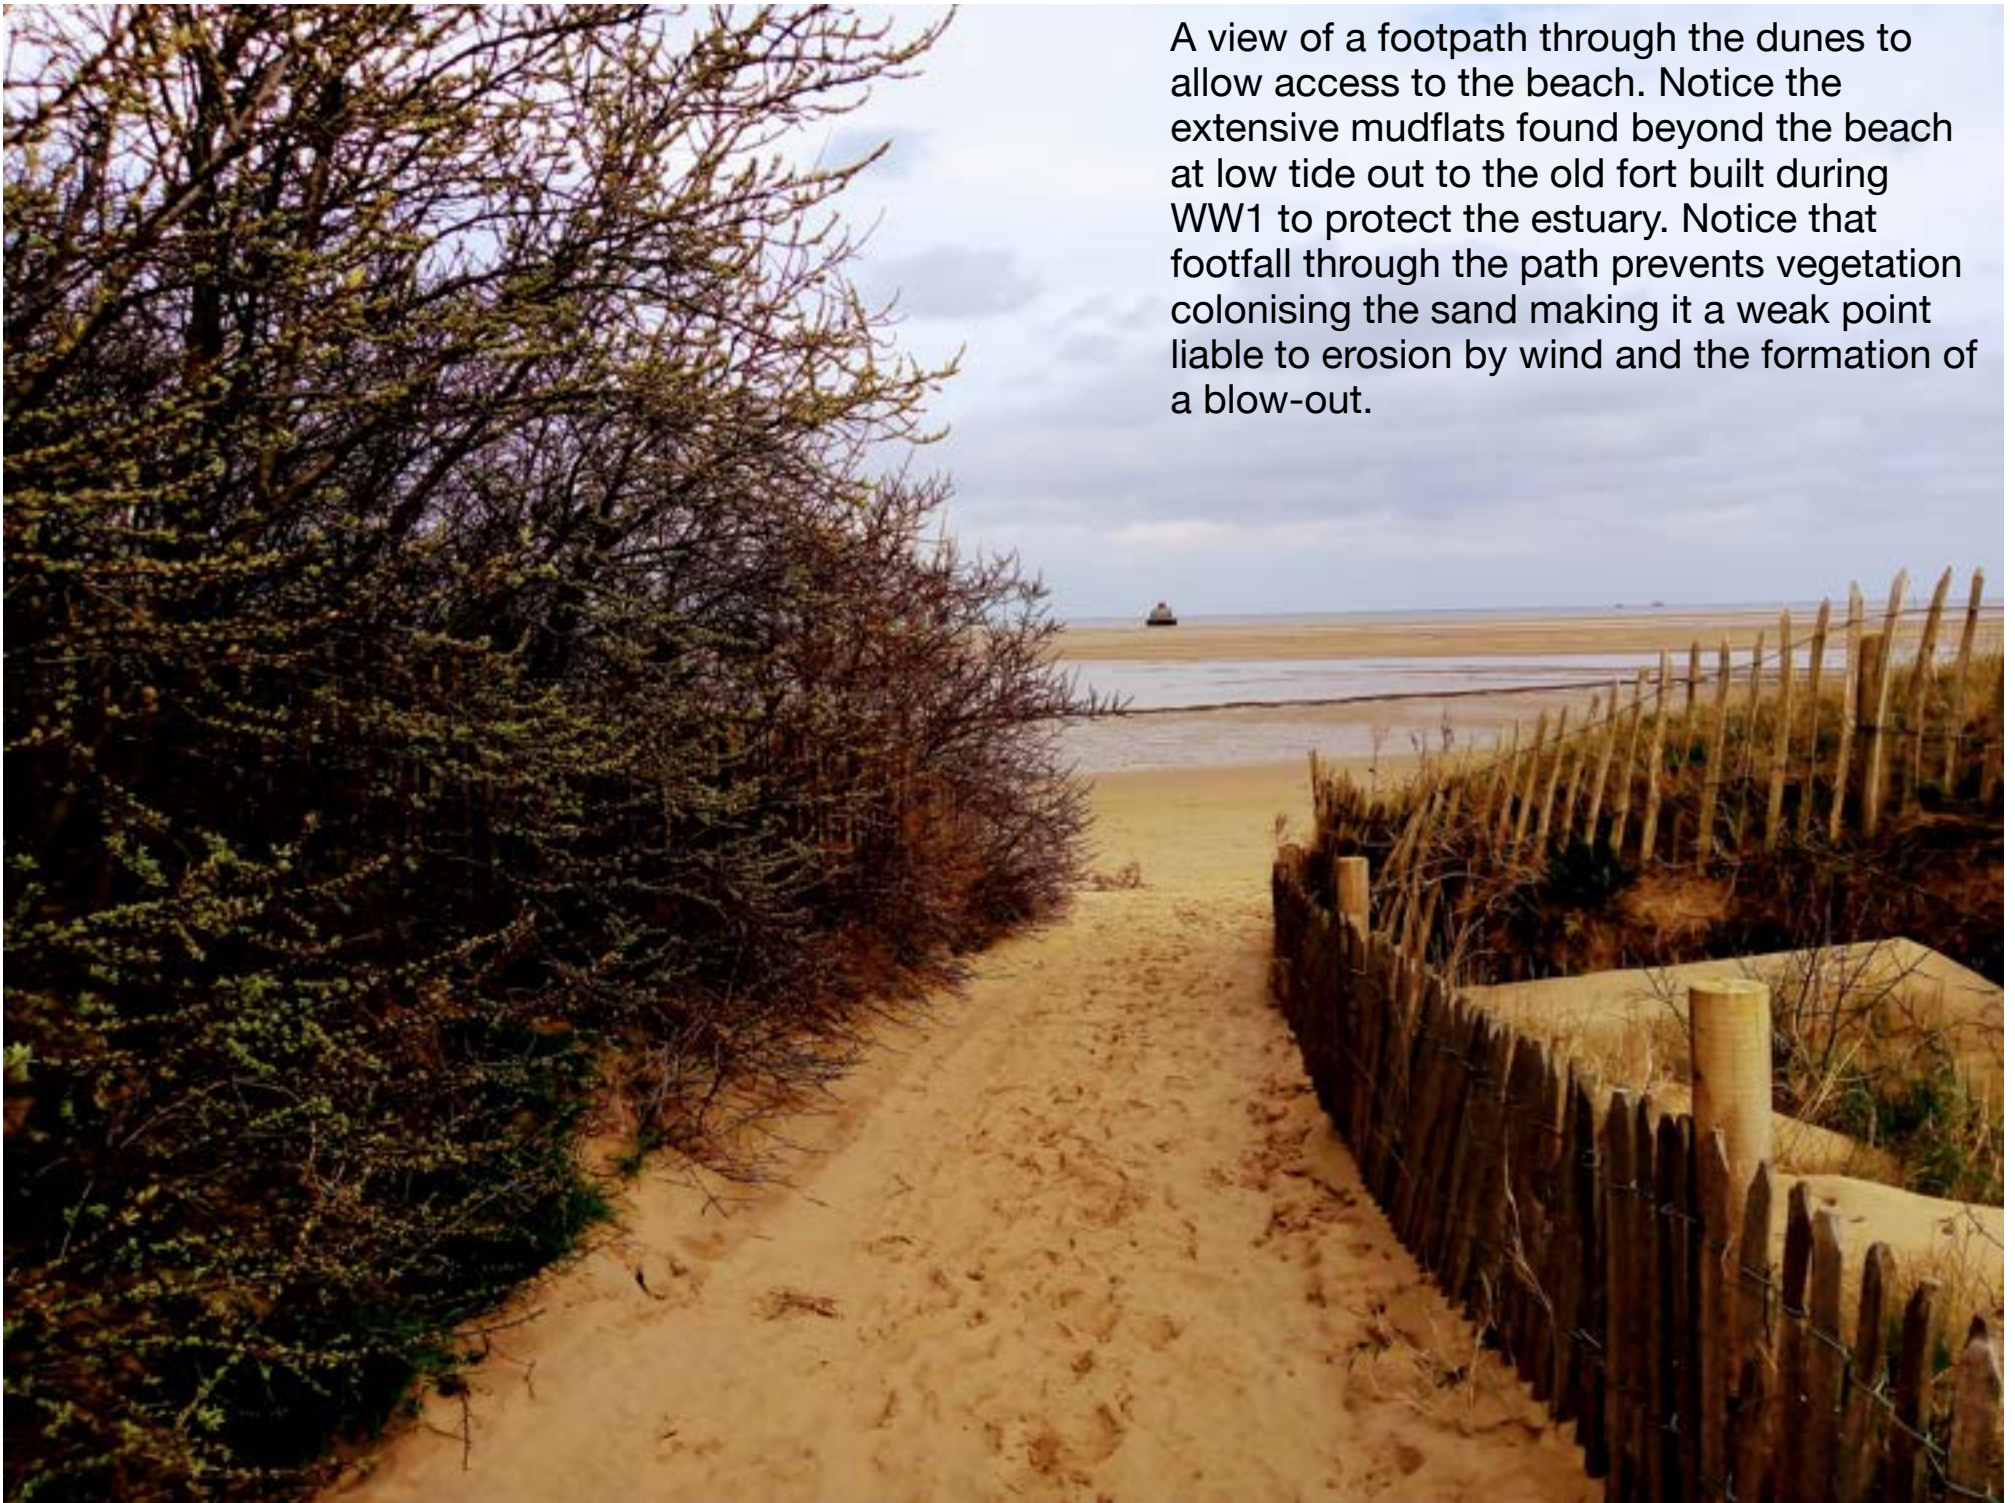
The dune ridge to the left and stabilised sand dunes in the centre. To the right are the Fitties holiday chalets. The holiday chalets are designated as at risk of flooding and there is a further defensive embankment, St Anthony's bank, further inland to the right.

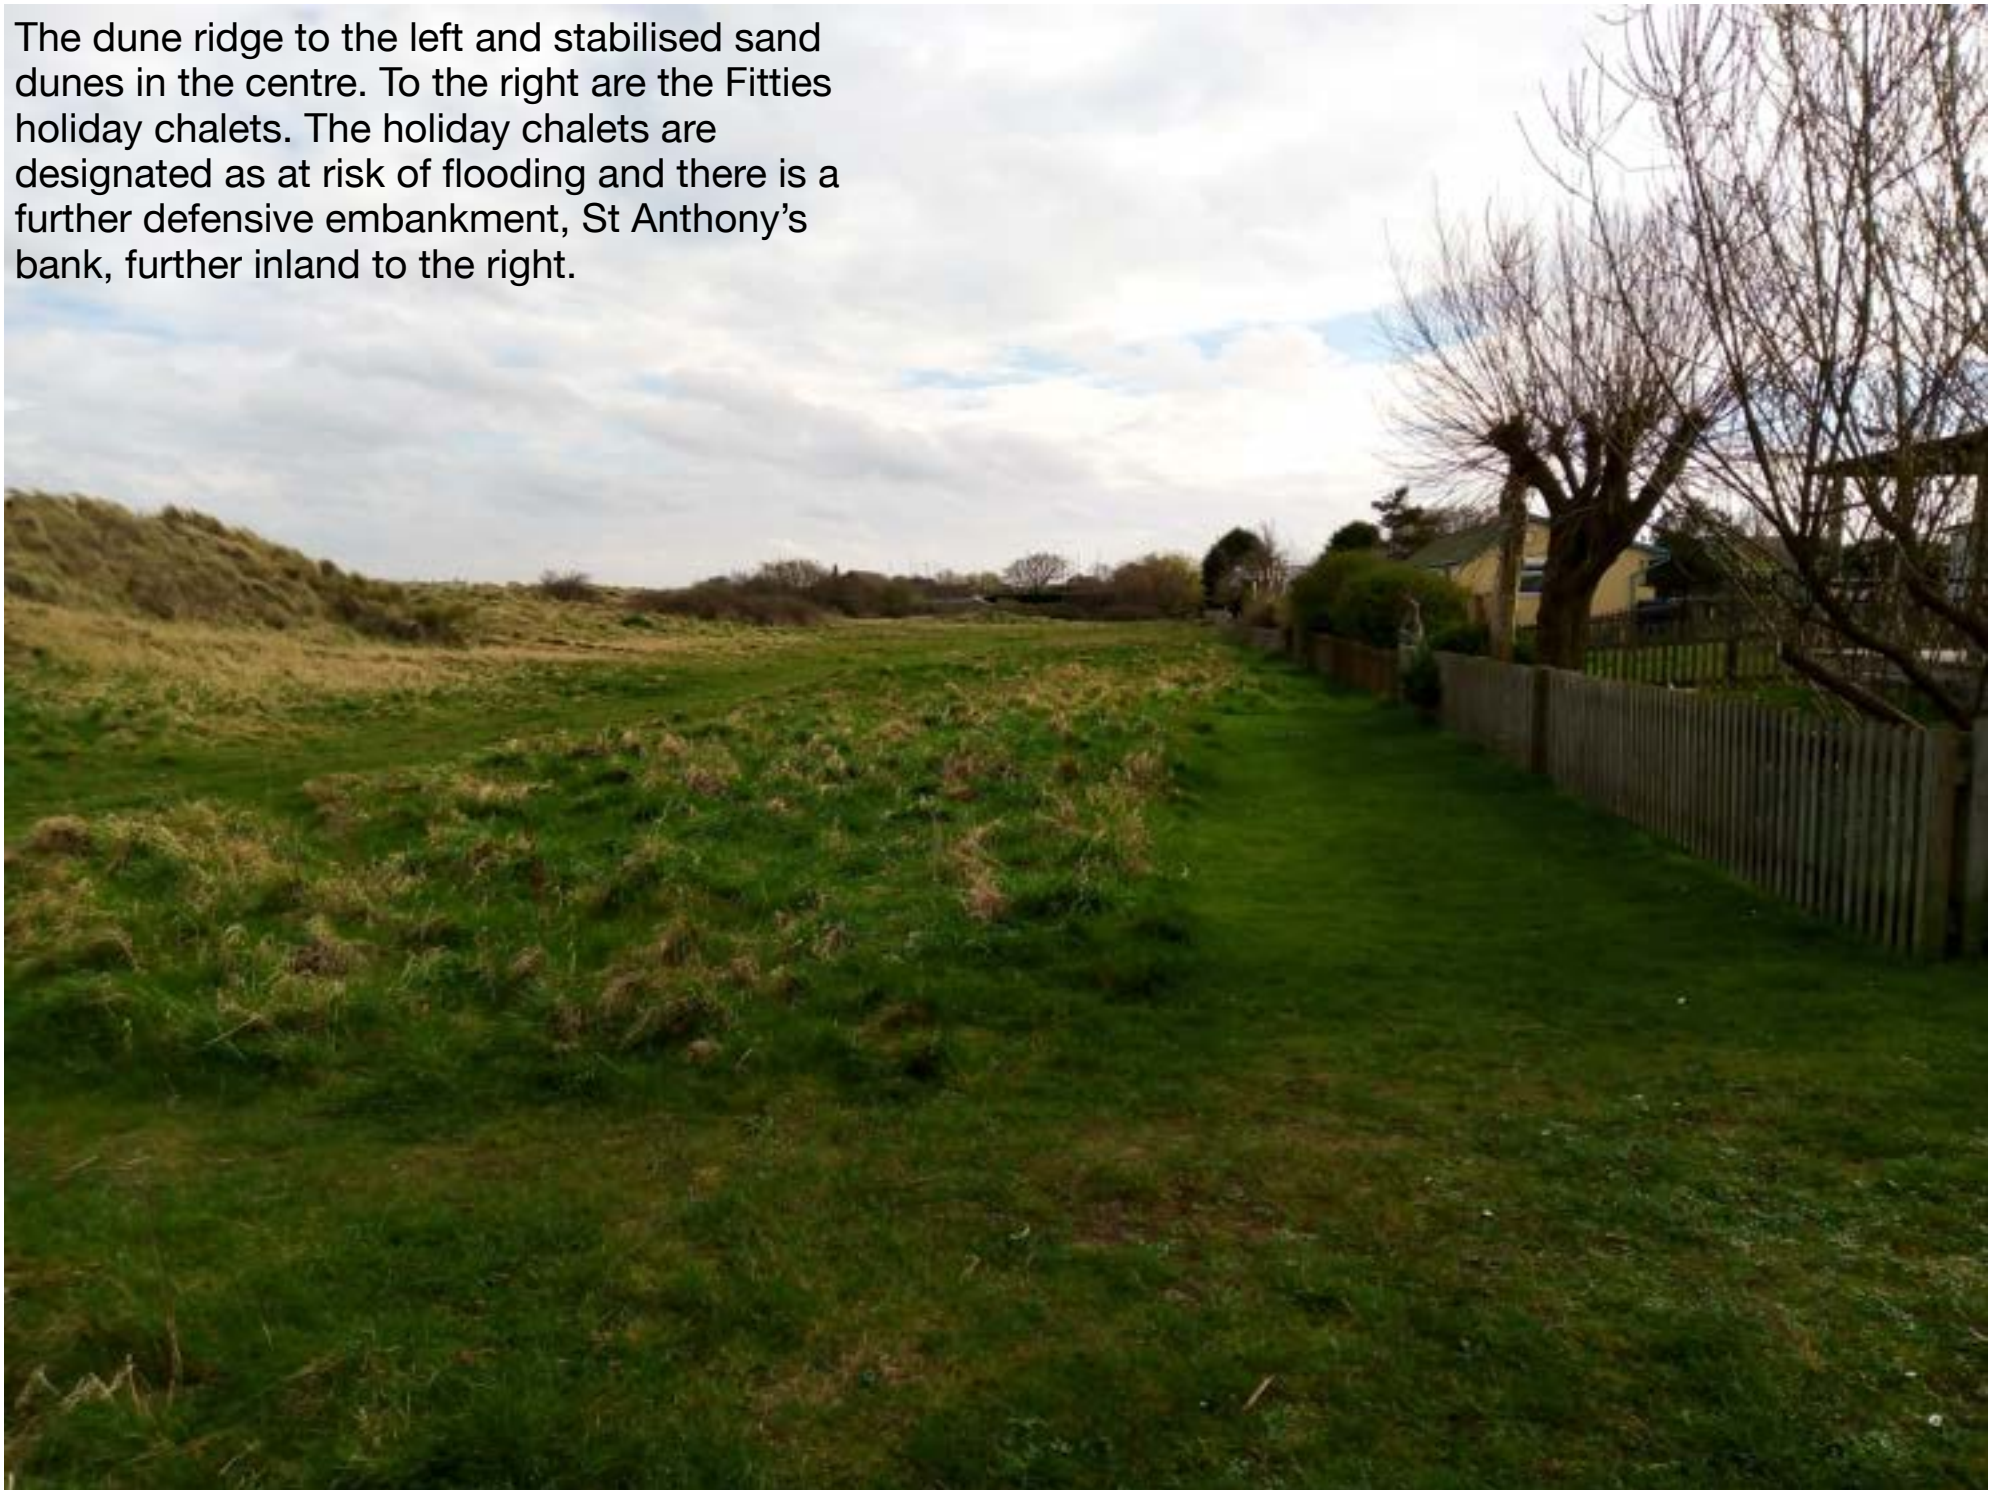
Formidable gabions at the north end of fifties dune belt. The beach seems to have been depleted here and large boulders have been placed at the foot of the gabions to prevent undercutting.

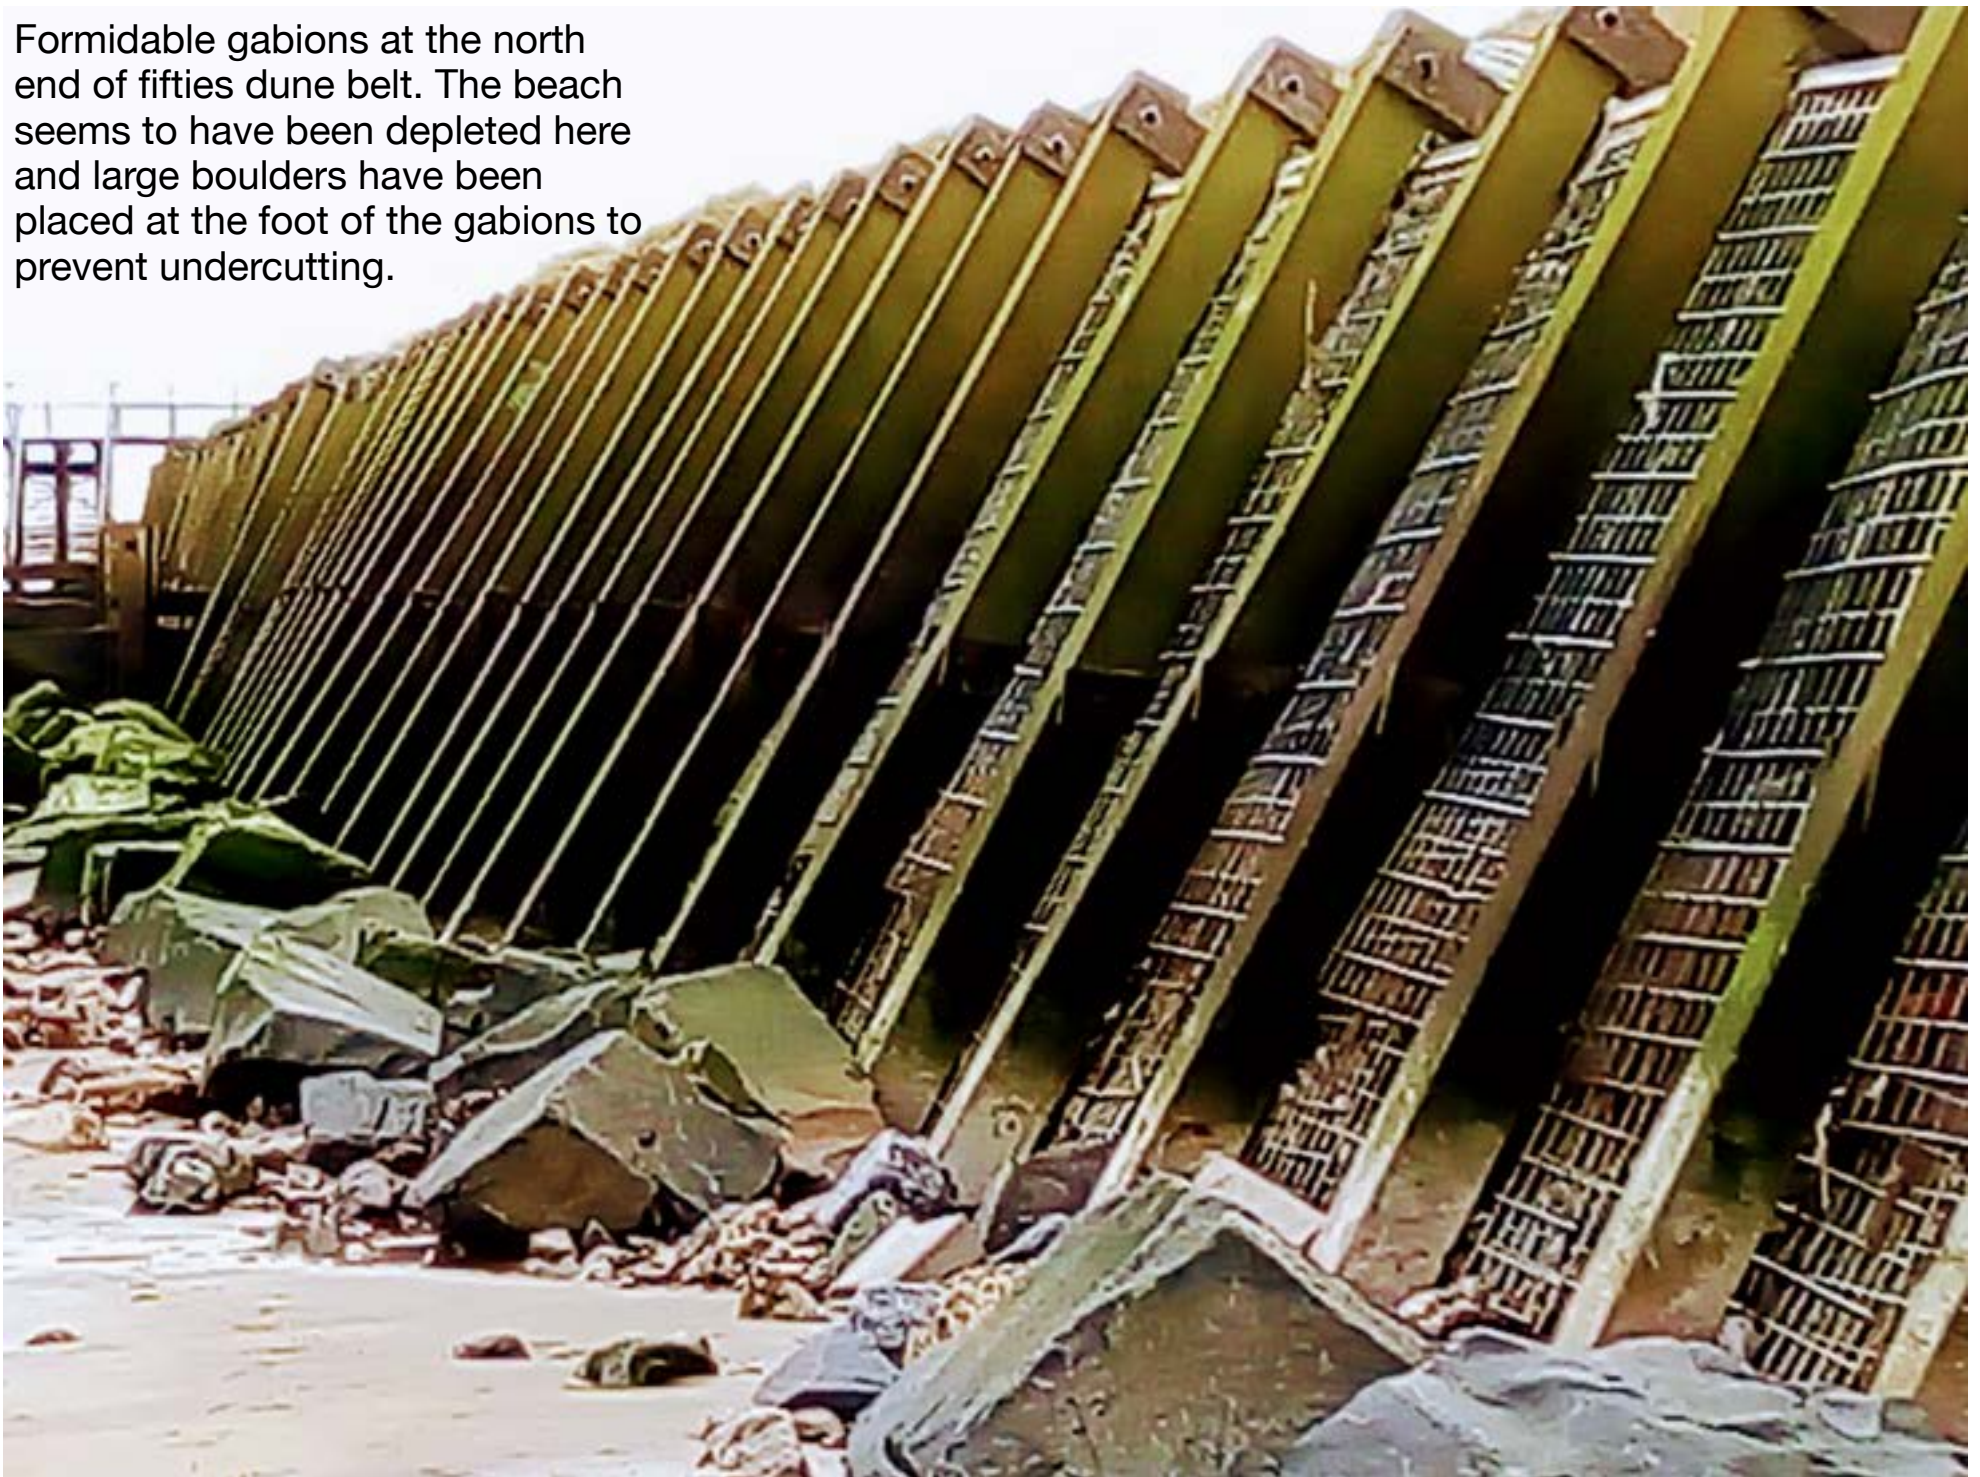
The concrete reinforced defence embankment, St Anthony's bank, with beach access for tourists, and to the right the start of a newly forming dune belt.

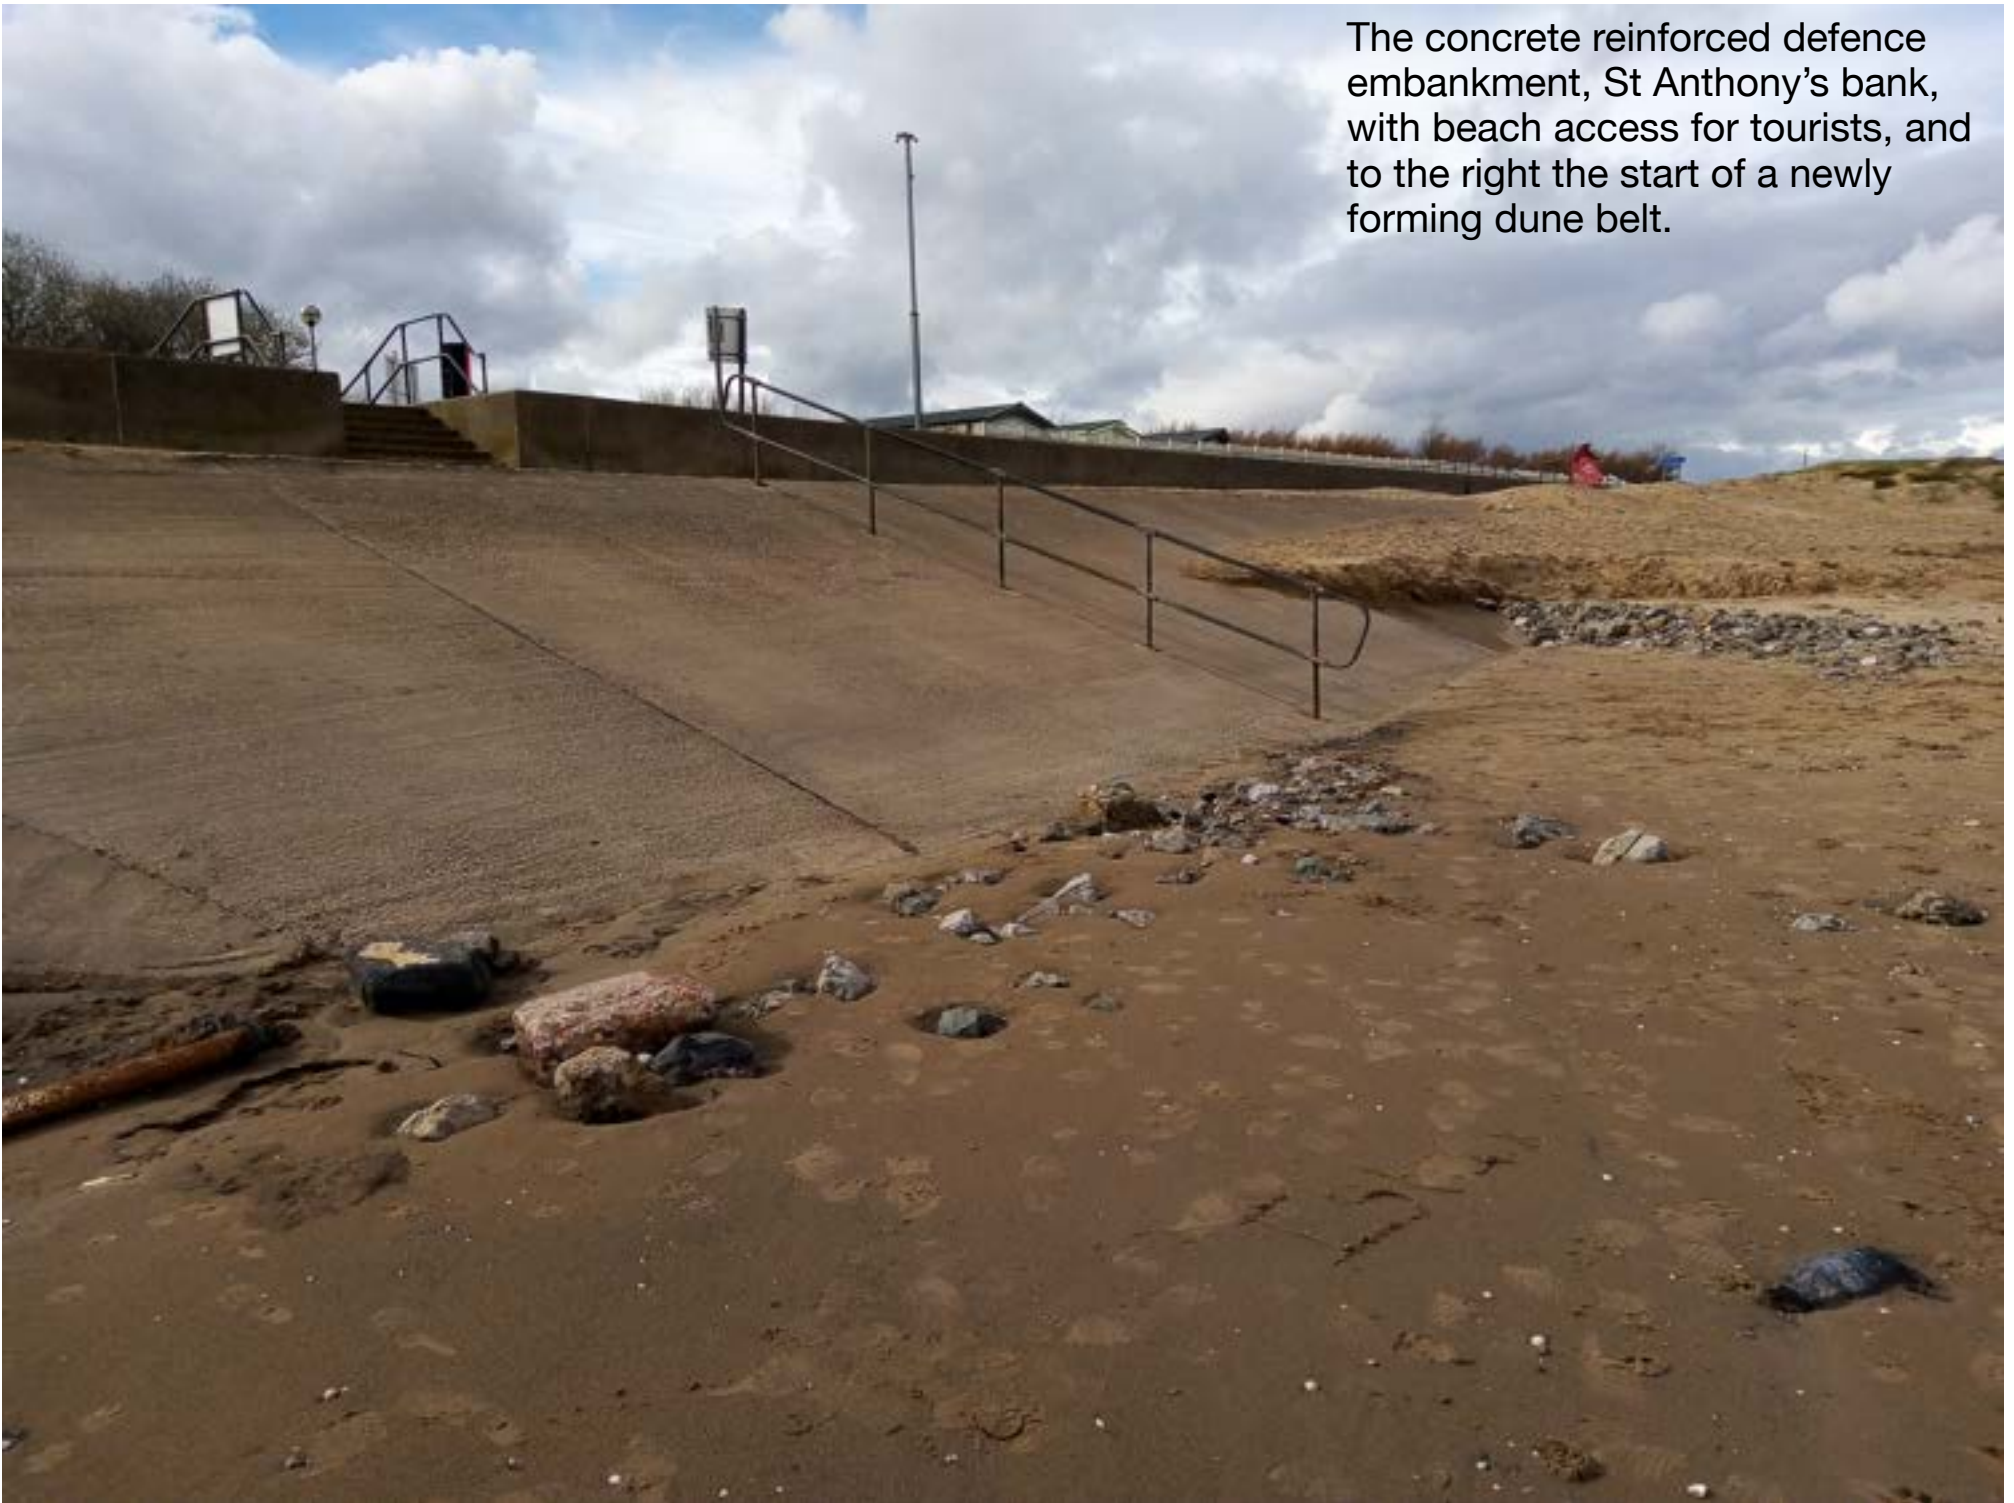
Concrete defences of the sand dunes, but the beach here has been depleted and the concreted defences have been undercut.

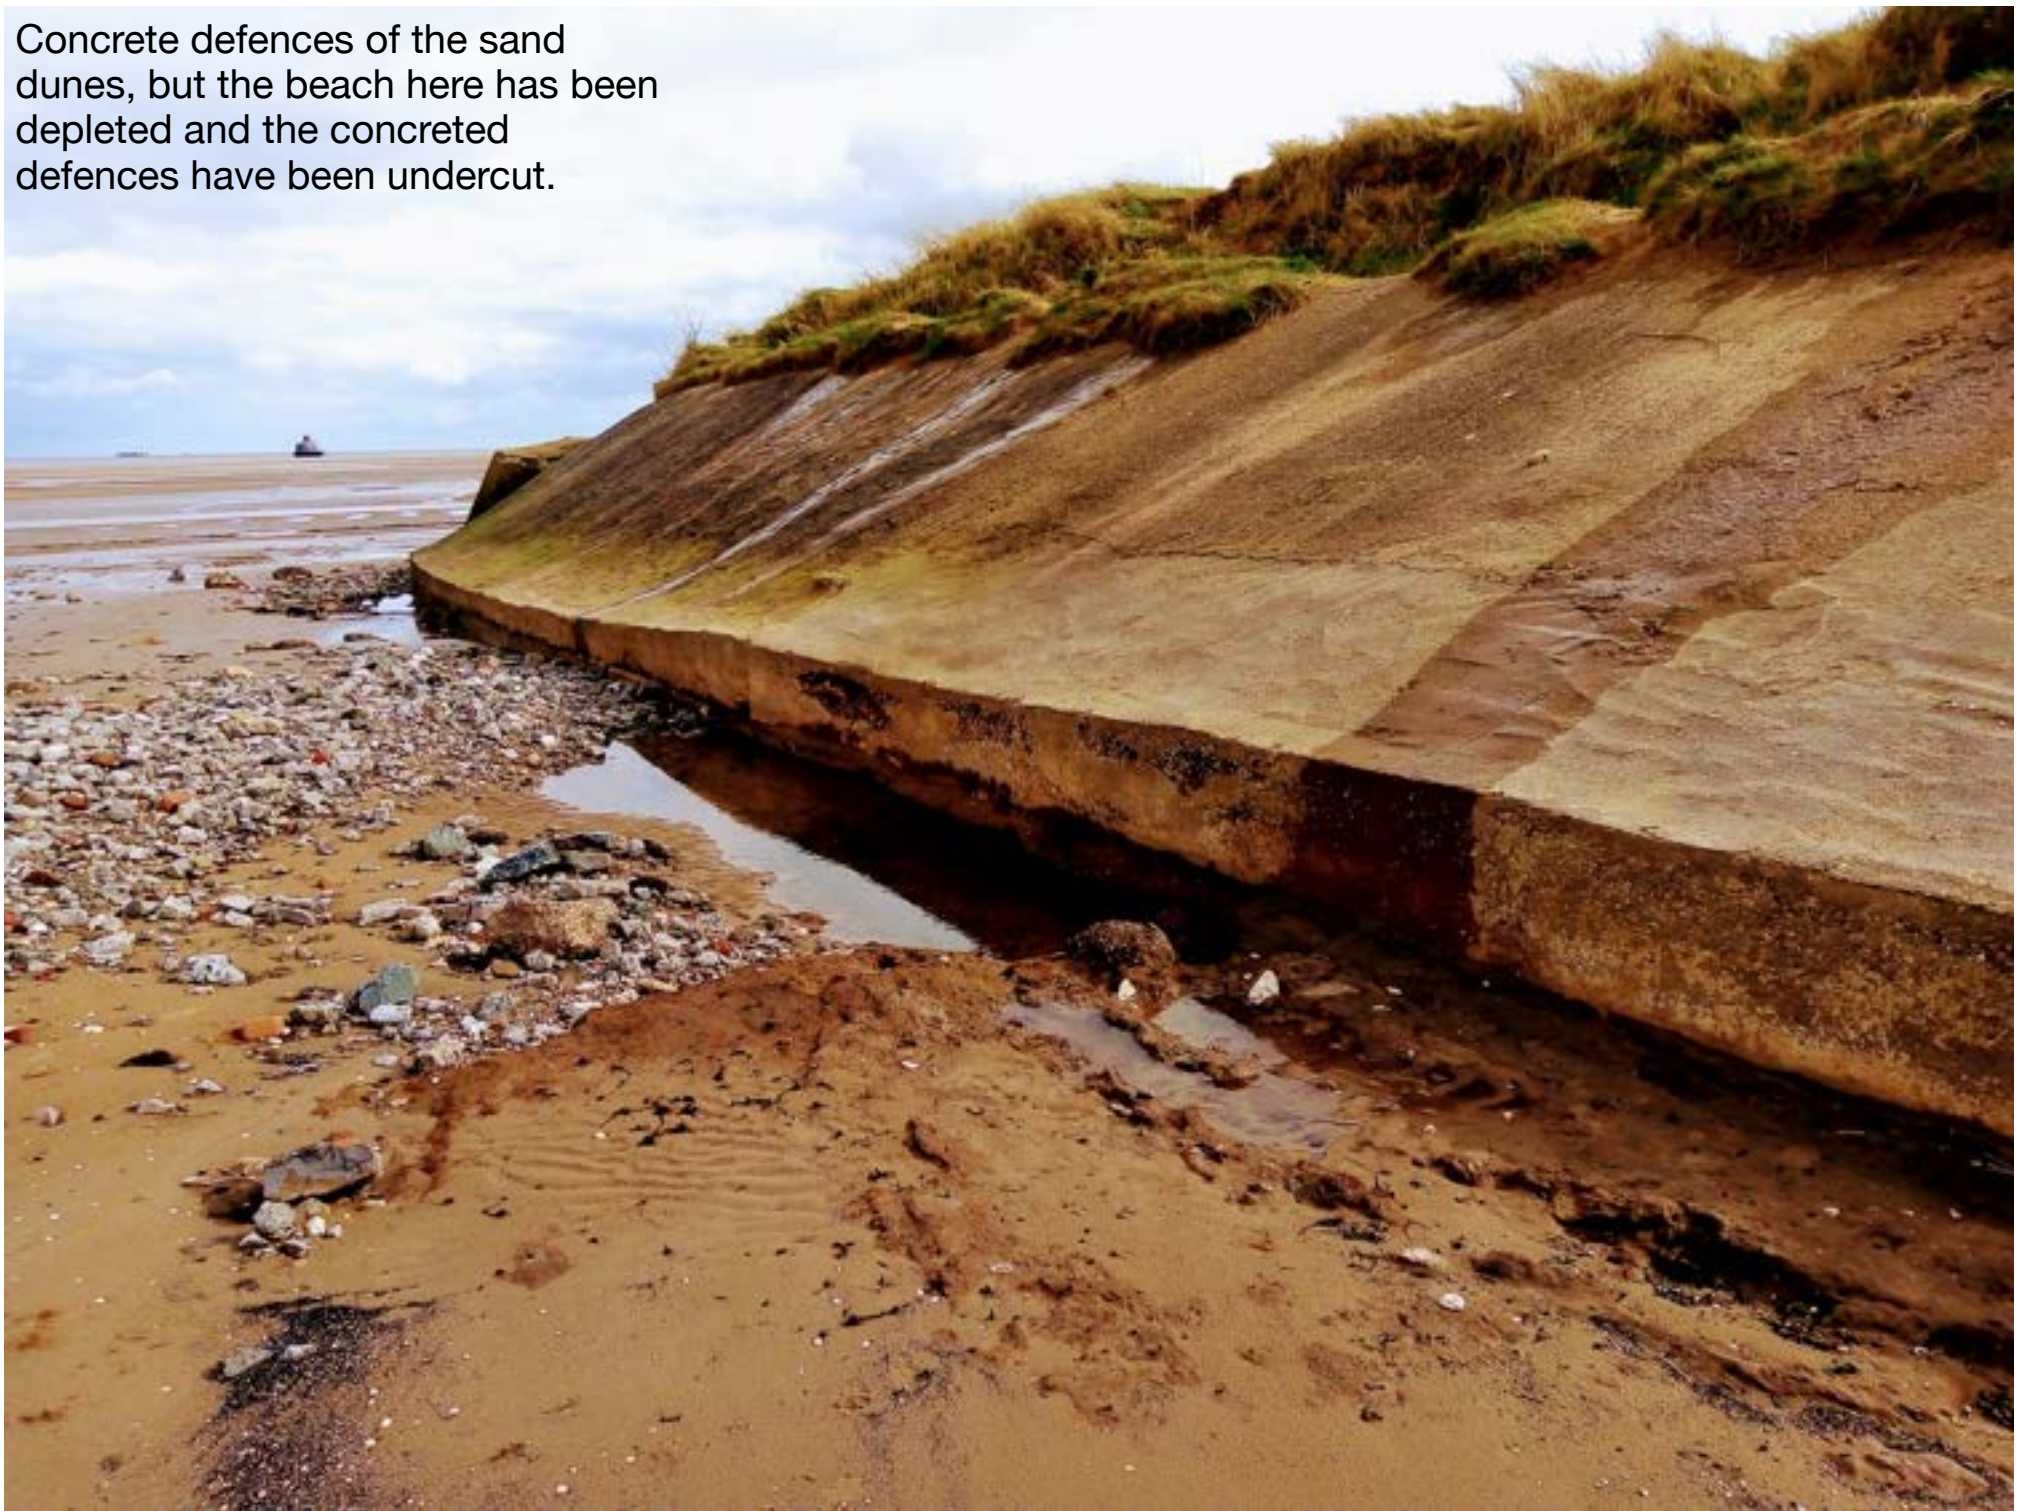
Sand dune formation in front of St Anthony's bank. These foredunes show the early stages of sand dune formation. The wind blows sand from the extensive beach to the right and it begins to be stabilised by plants like marram grass.

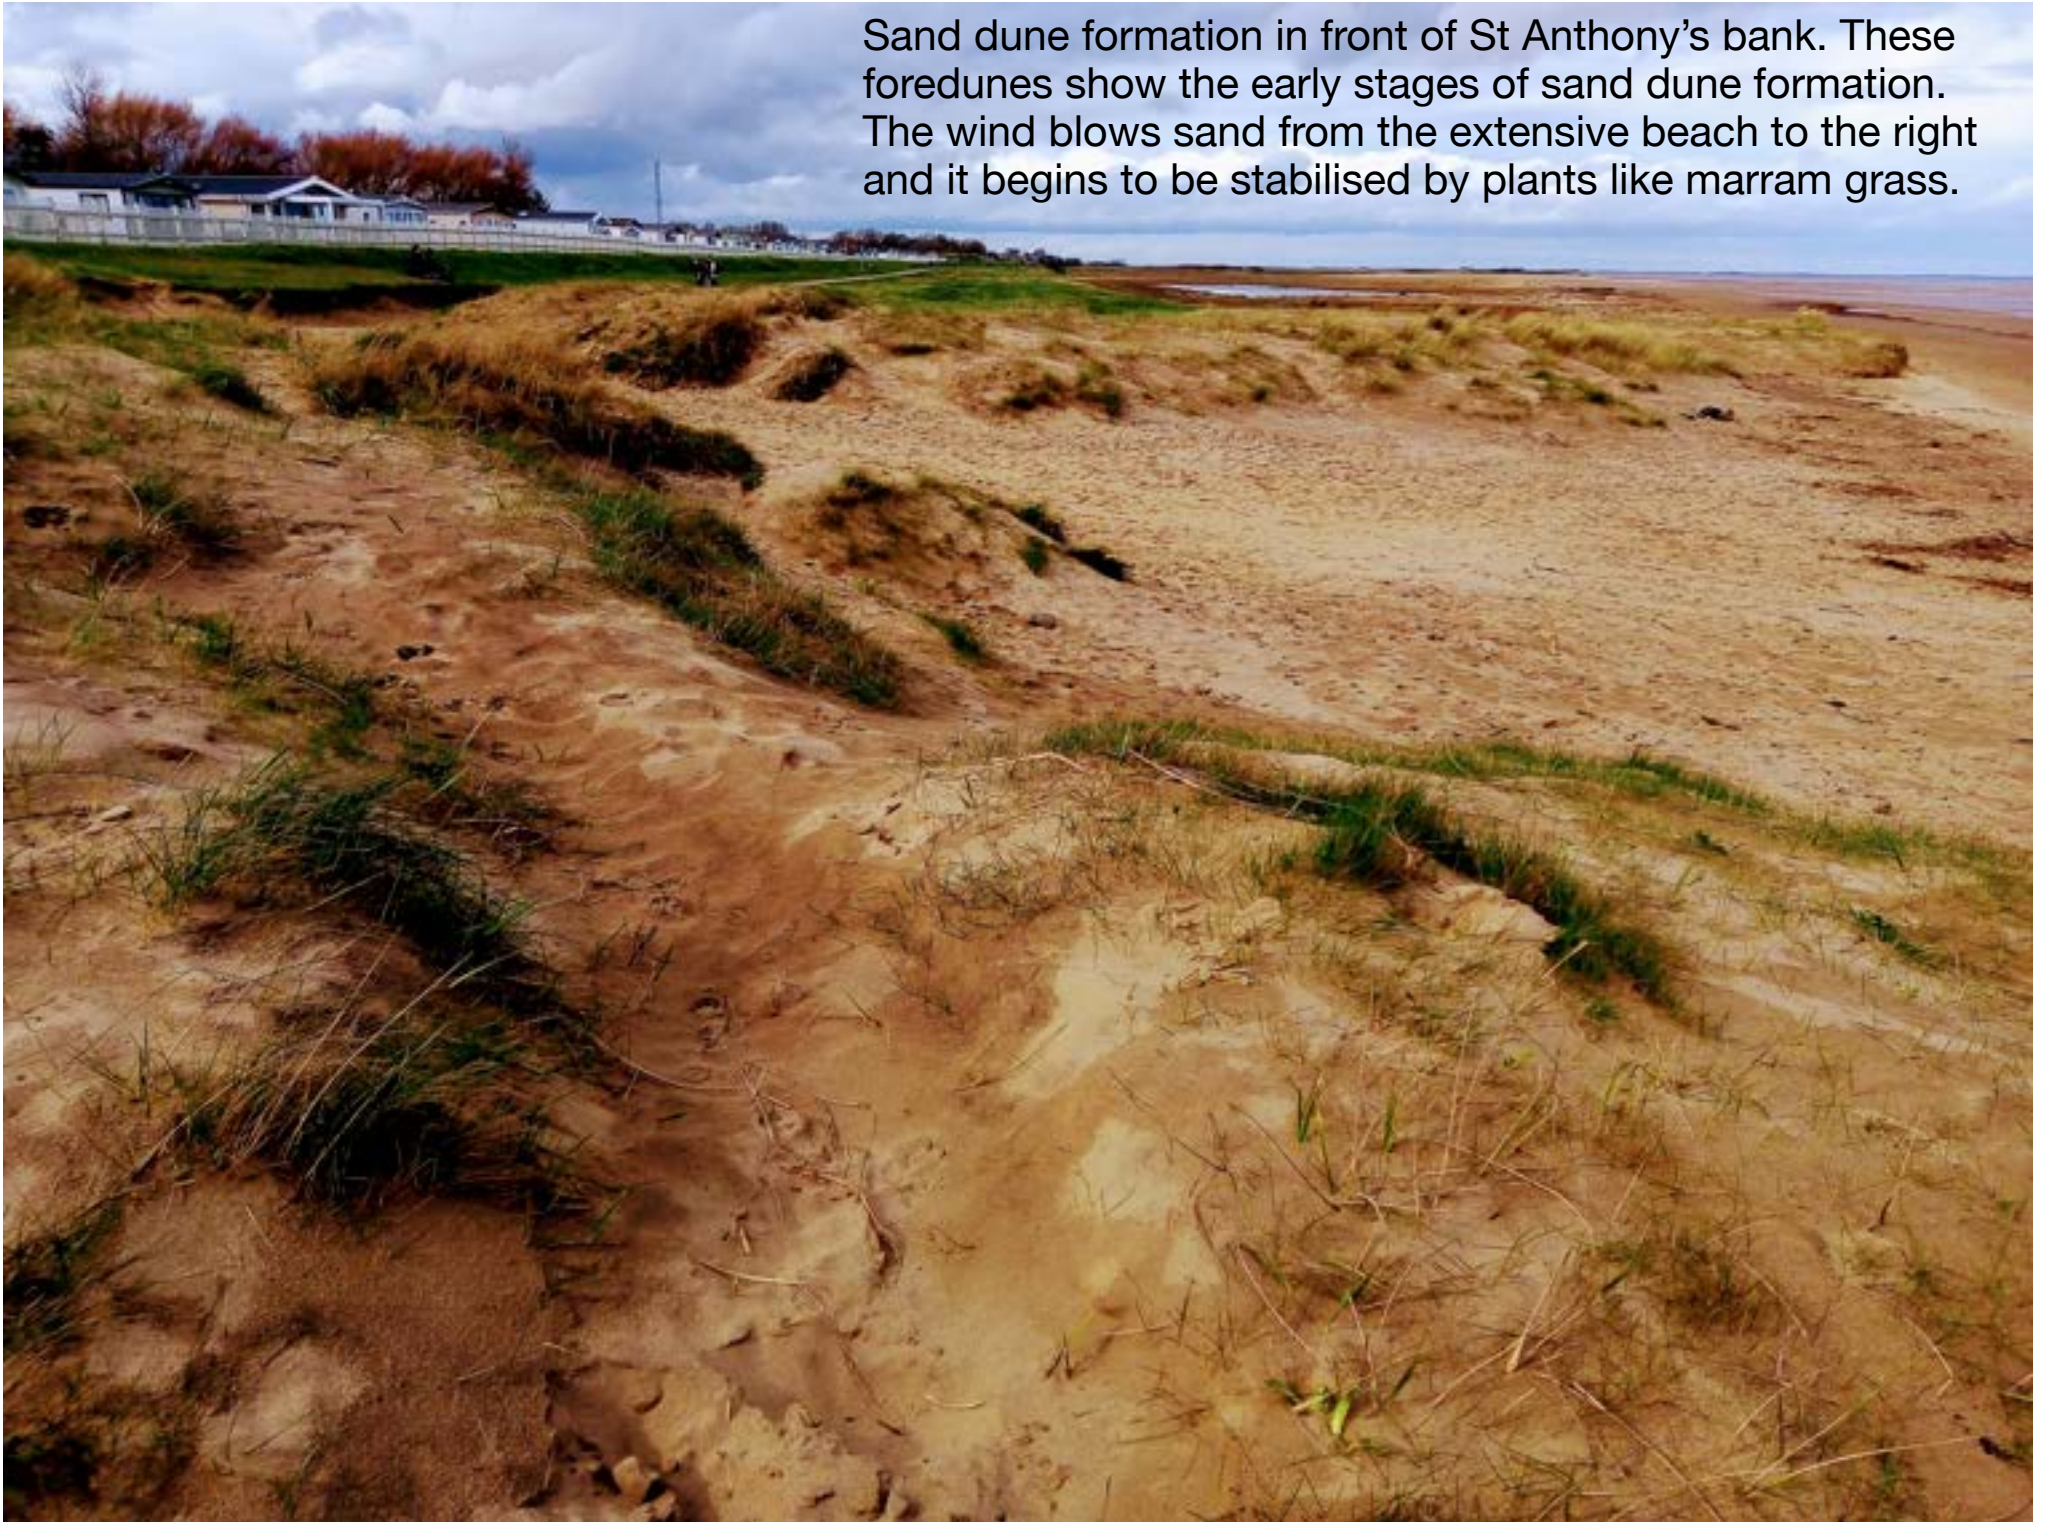
A view from St Anthony's bank, the defensive embankment, across the salt marsh to the newly formed dune belt on the developing whaleback. Both the dunes and the salt march act as natural, soft defences enhancing and preserving biodiversity at the same time.

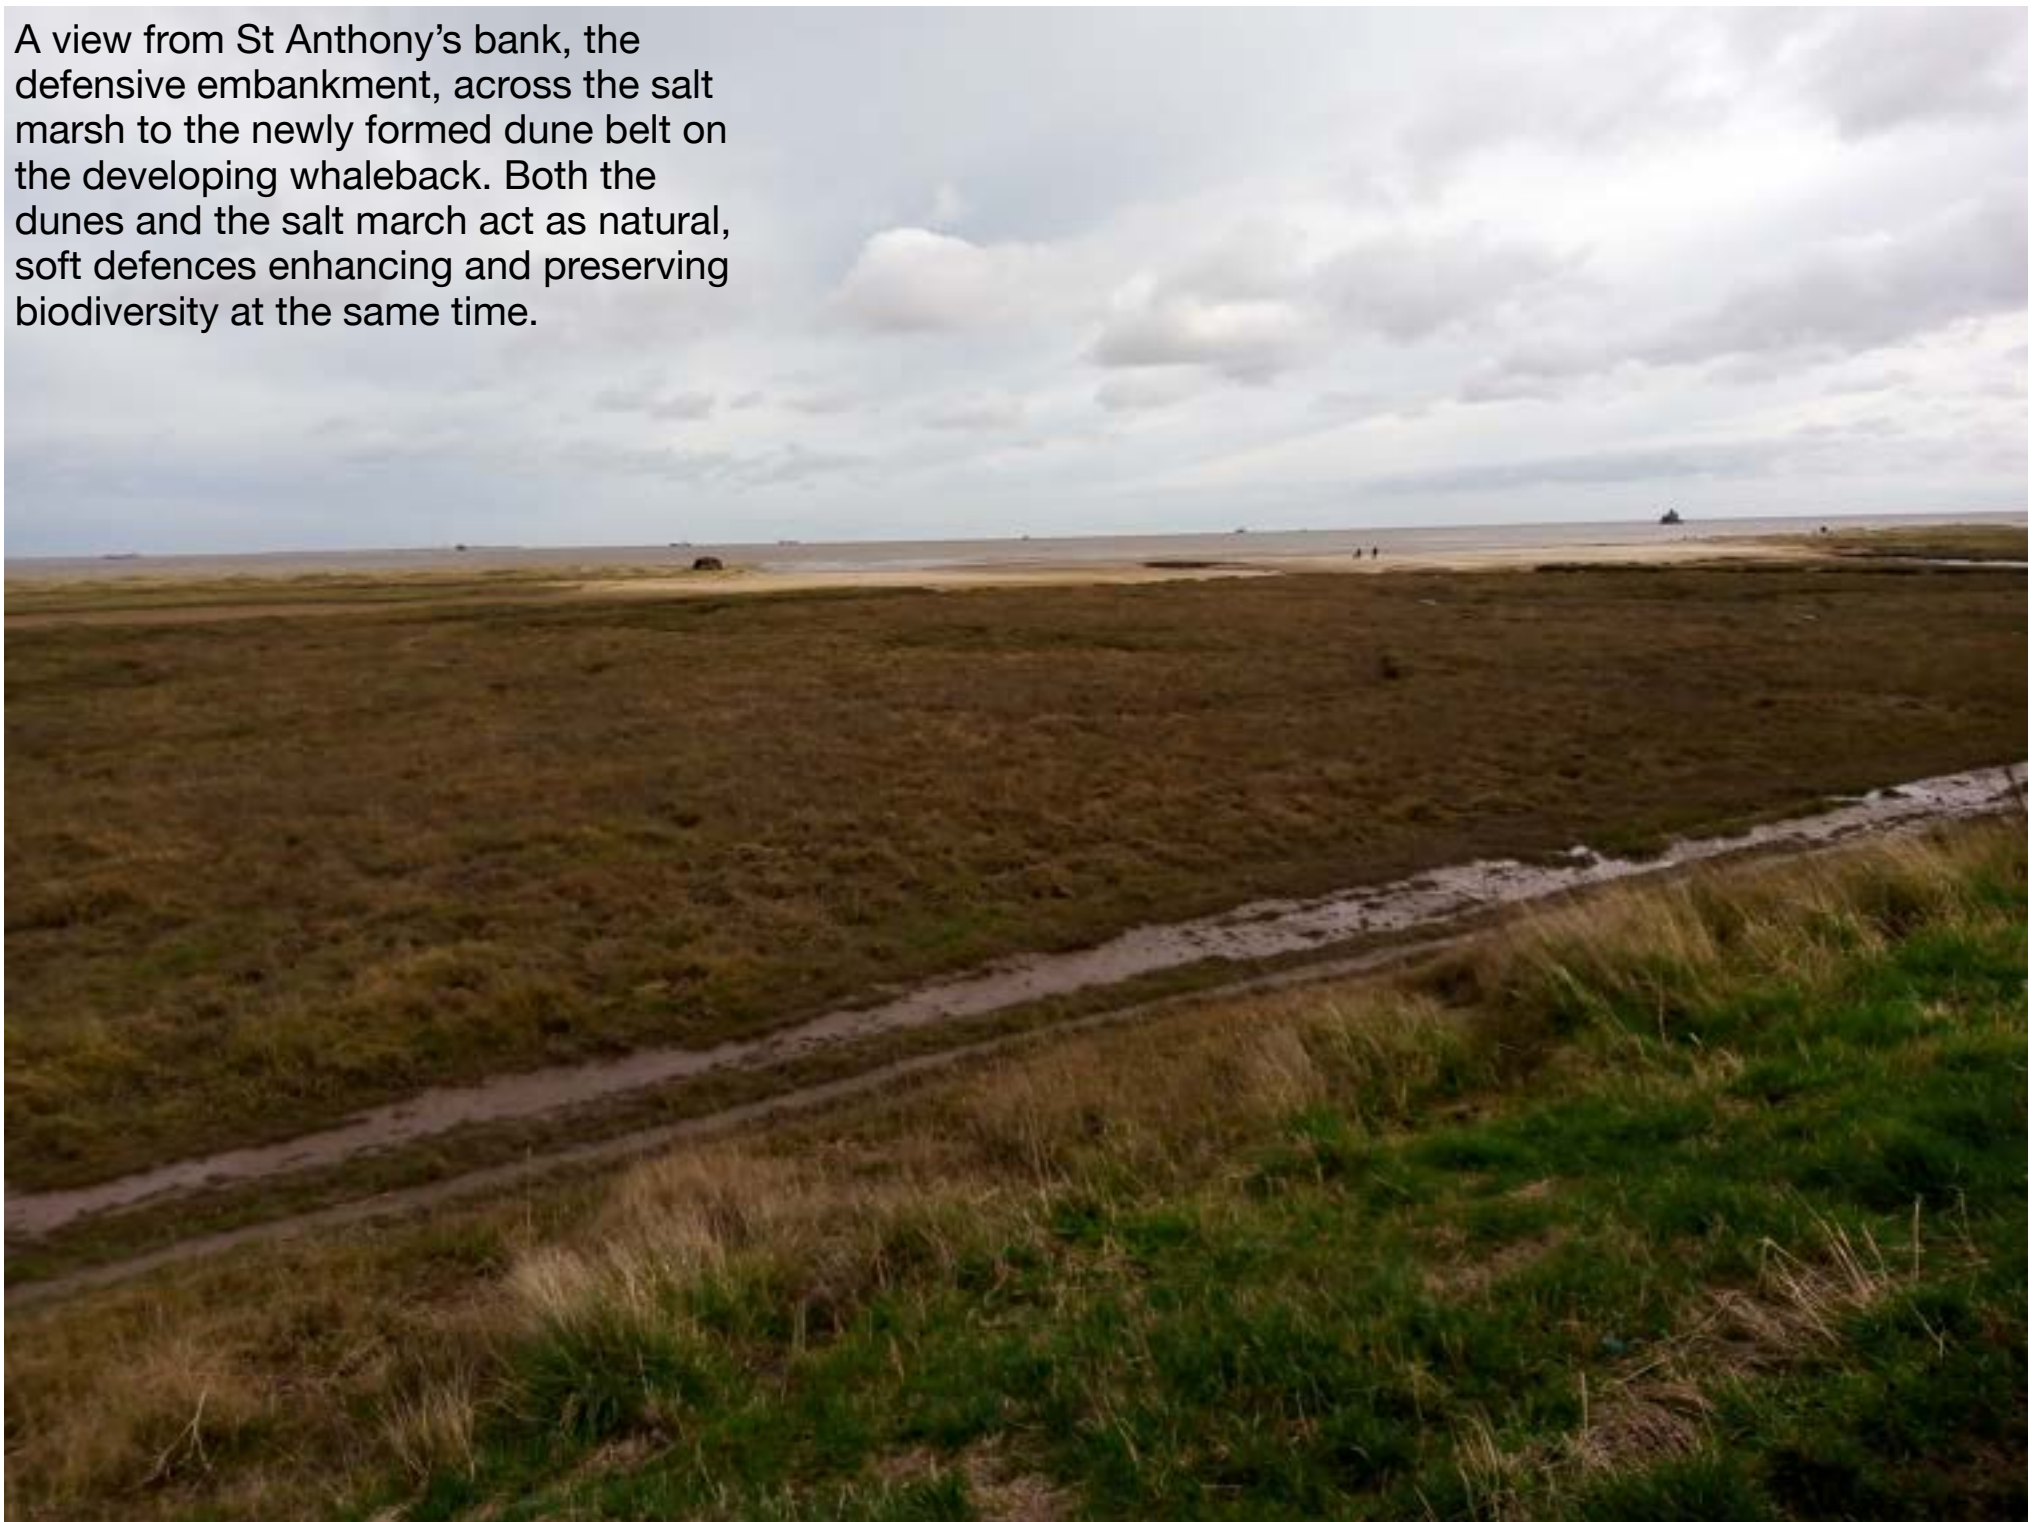
A channel outflow cuts through the natural defence offered by the salt marsh. This marsh area is only covered at high tides as seawater enters through the creeks, and over time further sedimentation will mean that it will be covered by fewer and fewer high tides if the progression is allowed to continue.
