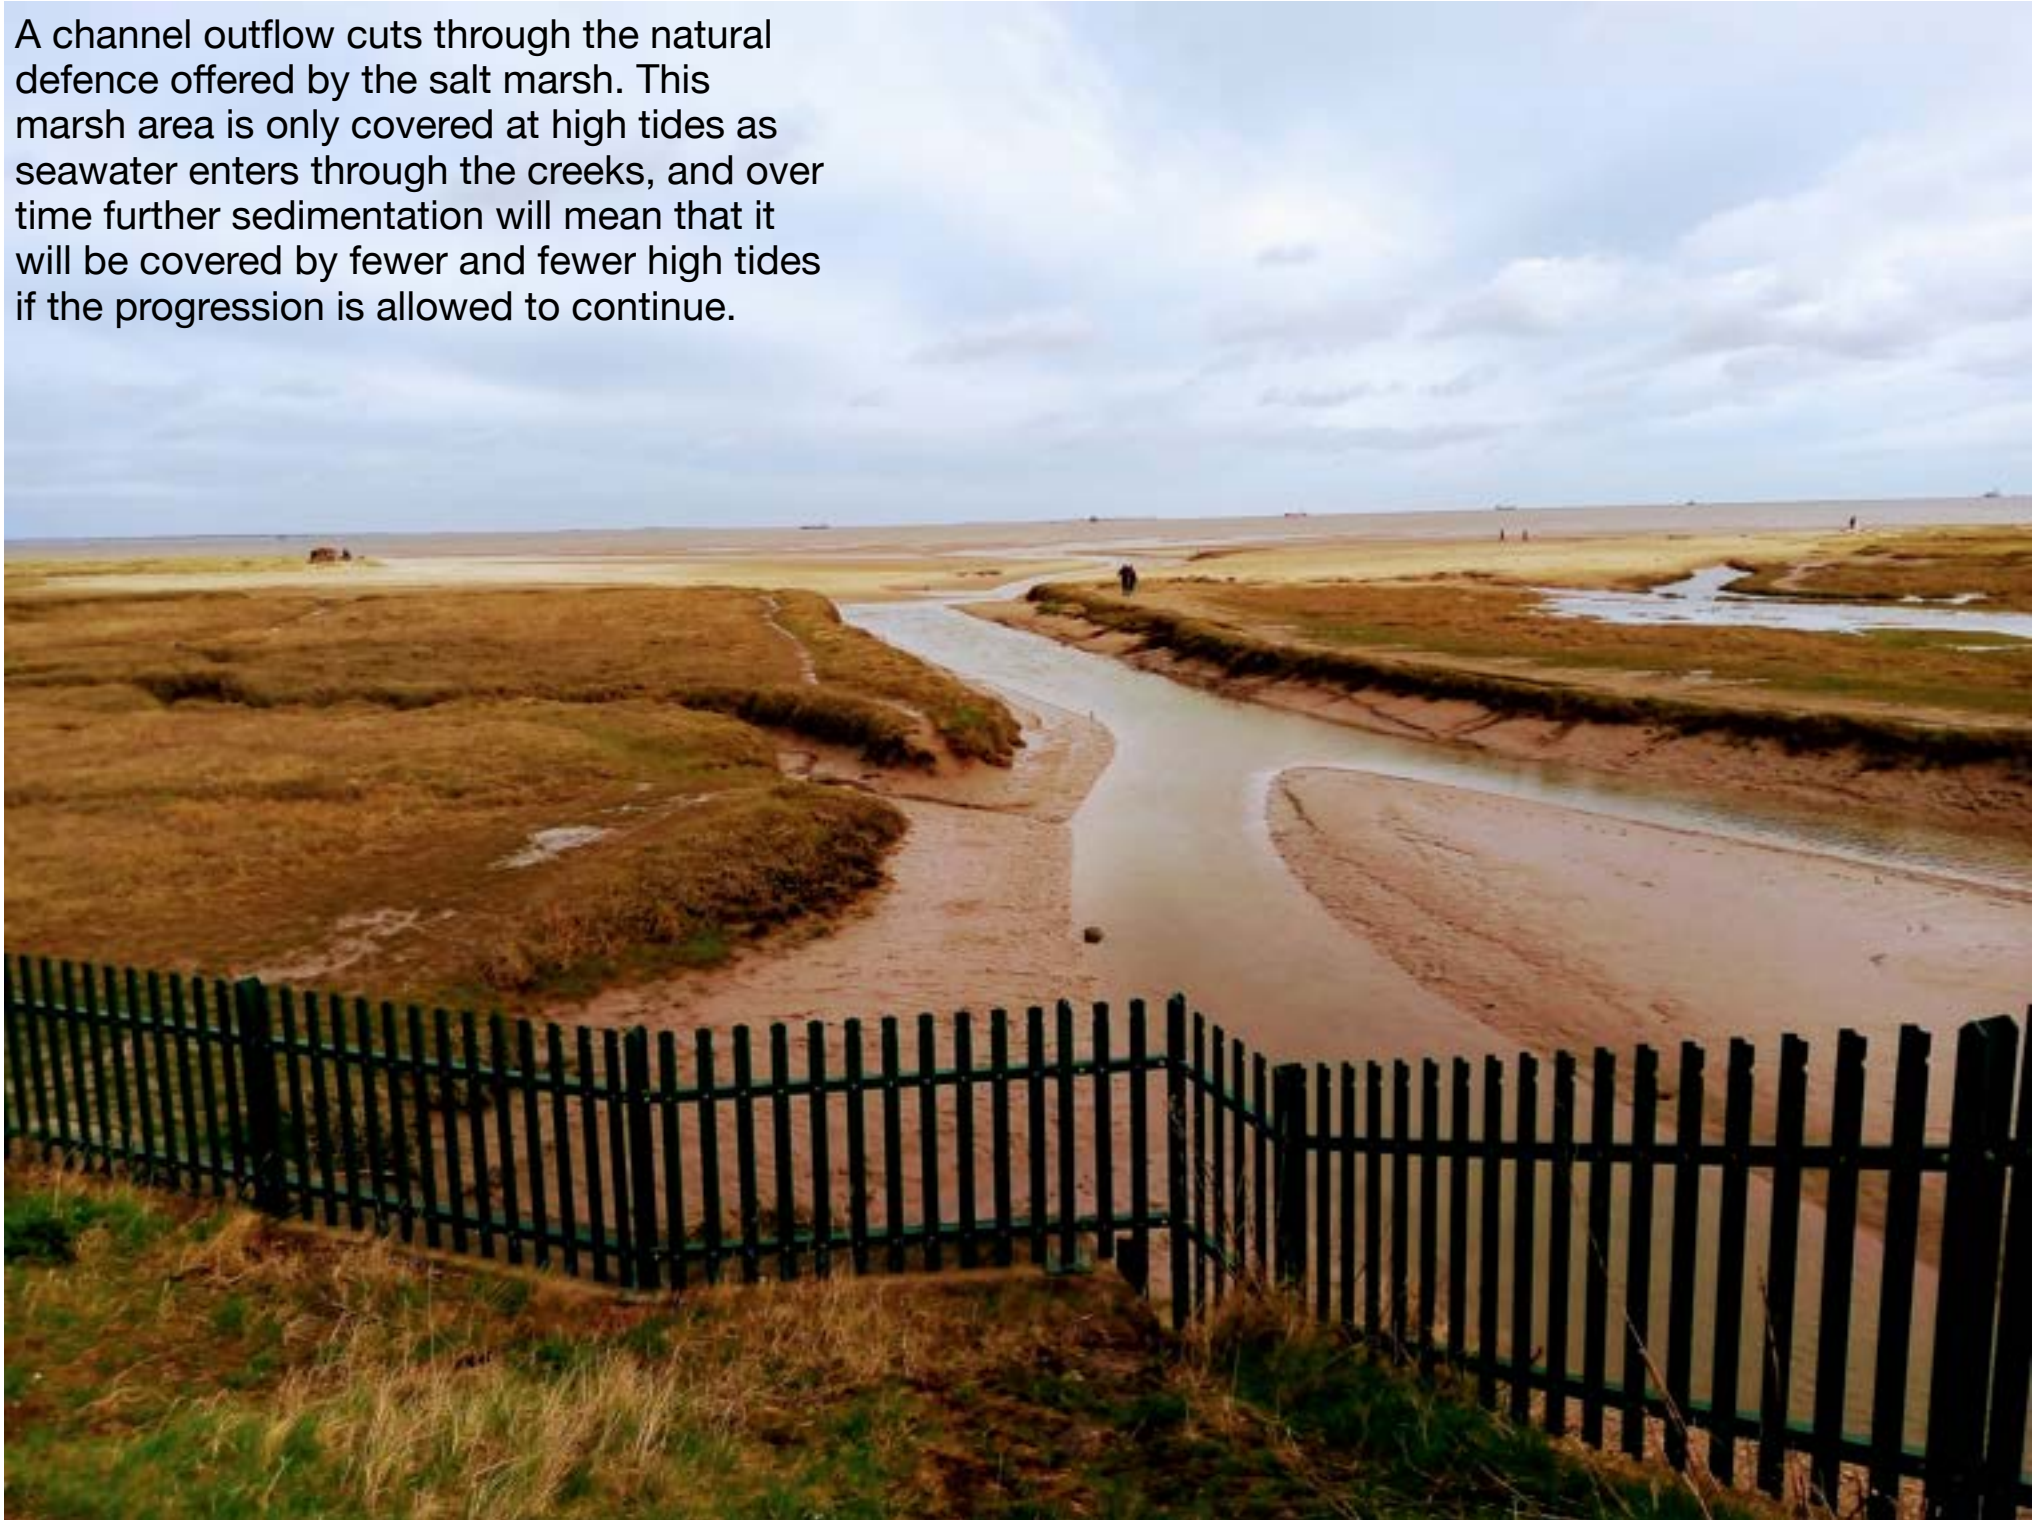
Extensive mudflats beyond St Anthony's bank at low tide. One of the main ebb and flow channels seen in the mid distance. This channel acts as a stream between tides and meanders and moves across the Mudflats. This area show rapid changes in form, almost with every tidal cycle.
