WATER MAIN BREAKS, WATER HAMMER, CORROSION, AND FATIGUE FAILURES

Robert A. Leishear, Ph.D., P.E., ASME Fellow
Leishear Engineering, LLC

ABSTRACT

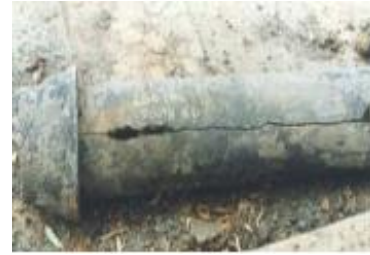
Figure 5: Cast Iron Cracking and Corrosion (Figs. 5 – 15 Reprinted by permission, WSAA [6])

In a second study, the Water Services Association of Australia (WSAA [6]) investigated underground water main and sewer services, where internal corrosion due to sewage was a failure mode in addition to water hammer. Figures 5 through 15 show the effects of cracking and corrosion on numerous materials.

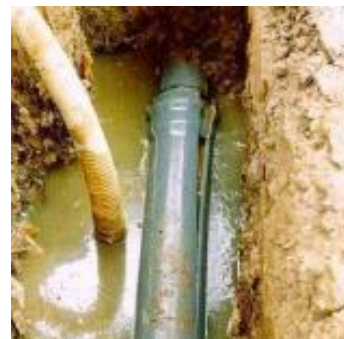
Figure 9: PVC Cracking (WSAA [6])

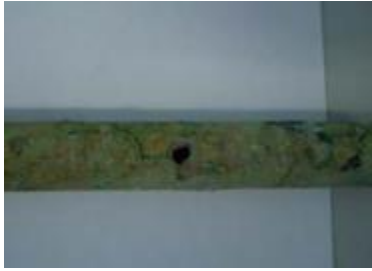
Figure 10: Copper Cracking and Corrosion (WSAA [6])

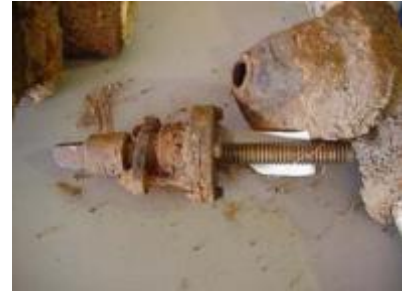
Figure 15: Corroded and Cracked Underground Valve (WSAA [6])

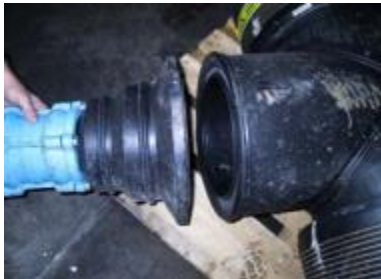
Figure 12: HDPE Butt Weld Crack (WSAA [6])

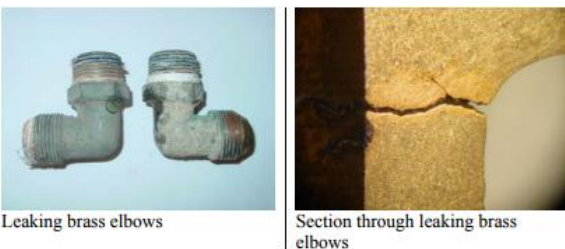
Leaking brass elbows

Section through leaking brass elbows

Figure 13: Cracks in Brass Elbows (WSAA [6])

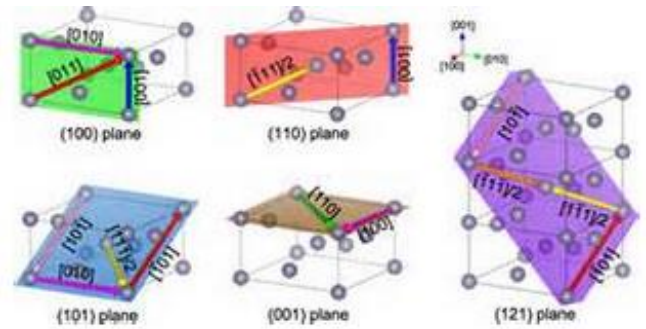
Figure 17: Slip Planes in BCC Crystals (Note that transgranular cracking may grow along any of the crystallographic planes without preference for a specific slip plane.)

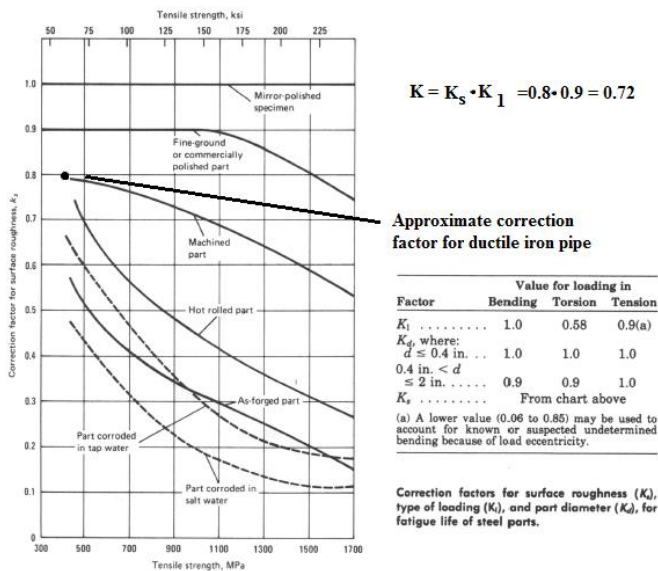
Figure 26: Fatigue Limit Correction Factor (ASM [11])

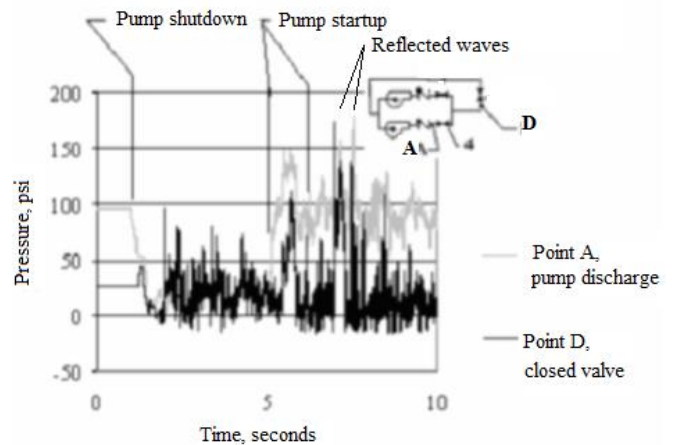
Figure 38: SRS, Pump Startup against a Closed Valve (Note that pump pressures nearly double during startups)

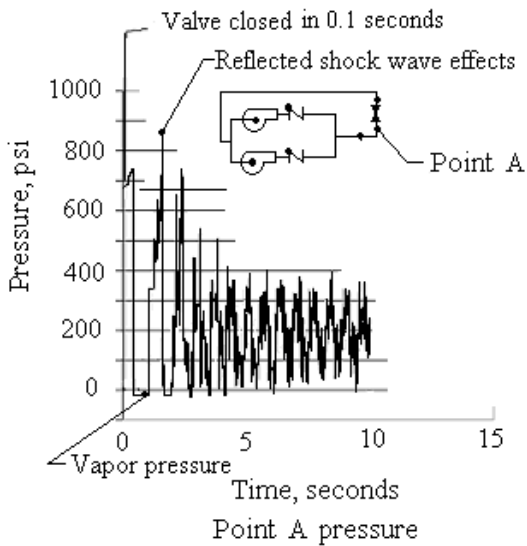
Figure 39: SRS, Cooling Coil Pressures Due to a Sudden Valve Closure (277 psi, Maximum Underground, Ductile Iron Piping Pressure. Note that the DLF < 4 for this suddenly applied load)

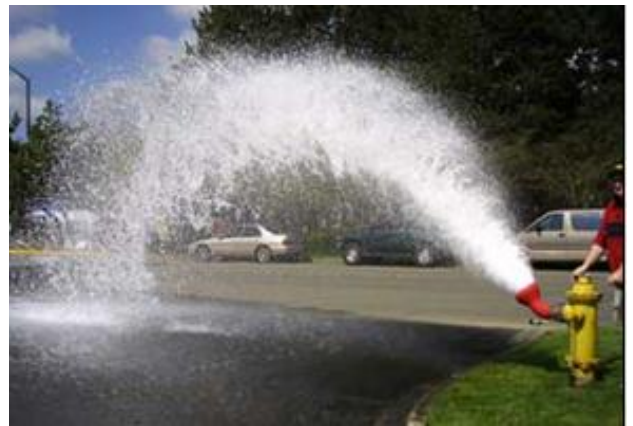
Figure 42: Annual Fire Hydrant Testing

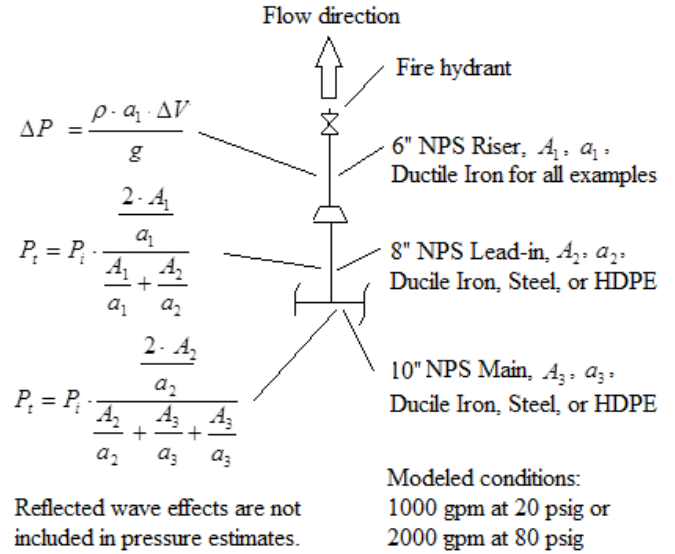
Figure 44: Simplified Water Main and Fire Hydrant Models
