# Inspection Report

**Property Address:**  
1234 Anystreet  
Chicago IL 60647

**Above Grade Home Inspectors**

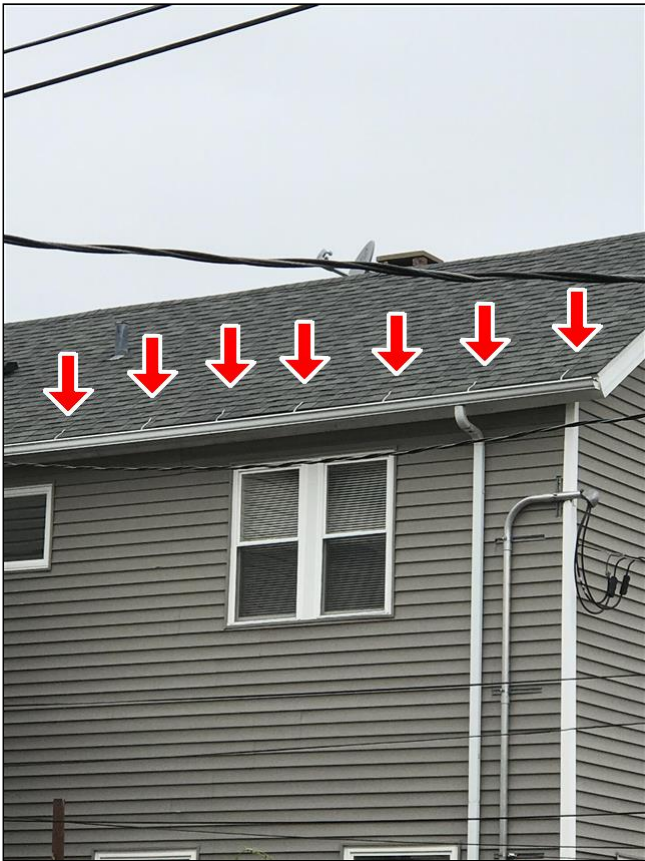
1.3 Item 1(Picture) Gutter hangers are installed over roofing shingles. Nails driven through the top of the shingles may lead to moisture intrusion. Repairs are needed.

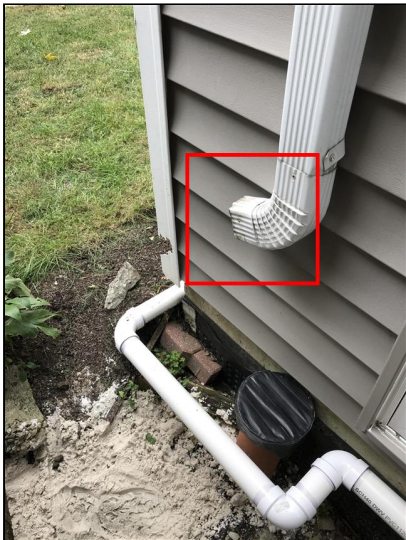
1.3 Item 3(Picture) Downspout drains too close to the building, further deterioration may occur if not corrected.

| Items |
|---|
| Downspout drains too close to the building, this can cause uneven swelling of expansive soils and may result in shifting and cracking foundations, sidewalks, driveways and parking lots next to the building. Have a licensed contractor extend the downspouts to drain at least 6 feet from the structure. |

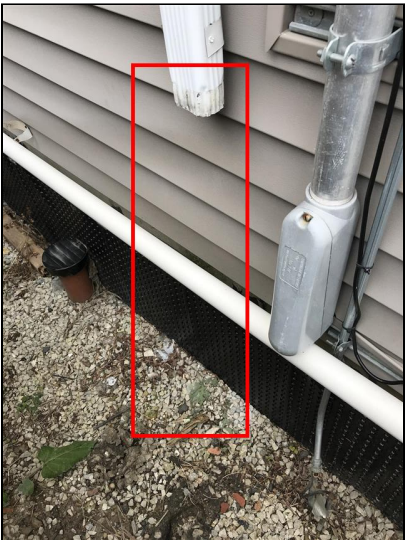
1.3 Item 4(Picture) Downspout drains too close to the building, further deterioration may occur if not corrected.

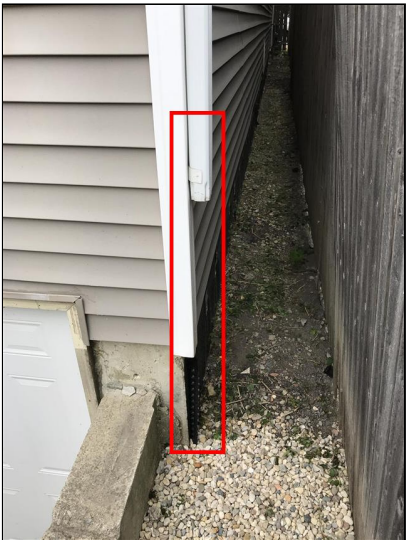
1.3 Item 5(Picture) Downspout drains too close to the building, further deterioration may occur if not corrected.

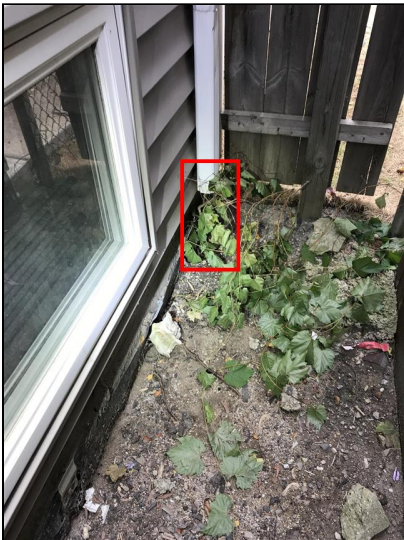
1.3 Item 6(Picture) Downspout drains too close to the building, further deterioration may occur if not corrected.

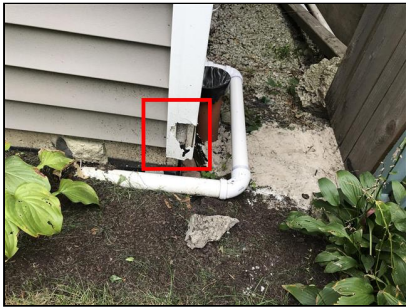
2.0 Item 1(Picture) Vinyl siding corner piece is damaged at the right side of home (when facing front).

- 2.0 Wall Cladding Flashing and Trim
- Comments: Inspected, Repair or Replace
- The Vinyl siding at the exterior in areas is damaged. Further deterioration can occur if not corrected. A qualified contractor should inspect and repair as needed.
- 2.1 Doors (Exterior)
- Comments: Inspected, Repair or Replace
- Have a licensed contractor repair or replace rear sliding patio door. Further deterioration may occur if not corrected.

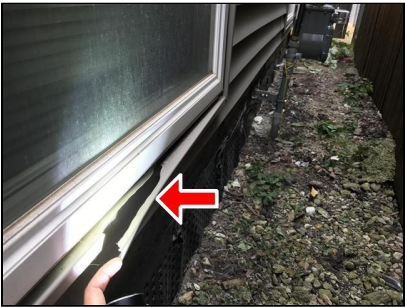
2.0 Item 2(Picture) Vinyl siding at left basement window (when facing front) is damaged.

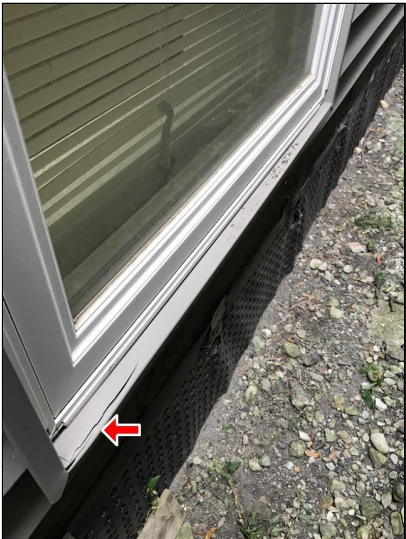
2.0 Item 3(Picture) Vinyl siding at right basement window (when facing front) is damaged.

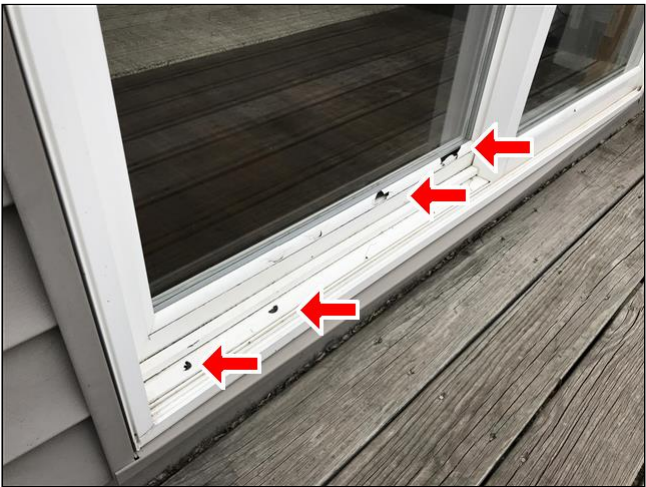
2.1 Item 1(Picture) Rear patio door is damaged at exterior. Repair or replacement needed.

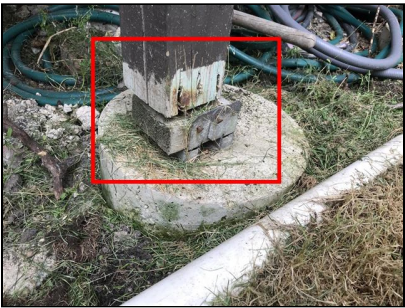
2.3 Item 1(Picture) Front porch support post is not properly attached to pier. Repairs are needed.

Have a licensed contractor repair or replace front and rear porch structures as needed. Further deterioration may occur if not corrected.

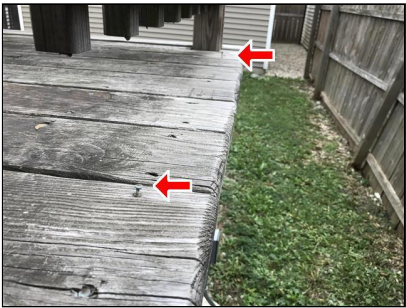
2.3 Item 2(Picture) Rear porch is weathered/deteriorated. There are nails that are backing out of the floor boards that may pose a trip hazard. Safety hazard.

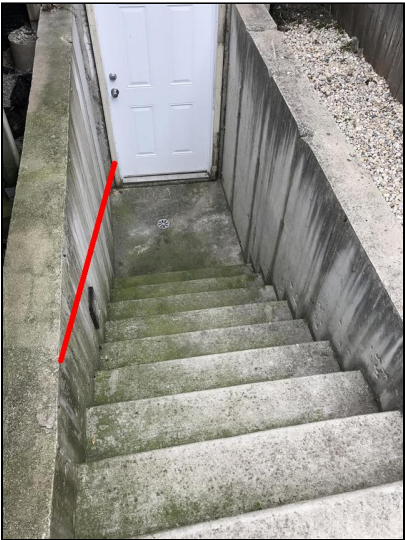
2.3 Item 3(Picture) Missing handrail at stairs to basement (rear). Safety hazard.

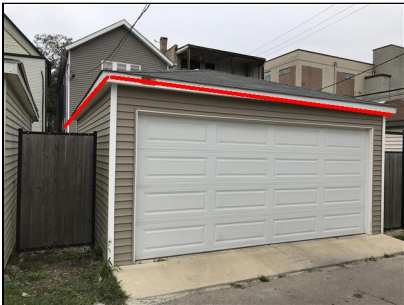
3.7 Item 1(Picture) Garage lacks gutters and downspouts.

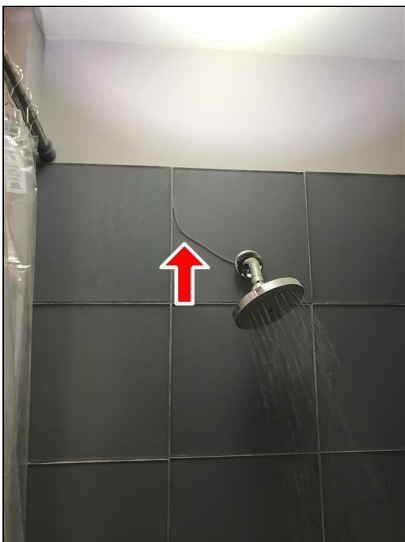
4.1 Item 1(Picture) Cracked wall tile in shower at first floor bathroom. This is cosmetic and for your information only.

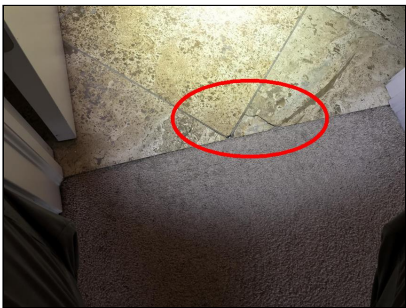
4.2 Item 1(Picture) Damaged tile at entrance to master bathroom (from master bedroom).

Have a licensed contractor repair or replace damaged tile as needed.

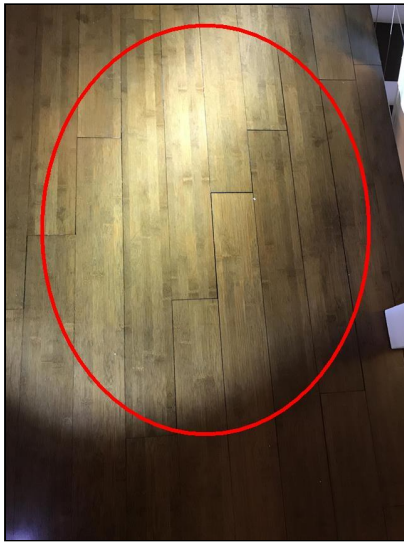
4.2 Item 2(Picture) Noticeable gaps at flooring at second floor.

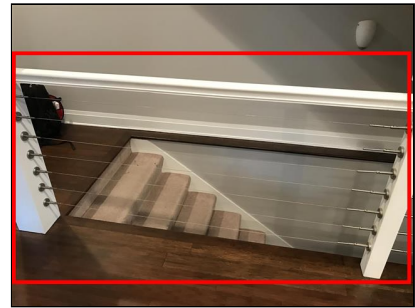
4.3 Item 2(Picture) Guardrails at landing are easily climbable (ladder effect) by small children. Safety hazard.

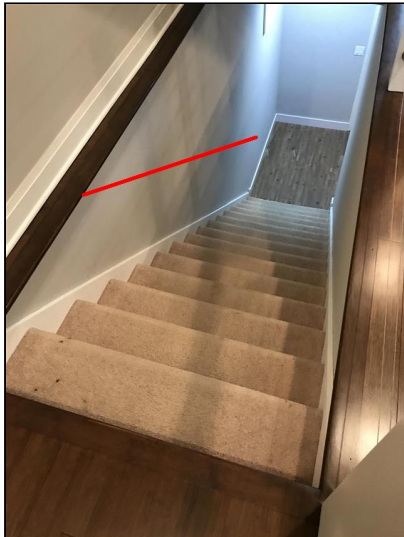
4.3 Item 3(Picture) Stairs to basement are missing handrail. Safety hazard.

The hand/guard rail for the stairs to basement is missing. A fall or injury could occur if not corrected. A handrail should be installed for safety A qualified contractor should perform the work.

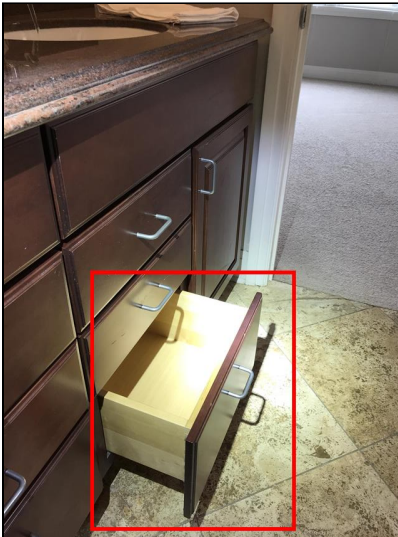
4.4 Item 1(Picture) Master bathroom cabinet drawer does not operate smoothly.

Drawer track in master bath does not work smoothly. I recommend repair or replace as necessary.

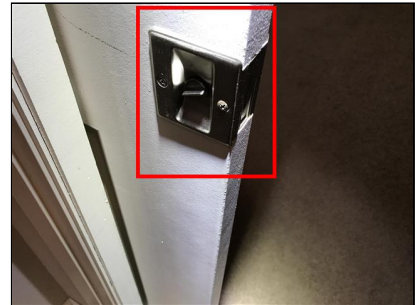
4.5 Item 1(Picture) Pocket door hardware does not engage properly at master bathroom.

Have a licensed contractor repair or replace the doors/hardware in order for them to close properly.

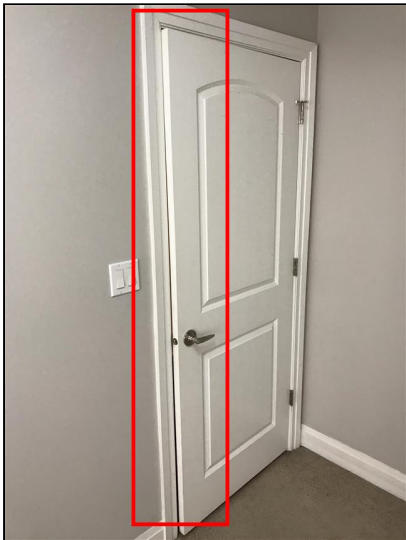
4.5 Item 2(Picture) Front bedroom door does not close properly due to alignment.

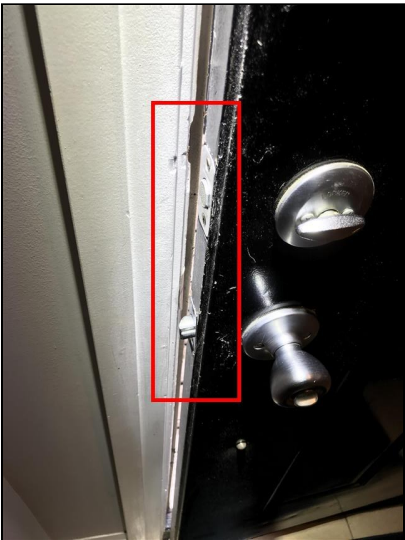
4.5 Item 3(Picture) Main entry door hardware sticks at door frame.

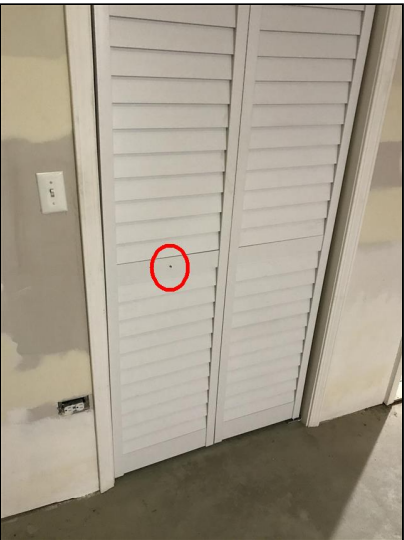
4.5 Item 4(Picture) Missing door hardware at mechanical room bi fold door.

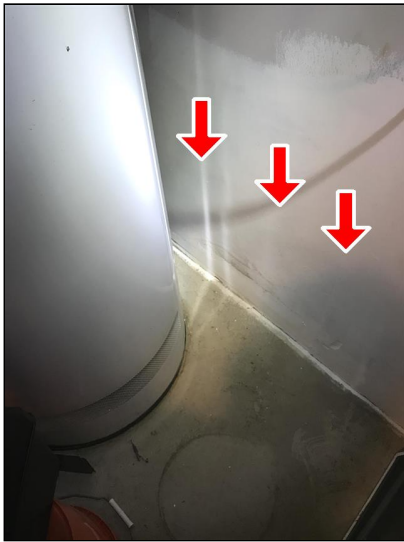
5.0 Item 1(Picture) Area where elevated moisture levels were detected.

**Comments:** Inspected, Repair or Replace  
Have a licensed contractor remove wall covering and inspect structure below for moisture damage.

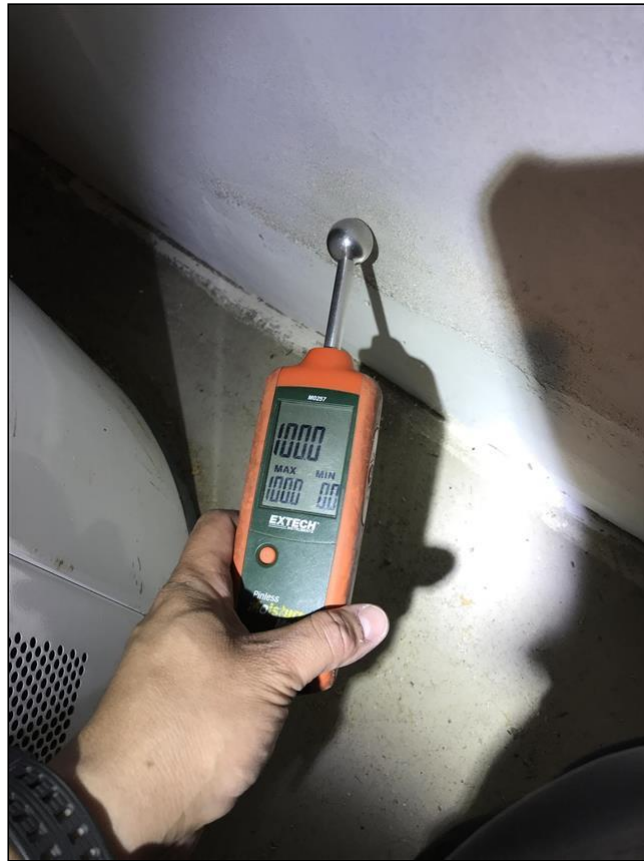
5.0 Item 2(Picture) Moisture meter detected 100 percent moisture (live leak) in drywall behind hot water heater. Repairs are needed.

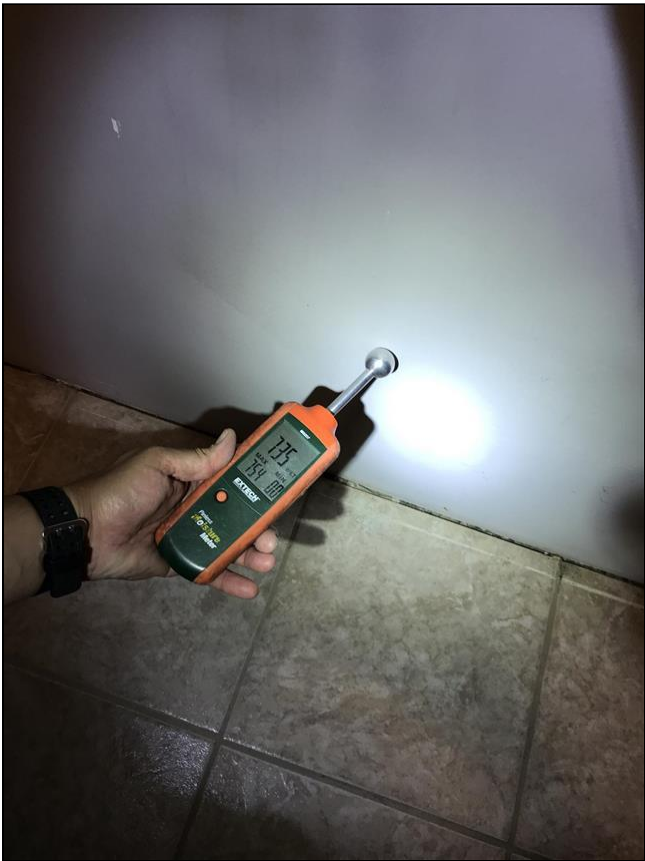
5.0 Item 3(Picture) Moisture meter detected 73.5 percent moisture (live leak) in laundry room wall (wall adjacent to hot water heater). Repairs are needed.

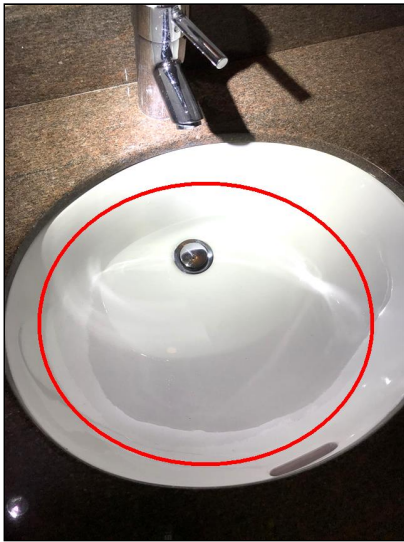
6.0 Item 1(Picture) Master bathroom sink (on right) is slow to drain.

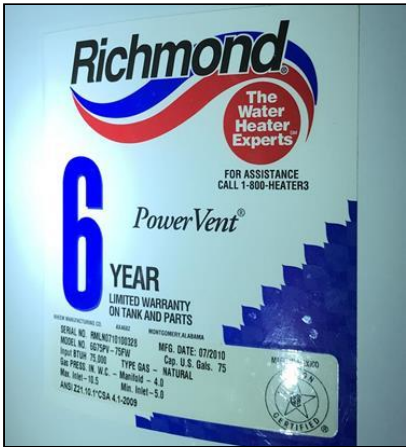
6.2 Item 1(Picture) The water heater appears to be leaking at bottom (visible rust). A replacement may be needed. Further deterioration may occur if not

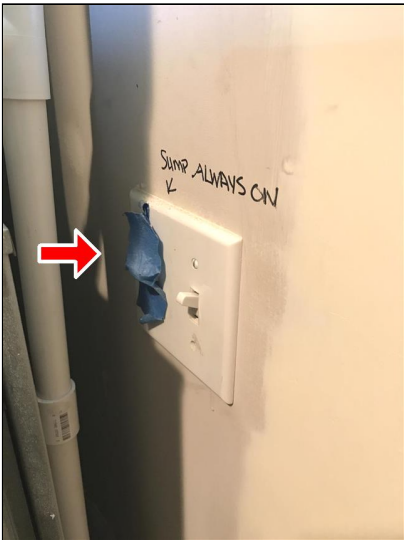
6.6 Item 1(Picture) Sump pump may be accidentally turned off due to switch placement.

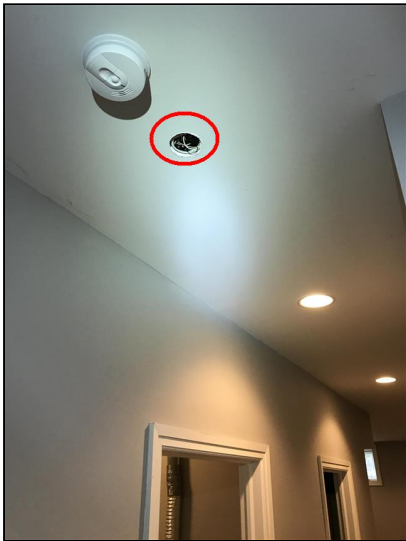
7.3 Item 1(Picture) Open electrical junction box in basement ceiling.

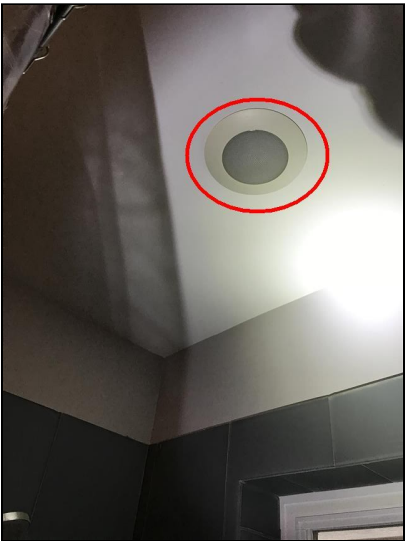
7.4 Item 1(Picture) Light fixture in bathroom shower on first floor did not function at the time of inspection.

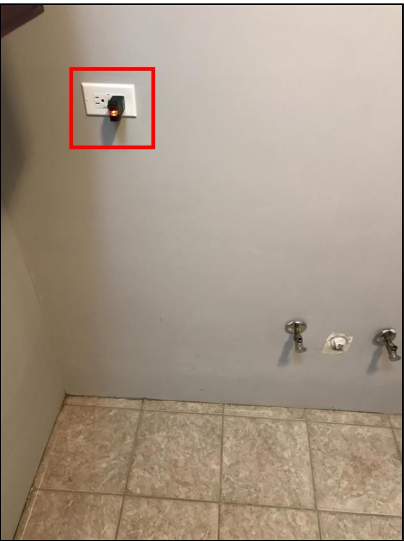
7.5 Item 1(Picture) GFCI did not trip at the laundry room. Shock hazard.

Have a licensed electrician repair the faulty GFCI in the laundry room. Shock hazard.
- 7.6 Location of Main and Distribution Panels

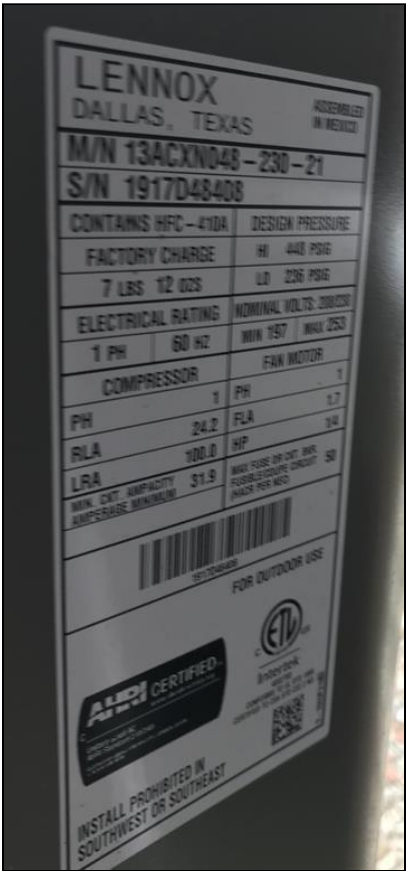
8.8 Item 1(Picture) Air conditioning condenser manufactured 04/17.

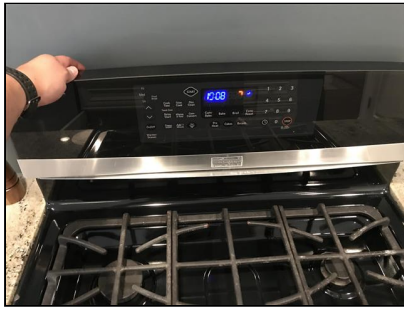
10.0 Item 1(Picture) Stove/range is missing anti tip bracket. Safety hazard.

Anti-tip brackets are metal devices designed to prevent freestanding ranges from tipping. They are normally attached to a rear leg of the range or screwed into the wall behind the range, and are included in all installation kits. A unit that is not equipped with these devices may tip over if enough weight is applied to its open door, such as that from a large Thanksgiving turkey, or even a small child. A falling range can crush, scald, or burn anyone caught beneath. Have a licensed contractor install anti tip bracket.

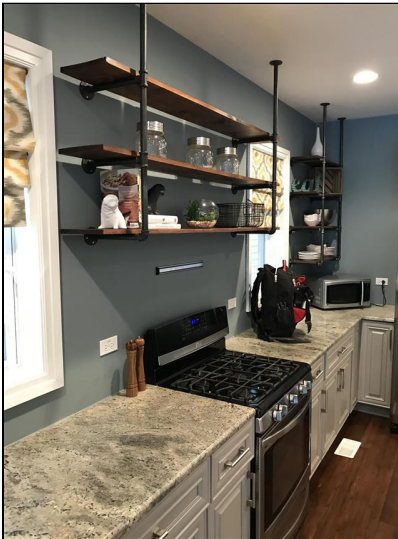
10.1 Item 1(Picture) The range hood fan is missing.

I recommend repair or replace as needed.

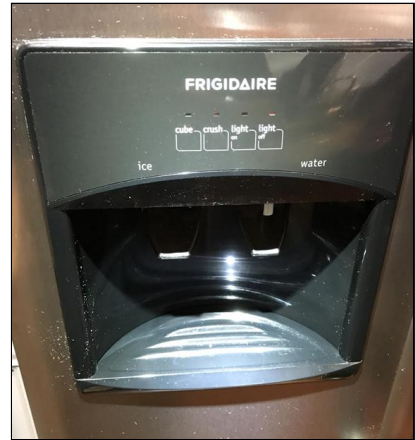
10.3 Item 1(Picture) Refrigerator water dispenser and ice maker did not function at the time of inspection.

Have a licensed contractor repair or replace water line as needed.

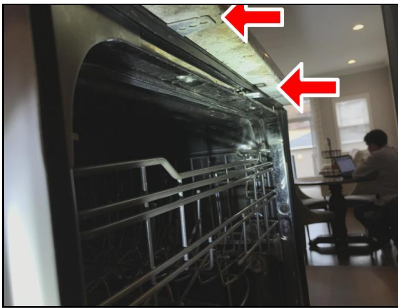
10.4 Item 1(Picture) The dishwasher is loose and needs securing to underside of countertop (using a proper length screw).

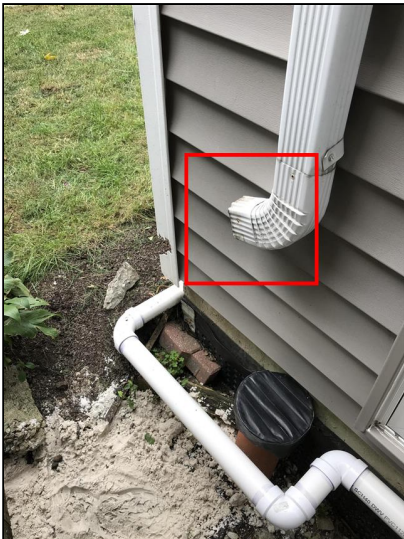
1.3 Item 3(Picture) Downspout drains too close to the building, further deterioration may occur if not corrected.

Downspout drains too close to the building, this can cause uneven swelling of expansive soils and may result in shifting and cracking foundations, sidewalks, driveways and parking lots next to the building. Have a licensed contractor extend the downspouts to drain at least 6 feet from the structure.

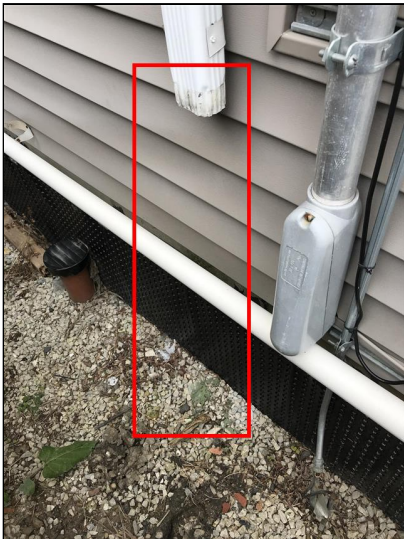
1.3 Item 4(Picture) Downspout drains too close to the building, further deterioration may occur if not corrected.

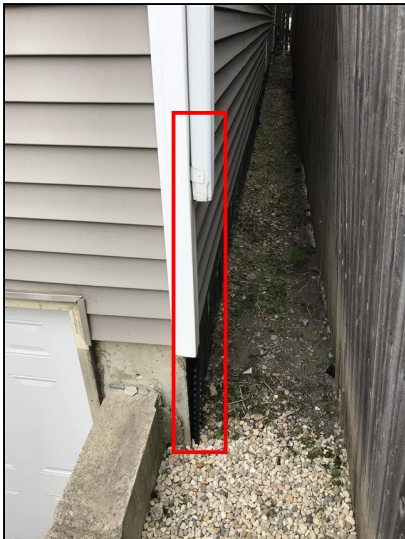
1.3 Item 5(Picture) Downspout drains too close to the building, further deterioration may occur if not corrected.

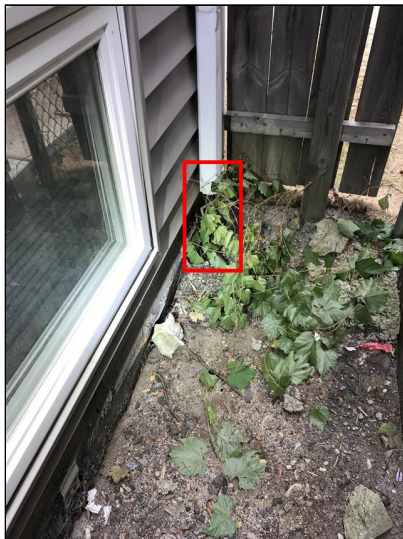
1.3 Item 6(Picture) Downspout drains too close to the building, further deterioration may occur if not corrected.

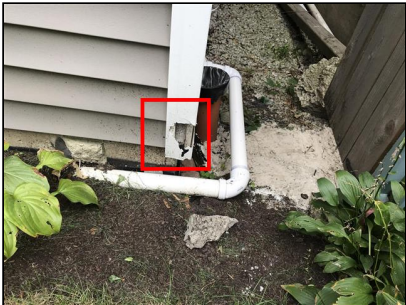
2.0 Item 1(Picture) Vinyl siding corner piece is damaged at the right side of home (when facing front).

The Vinyl siding at the exterior in areas is damaged. Further deterioration can occur if not corrected. A qualified contractor should inspect and repair as needed.

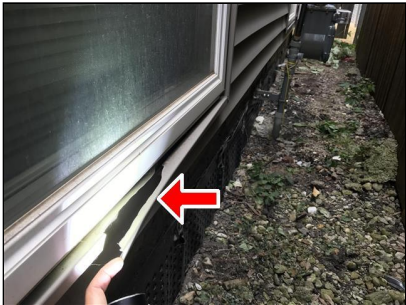
2.0 Item 2(Picture) Vinyl siding at left basement window (when facing front) is damaged.

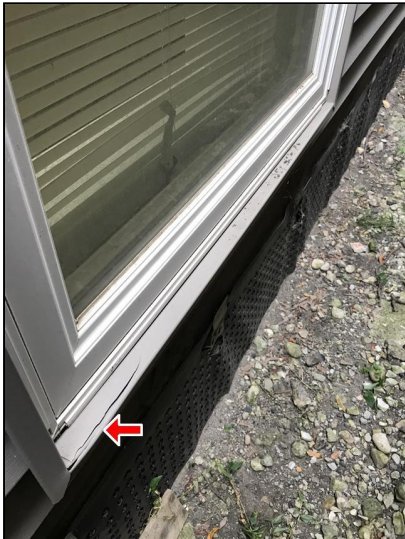
2.0 Item 3(Picture) Vinyl siding at right basement window (when facing front) is damaged.

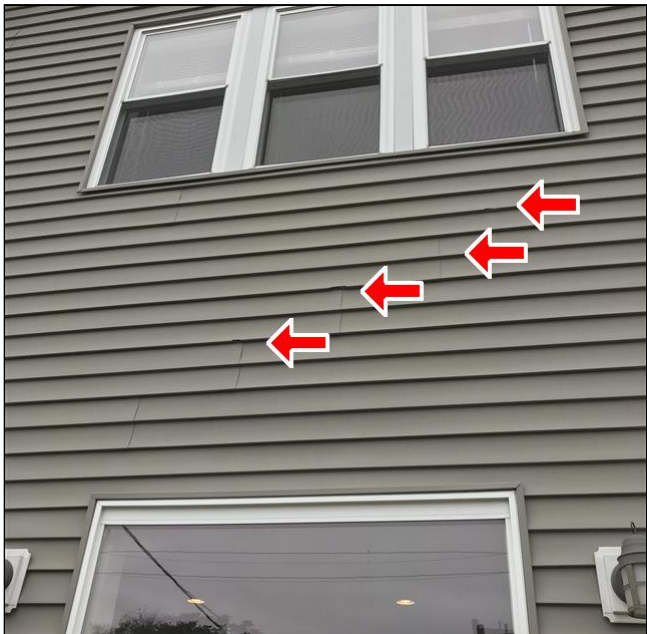
2.0 Item 4(Picture) Siding is damaged at rear of home.

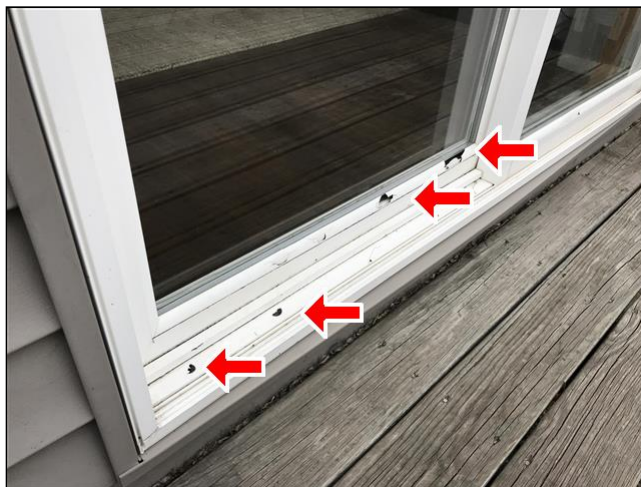
2.1 Item 1(Picture) Rear patio door is damaged at exterior. Repair or replacement needed.

Have a licensed contractor repair or replace rear sliding patio door. Further deterioration may occur if not corrected.

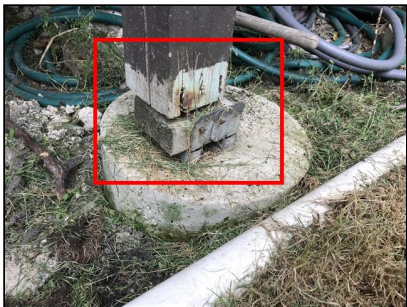
2.3 Item 1(Picture) Front porch support post is not properly attached to pier. Repairs are needed.

Have a licensed contractor repair or replace front and rear porch structures as needed. Further deterioration may occur if not corrected.

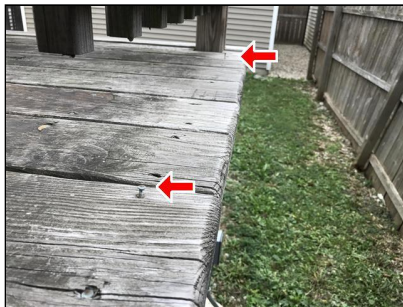
2.3 Item 2(Picture) Rear porch is weathered/deteriorated. There are nails that are backing out of the floor boards that may pose a trip hazard. Safety hazard.

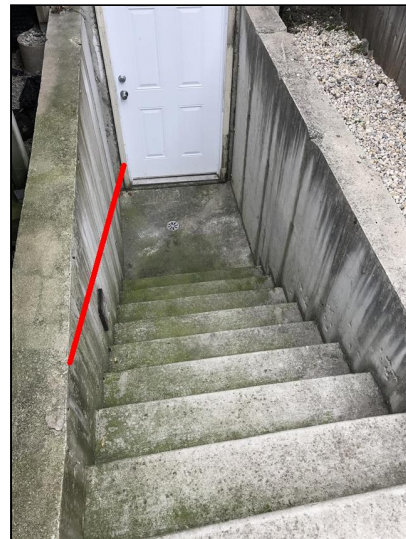
2.3 Item 3(Picture) Missing handrail at stairs to basement (rear). Safety hazard.

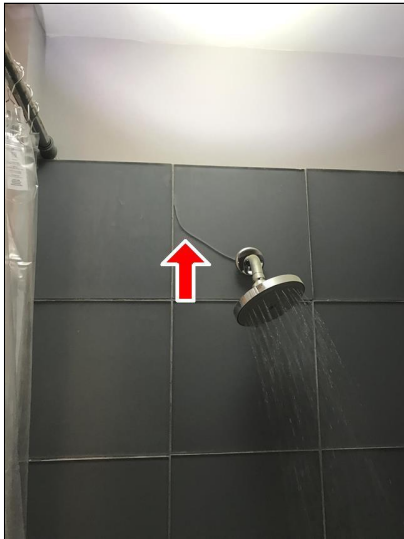
4.1 Item 1(Picture) Cracked wall tile in shower at first floor bathroom. This is cosmetic and for your information only.

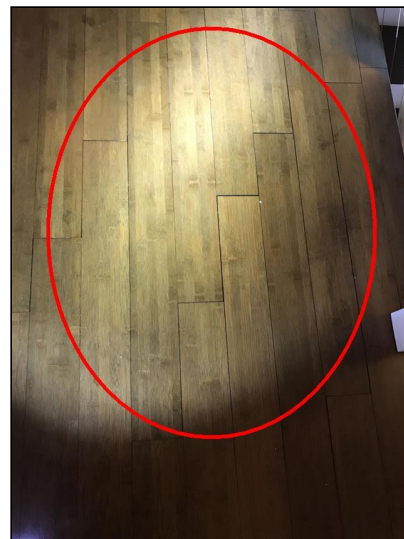
4.2 Item 2(Picture) Noticeable gaps at flooring at second floor.

Have a licensed contractor repair or replace damaged tile as needed.

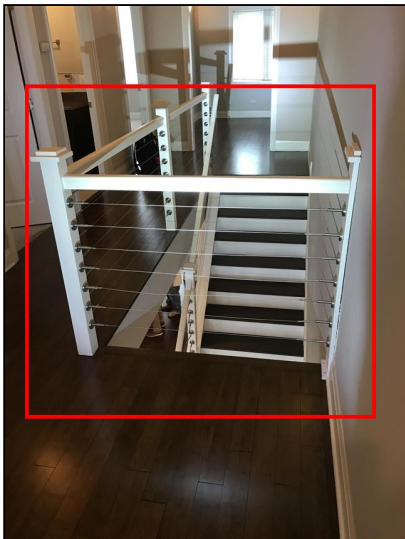
4.3 Item 1(Picture) Guardrails at landing are easily climbable (ladder effect) by small children. Safety hazard.

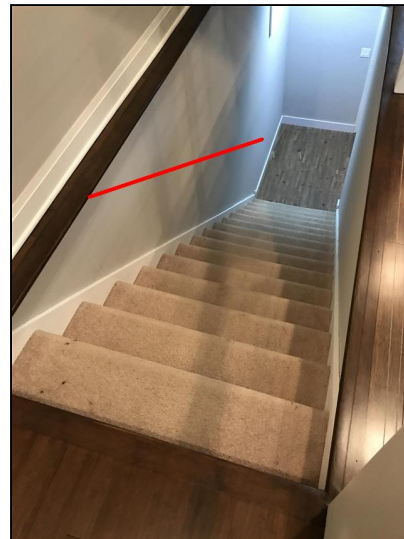
4.3 Item 3(Picture) Stairs to basement are missing handrail. Safety hazard.

The hand/guard rail for the stairs to basement is missing. A fall or injury could occur if not corrected. A handrail should be installed for safety A qualified contractor should perform the work.

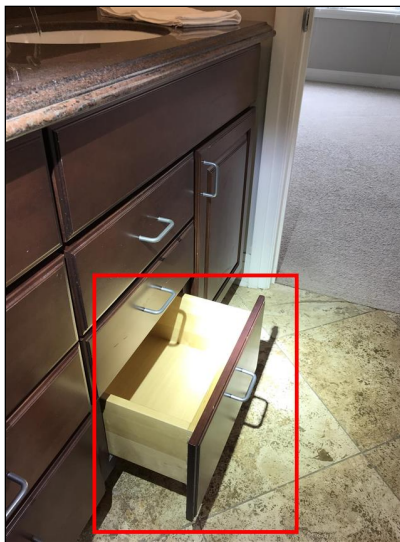
4.4 Item 1(Picture) Master bathroom cabinet drawer does not operate smoothly.

Drawer track in master bath does not work smoothly. I recommend repair or replace as necessary.

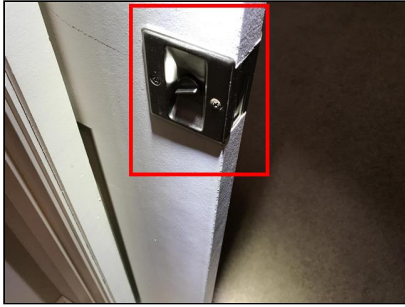
4.5 Item 1(Picture) Pocket door hardware does not engage properly at master bathroom.

Have a licensed contractor repair or replace the doors/hardware in order for them to close properly.

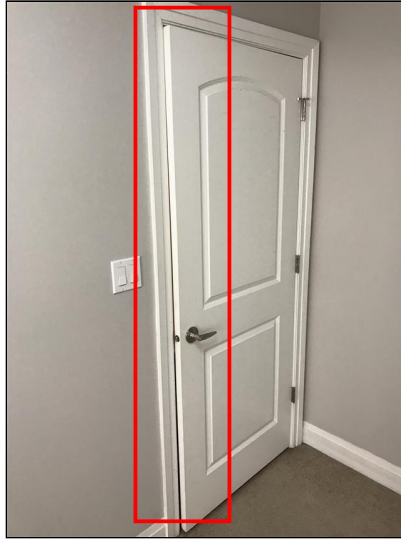
4.5 Item 2(Picture) Front bedroom door does not close properly due to alignment.

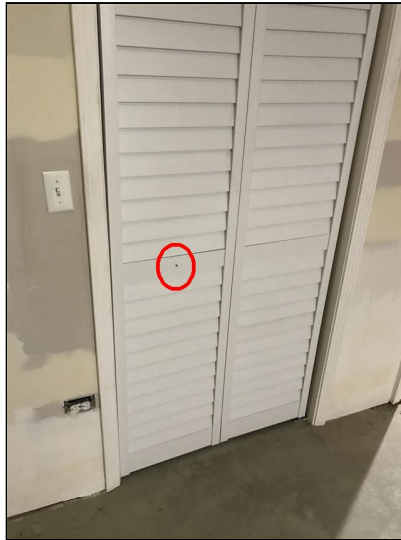
4.5 Item 4(Picture) Missing door hardware at mechanical room bi fold door.

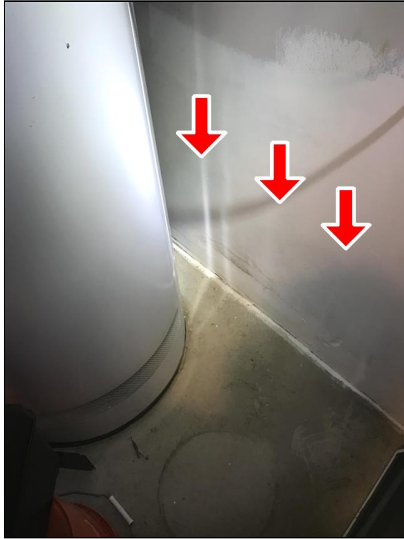
5.0 Item 1(Picture) Area where elevated moisture levels were detected.

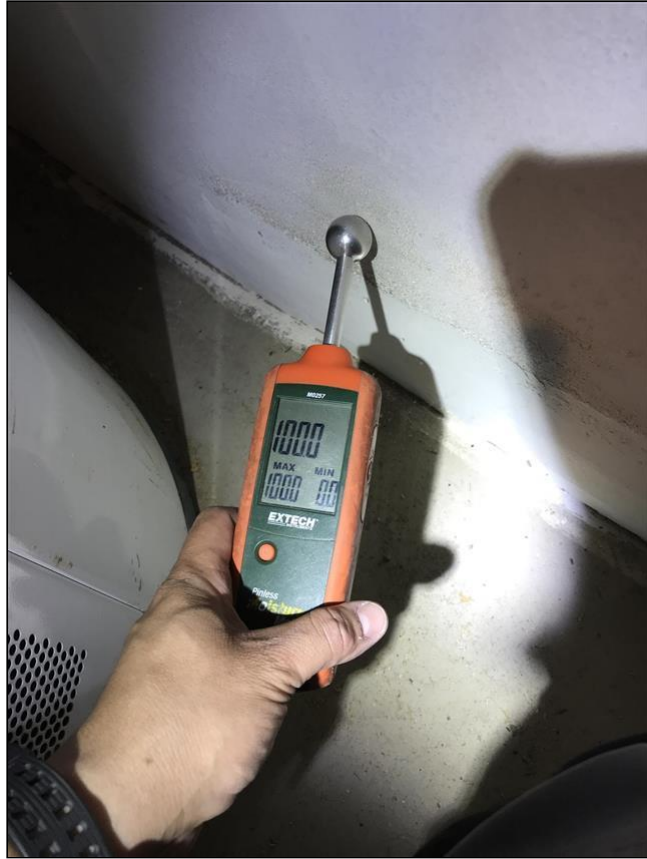
5.0 Item 2(Picture) Moisture meter detected 100 percent moisture (live leak) in drywall behind hot water heater. Repairs are needed.

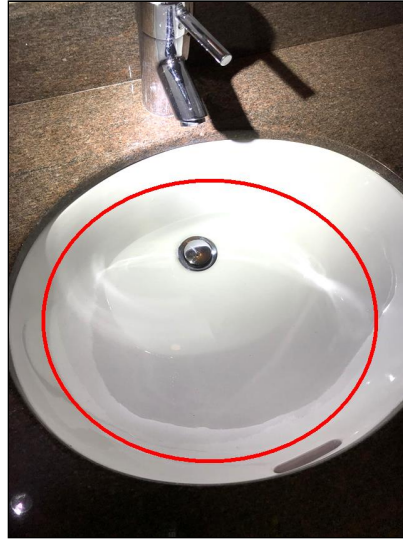
6.0 Item 1(Picture) Master bathroom sink (on right) is slow to drain.

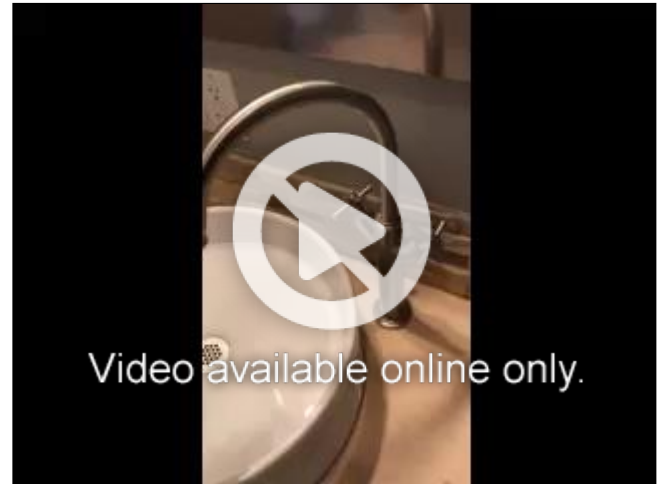
6.1 Item 2(Video) Loose fixture at first floor bathroom sink.

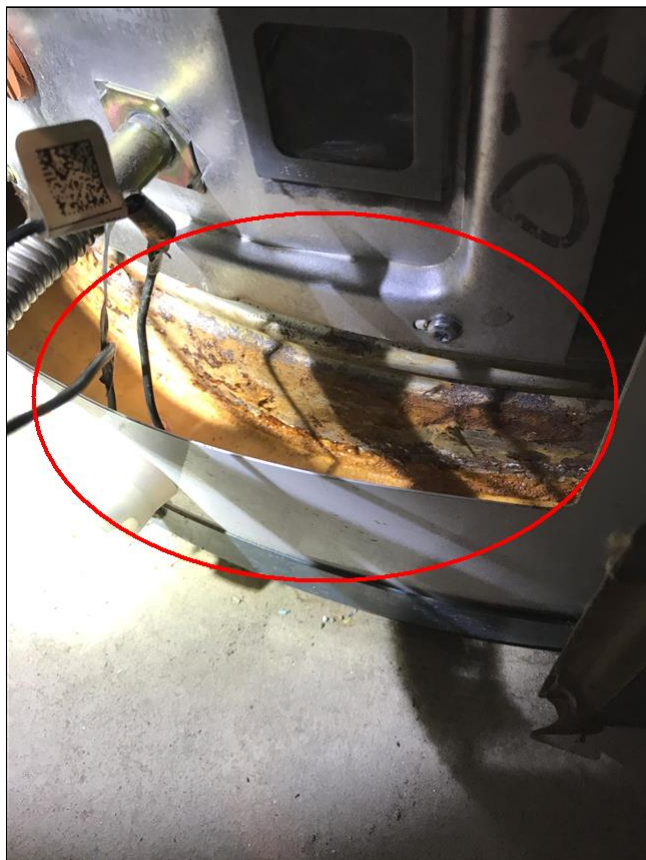
6.2 Item 1(Picture) The water heater appears to be leaking at bottom (visible rust). A replacement may be needed. Further deterioration may occur if not

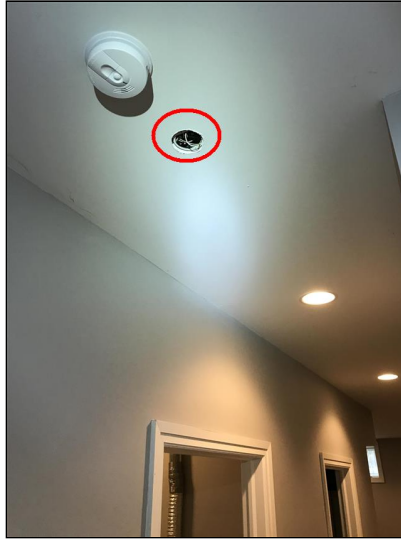
7.3 Item 1(Picture) Open electrical junction box in basement ceiling.

Have a licensed contractor place live wires in junction box and install cover. Shock hazard.
- 7.4 Polarity and Grounding of Receptacles within 6 feet of interior plumbing fixtures, all receptacles in garage, carport and exterior walls of inspected structure

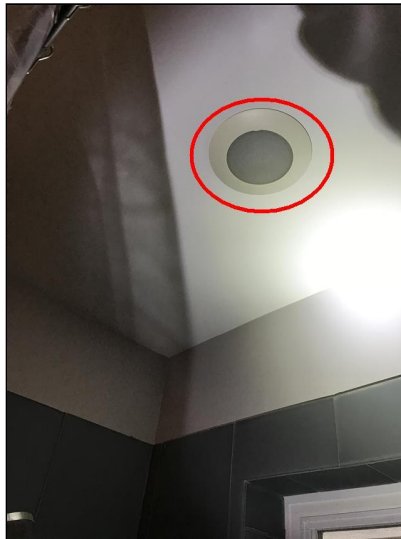
7.4 Item 1(Picture) Light fixture in bathroom shower on first floor did not function at the time of inspection.

Have a licensed contractor repair or replace bulb/fixture in first floor bathroom shower.
- 7.5 Operation of GFCI (Ground Fault Circuit Interrupters)

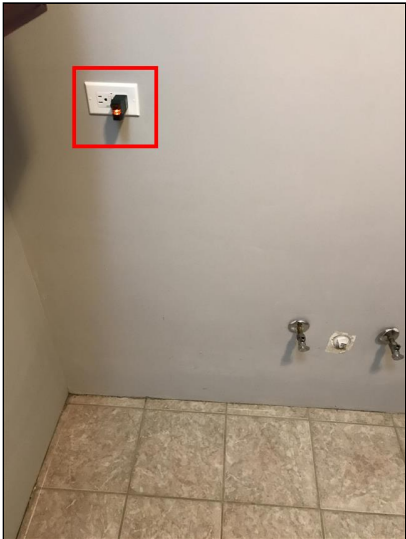
7.5 Item 1(Picture) GFCI did not trip at the laundry room. Shock hazard.

Have a licensed electrician repair the faulty GFCI in the laundry room. Shock hazard.

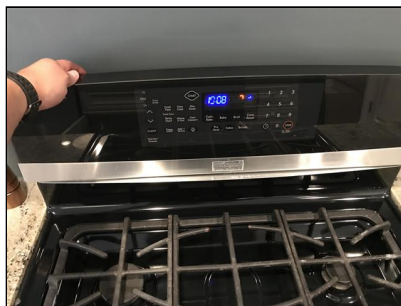
10.0 Item 1(Picture) Stove/range is missing anti tip bracket. Safety hazard.

Anti-tip brackets are metal devices designed to prevent freestanding ranges from tipping. They are normally attached to a rear leg of the range or screwed into the wall behind the range, and are included in all installation kits. A unit that is not equipped with these devices may tip over if enough weight is applied to its open door, such as that from a large Thanksgiving turkey, or even a small child. A falling range can crush, scald, or burn anyone caught beneath. Have a licensed contractor install anti tip bracket.

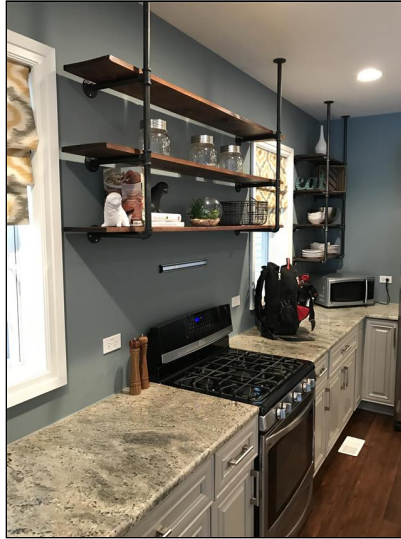
10.1 Item 1(Picture) The range hood fan is missing.

I recommend repair or replace as needed.

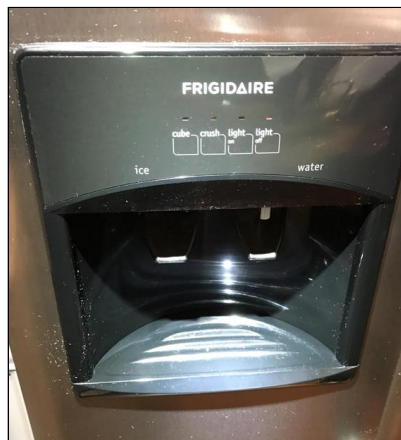
10.3 Item 1(Picture) Refrigerator water dispenser and ice maker did not function at the time of inspection.

Have a licensed contractor repair or replace water line as needed.

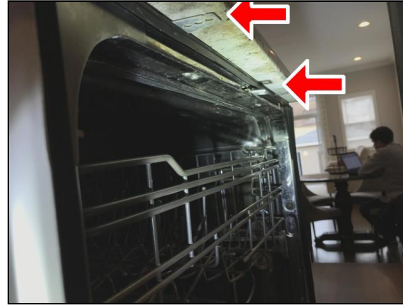
10.4 Item 1(Picture) The dishwasher is loose and needs securing to underside of countertop (using a proper length screw).

I recommend repair as necessary.
