PERFORATION AND STRIPPING REPAIR WITH MINERAL TRIOXIDE AGGREGATE AND BIODENTINE : 2 CASE REPORTS

Abstract: the main objective of these 2 case reports is to highlight the choice making between Mineral Trioxide aggregate and Biodentine in management of root canal stripping and root canal perforation with consideration of clinical and histological previous findings. In the 2 case reports stripping and perforation were iatrogenic errors that occurred within endodontic treatment performed by students.

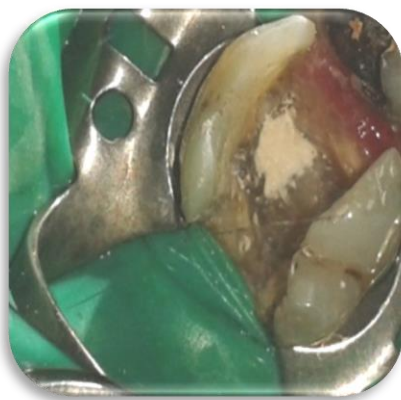
Figure 2: perforation repair with Biodentine.

calcium hydroxide was left for 7 days in contact with the perforation site. In the second appointment, calcium hydroxide was carefully removed with sodium hypochlorite rinse, the perforation site was assessed and dried with sterile absorbent paper points, there was no blood or exudation before the Biodentine was applied. Biodentine (Septodont, St Maur-des-Fossés, France) was mixed according to manufacturers instructions, the material was compacted into the defect, and a periapical radiography was taken to control marginal adaptation of the repair material.

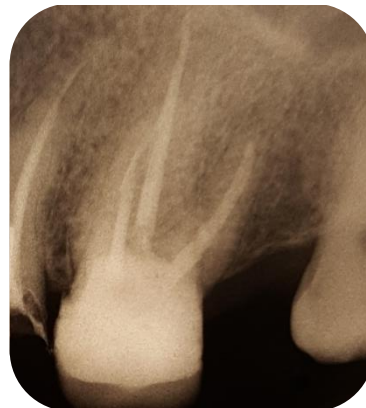
Figure 3: 1year later radiograph shows no periodontal attachment loss in the furcation area.

The tooth was temporarily filled with Biodentine, definitive coronal restoration was performed with resin composite. At the 6-month and the 1 year recalls, the tooth remained asymptomatic with no pain, no response to percussion and palpation, periodontal probing depth remained normal and no radiolucency was detected in the furcation area around the repaired perforation.

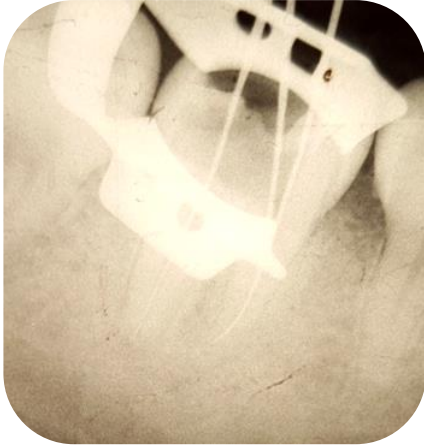
Figure 4: intra-operative X-ray for working lengths of #47.

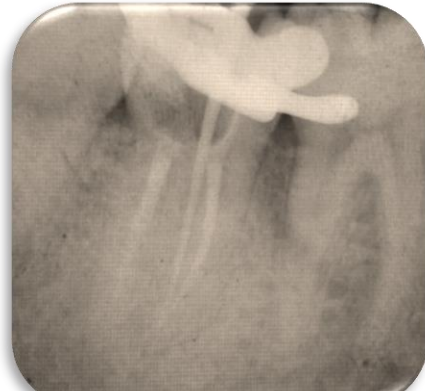
Figure 5: intra-operative X-ray for gutta-percha master cones adjustment control confirms presence of stripping in the mesio-buccal canal of #47.

The working length of the distal, the mesio-buccal and the mesio-lingual canal was determined radiographically, the root canals were cleaned and shaped using a crown-down technique with Nickel-Titanium Protaper instruments. While drying the mesio-buccal canal, blood impregnation of the paper points was observed at the coronal third of the same canal. A manual K-File 15 was introduced in the mesio-buccal canal revealed that the root-canal curvature was not maintained, and a thickening of the mesio-buccal canal wall close to furcation area.

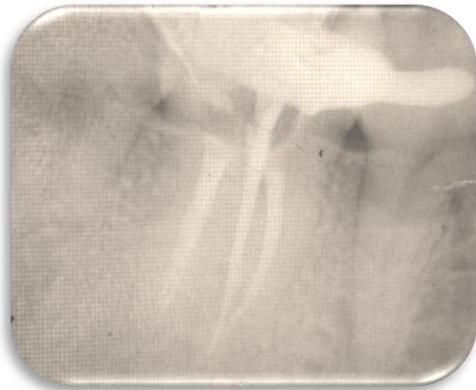
Figure 6: radiographic control of root canal fillings of #47.

At the same appointment, the mesio-lingual and the distal canal were filled using the lateral condensation technique. Calcium hydroxide was used as a temporary dressing in the mesio-buccal canal. After 7 days canal medication was removed, the mesio-buccal root canal was re-entered and irrigated with 2% sodium hypochlorite.

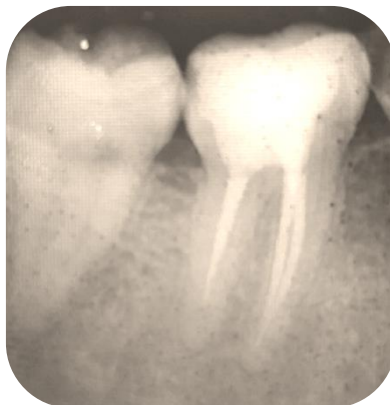
Figure 8: A 2 years recall radiograph showing absence of insertion loss of #47.

At the 1 year and the 3 years follow-up, tooth #47 remained asymptomatic, with no periodontal probing depth. Radiographic evaluation showed no radiolucency or desmodontal space enlargement in relation to the furcation area.
