# Cows and Fish

## Riparian Health Summary Report 2011

Rob and Doris Nanninga  
Adams Lake

**Location:** SE 10-36-4 W5M

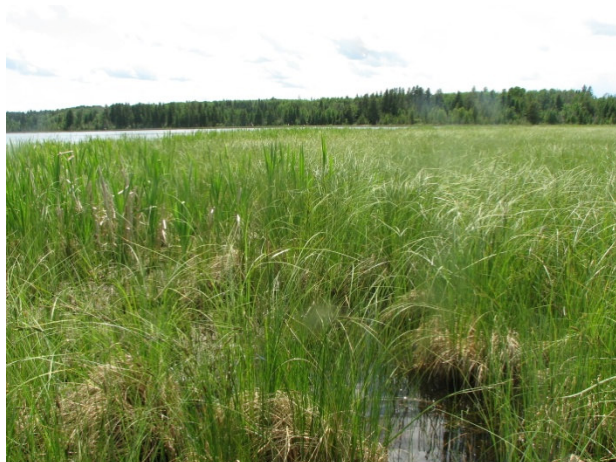
D. White, RHIP01ADS002

**ADS1W.** West end, south view. The site is well covered by native, riparian vegetation.

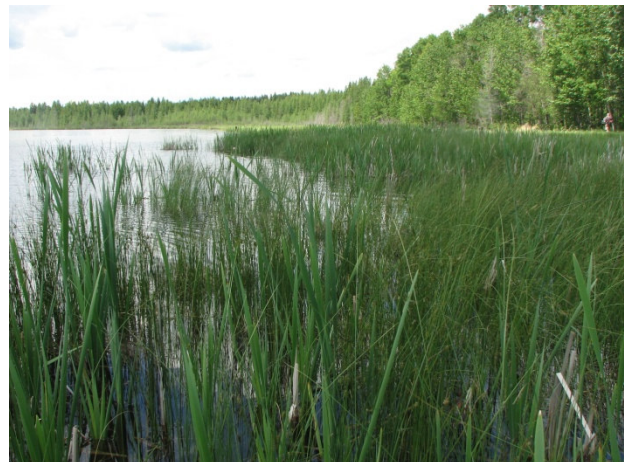
D. White, RHIP01ADS011

**ADS1E.** East end, west view. The riparian area remains in a natural state, allowing it to effectively perform its many functions.
