U.S. v. Brace et al. - Expert Report: Ecological Functions and Connections of Marsh Site Wetlands
Prepared by: Robert P. Brooks, Ph.D., Brooks Consulting

United States v. Brace et al., 17-cv-06, W.D. Pa.
Expert Report: Ecological Functions and Connections
of Wetlands and Waters at the Marsh Site,
Waterford, Erie County, Pennsylvania

Prepared for:
U.S. Department of Justice

18 December 2017

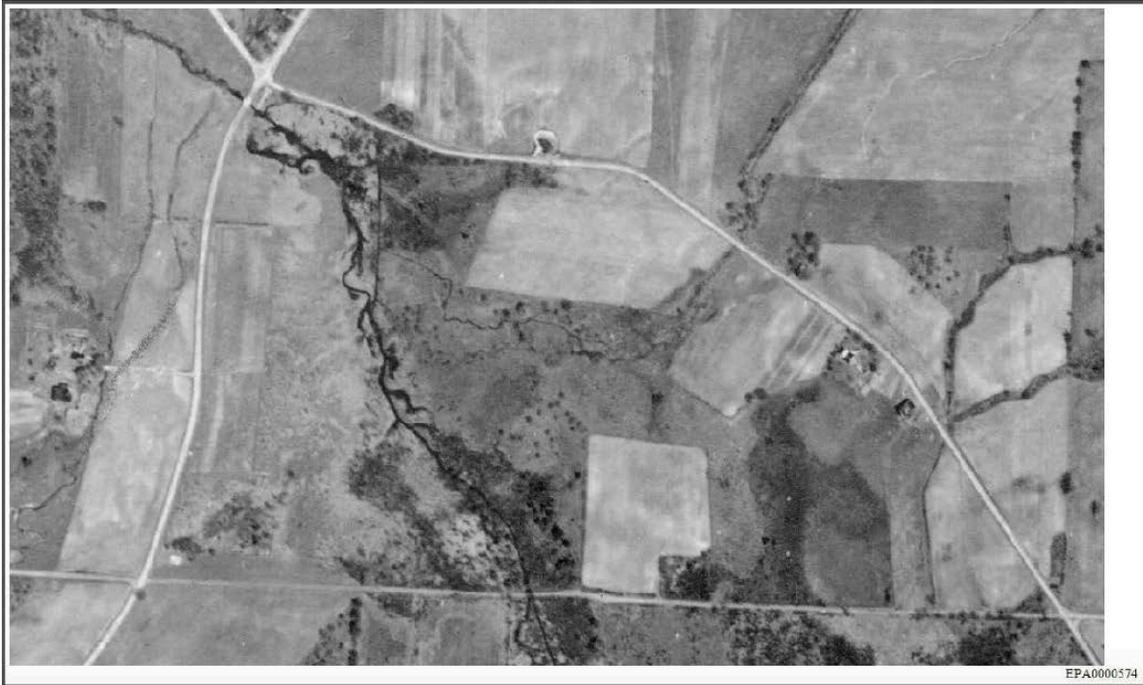
Figure 3. 1939 aerial photograph of the Marsh Site (B&W; obtained from DOJ).

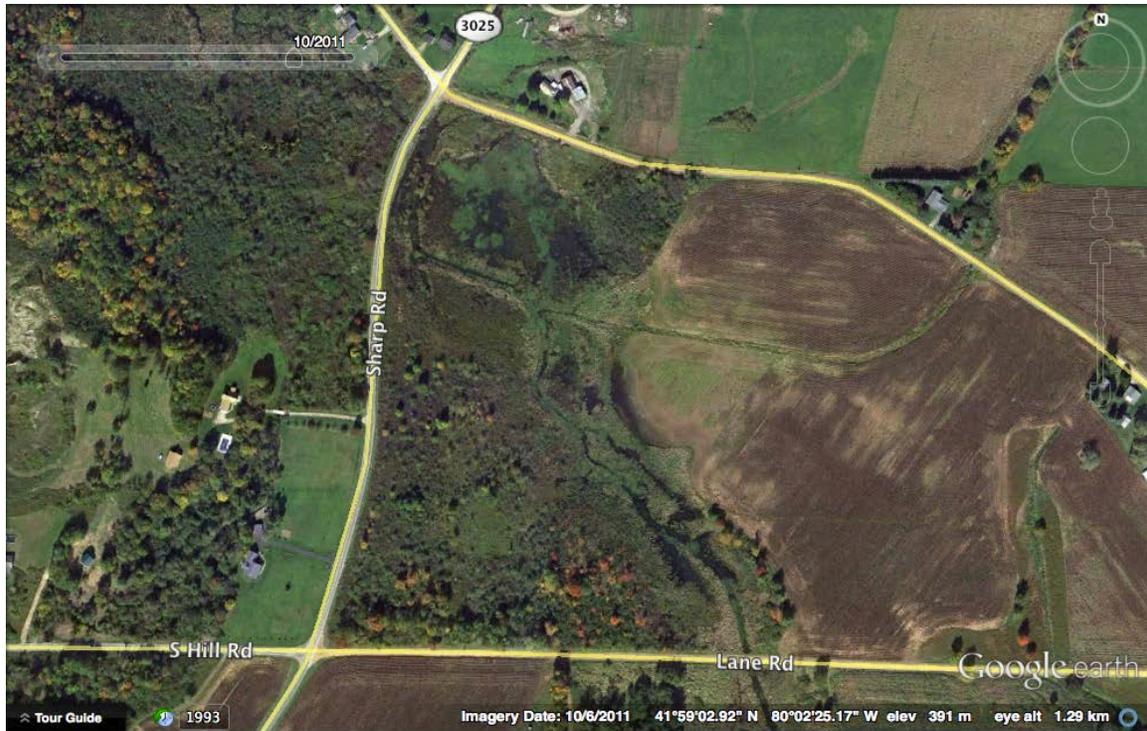
Figure 7. October 2011 aerial photograph of the Marsh Site (natural color; Google Earth).

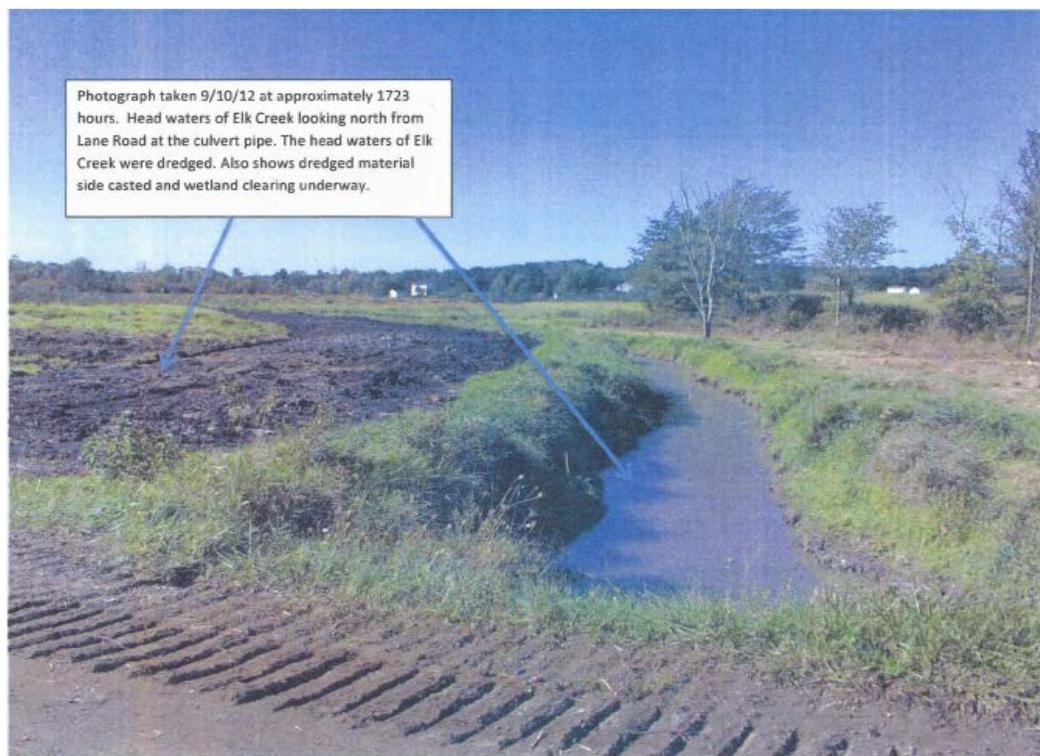
Figure 14. September 2012 photograph from Marsh Site inspection by Smolko; Elk Creek from Lane Road looking downstream (north) showing disturbed soils and side-casting from dredging Elk Creek.

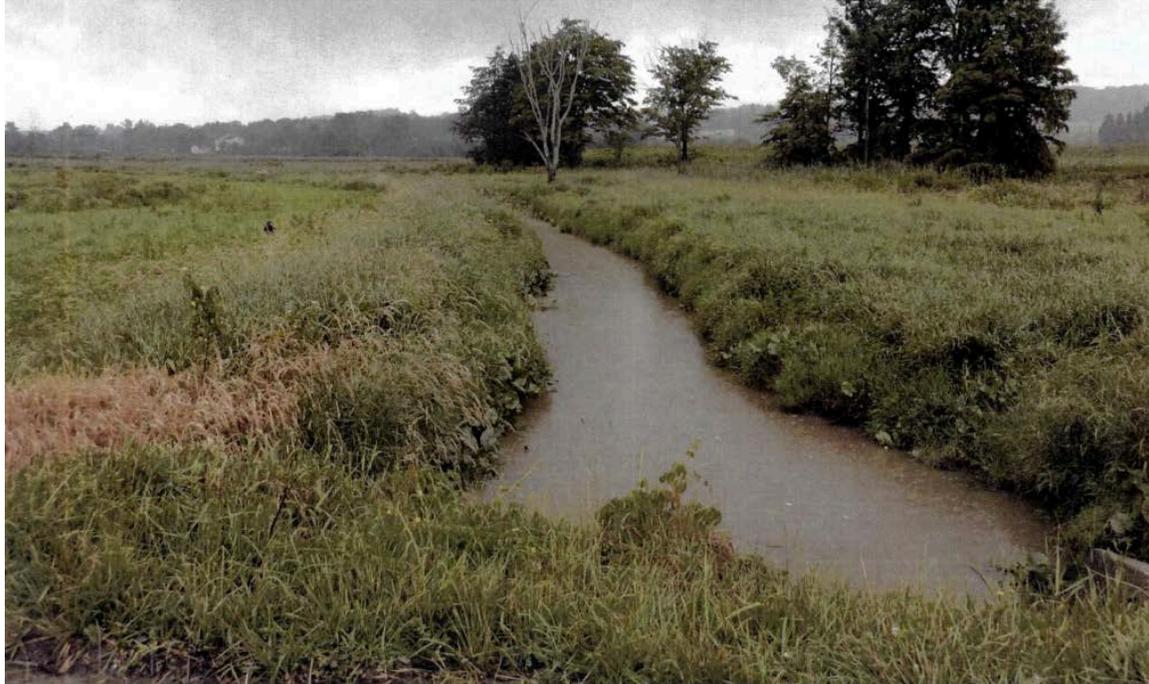
During the June 2013 inspection, new growth of hydrophytic vegetation was observed in portions of the site previously disturbed (Figures 15, Lane Road bridge). **Based on the wetland delineation data sheets from three samples points, all located on the Marsh Site,** hydrophytic plants were dominant, and soils showed hydric characteristics (i.e., chroma of 1 or 2, gleyed matrix, mottles). Surface hydrology was observed, so evidence of all three wetland parameters was present, indicating the presence of wetlands on the Marsh Site. Their Sample Point #1 was located near my Sample Point #6. Their other two points were located in the middle area of the Marsh Site. Heavy rains made obtaining additional soil samples difficult, and obscured some of the natural surface hydrology. A site inspection report from the same visit prepared by Scott Dudzic of the Pennsylvania Department of Environmental Protection (PADEP) dated 27 June 2013 described similar findings.

Figure 15. June 2013 photograph from Marsh Site inspection by EPA; Elk Creek from Lane Road looking downstream (north) showing recovering herbaceous vegetation after soil disturbance in 2012, and channelized reach of Elk Creek.

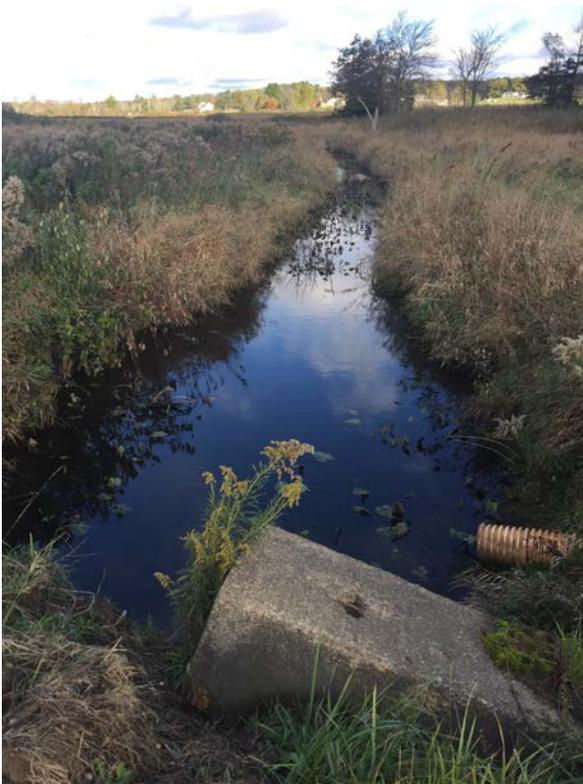
Figure 16. October 2017 photograph from Marsh Site inspection by Brooks; Elk Creek from Lane Road looking downstream (north) showing recovering herbaceous vegetation after soil disturbance in 2012, and channelized reach of Elk Creek.

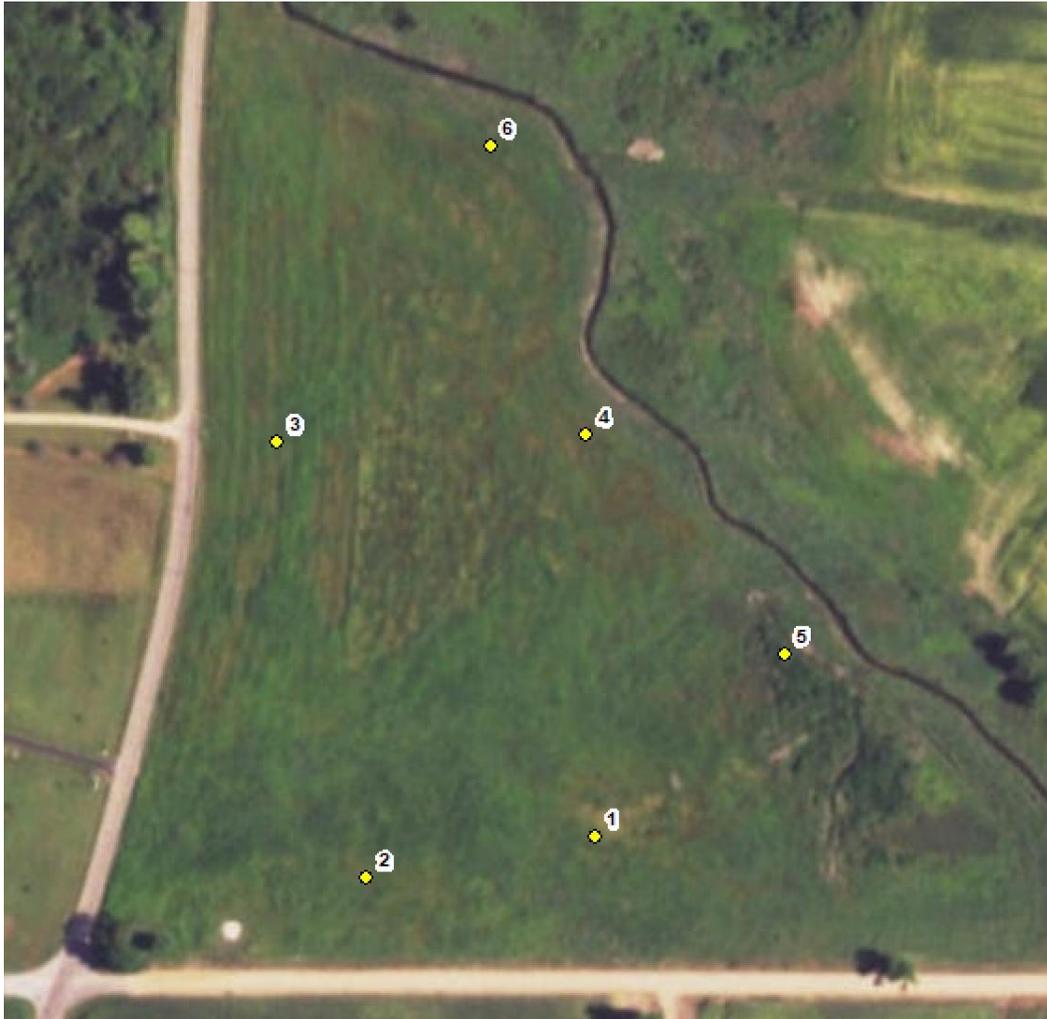
On 16 October 2017, I chose and sampled the ecological characteristics of six points on the Marsh Site (Figures 2 & 17). The objective was to collect sufficient data to reach an independent opinion about the occurrence of wetlands on the Marsh Site and their connectivity to Elk Creek at the current time (October 2017), which is defined as *post-disturbance* (after the major land and water alterations by Brace in 2012). I also was tasked to consider the extent and condition of wetlands on the Marsh Site before the 2012 alterations; defined as *pre-disturbance*.

Sample Point #1 (Figure 17) – Located at (approx. lat-long: 41.9793548, -80.0456344), which is at the visual intersection of the gas well tank on Lane Road to the south, and the end of the tree row along the east side of Elk Creek downstream of the culvert on Lane Road. I chose this point because it was located upslope of the patch of alder shrubs in the southeast corner of the Marsh Site. The alder patch, later sampled as Sample Point #5, appeared to be quite wet, so I wanted to know the conditions upslope.

Figure 17. Approximate locations of six Sample Points for wetland identification protocol superimposed on a 2015 image of the Marsh Site from ESRI (Brooks Oct 2017).

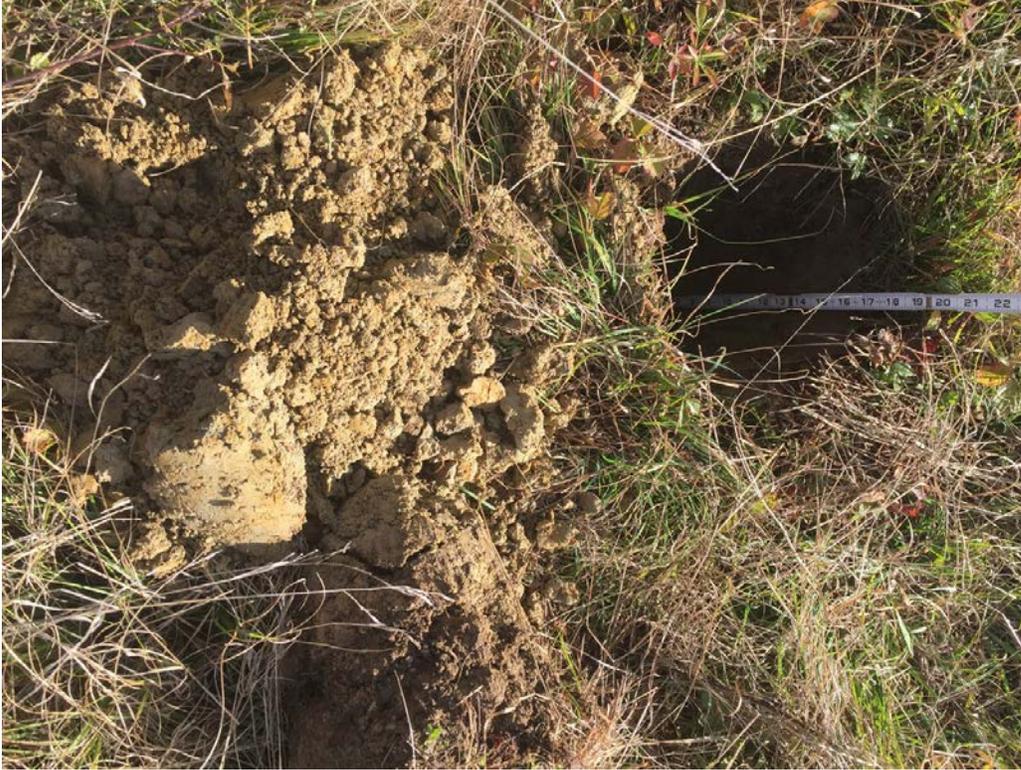
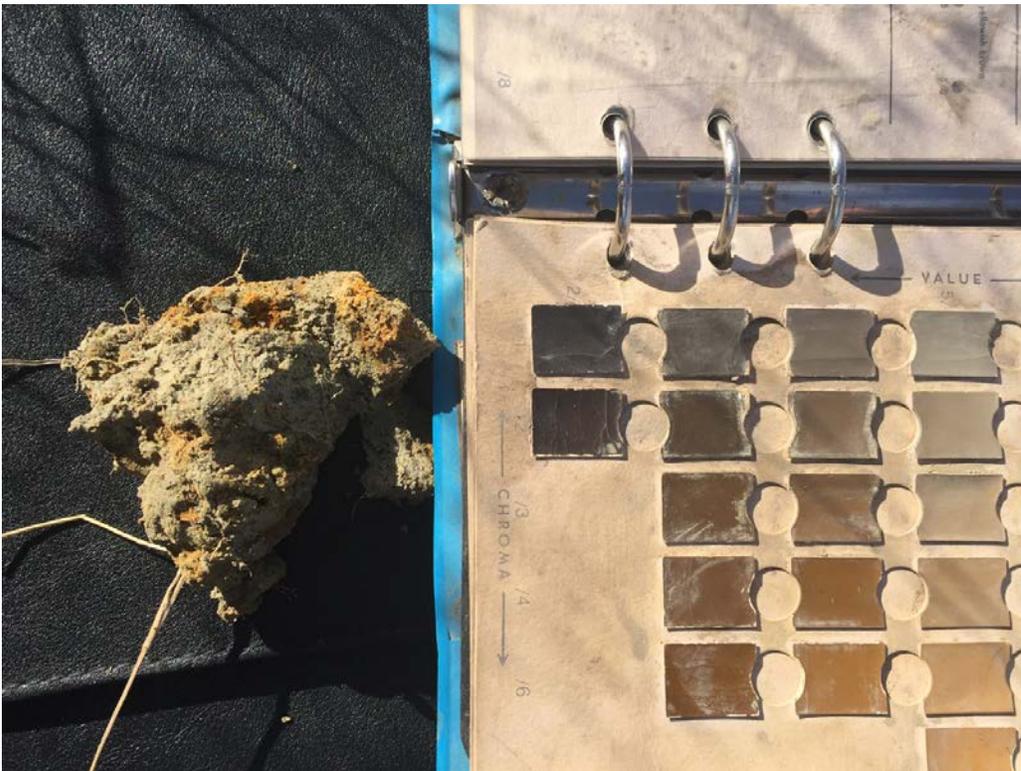
increasing to about 30% from 5-18 inches, with color of 7.5YR6/8. Soil texture from 0-5 inches was smooth, and an extended ribbon of 2.0 inches, indicating this is a silty clay loam. From 5-18 inches the soil had slight grit, and after moistening, a ribbon extended to 1.5 inches, indicating a texture of clay loam. Based on later laboratory analysis, the organic matter content from a sample taken at a depth of about 8-12 inches was quite low at 0.9% (Table 3). In summary, the soil at Sample Point #1 showed hydric characteristics (i.e., low matrix chroma, the presence of redoximorphic features; Figures 19 & 20).

Figure 19. Marsh Site Sample #1 soil pit with profile (see text for description).

Figure 20. Munsell soil colors for Sample #1 showing hydric matrix, brighter mottles and oxidized rhizospheres (see text for discussion).

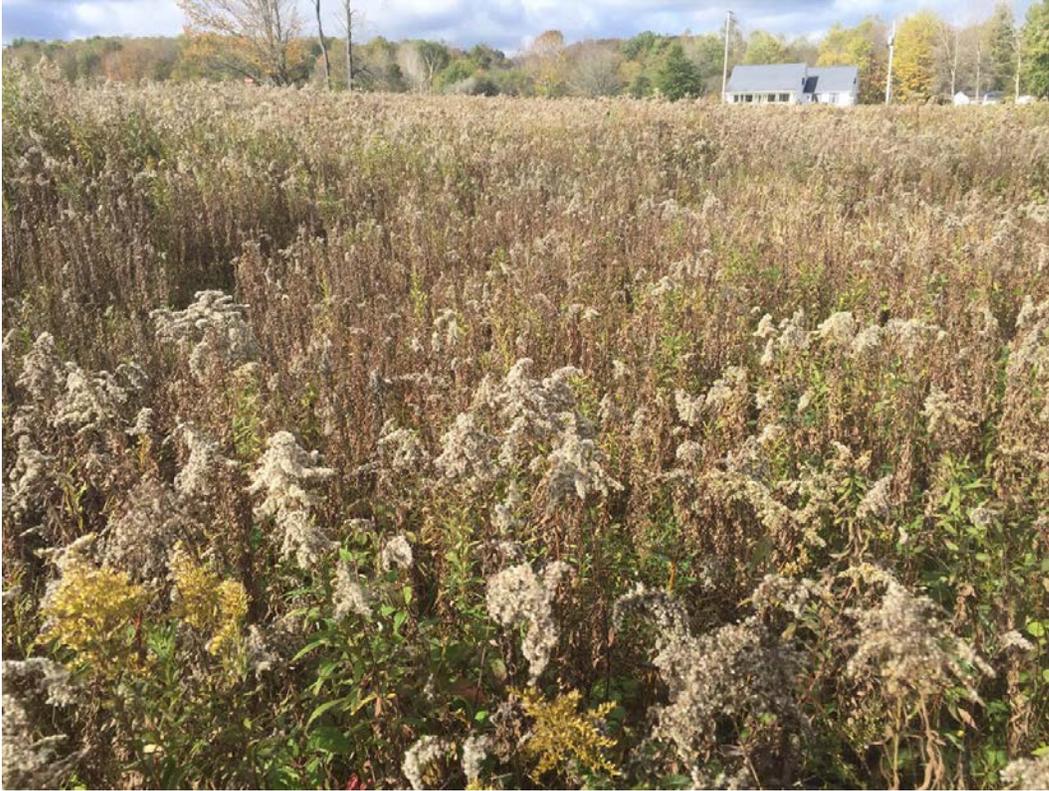
The vegetation in the vicinity of Sample Point #2 consisted of a combination of herbaceous and shrub species (Figure 23). The Dominance Test was positive for hydrophytic vegetation at 67% wetland species. There were no definitive hydrologic indicators at this point. Since normal circumstances do not exist at Sample Point #2, due to site alterations of hydrology and vegetation, the presence of all three wetlands indicators is not necessary to determine if the site is a wetland where a plausible explanation for the unconfirmed indicator is found. There was not sufficient detail available for the layout of the tile drainage and ditch network to estimate quantitative impacts on the Marsh Site, nor are there any known hydrologic measuring devices on site. The presence of a histosol (highly organic hydric soil), however, is a strong indicator that hydric conditions are present, especially when a viable hydrophytic plant community is present. Based on observations and the presence of a histosol, which develops over extensive time periods when conditions are sufficiently wet, there is active hydrology on this portion of the Marsh Site. Therefore, in my opinion wetlands are present at Sample Point #2 at the present time, despite efforts to alter the hydrology and vegetation in 2012.

Figure 23. Marsh Site Sample#2 vegetation (looking west) (see text for description).

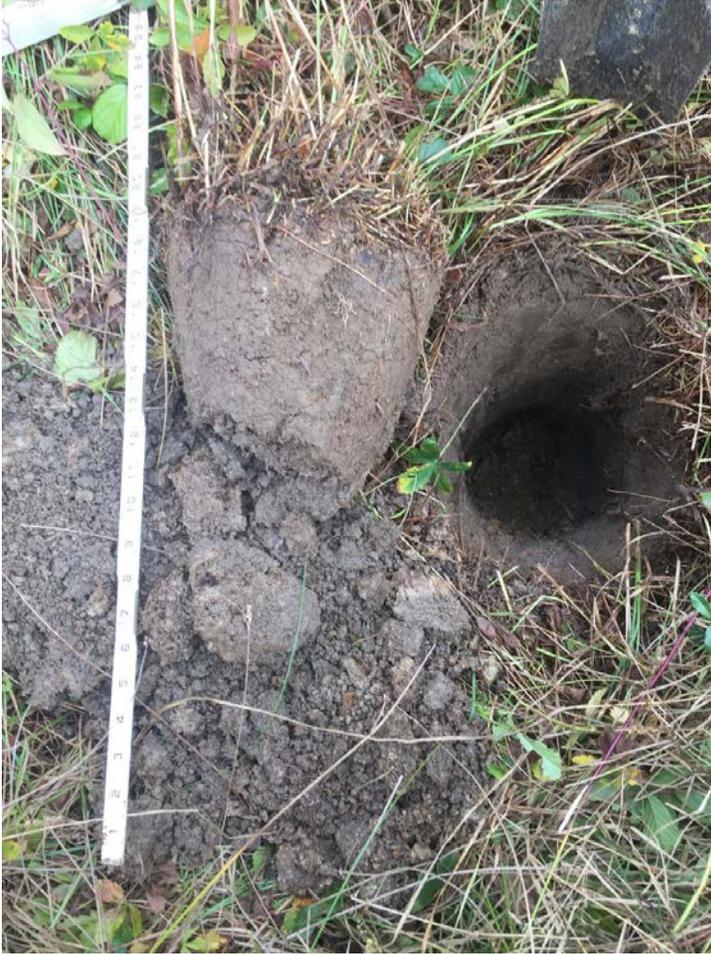
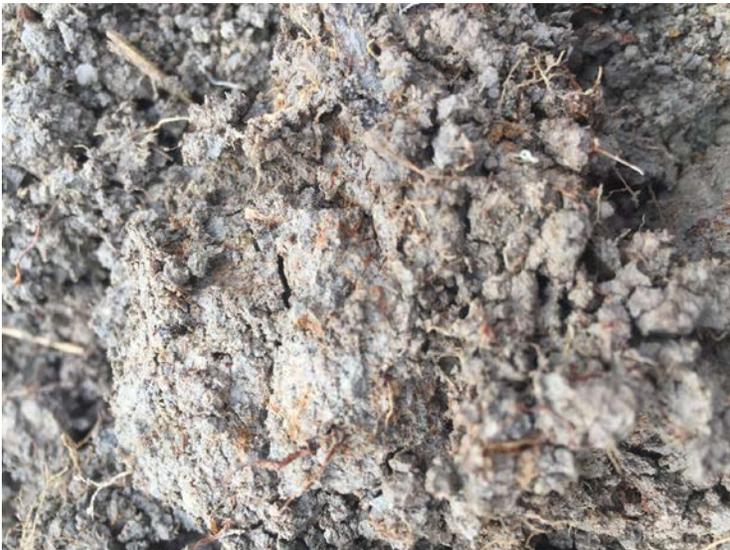
Sample Point #3 – Located at (41.9806992, -80.0470911) in a level area about 200 feet off Sharp Road. According to the Erie County Soil Survey, this point is located near the transition between Canandaigua mucky silt loam, which is listed as a strongly hydric soil in this county, and Red Hook silt loam (along Sharp Road), which is listed as a non-hydric soil (Figures 17 & 18). The soil pit suggested this is a transition area, with 5YR5/1 matrix from 0-10 inches, and mottles occupying 10% with a color of 75YR5/6. Oxidized rhizospheres were observed (and photographed, Figure 25) in the upper 9-10 inches. The soil texture was not gritty, and produced a ribbon of 1.5 inches, indicating this is a silty clay loam. From 10-18 inches the matrix color was a mixture of 10YR6/2 and 10YR4/4, with small areas (2%) of mottles of 5YR4/4 presenting redoximorphic features (Figure 24 & 25).

Figure 24. Marsh Site Sample #3 soil pit and profile, (see text for description).

Figure 25. Marsh Site Sample #3 oxidized rhizospheres, 9-10 inches depth (see text for description).

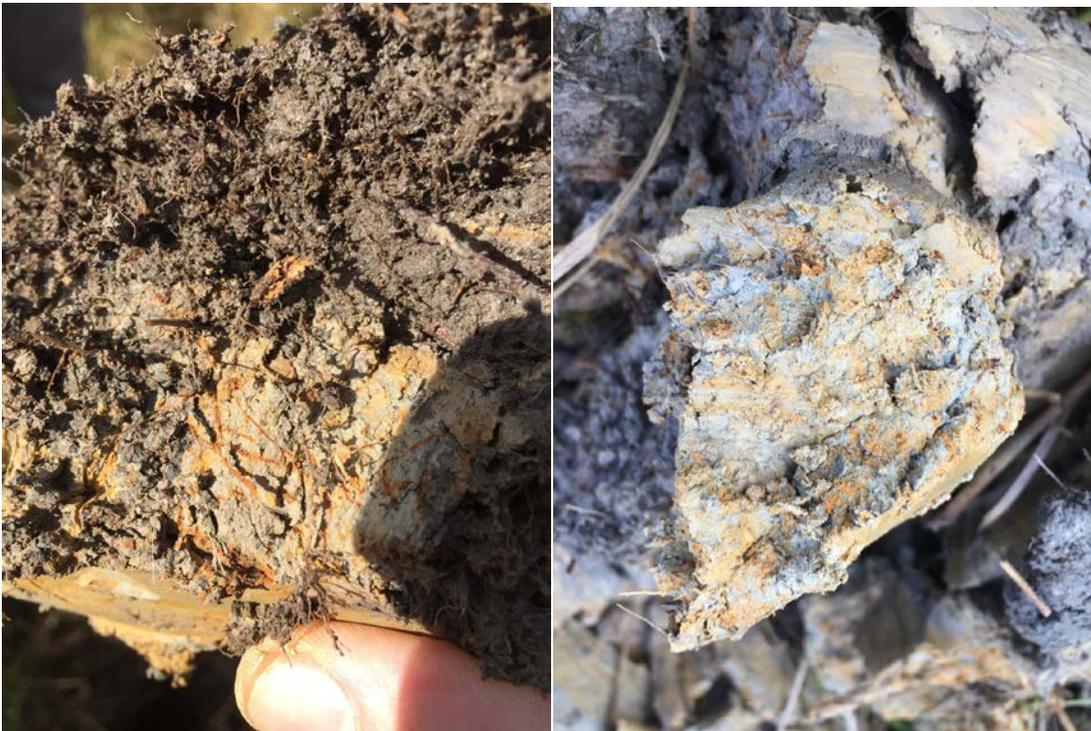
Figure 35. Marsh Site Sample #6 hydric soils: left – oxidized rhizospheres near surface; right – gleyed soil with mottles in lower portion of soil pit.

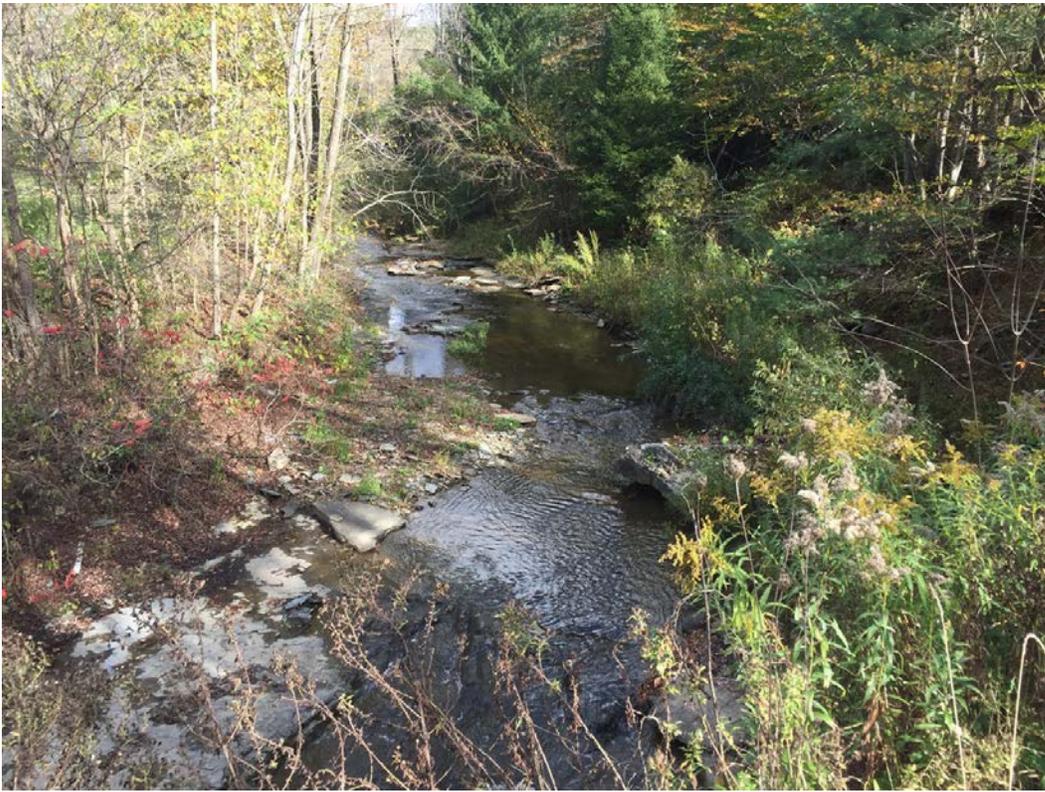
Figure 52. Hamot Road bridge looking upstream; stream bed rocky and relatively steep-sided, more incised than upstream portions of Elk Creek.

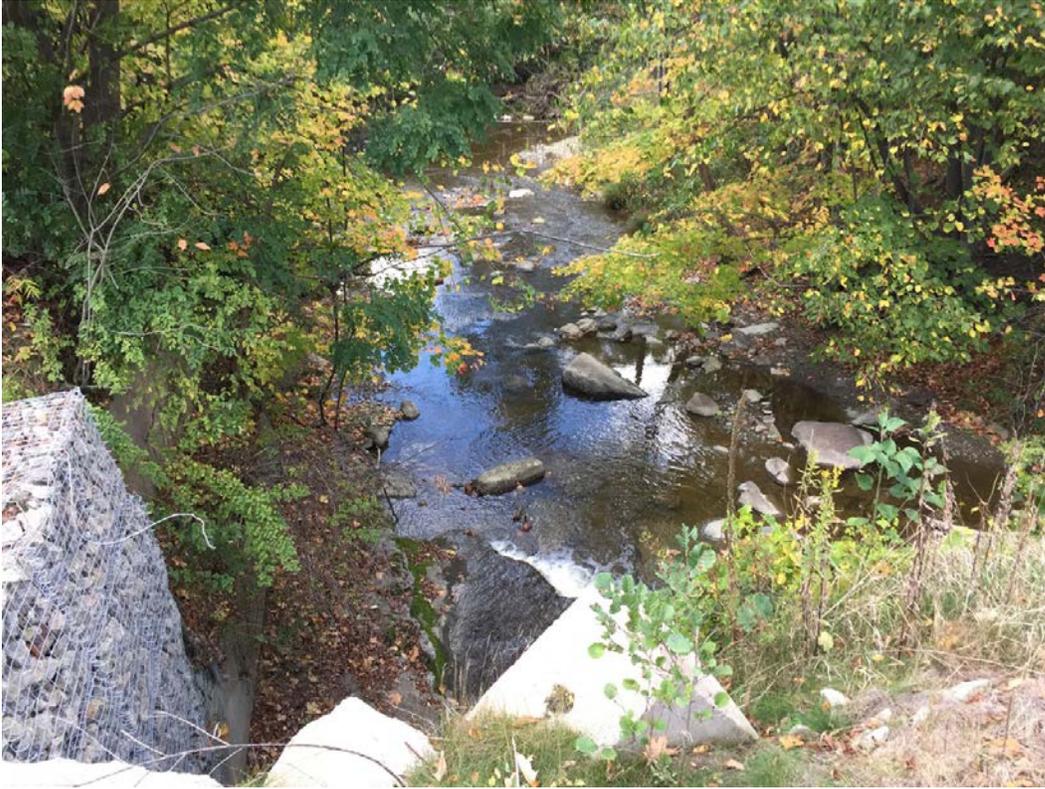
Figure 53. Elk Creek crossing under Oliver Road, steep-sided gorge; bridge supported by gabions.

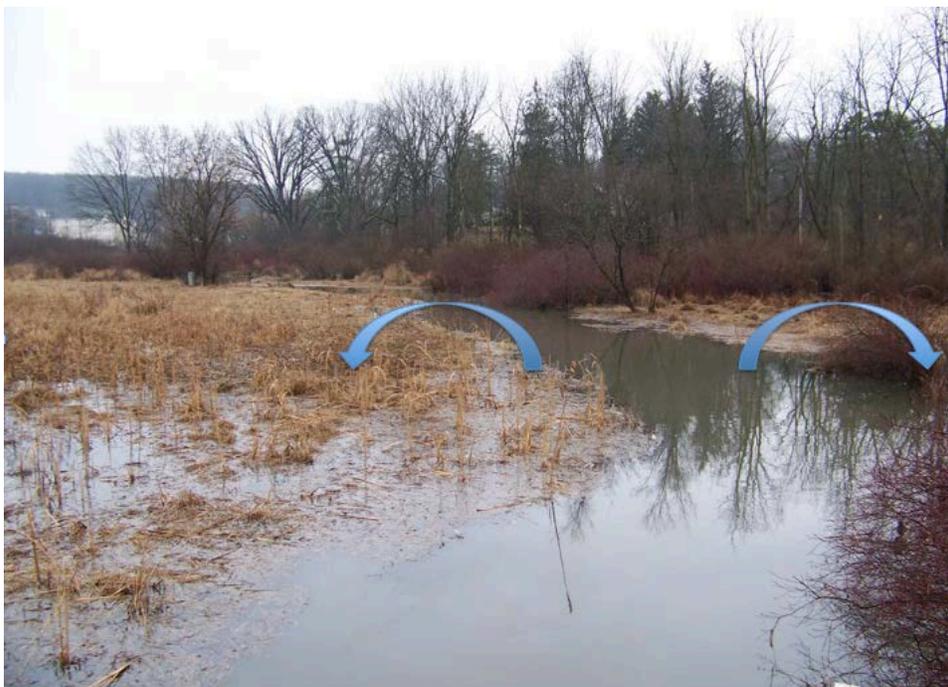
Figure 58. Example of overbank flooding of a similar sized stream where the stream is connected to the floodplain allowing frequent movement of water from the stream to the floodplain and from the floodplain back to the stream channel (Photograph by R. Brooks from central Pennsylvania).

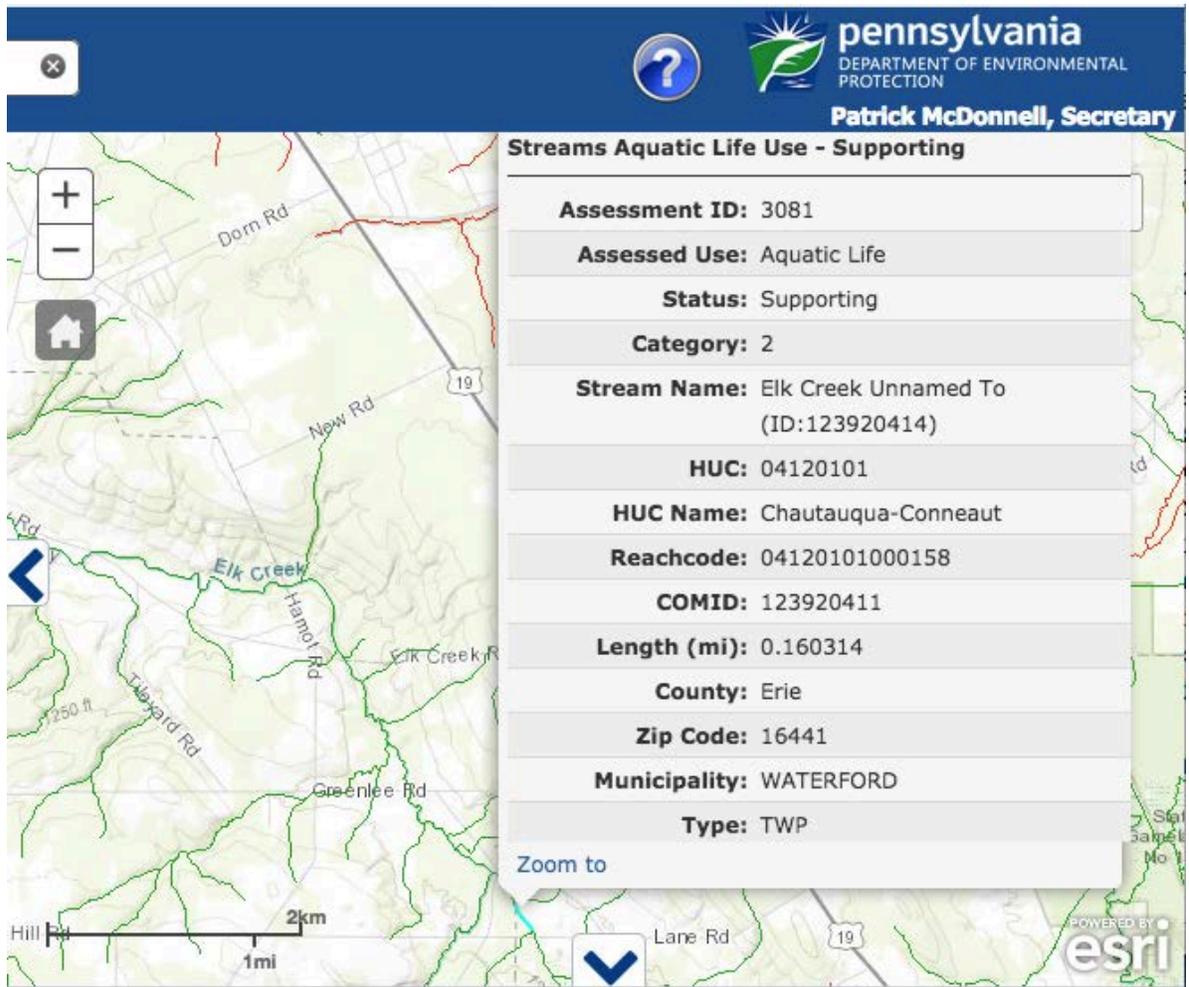
Figure 67. Elk Creek reach along the Marsh Site (see Zoom to arrow above) assessed by PADEP as Supporting Aquatic Life Use for the 2016 Triennial Integrated Water Quality Monitoring and Assessment Report (303(d) list). All streams of Elk Creek watershed appear to be in the same category.

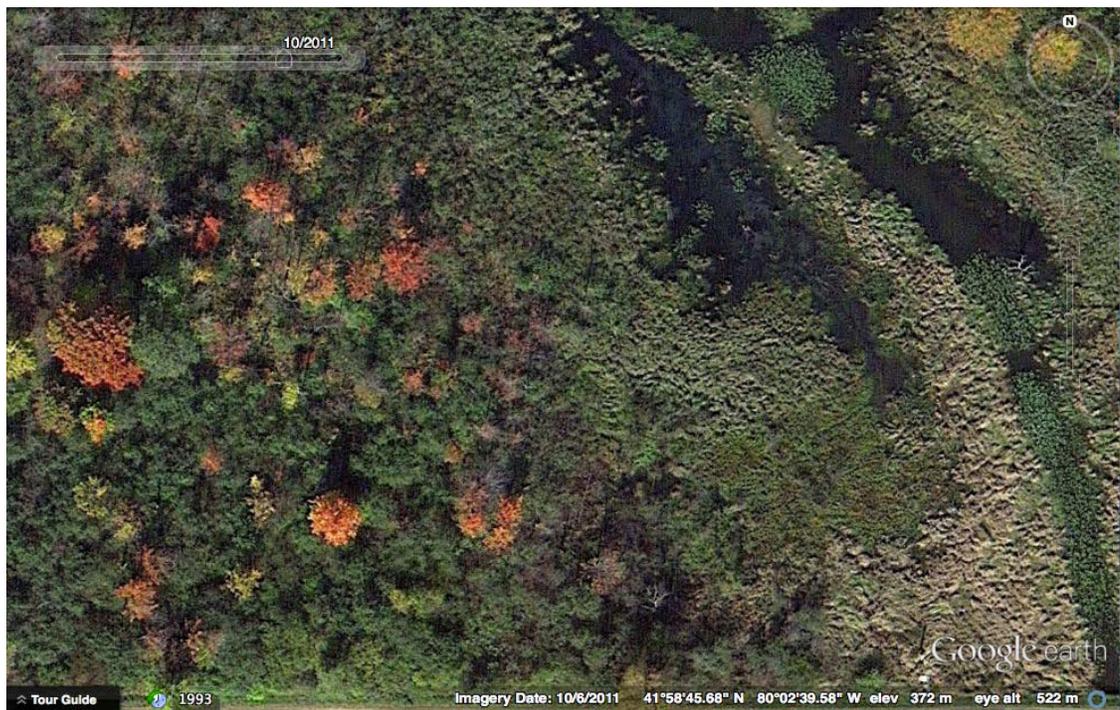
Figure 68. Conceptually, wetland and stream restoration of the Marsh Site should be designed and constructed to reach vegetation communities and hydrologic regimes comparable to the pre-disturbance condition of the site (2011 aerial photograph – close-up of southeast corner of the Marsh Site (Google Earth)).
