REHABILITATION OF AN EDENTULOUS PATIENT WITH REINFORCED MAXILLARY COMPLETE DENTURE: A CASE REPORT

ABSTRACT:

CASE DETAIL:

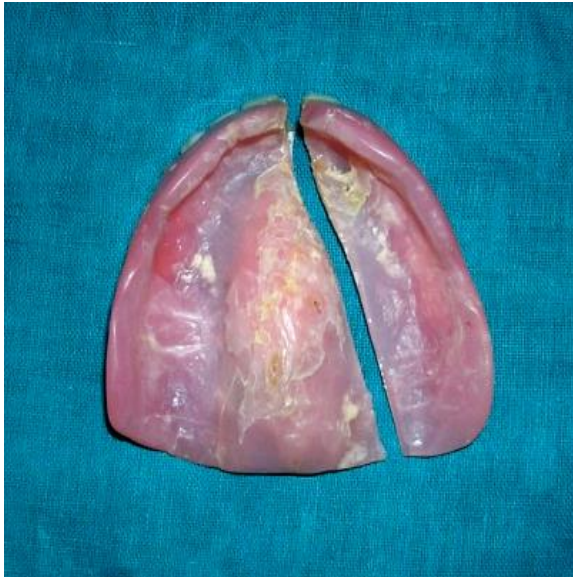
Fig 1. Fractured previous denture.

A 62 year male patient reported with the chief complaint of repeated breakage of upper complete denture. The patient gave a history of denture wear for the past one year. The maxillary complete denture was repaired and relined repeatedly within the first year due to fracture in the midline (Fig 1). Intraoral examination revealed moderately formed but constricted maxillary edentulous ridge with deep palatal vault (Fig 2). The mandibular ridge was edentulous, broad and well formed (Fig 3). The interridge distance was adequate and ridges were in Class I relationship anteriorly. The ridge condition was good despite the loss of teeth due to periodontal reasons. The patient was a strict vegetarian without any deleterious habits and no relevant medical condition, indicating that the masticatory forces would not have been too high to cause repeated fracture. A

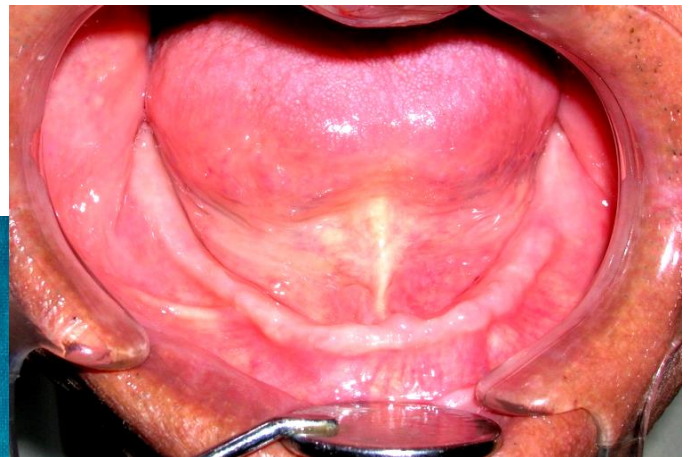
Fig 3. Broad, well-formed mandibular edentulous ridge.

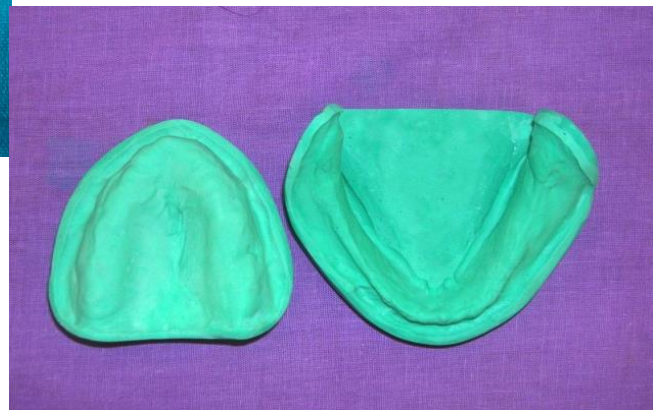
Fig 4. Master casts showing marked difference in posterior width.

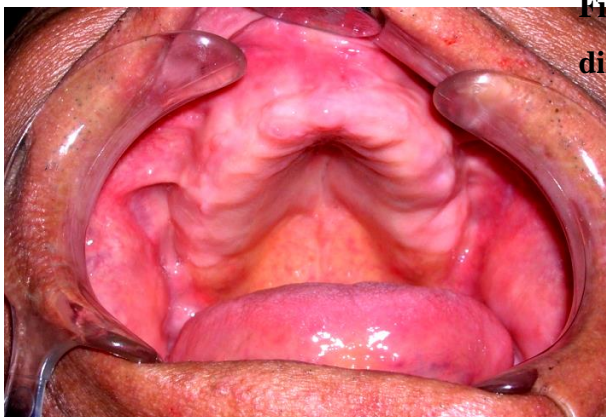
Fig 2. Constricted maxillary edentulous ridge.

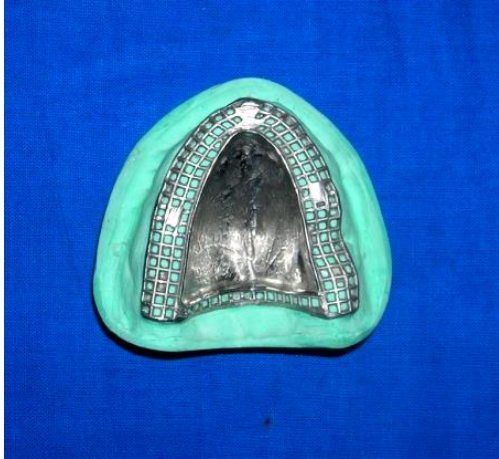
Fig 5. Metal base positioned on the maxillary master cast.

Preliminary impressions were made in impression compound (Y-Dents, MDM Corporation, India) and primary casts were poured in dental plaster (Kalabhai Dental Private Limited). Tissue molding was done using sectional technique using DPI Pinnacle tracing stick and final impressions were made using polyvinylsiloxane (Elite HD+; Zhermack, Italy). Master casts (Fig 4) were poured in dental stone type III (Kalstone, Kalabhai Dental Private limited). The maxillary cast was duplicated using reversible hydrocolloid and refractory cast was poured with ethyl silicate bonded investment material. The denture base pattern wax was adapted on the refractory cast. Sprues were attached followed by investing. The denture base was casted with cobalt chromium alloy. The metal base was finished and placed on the master cast (Fig 5). It was checked for intimate fit and retention in the mouth. Facebow transfer and

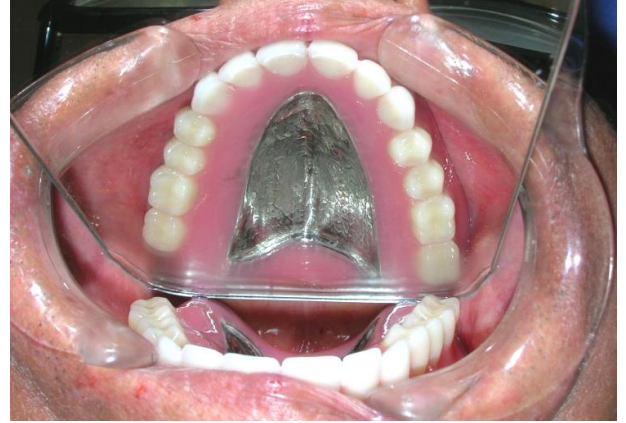
Fig 7. Maxillary denture with metal base in situ.

maxillomandibular relation were recorded. Teeth arrangement was done in balanced occlusion on a semiadjustable articulator. Try-in was done to patient and operator's satisfaction (Fig 6). This was followed by acrylization of dentures using heat polymerizing acrylic resin (DPI, India). Laboratory remount was done to remove the interferences. Minor adjustments were done intraorally to obtain optimum occlusion. Dentures were given to the patient followed by post-denture insertion instructions, particularly emphasizing on maintenance and hygiene (Fig 7). The patient was satisfied with the aesthetic outcome and could particularly experience the difference in the fit of denture. Most noticeably, the patient's attitude and disposition had changed due to the psychological advantage of an "unbreakable denture" (Fig 8).

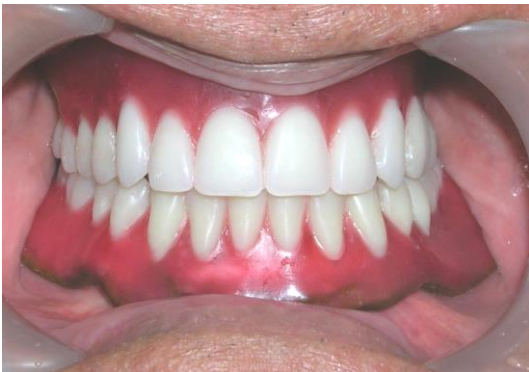
Fig 6. Try-in.
