South Fork Export Cable

Phase 1 Environmental Site Assessments

Phase I Environmental Site Assessment

Cove Hollow Road

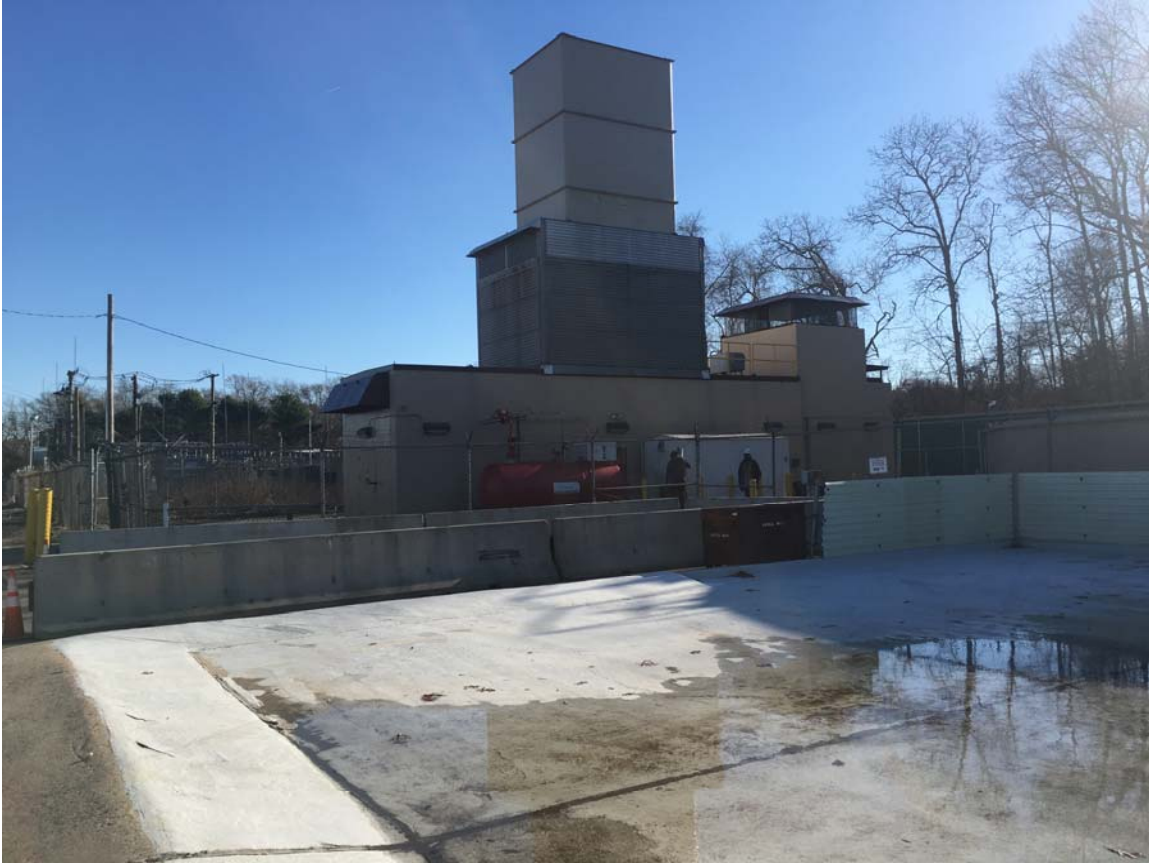
Photograph No. 1: The National Grid Generating Station located on the subject property. View is to the southwest.

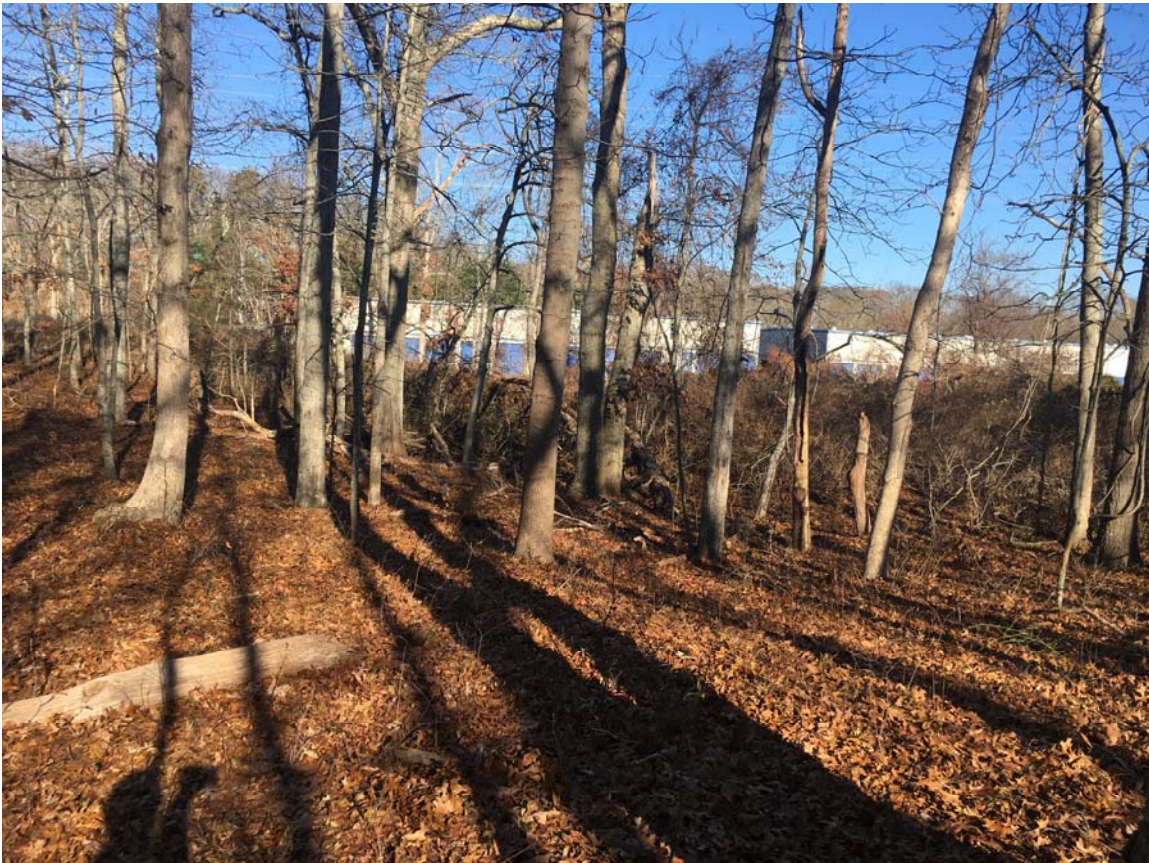
Photograph No. 2: Representative photograph of the proposed substation lease area observed throughout the subject property.

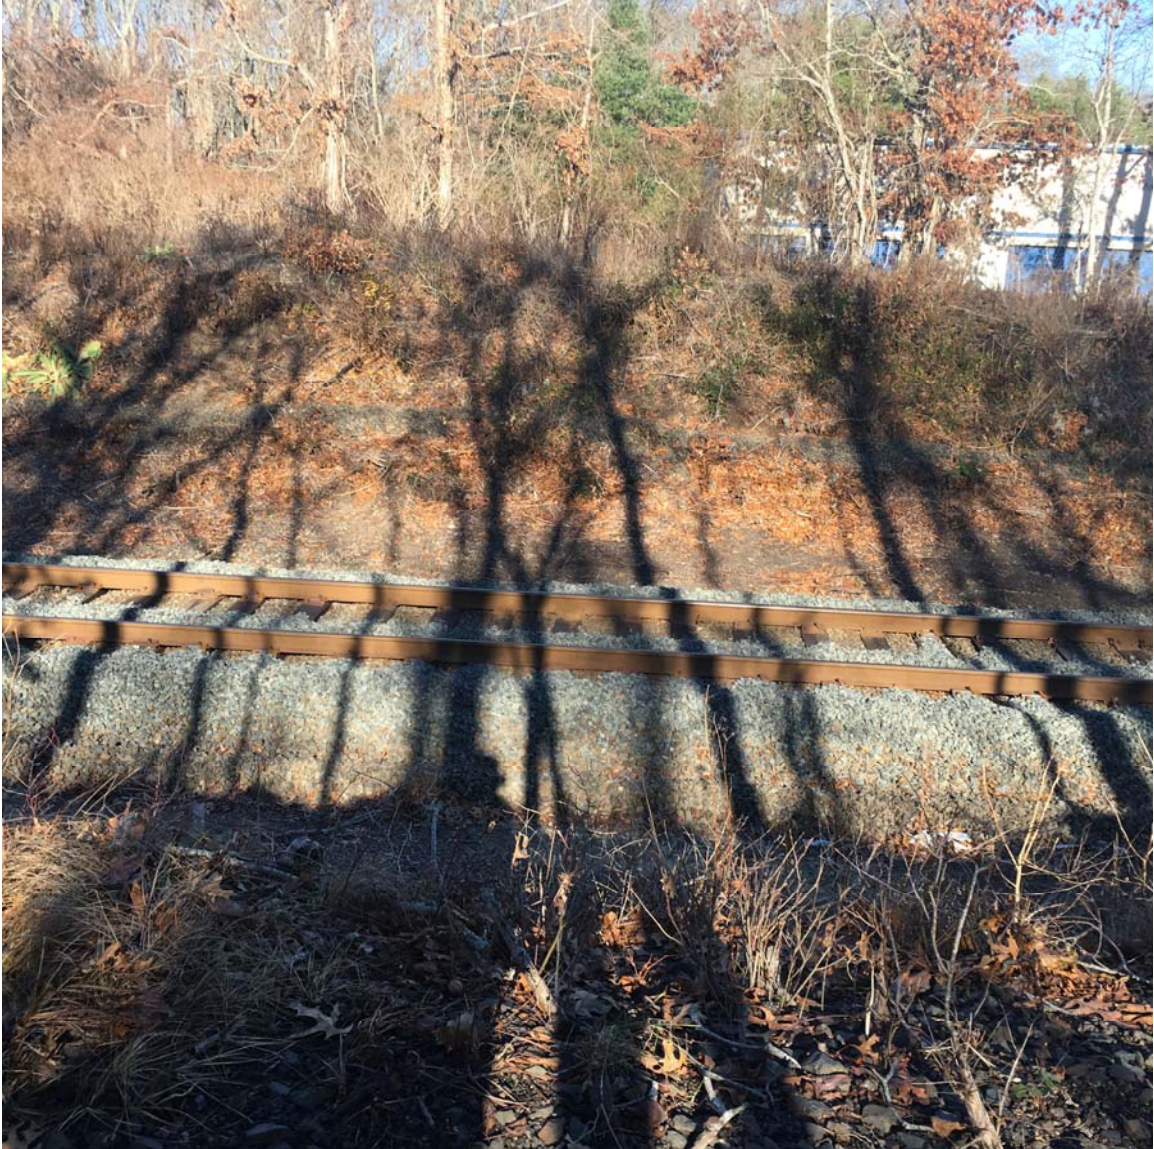
Photograph No. 3: The LIRR right-of-way, along with a self-storage facility. View is to the north.

North: LIRR right-of-way, along with a self-storage facility (Appendix B, Photograph No. 3).

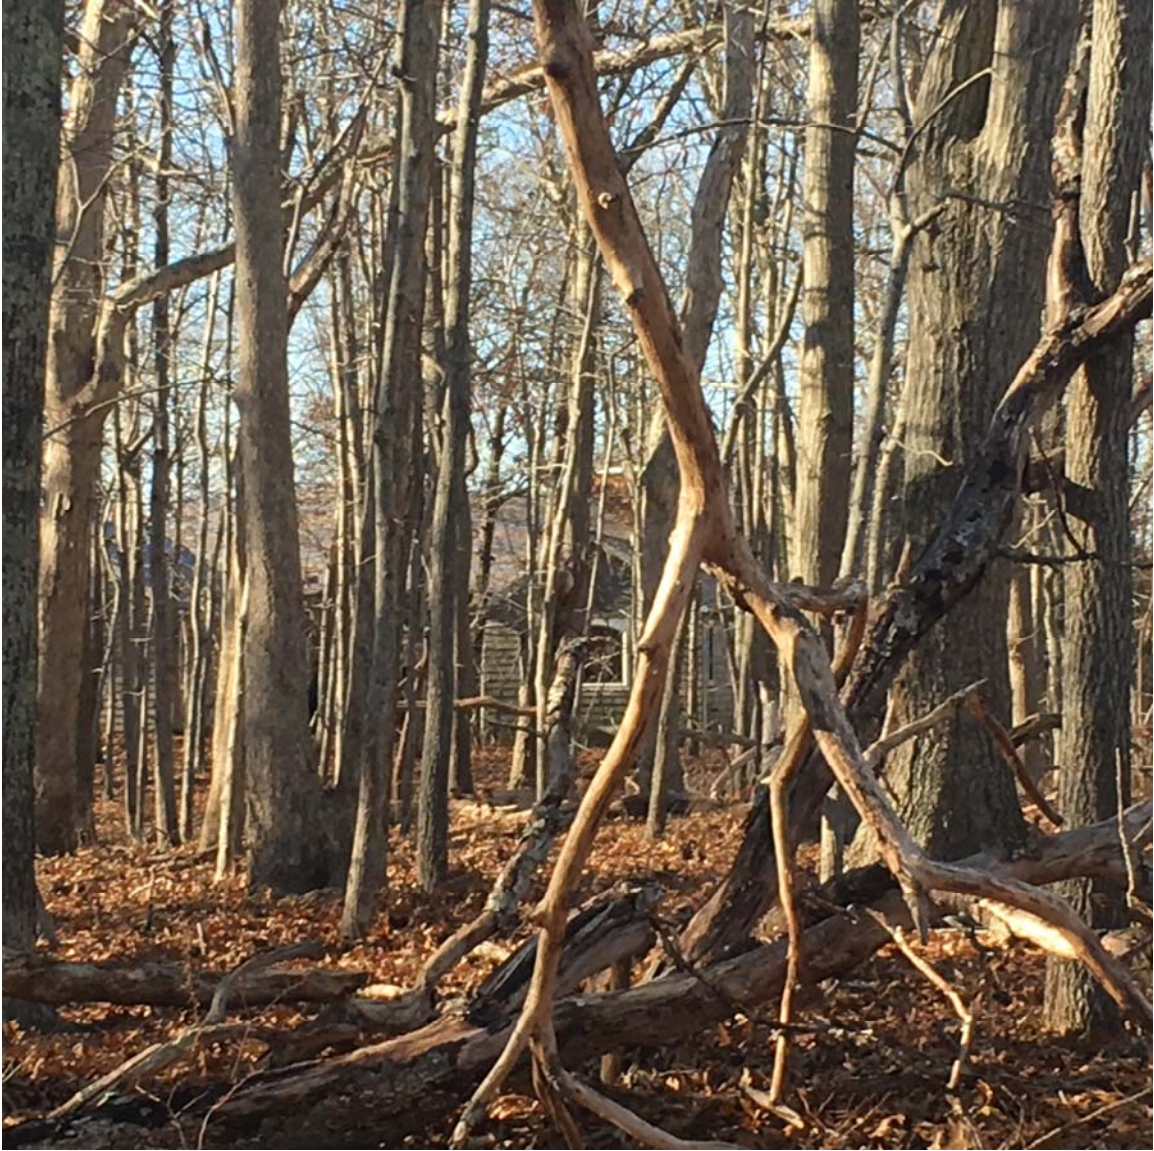
Photograph No. 4: Undeveloped woodlands and a single-family residence. View is to the south.

- South:** Undeveloped woodlands and a single-family residence (Appendix B, Photograph No. 4).
- East:** Cove Hollow Road, along with undeveloped woodlands and sparse single-family residences.
- West:** Undeveloped woodlands.

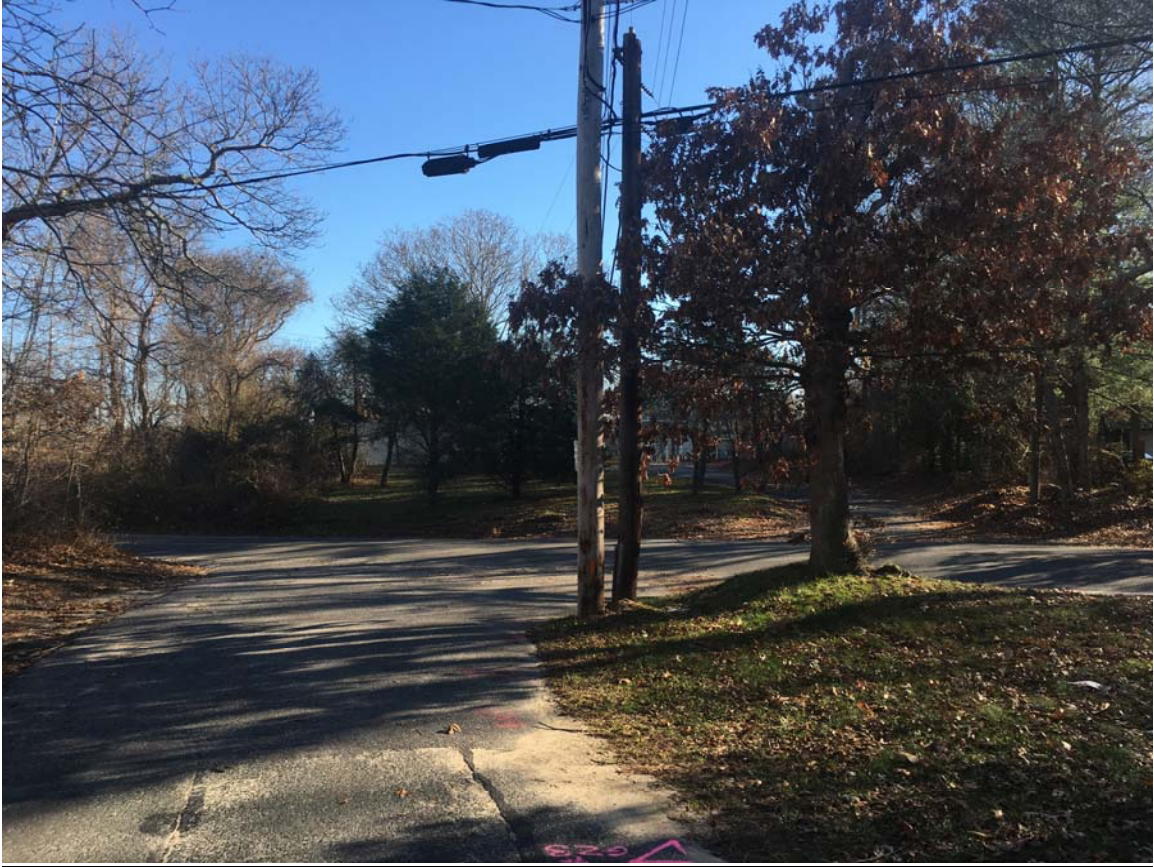
Photograph No. 5: The paved driveway providing access to the subject property from Cove Hollow Road.

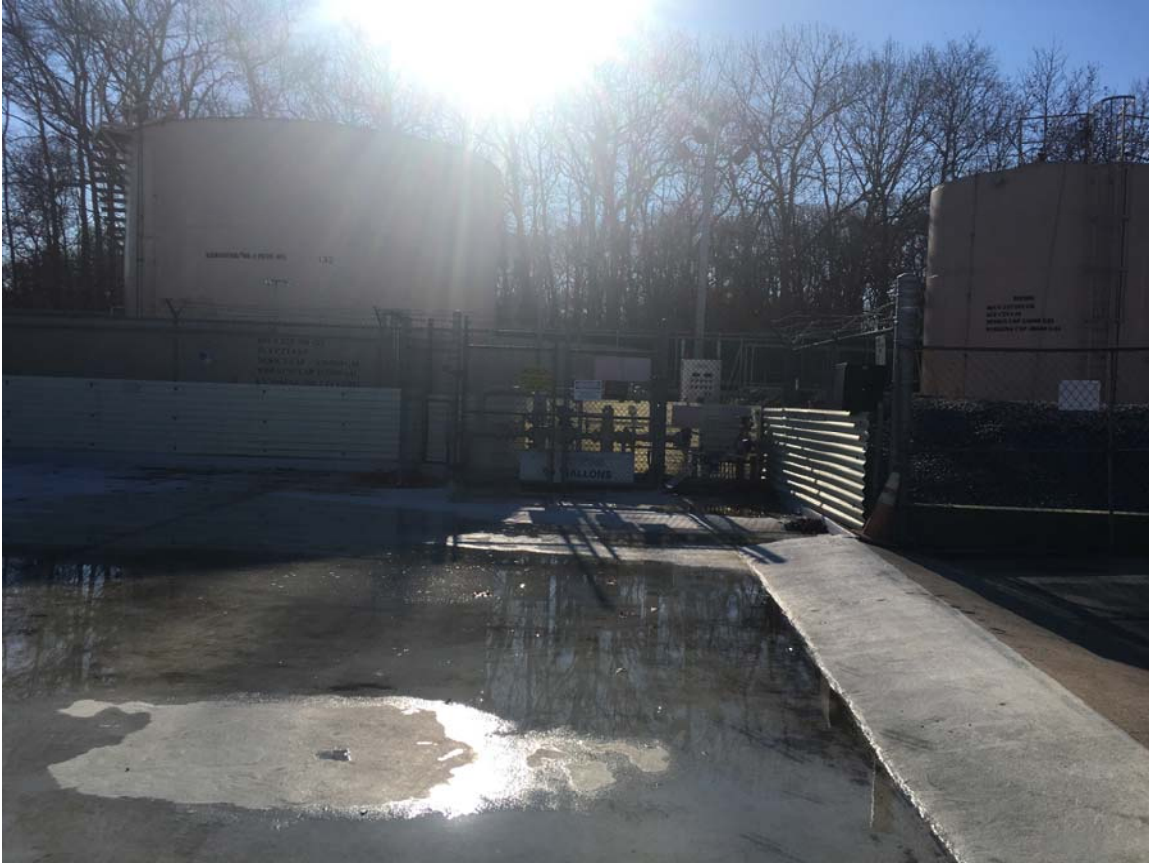
A 135,000-gallon kerosene storage tank, along with a 55,000-gallon diesel storage tank are located within the National Grid Generating Station. During the visual inspection, the storage tanks were noted to be in good condition, with no evidence of leaks or historical releases. As such, the presence of same are not considered a significant environmental risk.

Photograph No. 6: A kerosene and diesel storage tank located within the National Grid Generating Station. View is to the south.

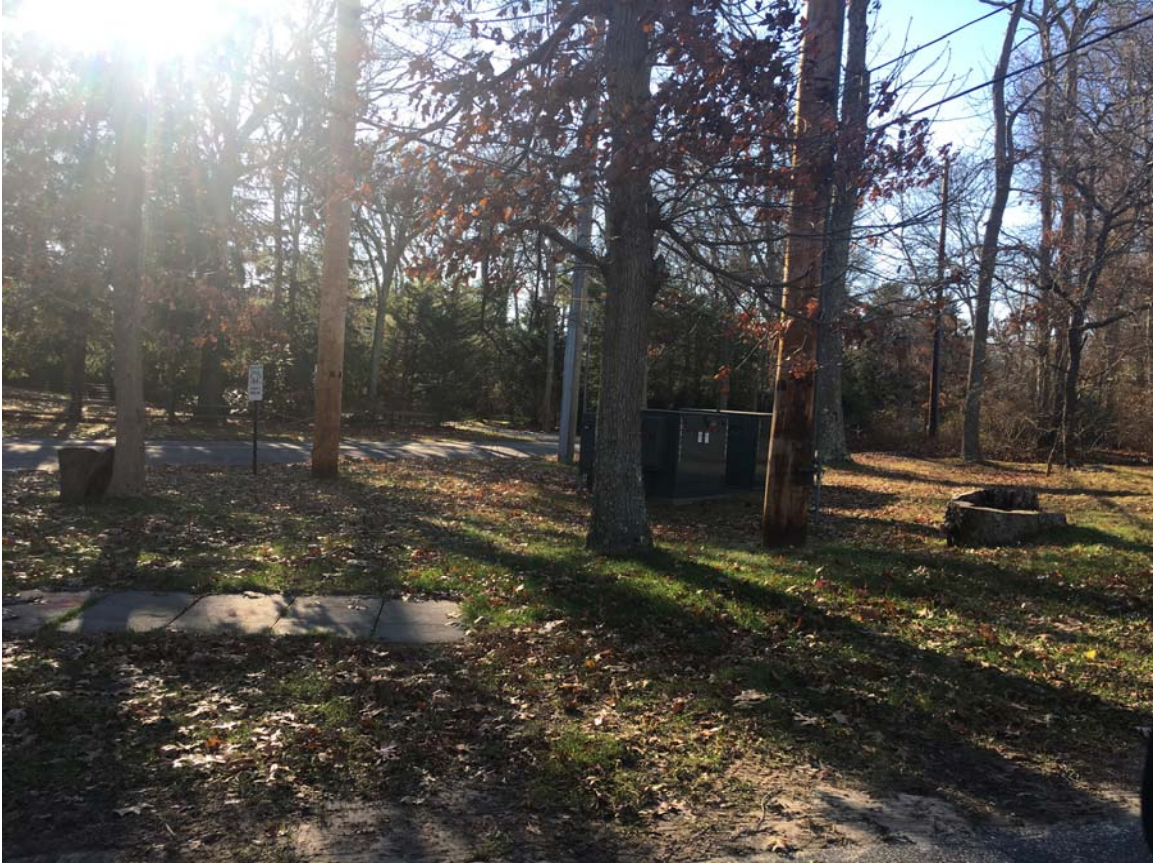
Two-pad mounted transformers were observed on the eastern portion of the subject property. During the visual inspection, the transformers were noted to be in good condition, with no evidence of leaks or historical releases. As such, the presence of same are not considered a significant environmental risk.

Photograph No. 7: Two pad-mounted transformers located on the eastern portions of the subject property, along Cove Hollow Road.

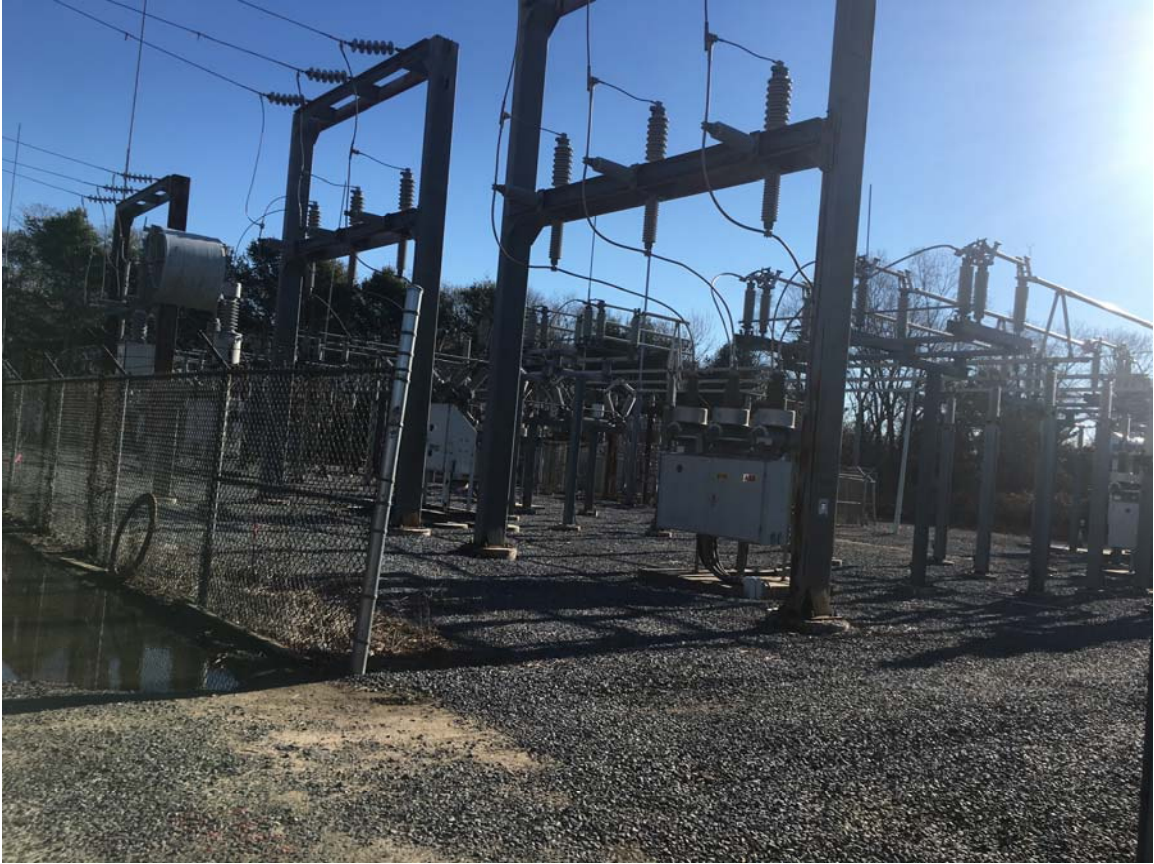
Photograph No. 8: Ground-based transformers, located within the central eastern portions of the subject property.
