Inspection Report

Property Address:
49028 North Main Sreet
New River AZ 85087

Inspection Services LLC

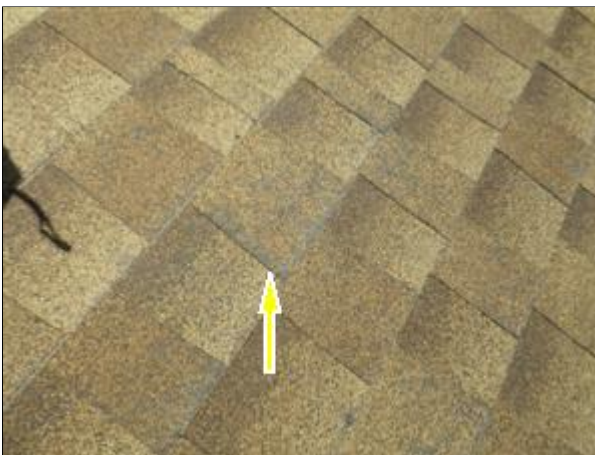
While the condition of the house roof covering was functional during todays inspection. There is some granular loss noted around the air conditioning unit. Keep in mind the inspection is only a snapshot of the current condition. These conditions can change from hail, wind or someone walking on the roof. If you feel any of these actions have taken place after todays inspection, I recommend the roof be reinspected prior to close of escrow.

granular loss

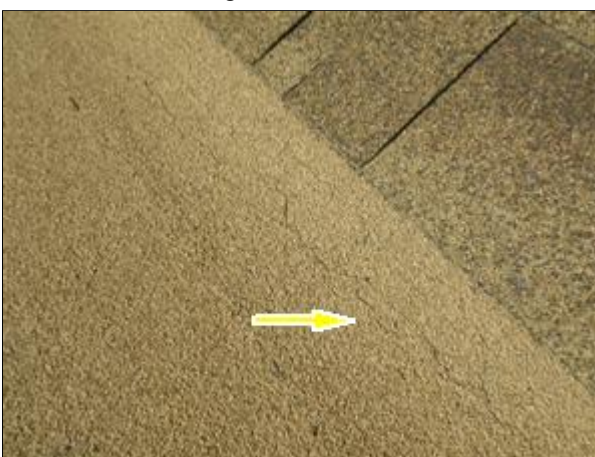
The patio roof was functional. There is some alligatoring and mumping beginning to occur. Rolled roofing normally has about a 15 year life span. Recommend continued evaluation and repair as necessary

alligatoring

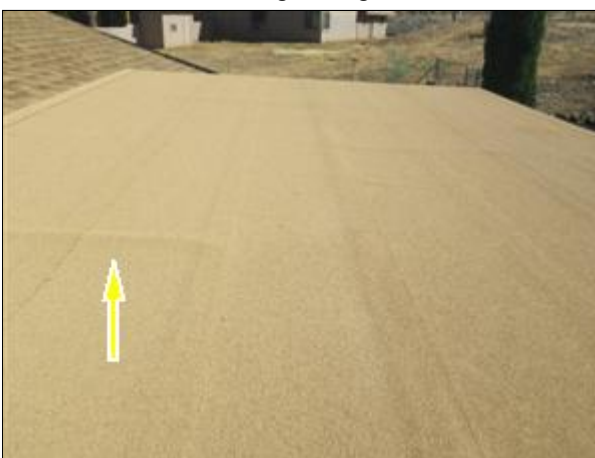
mumping

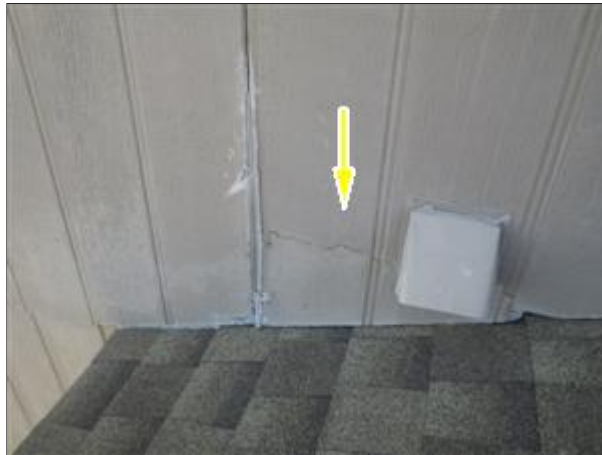
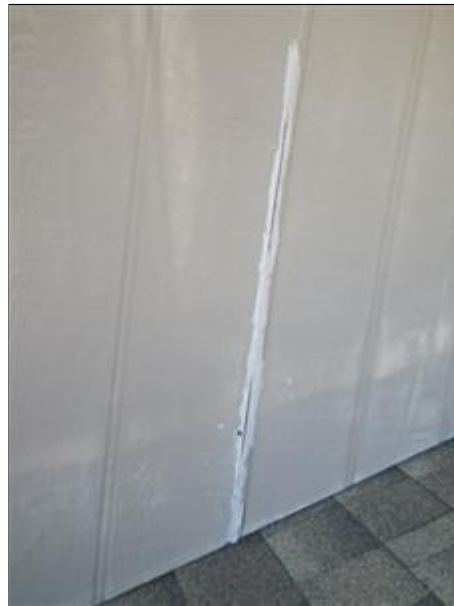
(1) There has been some patching of the wall cladding above the garage. Recommend budgeting to paint the exterior cladding.

patching

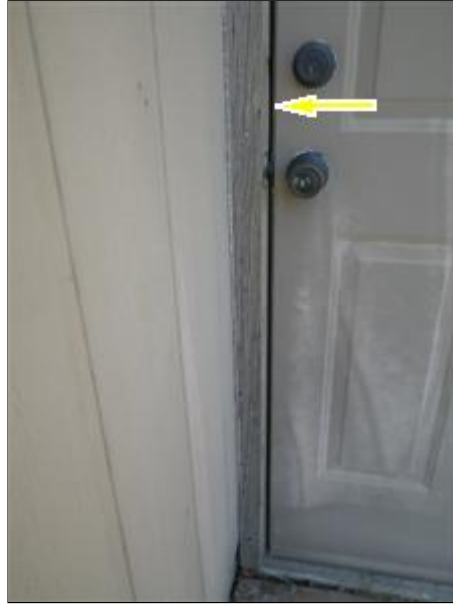
(2) Trim on the side of the garage door needs painted. Recommend painting by a qualified person.

paint trim

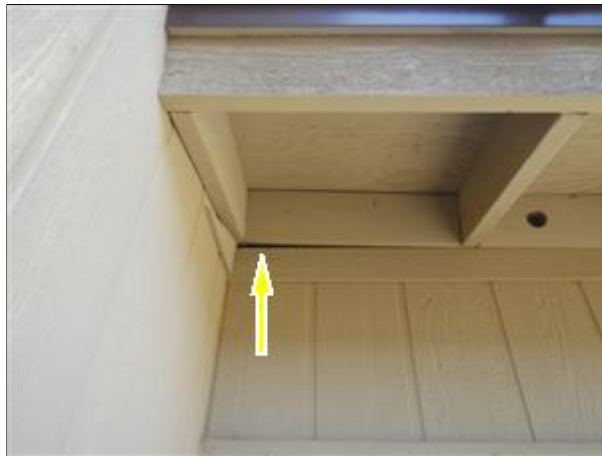
(3) There is a gap between the wall and the eaves at the garage. Recommend evaluation and repair by a qualified person.

gap

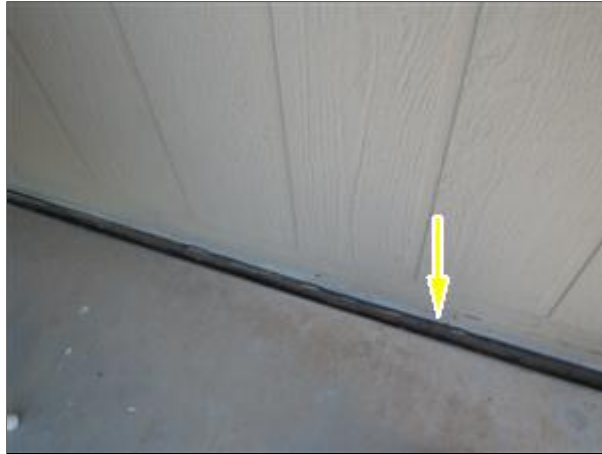
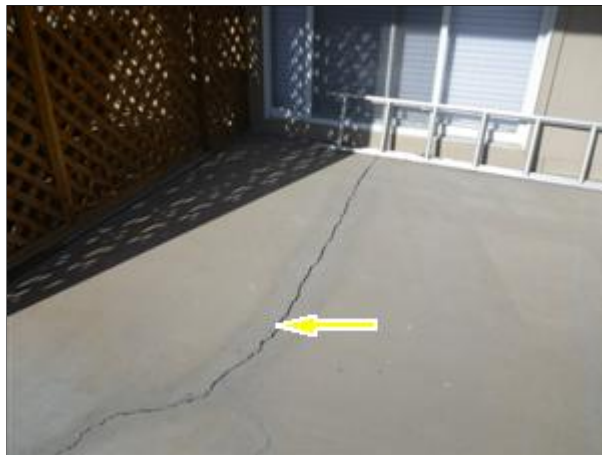
Patio concrete has a large crack.

crack

Recommend these items be evaluated by a qualified contractor.

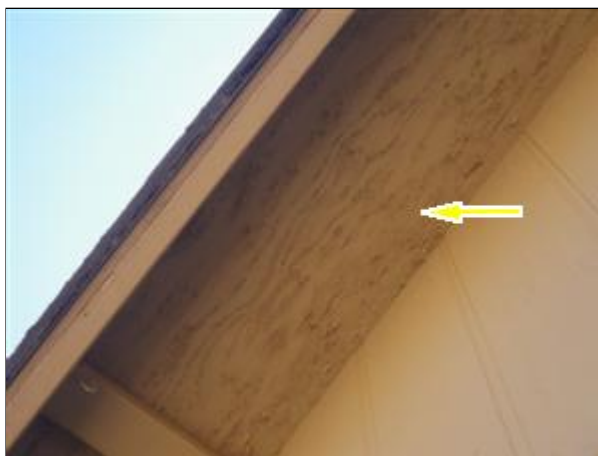
(1) The paint on the eaves has failed in some areas and there is no paint on a section of the eaves at the patio.

no paint

Fascia board needs to be painted. Recommend painting of these items by a qualified person.

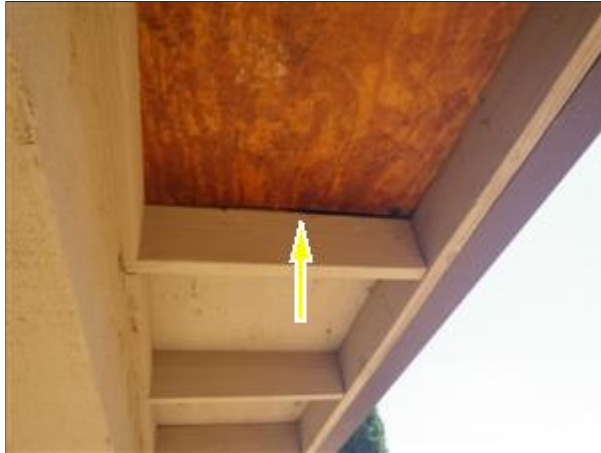
(2) There is a section of the eave at the patio that has lifted and needs to be re-secured. Recommend repair by a qualified person.

lifted

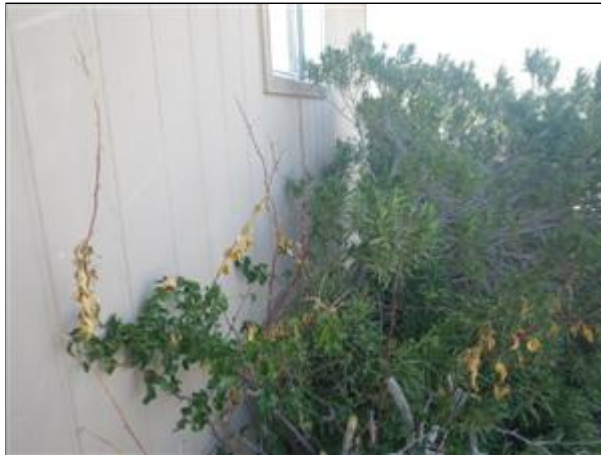
The landscape bushes/trees are touching the house in several areas. Recommend they be trimmed back so they are not in contact with the wall cladding.

trim bushes

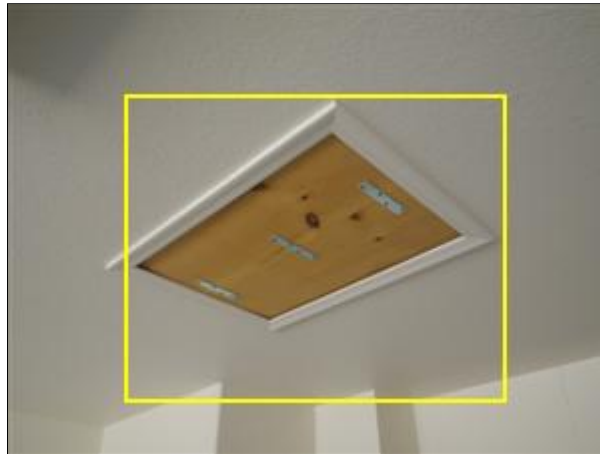
The firewall between the garage ceiling and the house is compromised by the wooden scuttle cover. The scuttle should be made of 5/8" dry wall or a non flammable product. This is considered unsafe until corrected. A qualified person should correct for safety.

wood scuttle

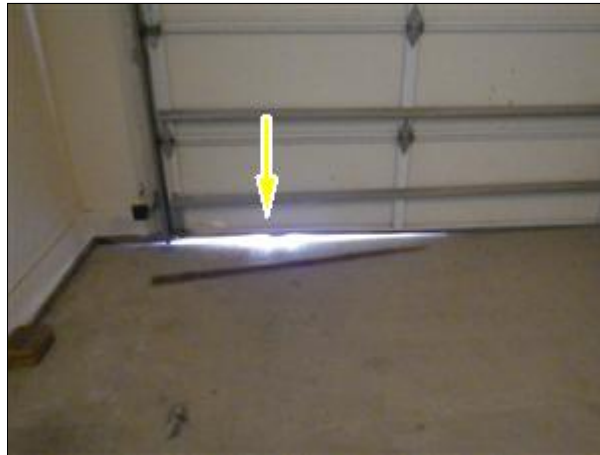
no seal

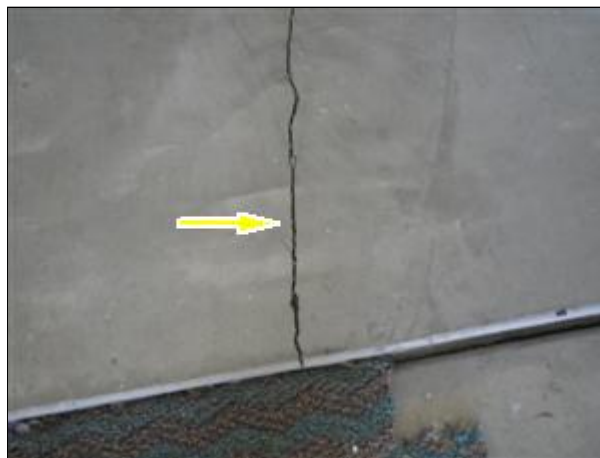
The garage floor has some settlement cracking. Cracking is normal for the age of the home but some of these crack are beyond an 1/8" wide. The east section of the floor is slightly higher than the west end. The east section of the garage door does not seal because the floor is not level. Recommend evaluation of the garage floor by a certified concrete contractor to insure the integrity of the floor.

cracking

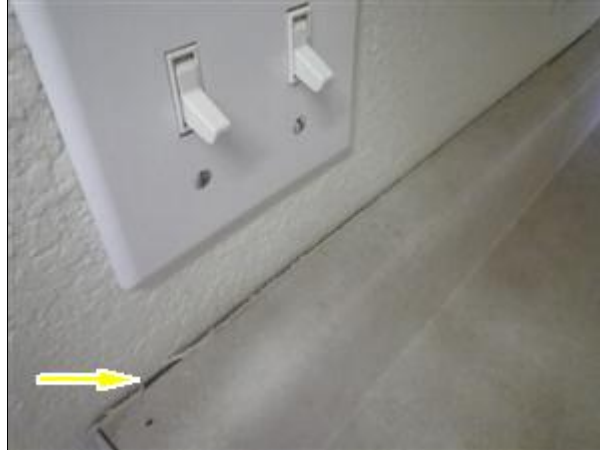
need caulk

Recommend repair by a qualified person.

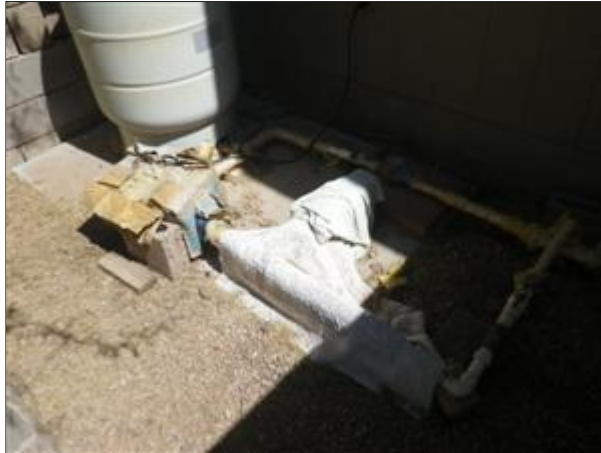
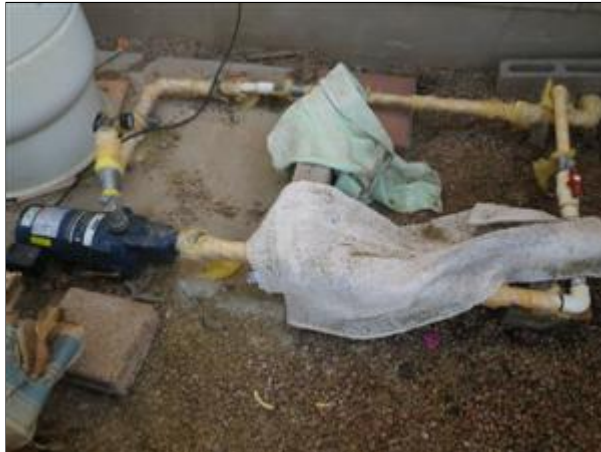
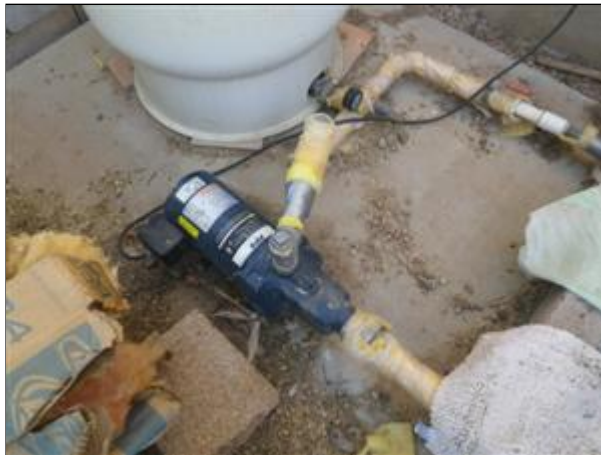
PVC piping at the pressure tank is exposed and not properly supported. Recommend evaluation and repair by a qualified person.

pressure tank

piping

pump

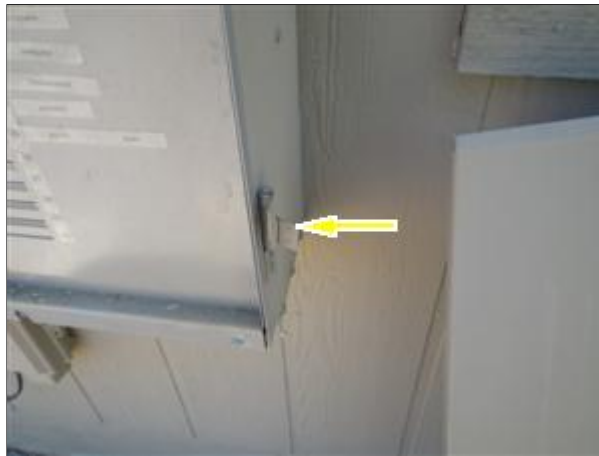
The main panel door has a broken hinge. Recommend repair by a qualified person.

broken hinge

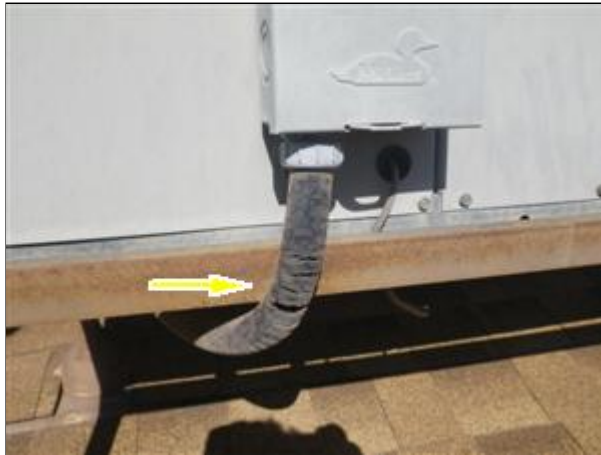
Flex conduit to the A/C disconnect is damaged. Recommend repair by a qualified contractor.

damaged conduit

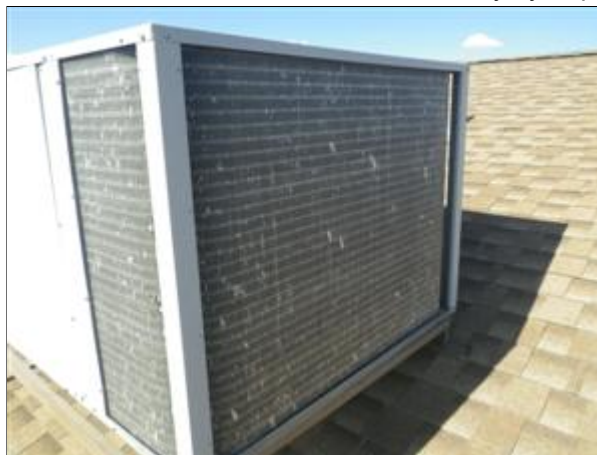
The condenser is dirty and the fins need combed.. This can cause higher pressures in the unit and increase utility bills. I recommend it be cleaned and serviced annually by a qualified HVAC Contractor.

comb fins
