**Sentinel West  
RESERVE STUDY FOR  
COMMON AREA COMPONENTS**

MARIETTA, GEORGIA

February 2014

RE: Reserve Study of the Sentinel  
West Subdivision, Marietta GA

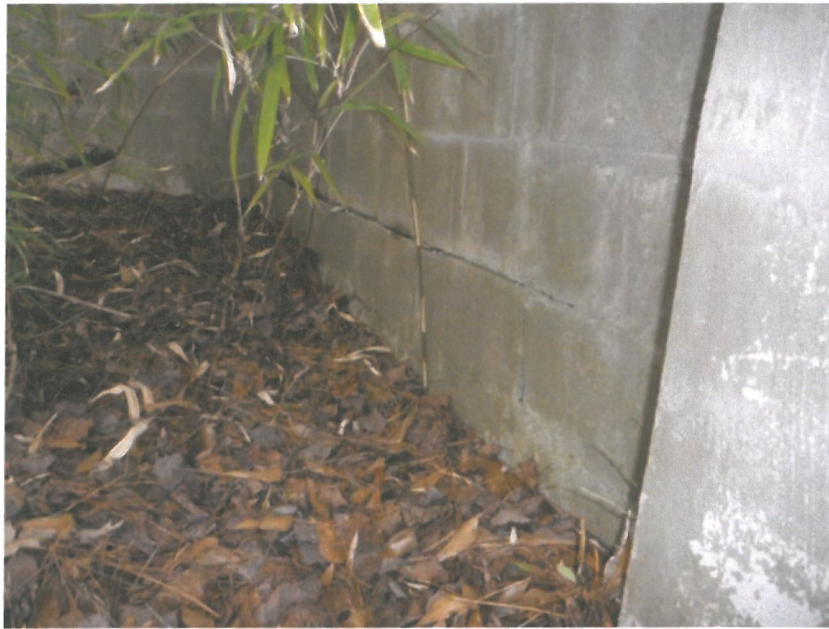
Foundation crack at rear of Entrance Monument

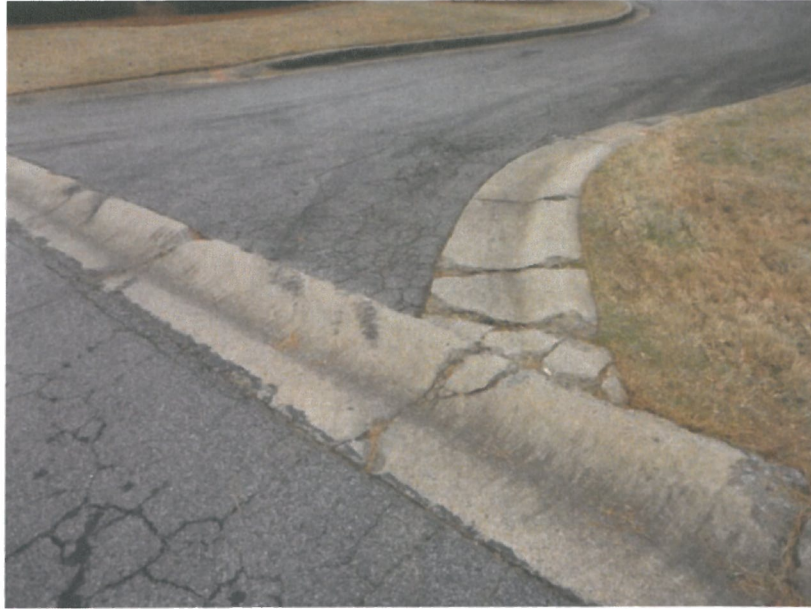
Curbs and paving at clubhouse entrance

Asphalt Paving: Sealing cracks should be part of a maintenance program for the reduction of asphalt and gravel base expansion and failure. Slumping asphalt at the eastern entrance drive may be the result of a storm sewer line crossing. The governing water authority should be contacted for correction.

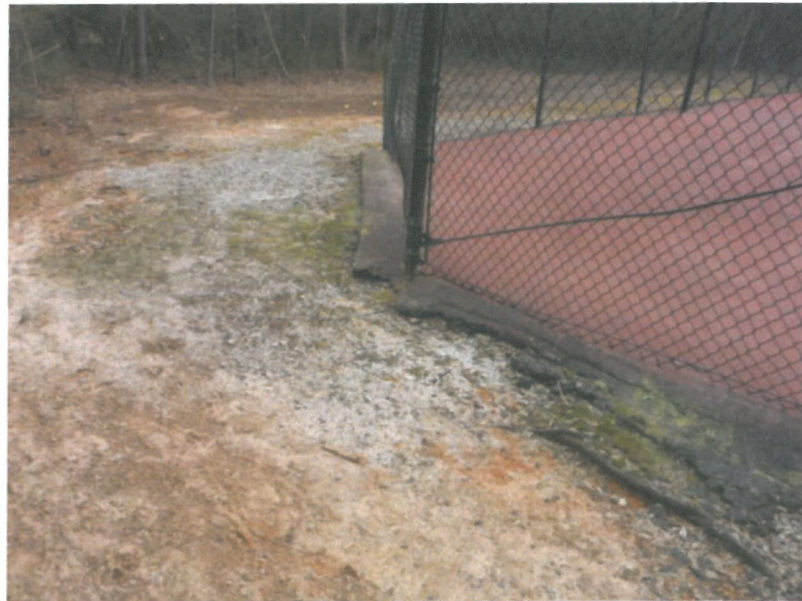
Rear of tennis courts

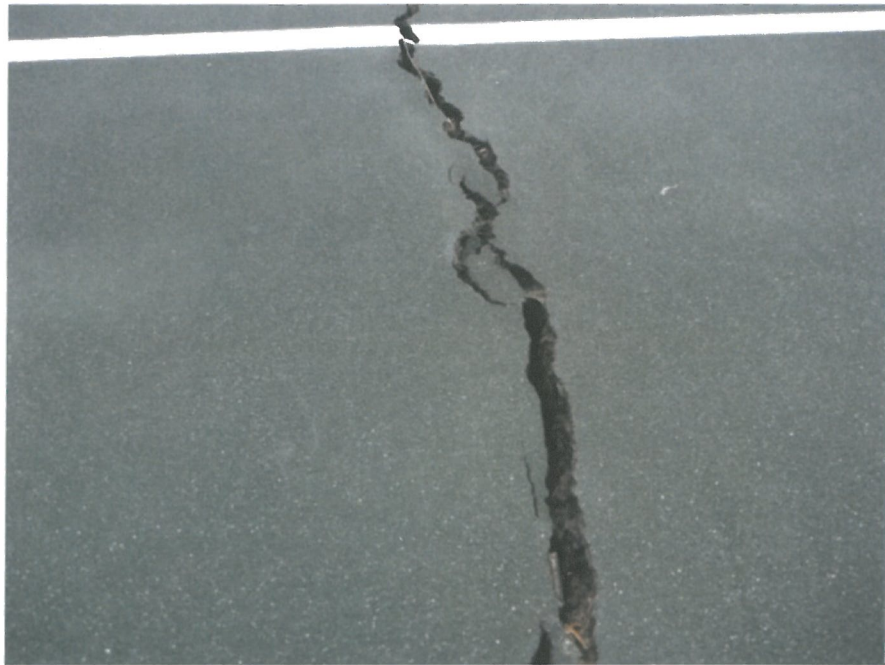
Tennis Courts: Tennis courts are commonly located in floodplain areas similar to the ones at Sentinel West. It is likely that the soil conditions below the tennis courts are not stable and are causing cracking.

Tennis court cracking

The cracks in the tennis courts will likely continue to reappear. According to Southeastern Tennis Courts, there are two recommended solutions and each cost around \$45,000 to \$50,000. The first involves pouring a six-inch concrete curb around the perimeter, and filling on top of the existing courts with four inches of gravel and two inches of asphalt. The other is a "Premiere" surface, which is a thin foam layer which includes a 25-year warranty and bridges the cracks.

Another option is a full reclamation and redo of the courts. Matt Graft of Talbot Tennis indicated a preliminary estimated price of \$53,000. We have used \$50,000 in this analysis and assumed the work would be done in year four.

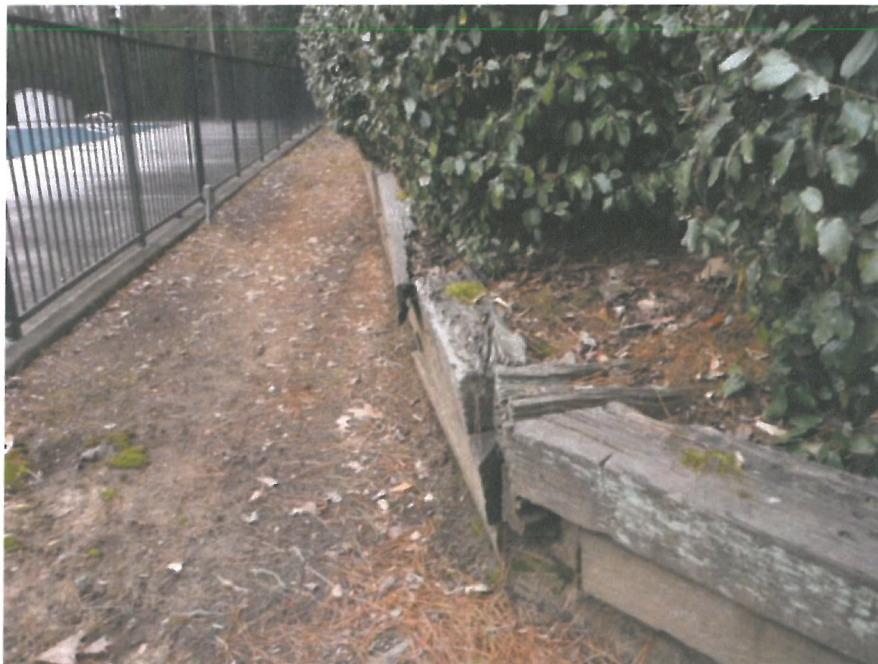
Aging retaining wall

Retaining Wall Repair: The wall is assumed to be replaced with like kind material. However, portions of the wall could possibly be eliminated by grading the slope. The swale between the wall and the pool deck should be maintained at a depth which will allow water to flow away from the pool.

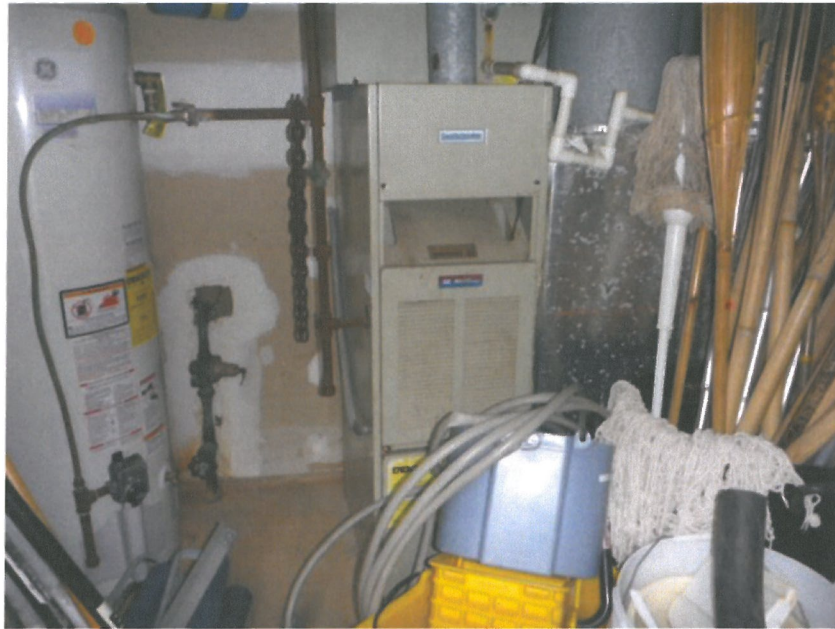
Aging clubhouse furnace

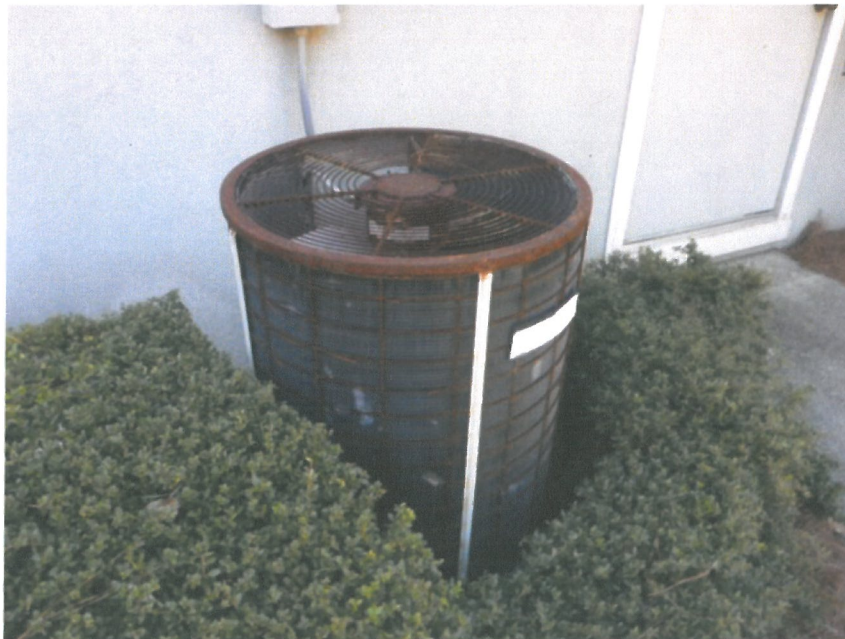
Aging Condensing unit

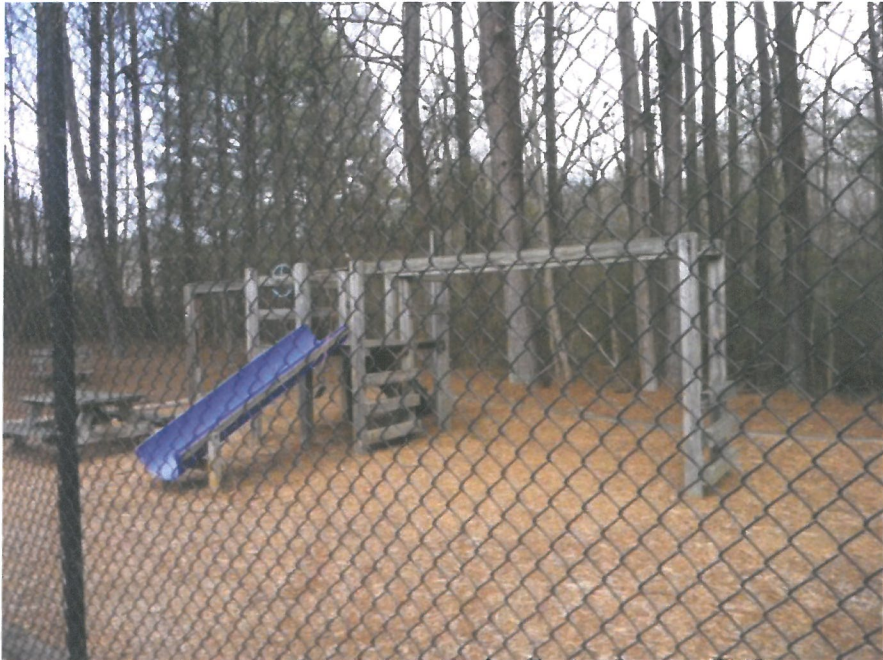
Playground equipment

Playground Equipment: The replacement of the playground equipment assumes materials typically found with new equipment, including metal and plastic. Many

options are available, but we have applied pricing that reflects replacing the functional utility of the existing equipment.

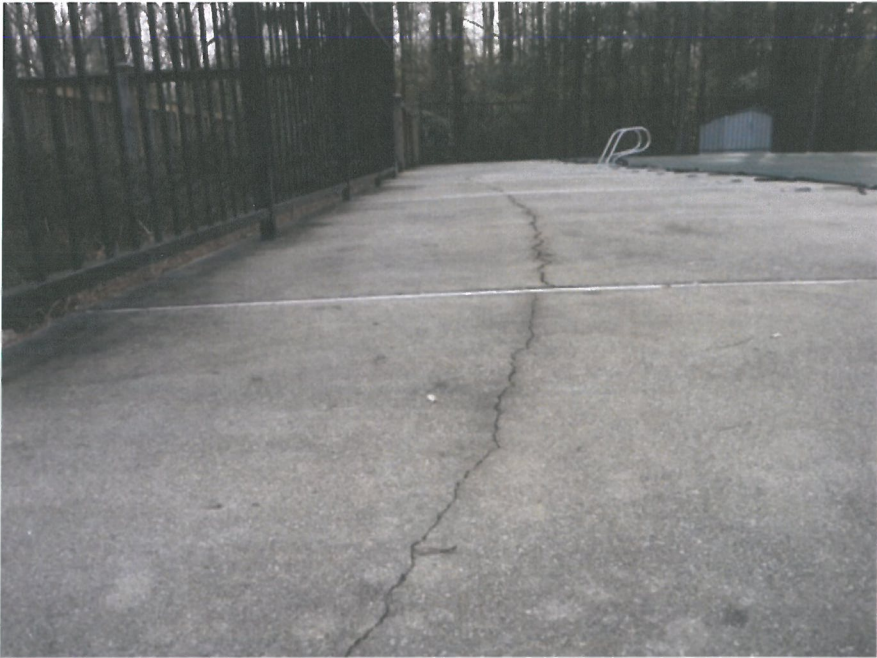
Pool concrete decking: The decking demonstrates cracking. Although this is not resulting in significant problems at this point, the cracks should be sealed in order to prevent acceleration of the issue, and should be part of a regular maintenance program. We have included a line item for a surface coat to be applied on the concrete decking.

The most costly upcoming known expense is the replacement of the tennis courts. The pool decking could potentially heave to a point to cause replacement if the existing cracks are not sealed.

Cracked pool decking surface
