Broken Sound Country Club (Boca Raton, FL) Green waste & Food waste Composting Operation

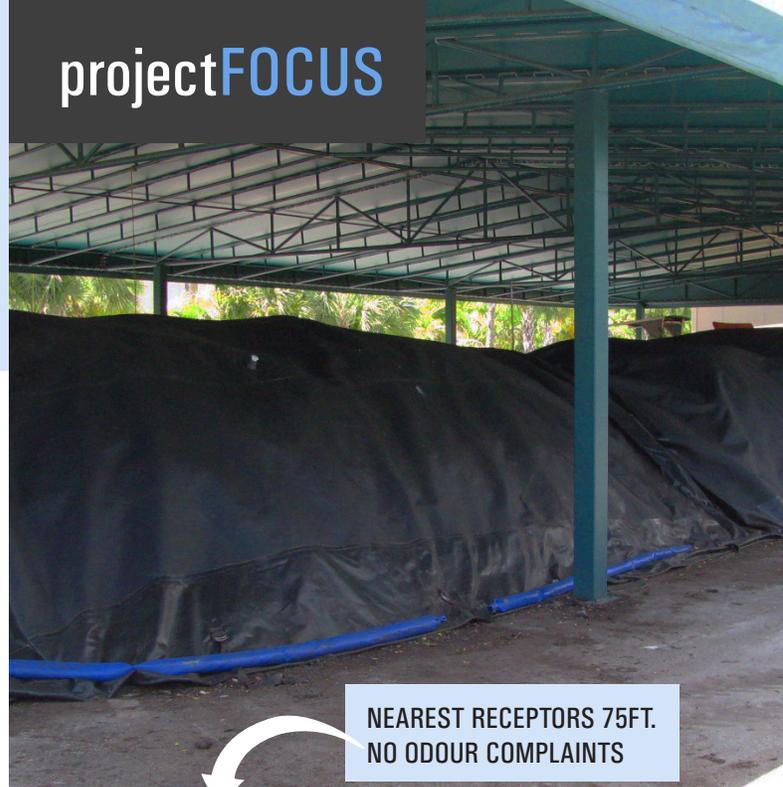
START UP	October 2009
SITE FOOTPRINT	1/2 acre
CAPACITY	230yd3/wk
ACTIVE COMPOSTING PHASE	5 days
CURING TIME	3 weeks
SCREEN SIZE (FINISHED PRODUCT)	3/8-inch

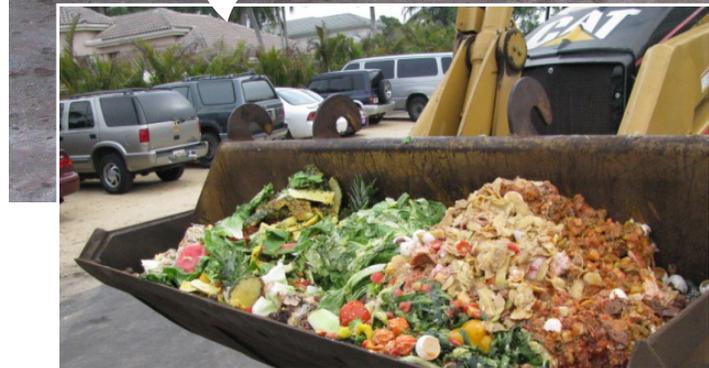
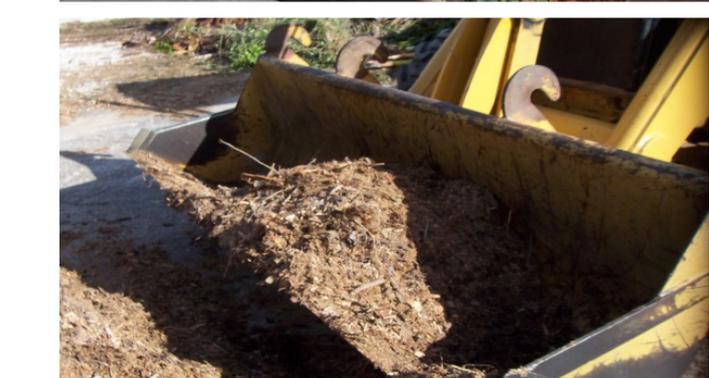
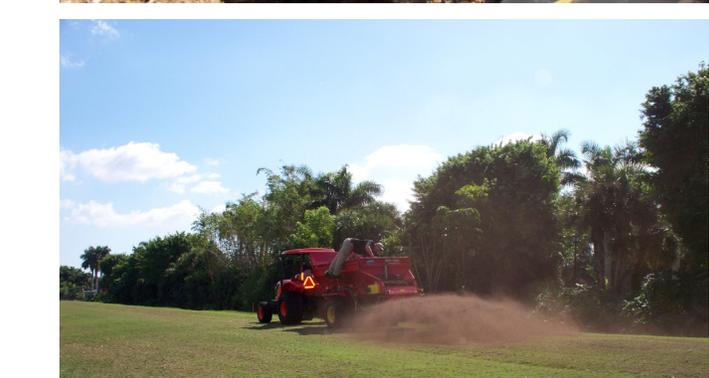
7 yd3 of landscaping material from the residential community, golf, and recreational facilities is mixed with 3 yd3 of food waste from the club's restaurants on a daily basis and feed into a rotary drum digester for the first phase of the composting process. After 5 days the material is then transferred to 3 Managed Organic Recycling, Inc. (MOR) compost covers and aerated for the compost curing phase. Control of odors is of great concern in the high end community which led Broken Sound to utilize MOR's compost covers in their operation.

Finished compost is screened on site and applied to the 2 golf courses and the residential landscape closing the loop on organic waste collection and processing for Broken Sound. The operation produces an effective soil amendment will saving on disposal fees and reducing the cost for fertilizer, pesticides and fungicides by at least a third.
