Inspection Report

Property Address:
1234 Anywhere Lane
Grand Junction CO. xxxxx

Jay's Inspection Service

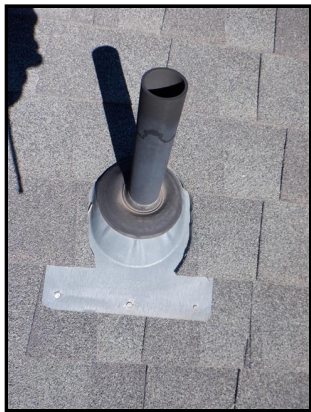
1.2 Picture 1

1.2 Plumbing vent pipes and roof flashings look good.

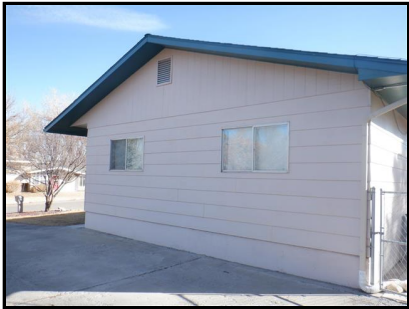
2.0 Picture 1

2.0 The exterior wood siding appeared to be functional at time of inspection.
The wood siding on east side of garage has water damage. FYI

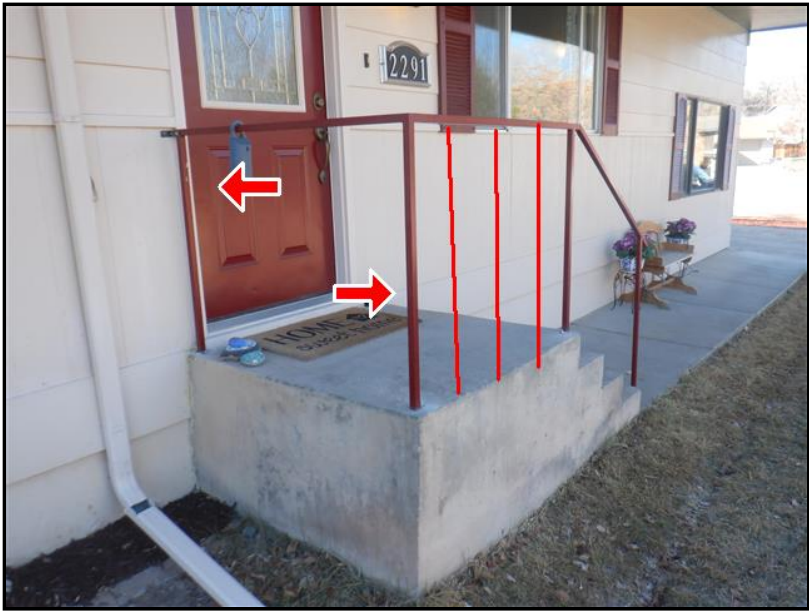
2.3 Picture 1

2.3 Recommend the handrail at front entry have balusters installed every four inches.

Patio area appeared to be functional at time of inspection. Common cracks. Seal as needed. Concrete pitted. The front entry concrete walkway/porch appeared to be functional at time of inspection.

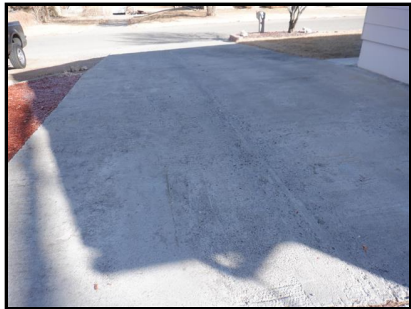
2.4 Picture 1

2.4 The driveway and walkways appeared functional at time of inspection. Common cracks. Seal as needed. The concrete is pitted.

Recommend sealing all cracks larger than 1/4 inch wide to prevent water intrusion.

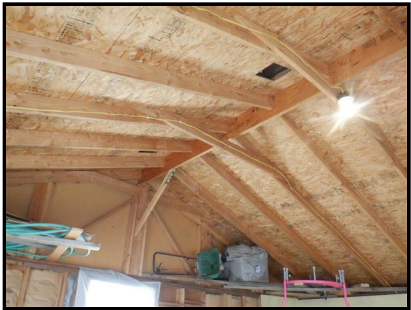
3.0 Picture 1

3.0 The garage ceiling structure is open 2x6.

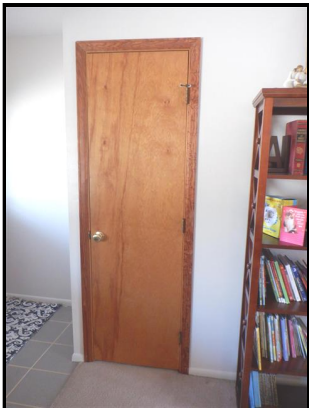
4.5 Picture 1

4.5 The master bathroom door does not latch properly. Recommend adjusting strike plate as needed.

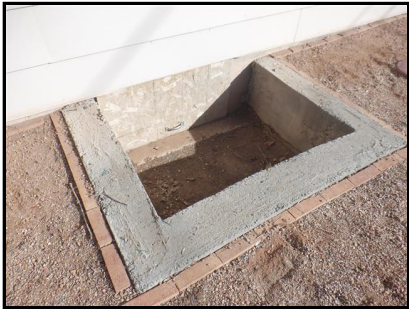
5.0 Picture 1

5.0 The crawlspace area and concrete foundation appeared to be functional at time of inspection. Entry is outside backyard.

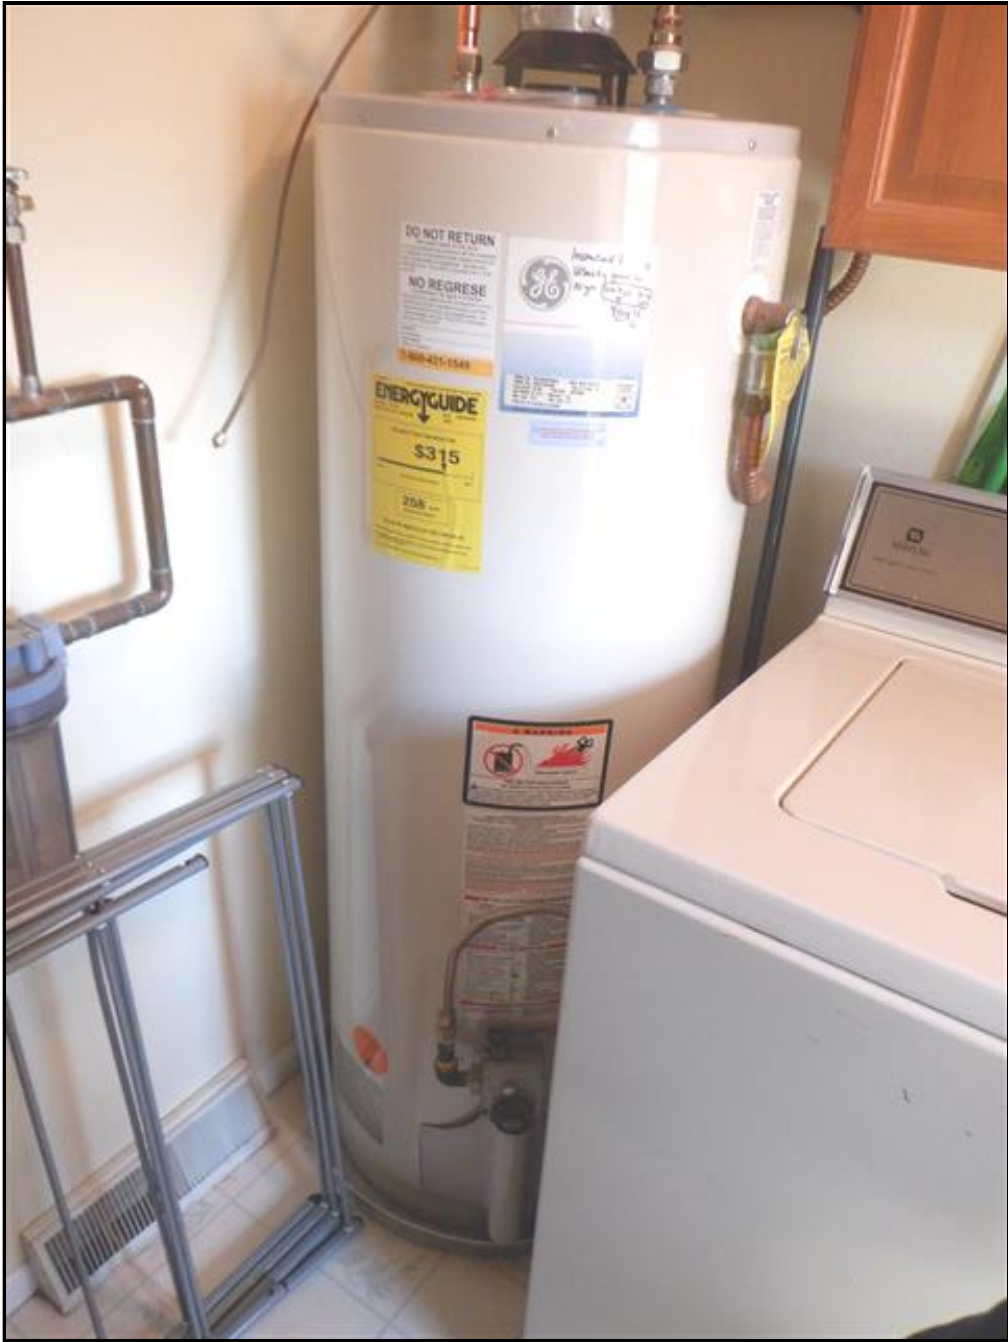
6.2 Picture 1

6.2 The water heater and expansion tank appeared to be functional at time of inspection. YR. 2009

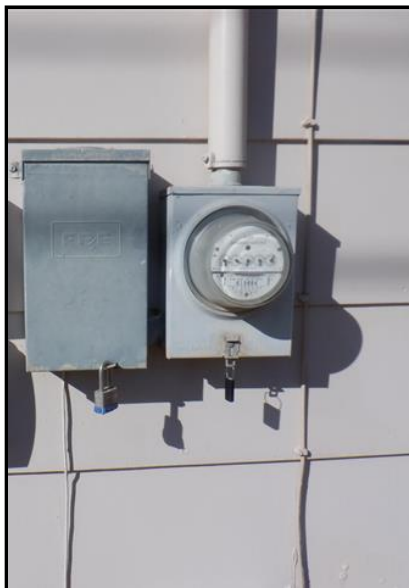
7.6 Picture 1

7.2 You have a Federal Pacific panel which is legal, but there is a possibility that the circuit breakers may not trip when shorted possibly causing an electrical hazard. Opinions by licensed electrical contractors on this panel varies between safe and unsafe. I recommend you consult a licensed electrical contractor for an opinion and correct if necessary.

7.6 The main panel box is located on east side of home. The main panel appeared to be functional at time of inspection.

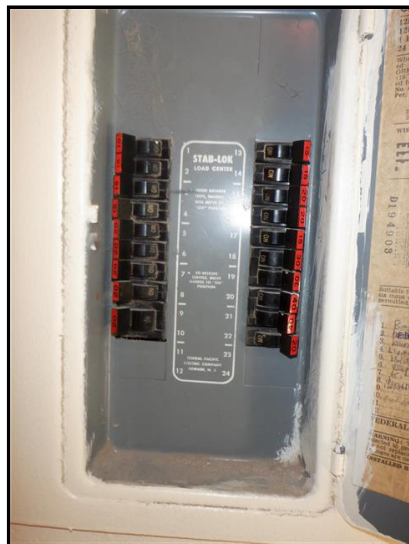
7.6 Picture 2

The sub panel is located in laundry room. Sub panel was functional at time of inspection

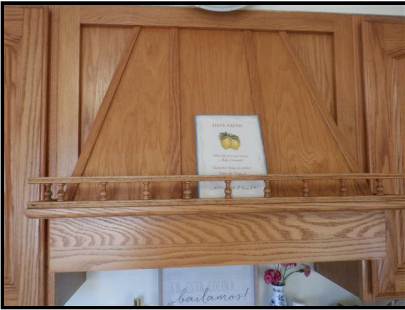
10.2 Picture 1

10.2 The range hood is missing in hood over range. Install as needed.

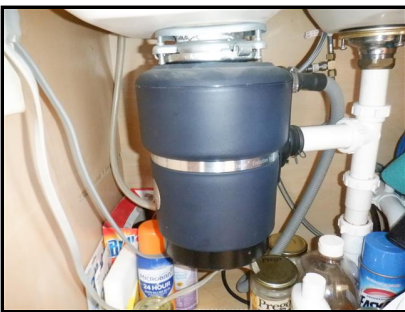
10.4 Picture 1

The disposal was wired in with extension cord and switch. This is not installed correctly according to electrical codes. Recommend repairs by qualified contractor.

The switch on right side of kitchen sink should operate the disposal. The switch powers the top half of plug under kitchen sink for disposal. The bottom half of plug is hot for dishwasher.
