PROPERTY INSPECTION REPORT

Concerning: XXXX Chiva Drive, Little Elm, Texas 75068

By: Jen K Chen (Jake) TREC #20333

XX/XX/2018

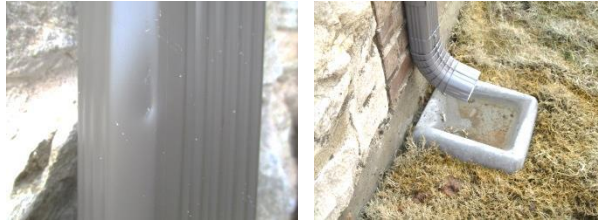
B. Grading & Drainage

Comments: On the north side, the downspout shows evidence of damage; needs to be repaired. All the splash blocks for the downspouts need to be turned open end, must face away from the house.

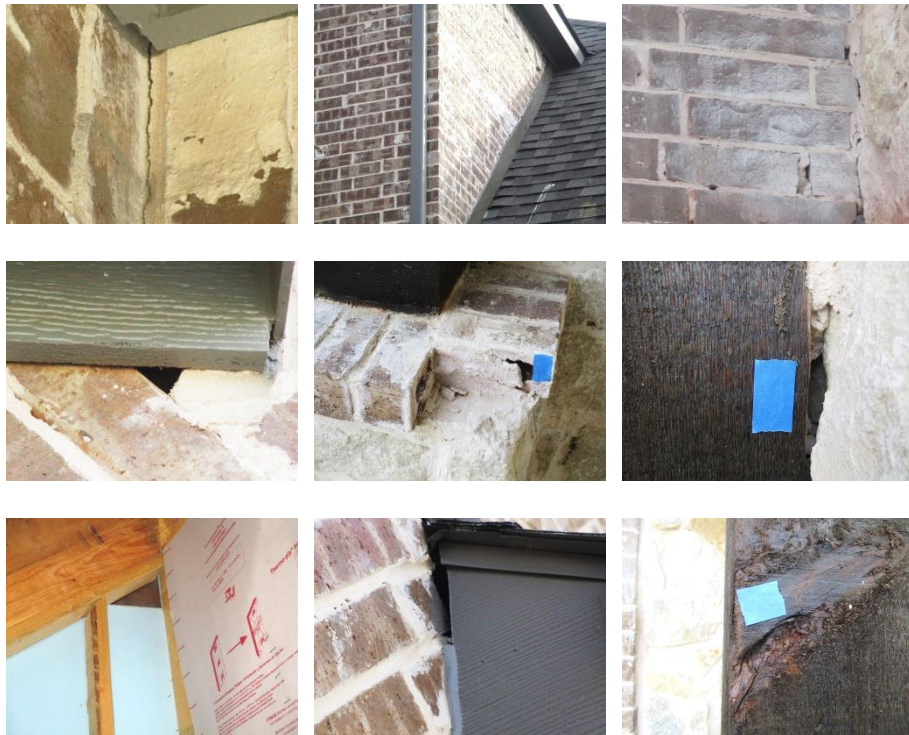
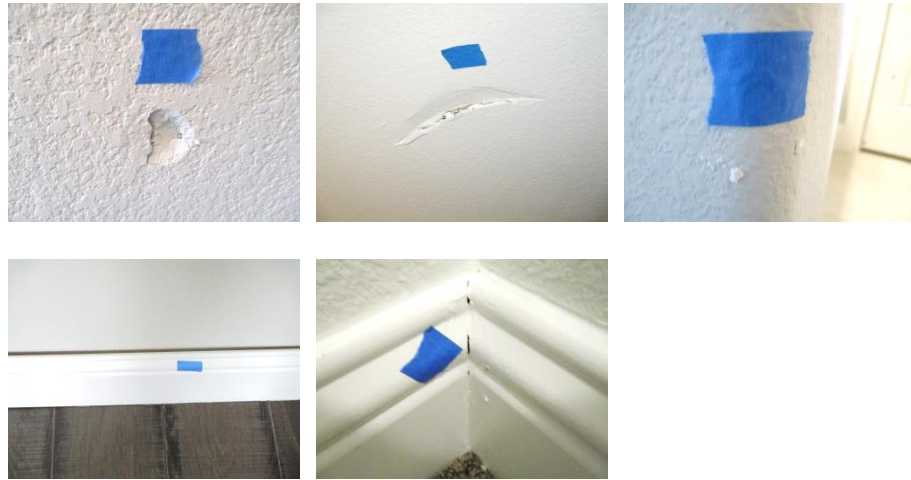
E. Walls (Interior & Exterior)

Comments: The exterior brick on the south side shows evidence of cracks; needs to be repaired. On the southeast corner of the exterior wall, the wall is dented inward; needs to be repaired. Some areas of the perimeter exterior brick walls have many holes that need to be filled with mortar. The left wood column below the brick in the front porch is damaged; needs to be repaired. The right wood column needs to be caulked to attach to the brick. The sheathing insulation panel on the west wall in the attic shows evidence of hole damage; needs to be repaired. At the front of the house, the soffit underneath the roof on the north side has hole damage that needs to be caulked. The right wood column in the front porch shows evidence of damage; needs to be repaired. All of the interior walls and baseboard with blue tapes show evidence of stains, unfinished paint, caulking or damage; need to be repaired.

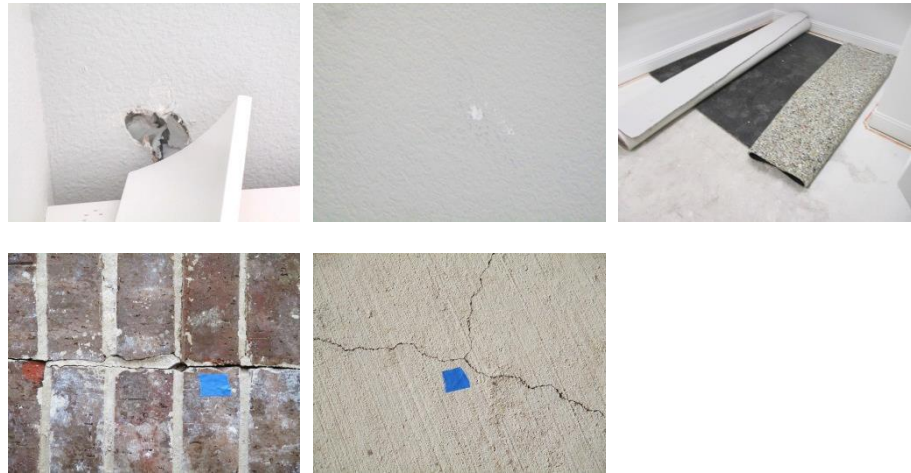
F. Ceilings & Floors

Comments: The ceiling in the kitchen has hole damage in the sheetrock that needs to be repaired. The ceiling wall in the downstairs north bedroom shows evidence of unfinished paint; needs to be repaired. The carpet flooring is undone of the walk-in-closet in the master bathroom; needs to be finished. The brick floor mortar joint in the front porch shows evidence of cracks; needs to be repaired. The concrete floor in the backyard patio shows evidence of cracks; needs to be repaired.

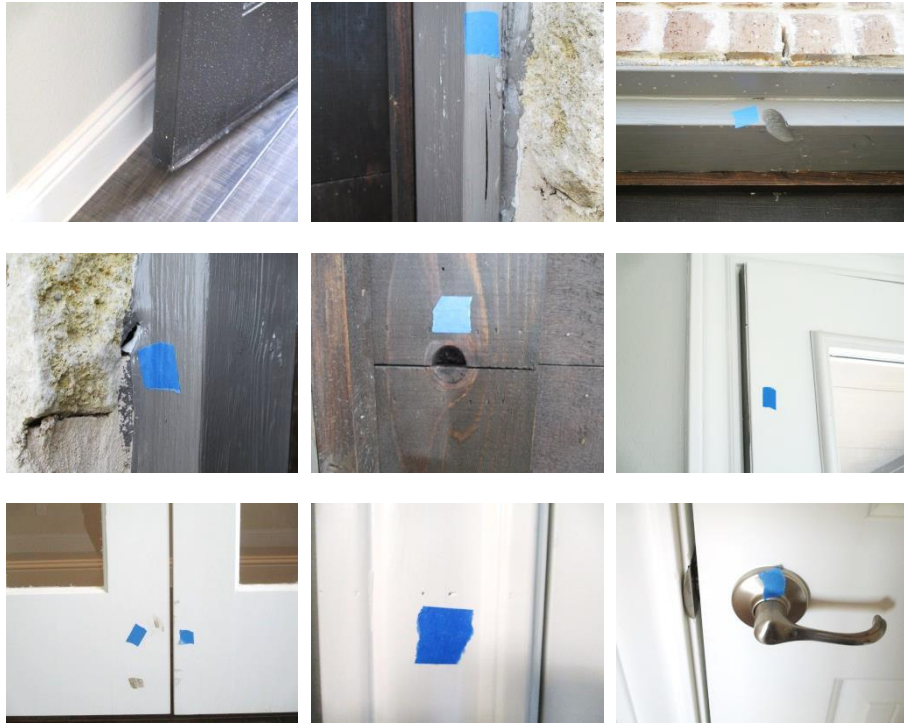
G. Doors (Interior & Exterior)

Comments: Opened and closed all doors and checked outside locks. The front door stopper is missing; needs to be restored. The door frame at the garage door shows evidence of damage; needs to be repaired. The garage door frame needs to be caulked to brick. The garage door shows evidence of damage; needs to be repaired. The backyard door cannot be completely closed; needs to be repaired. The weather strip of the front and backyard exterior door is missing; needs to be restored. All the areas with blue tape on the interior and exterior doors and door frames show evidence of wood damage, unfinished paint or stains; needs to be repaired. The door lock of the closet in the upstairs game room is inoperable; needs to be repaired.

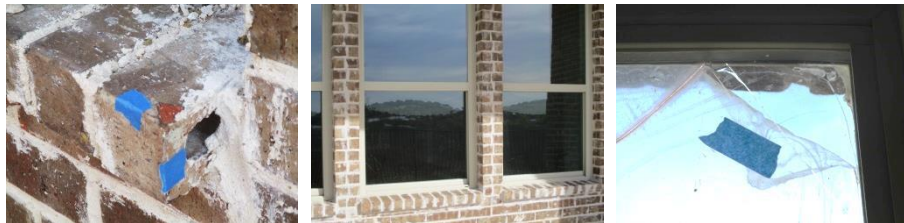
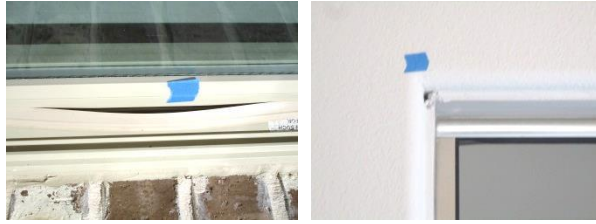
H. Windows

Comments: Opened and closed all windows and checked locks. Along the east side, the exterior window sills show evidence of hole damage; needs to be repaired. All the window screens are missing; needs to be restored. On the north wall of the downstairs north bedroom, the glass of the upper center window is broken; needs to be repaired. Along the south and north side, the exterior window's glazing bead shows evidence of damage; needs to be repaired. The interior window in the master bathroom needs to be caulked to wall.

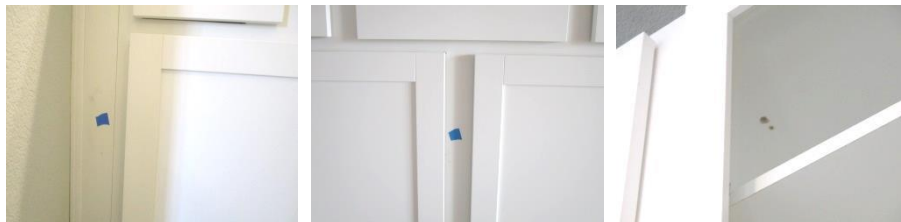
L. Other

Comments: The following places with blue tape shows evidence of scratches, unfinished paint, stains and wood damage; needs to be repaired: kitchen and master bathroom. The molding on top of the upper cabinet in the kitchen is missing; needs to be restored.

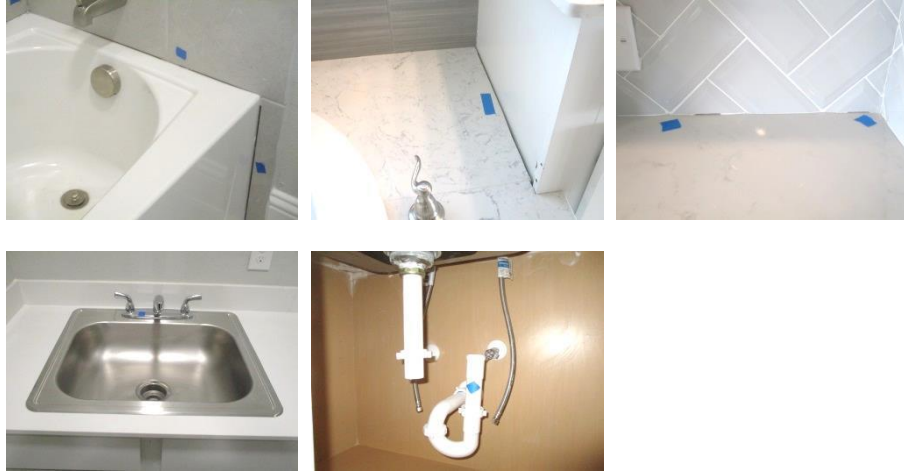
A. Water Supply System and Fixtures

Comments: The regROUT is needed between the bathtub, the tile and the corner in the master bathroom, bedroom's bathroom and upstairs bathroom. The kitchen countertop that is attached to the backsplash needs to be caulked. In the laundry room, underneath the sink, the drainage pipe is not connected; needs to be repaired.
