WELCOME to our first FM Project Profile,

This month's profile comes from Jim Roeger, a Facility Manager for Olive Garden.

The building caught fire a half-hour after the closing management team left the building after midnight, June 14, 2014. The fire resulted in a total loss of the building.

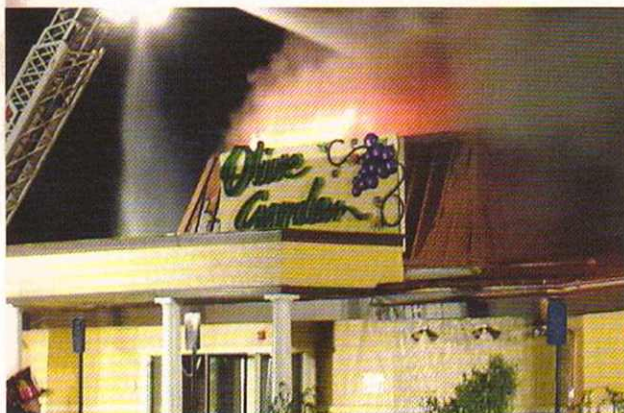
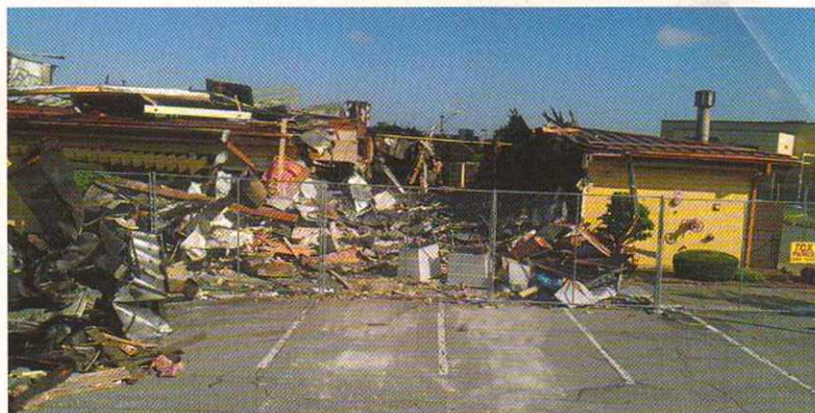
Two sets of firefighters with thermo-imaging cameras came in at the same time; one through the front door, the other through the back door. They both determined that the fire started in the vertical shaft of the exhaust hoods, right below the roof line.

The hood companies, in general, did a good job of cleaning the vertical runs of the hoods (from the top down, as well as from the kitchen floor up). It is the horizontal runs that get overlooked. (Although in this case the fire was detected in a vertical run.)

If there was a section of hoods that the cleaners couldn't get to, many times the hood cleaners would just leave it uncleaned and go on to the next restaurant. Every hood-cleaning company was contacted and made aware of the issue with horizontal runs. We went back and installed additional access panels in restaurants that had horizontal runs that were inaccessible.
