HOME INSPECTION

1234 Main Street
Beaverton, OR 97005

Buyer Name
07/14/2024 9:00AM

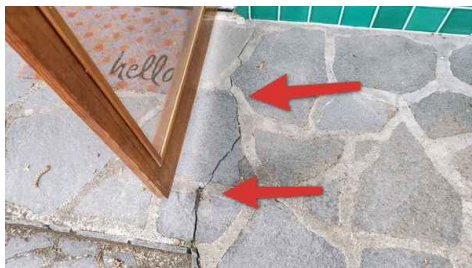
FRONT PORCH

CRACKS IN STONE

Any cracks and gaps should be sealed to prevent damage from moisture intrusion if it freezes in the winter.

Seal cracks

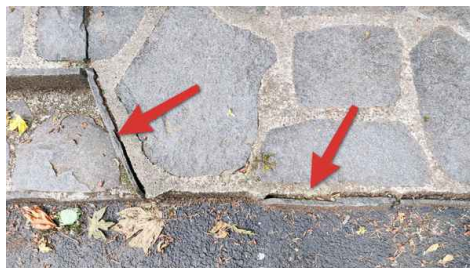
Fill gaps

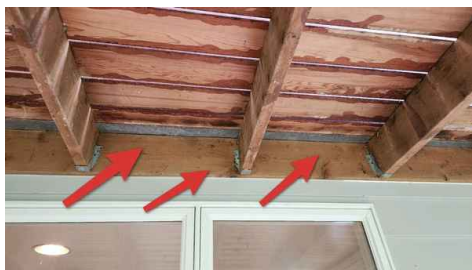
MISSING BOLTS OR LAG SCREWS

Bolt/Lag Screw Placement

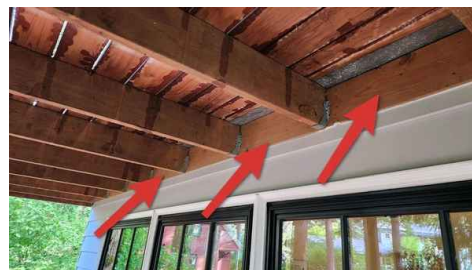
Missing lag screws

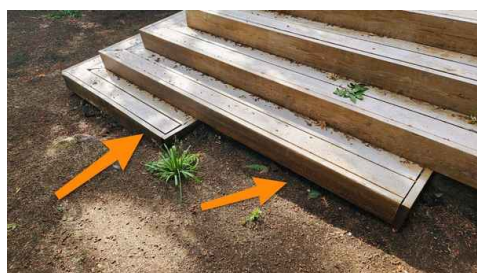
WOOD TO SOIL CONTACT

Avoid wood to soil contact as it will cause rot overtime and invite wood destroying organisms. Rot is already noted on the east side behind the stairs. This needs to be repaired.

Would to soil contact

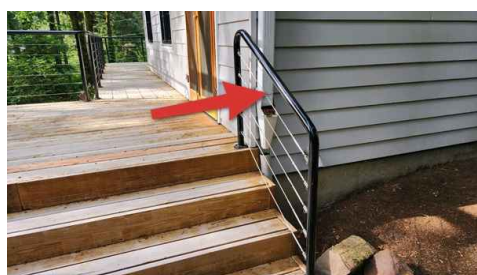
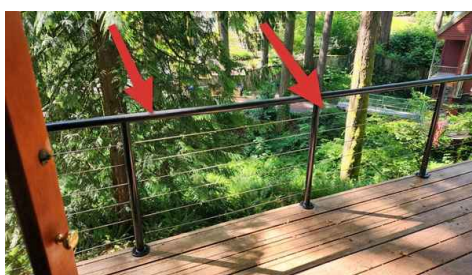
EAST SIDE, BALCONY

LOOSE GUARDRAIL

The guardrail is loose and needs to be better secured to the deck structure for safety.

Loose guardrail

Balcony guardrail loose

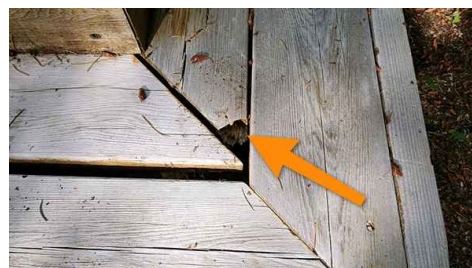
REFINISH DECK

It looks like a paint stripper or power washing was done to clean the deck. I recommend staining it for better protection. Some damage is noted. Replace individual boards as needed.

Damage

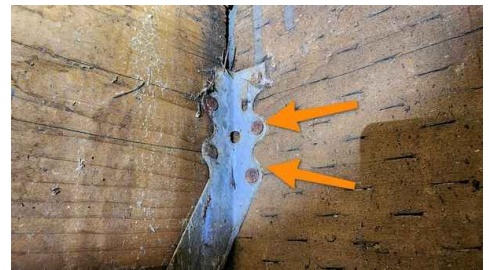
METAL BRACKETS

DECK-CORROSION

The nails at the metal brackets are starting to corrode. Monitor this closely and upgrade these as necessary. If you upgrade consider using stainless steel nails.

Corrosion

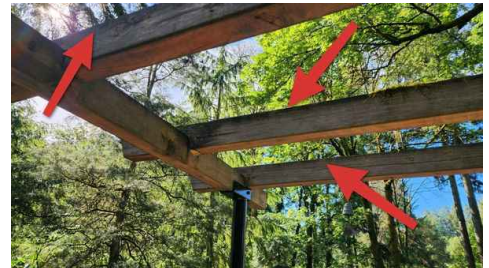
EAST

I recommend adding flashing on the beams at the decorative structure for protection. The wood is starting to get soft in places.

Add flashing

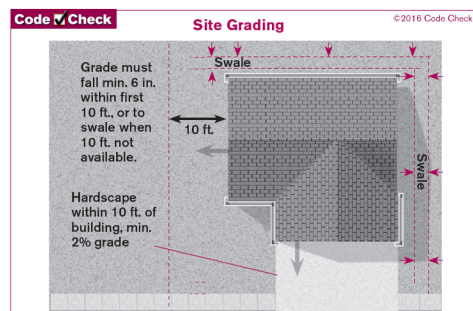
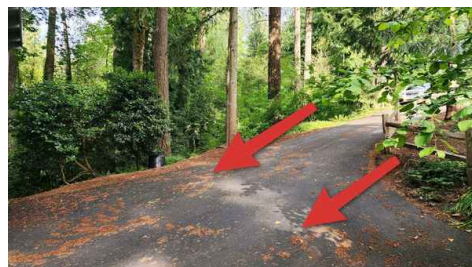
Grading is sloping towards the home in some areas. This could lead to water intrusion and foundation issues. Monitor the water run off when we have more rain and frequently check the crawlspace/basement to make sure there is no standing water. If you notice any, consult with a licensed drainage specialist about options of keeping these areas reliably dry.

Sloped to the house

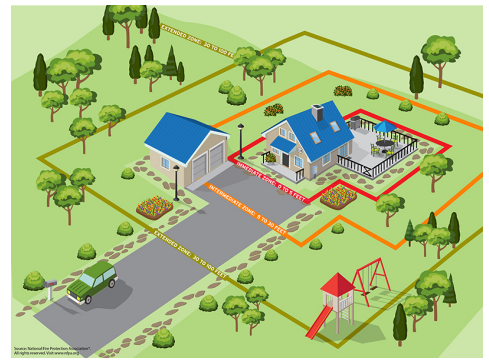
Maintain a clearance between shrubs/trees and the siding. 1-2 feet would be ideal. This will protect the siding from moisture and branches scraping over the surface.

Clearances

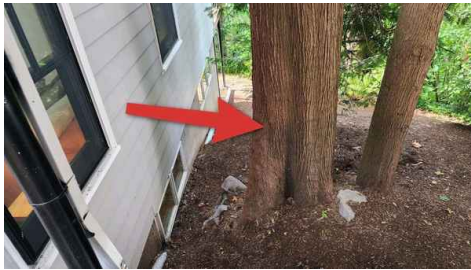
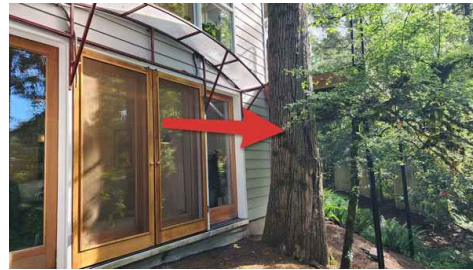
TREES CLOSE TO THE FOUNDATION

Trees planted too close to the foundation may cause damage to the structure. Monitor the foundation and remove trees as needed.

Close to the foundation

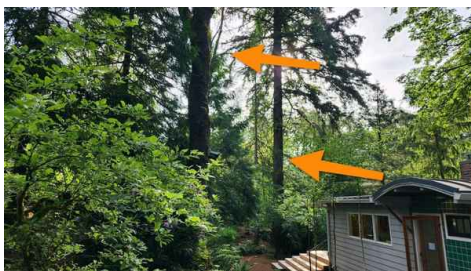
TREES CLOSE TO THE HOUSE

Since the big tree/trees is/are fairly close to the house, I recommend having them evaluated by a licensed arborist to make sure they are healthy and there is less of a risk of them falling down during a storm. Deterioration is visible at the bottom of the tree that's close to the house in the back, near the French door.

Close to the house

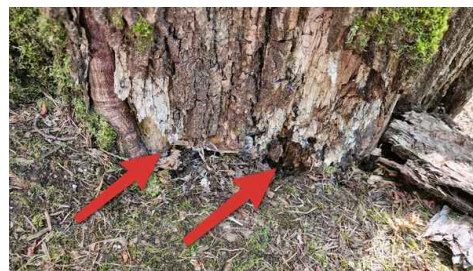
Deterioration

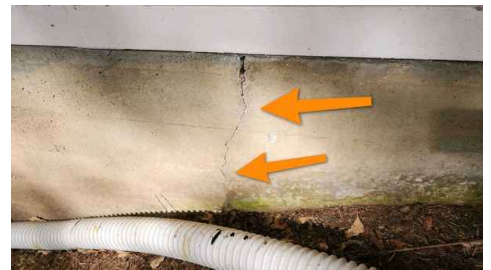
FOUNDATION CRACKS - MINOR

Minor cracking was noted at the foundation. This is common as concrete ages and shrinkage surface cracks are normal. I recommend monitoring for more serious shifting/displacement. You can seal the cracks with hydraulic cement or something similar if you prefer.

Minor crack

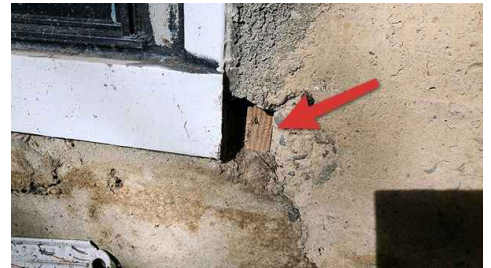
EAST SIDE

Exposed wood is visible next to the basement window. I recommend covering it to prevent potential water damage.

Protect wood

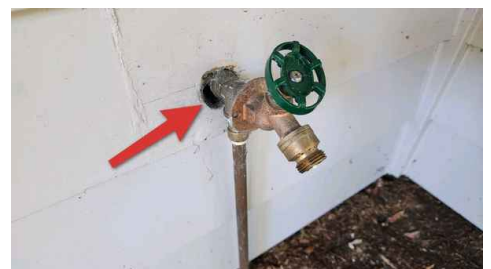
SEAL OPENINGS

Seal all openings around siding penetrations to prevent moisture intrusion.

Seal opening

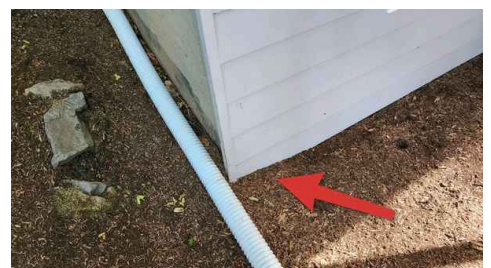
SOUTHWEST CORNER

I recommend creating a better clearance between the soil and the siding/trim to prevent water from seeping up and causing damage.

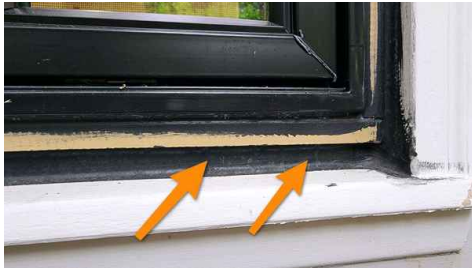
AROUND WINDOWS

A lot of caulking was used around the windows. This will need to be maintained. Moisture stains are visible below the front facing bathroom window. Monitor this closely during heavy rain and keep everything sealed.

Heavy caulking

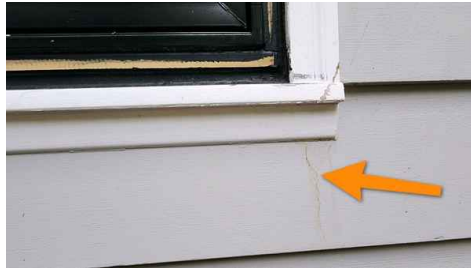
Stains below window

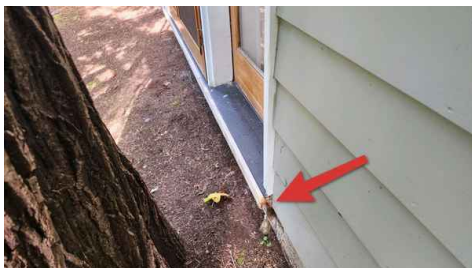
BASEMENT FRENCH DOOR

Some rot is noted on the side of the trim below the French door. Consider adding metal flashing for protection.

Rotting

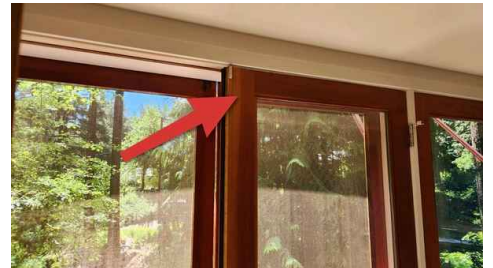
I was not able to easily open the fixed side of the French door in the basement. It is very sticky and should be adjusted.

Can't open

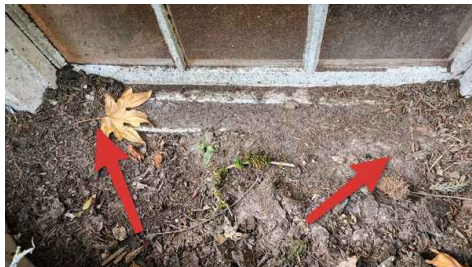
Maintain a clearance around the windows so moisture does not wick in which leads to rot and attracts wood destroying organisms. All leaves and soil needs to be removed on a regular basis.

The trim around the front facing basement window is already quite rotted and needs to be replaced.

Remove soil

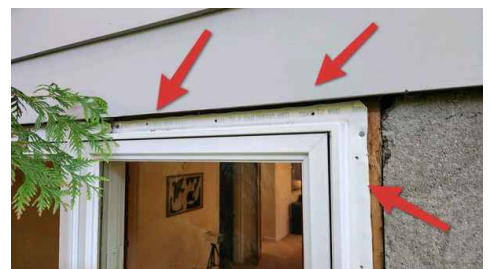
MISSING FLASHING AND TRIM

There is no house wrap, flashing or trim installed at the windows. This can lead to water intrusion and damage and needs to be repaired.

All exposed

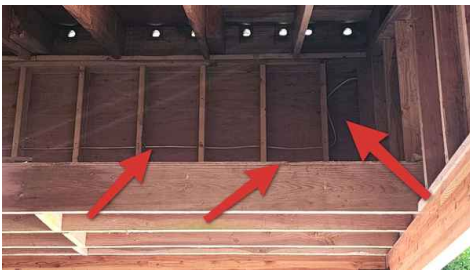
Any exposed wiring needs to be placed in conduit for protection.

Place in conduit

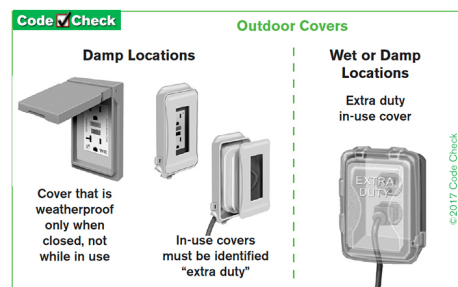
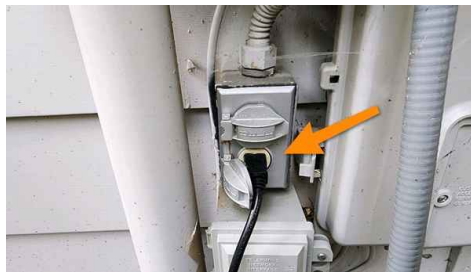
There are exterior rated outlet boxes available which are designed to protect wiring from any moisture and should be installed instead. They have a complete cover that opens from the top so the outlet is better protected, especially when something is plugged into it.

Upgrade outlet box

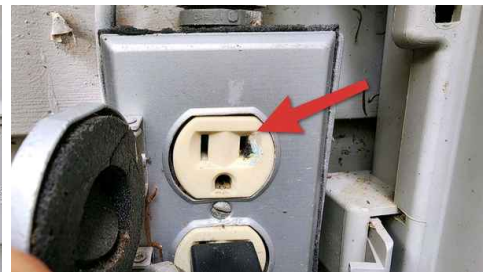
I can already see some staining on the outlet below the meter and the GFCI breaker was tripped when I tested it. Have this evaluated to make sure the outlet is safe.

Staining

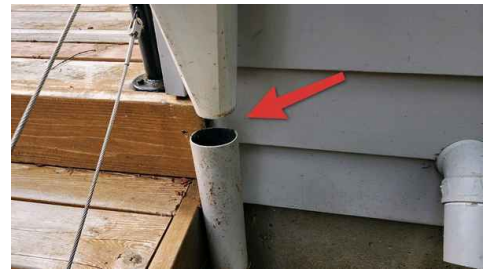
REPAIR DOWNSPOUT CONNECTION

Make sure that downspout is properly guided into the rain drain and water does not overflow. This can lead to too much moisture accumulation and water pushing into the basement.

Extend downspout into rain drain

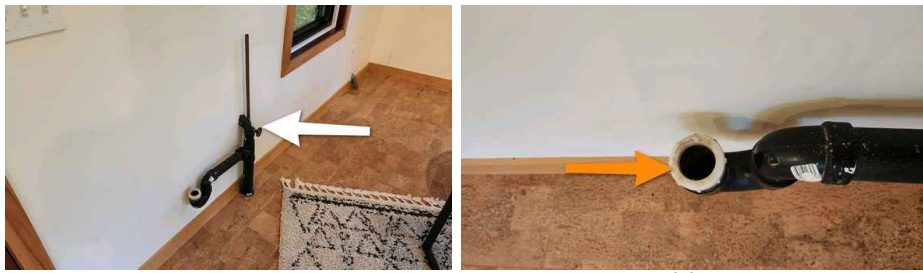
The unit is pre-plumbed for a sink but only the rough plumbing is present. Finish as needed. In the meantime, I recommend capping off the drain pipe to prevent sewer gases from entering the space.

Add cap

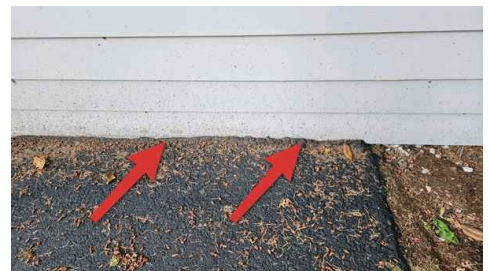
The driveway was partially poured against the siding. This can lead to water damage. Monitor and repair as needed.

Inadequate clearance

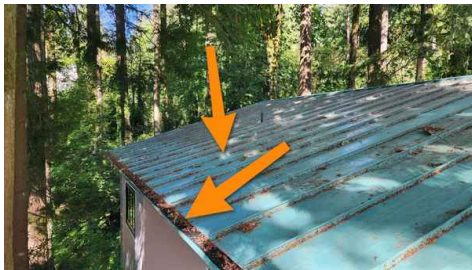
CLEAN ROOF AND GUTTERS

The roof should be cleaned on a regular basis. Screens are installed on the gutters which also still need to be cleaned. Otherwise moisture can get pushed back underneath the metal. Additionally, the cap on the gutter is missing and needs to be installed so the water does not run out on the side. The downspout connection is clogged and needs to be cleaned as well.

Clean roof and gutters

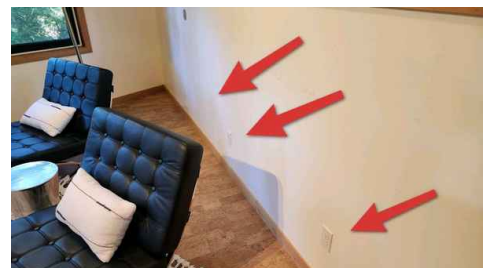
FRONT OF HOUSE

There is no power on the outlets along the front wall. Have this evaluated and repaired as needed. All GFCIs are working and all breakers are on.

No power

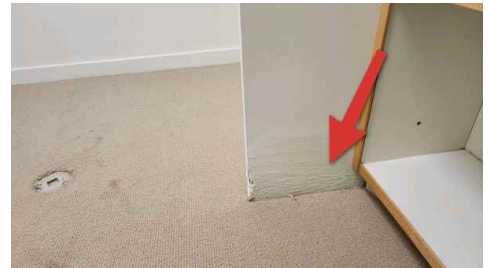
BEDROOM WALK IN CLOSET

OLD WATER DAMAGE

I observed evidence of old water damage in the closet. Check with the homeowner to find out what happened. Everything was dry at this time.

Old water damage

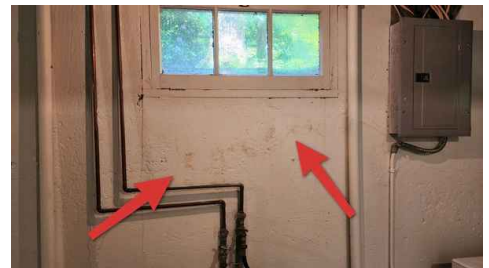
Front of House

OLD WATER STAINS

Since there are old water stains, I recommend checking basement again after we have more rain to make sure there is no standing water. If you find any, consult with a licensed drainage specialist about options of keeping the crawlspace reliably dry. In this location the water likely came from the window area which has rot on the outside.

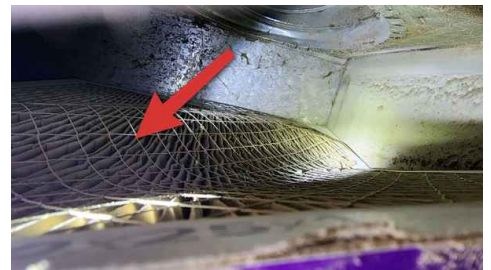
The furnace filter is dirty and needs to be replaced now.

Replace dirty filter

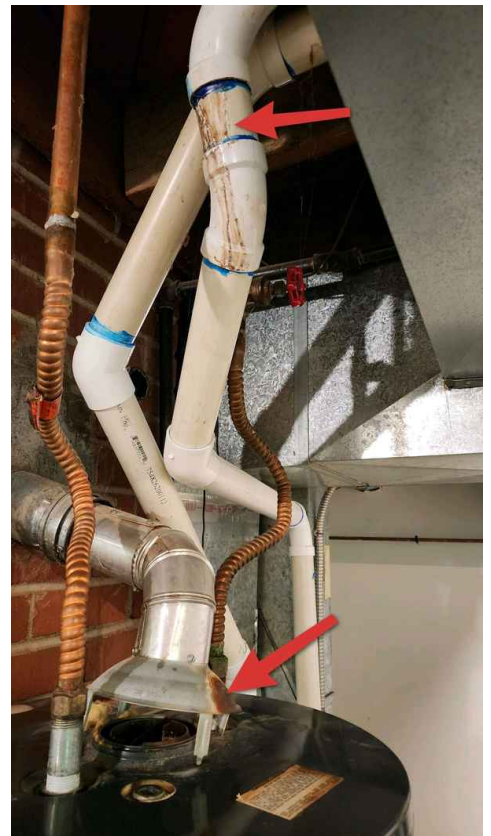
ABOVE WATER HEATER

FLUE PIPE LEAK

Staining is visible above the water heater area. Everything was dry at this time but needs to be monitored. The condensate may have leaked onto the draft hood diverter below which is quite corroded. Monitor this closely to detect ongoing issues early and make repairs as necessary.

Prior leak and corrosion

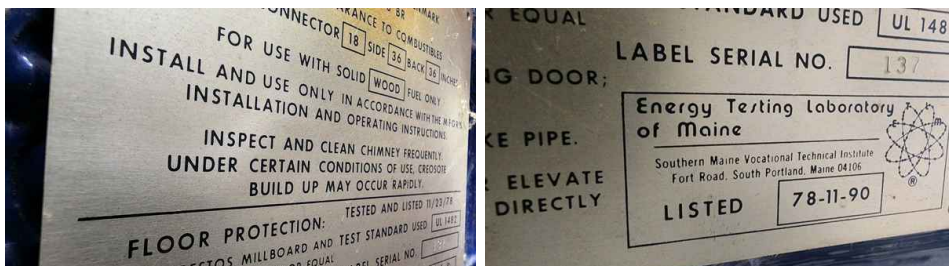
Verify that the wood stove is DEQ or EPA certified. If not, it needs to be removed and disposed off as required by the DEQ. I do see some labeling for testing behind the wood stove but it does not specify EPA or DEQ certification.

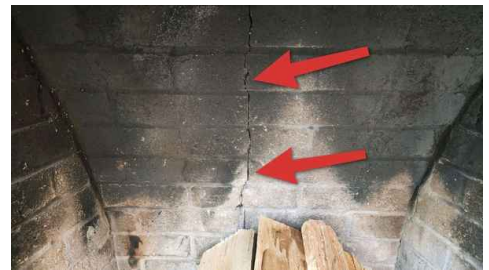
CRACKS IN FIREBOX

Cracks are visible in the firebox walls. This may allow carbon monoxide to enter other areas of the living space. Have the fireplace evaluated and repaired by a licensed fireplace contractor.

Cracked

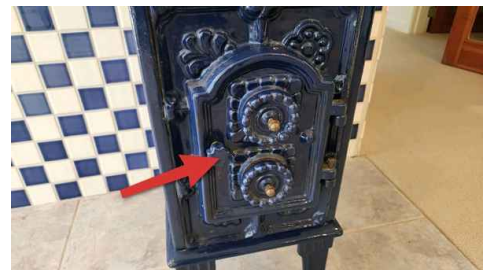
I was not able to open the door and check the inside of the firebox. Have the unit evaluated and repaired as needed.

Could not open

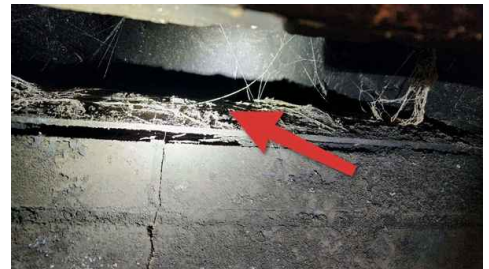
The damper does not work and needs to be repaired. There is no handle to operate it and it is wide open at this time. Otherwise this may get quite drafty in the wintertime.

Upgrade damper

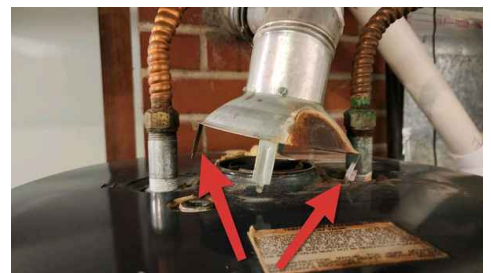
SECURE DRAFT HOOD DIVERTER

The draft Hood diverter is loose and needs to be properly installed and secured to the tank. Otherwise you risk backdrafting of exhaust gases into the basement. Staining and corrosion is visible which might however be from a leak at the furnace vent directly above.

Secure to tank

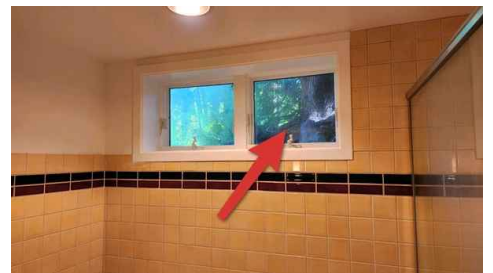
The right window does not open. This should be repaired.

Repair

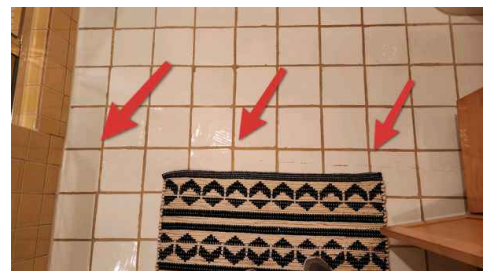
CRACKED TILE

The floor tile is cracked along the entire width.

Cracked

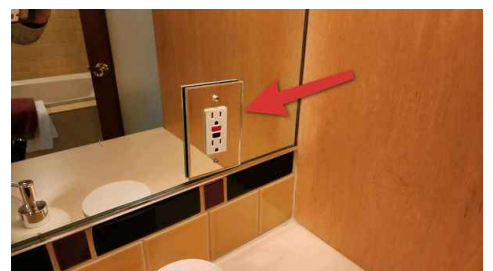
LOOSE OUTLET

The outlet is loose and should be better secured to the wall.

Loose

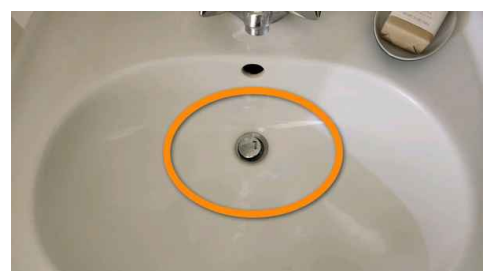
The stopper does not work, repair as needed.

Adjust stopper

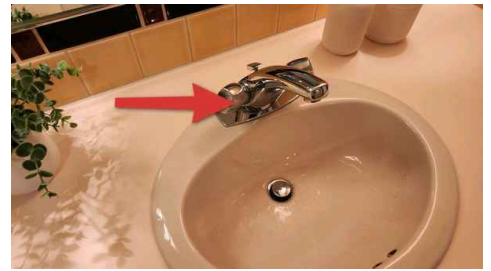
A water hammer is noted. It is the result of a pressure surge, or high-pressure shockwave that propagates through a piping system when a fluid in motion is forced to change direction or stop abruptly. This shockwave is also commonly referred to as a hydraulic shock or hydraulic surge, and may be characterized by a marked banging or knocking sound on the pipes immediately after shutoff. A water hammer arrestor can be installed to mitigate the issue. Consult with a plumber about options.

Water hammer

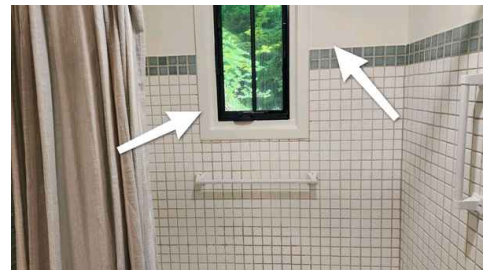
Maintain the caulk around the tub/shower to prevent moisture intrusion. This also includes maintaining the caulk at the wood trim around the window. If you notice too much water damage, consider upgrading to something else.

Maintain caulking

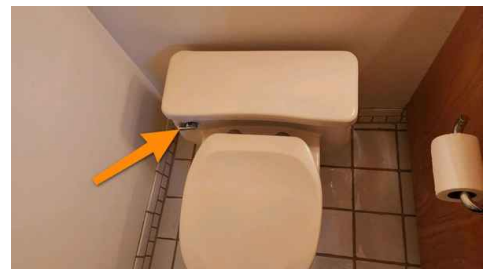
The flushing handle gets stuck and the toilet keeps on running. It was running when I came the first time to set up the radon monitor. This is very wasteful and needs to be repaired. It can also quickly rack up your water bill.

Monitor flashing mechanism

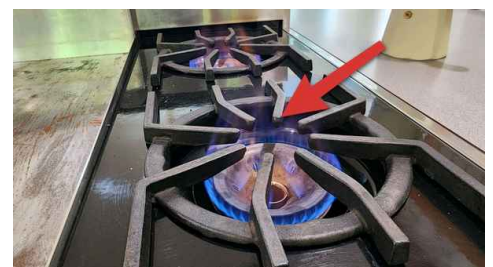
The oven is old and there are no automatic igniters. You have to use a lighter to start the burners. I was not able to get the griddle or the oven to come on. Check with the homeowner to find out if there is a trick.

Some of the flames are quite high and may need to be adjusted.

High flames

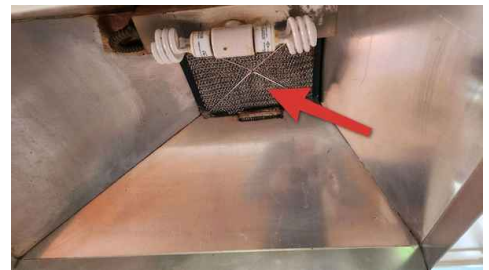
The vent is a bit noisy, as if something is grinding. Repair as needed. It is also older.

Grinding noise

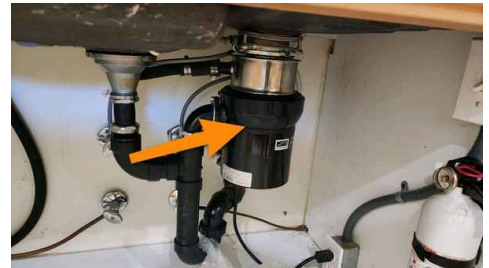
The garbage disposal is very noisy. I recommend having this evaluated and repaired as needed. Something might be trapped inside.

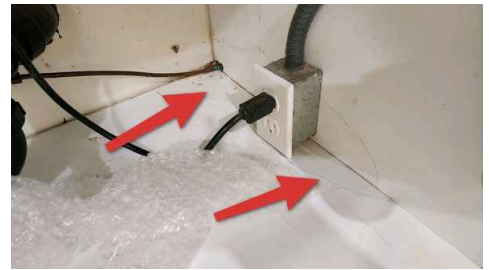
EVIDENCE OF PRIOR LEAK

I observed evidence of a prior leak. It was dry at this time but should be monitored to detect potential issues early.

Old damage

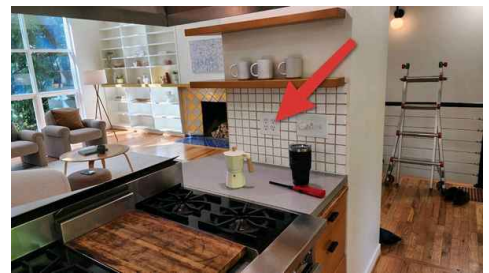
By today's standards, all outlets in the kitchen need to be GFCI protected and not just those near the sink. I recommend upgrading for safety.

Add GFCI

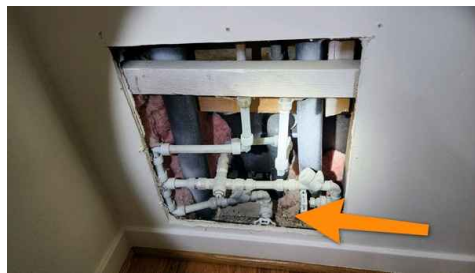
Install the missing cover panel on the backside of the bathroom plumbing. I noticed a lot of rodent droppings inside the first floor wall which should be cleaned out.

Add cover and remove droppings

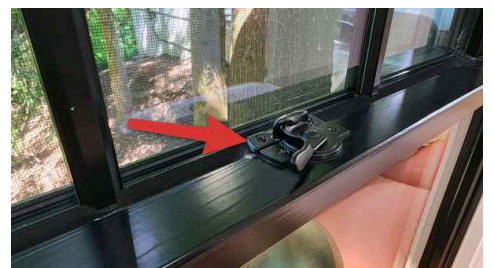
LOOSE WINDOW LATCH

The latch is loose and needs to be better secured. I try to tighten the screw but it doesn't stay in place.

Repair latch

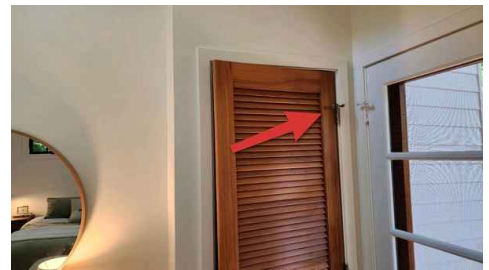
The hinge at the closet door is loose and needs to be repaired so the door can be properly closed.

Secure hinge

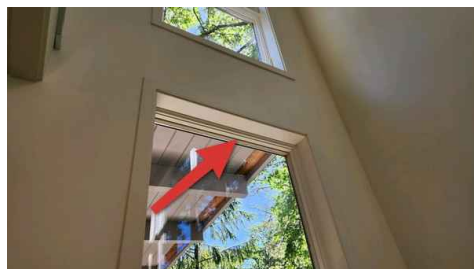
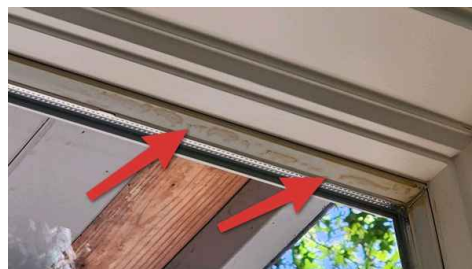
STAINS ABOVE WINDOW

I observed staining above the window. Monitor this closely during heavy rain to make sure there is no ongoing issue. I recommend asking the homeowner about this. The roof is newer and hopefully this is no longer an issue.

Stains

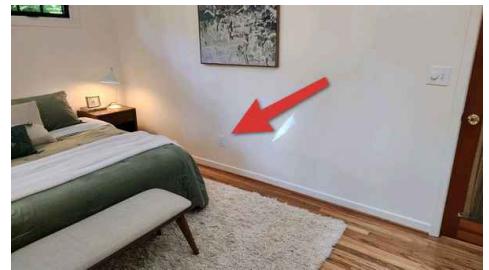
There is no power on the outlet and it does not reset. This needs to be repaired.

No power and does not reset

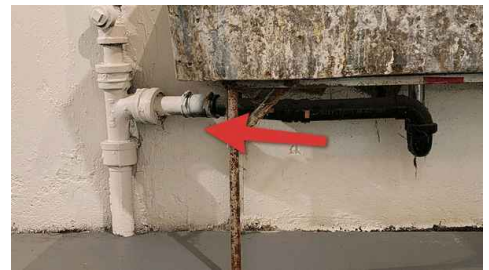
IMPROPER SLOPE

Uphill slope

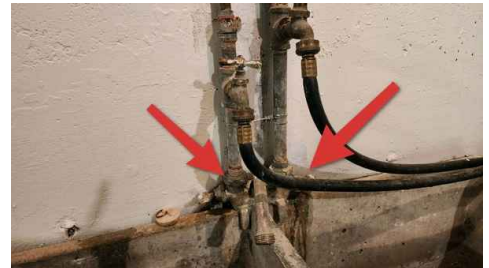
LEAKING FAUCET

Leaking

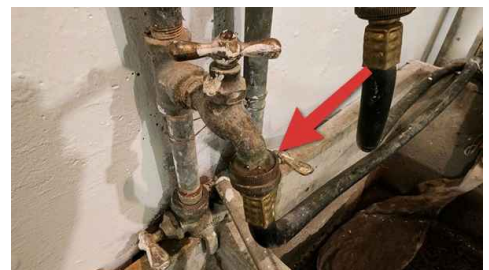
LEAKING

Leaking
