# Complete Home Inspections

Property Inspection Report

*Sample Inspection*

Inspection Site: Special Homeowners Lane.  
A Town, GA. 30101

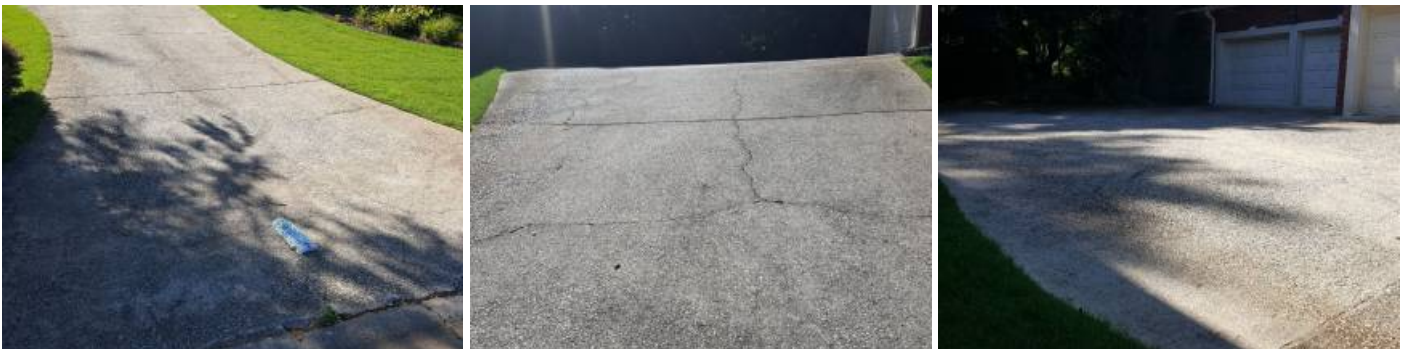
#### 3.6 Condition:

There are cracks and breaks in the driveway. These cracks noted are more major considering repairs. I recommend contacting an experienced building contractor concerning repairs.

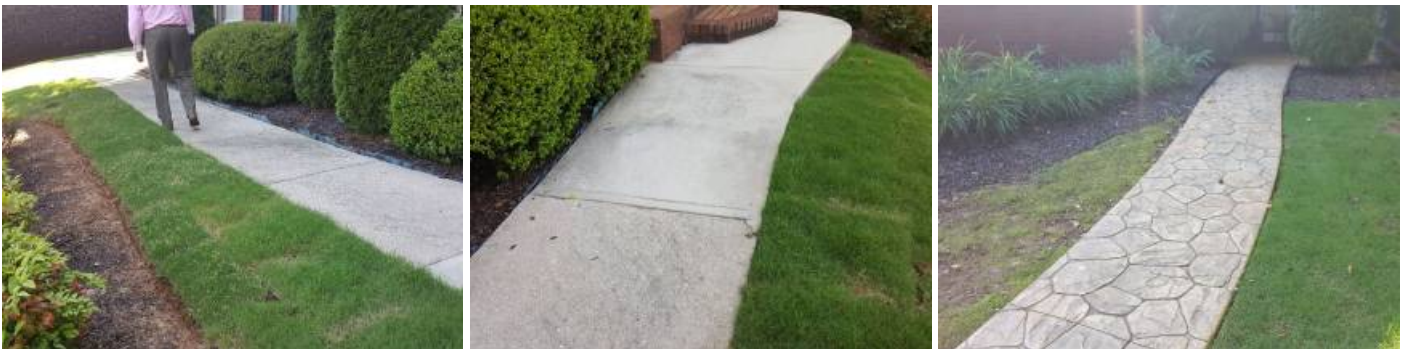
#### 3.7 Type:

The walkway is constructed with concrete.

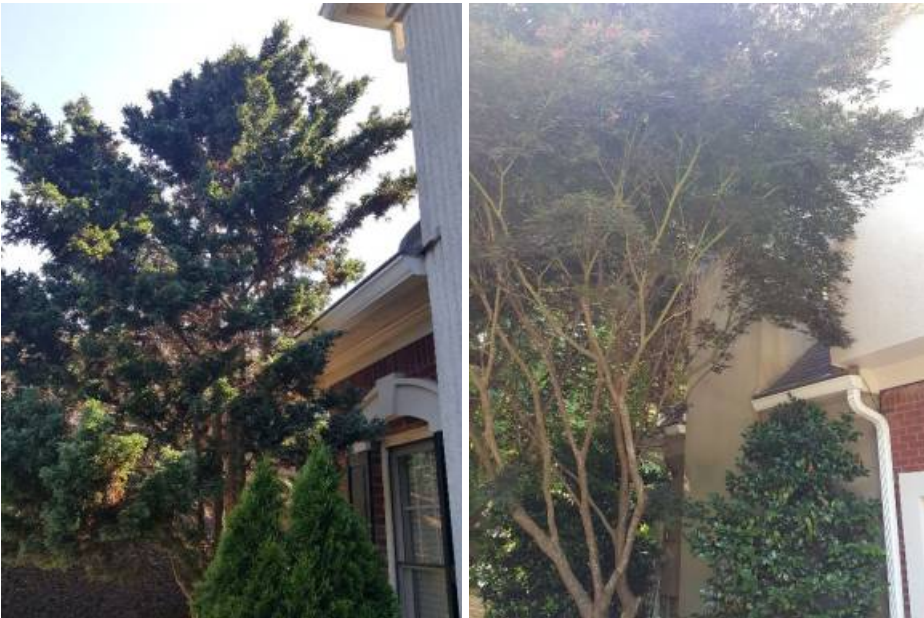
### 3.13 Condition:

There are trees planted close to the home. Tree roots can be very damaging to a home's foundation. Removal may be needed.

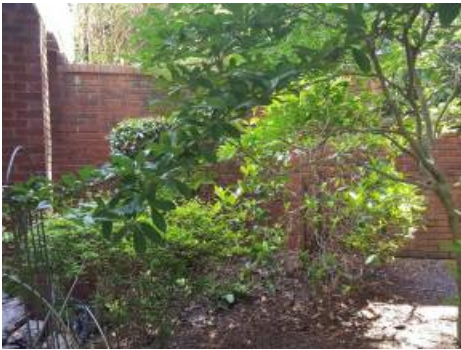
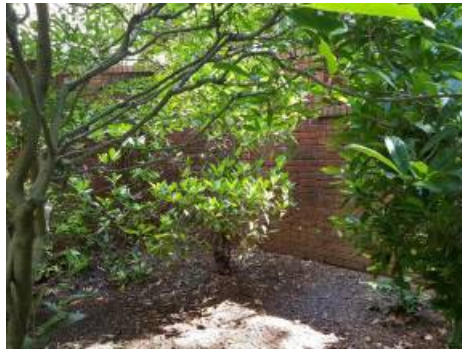
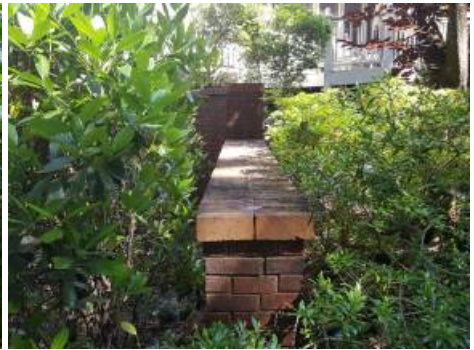
### 3.15 Rear Wall Type:

The retaining wall is of masonry type construction.

There are some cracks and mortar voids noted.

I recommend repairing and sealing any cracks with a good cement crack repair/epoxy.

If the cracks shift or widen over time, further evaluation would be required.

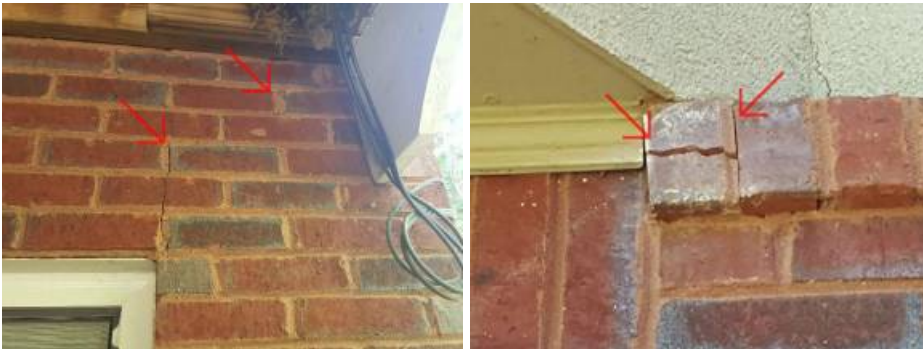
#### 4.2 Condition:

There is a crack in the brick under the front porch and on the right side of the home. I recommend this be accessed and repaired by a qualified mason.

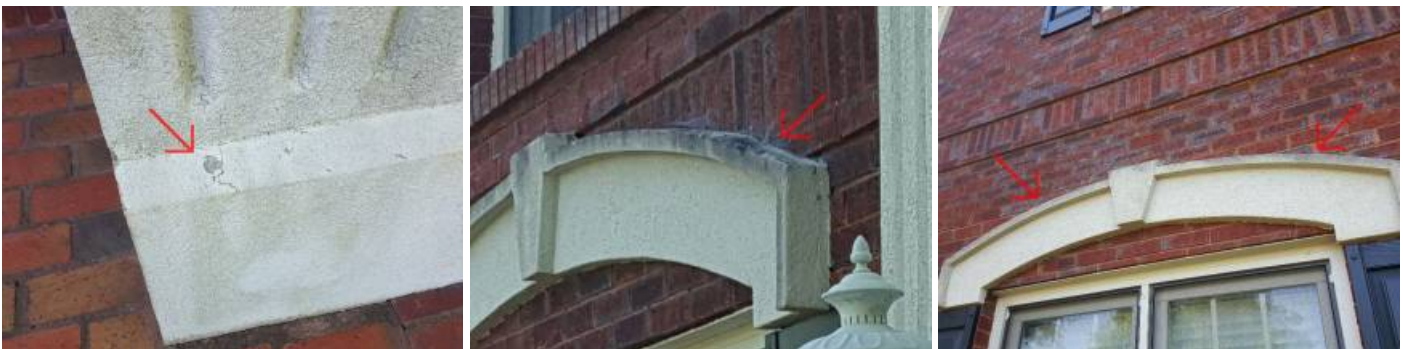
#### 4.3 Stucco Condition:

1. There is a void in the stucco on the front porch posts.
2. There is darkened areas at the tops of the stucco over the windows and doors.
3. There is a slight crack in the stucco on the right side of the home on the right side of the bay window.
4. There are some slight cracks in the stucco inside the screened in porch.
5. The Georgia Pest Control Associations "Good Business Practices" states that the system should be raised approximately six inches above grade and the bottom edge should be finished. The stucco system is at or in contact with the ground. I recommend having a qualified stucco contractor access, raise and finish the system and make the necessary repairs to the trim.

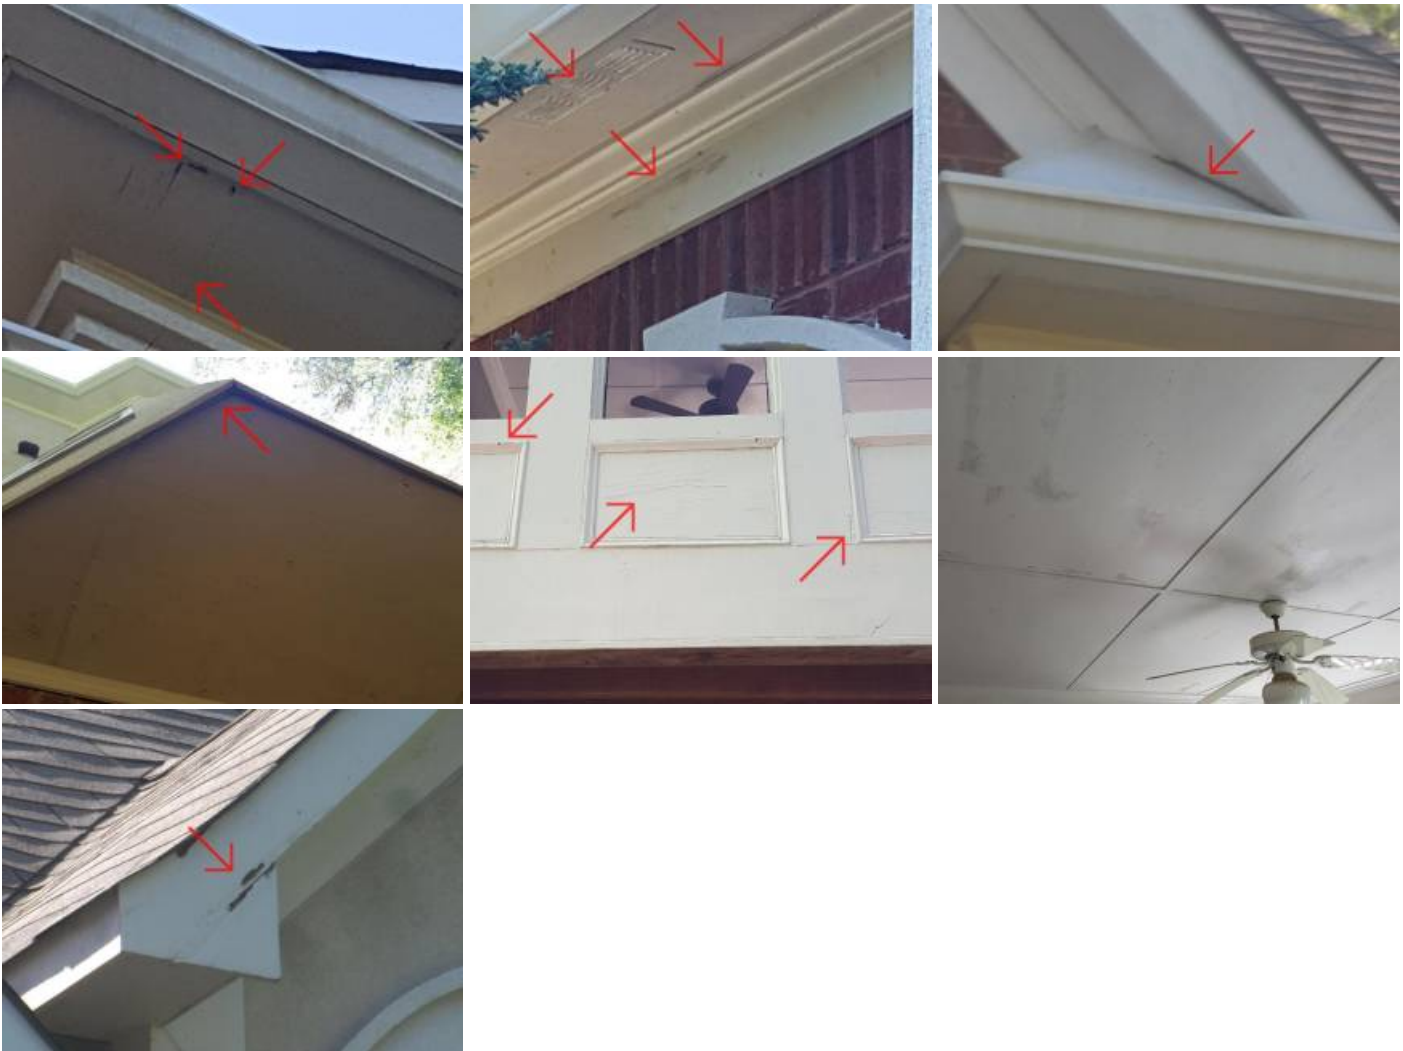
### 4.5 Exterior Trim Condition:

There were moisture stains/damage noted under eaves. This can be caused by gutters being full and the water runs up and out the rear onto the trim.

The paint on the exterior of the upper deck is worn thin.

There are numerous cracks, voids and some wood rot on the exterior trim.

I recommend the gutters be checked and leaned.

I recommend the trim be cleaned, repaired and re-painted.

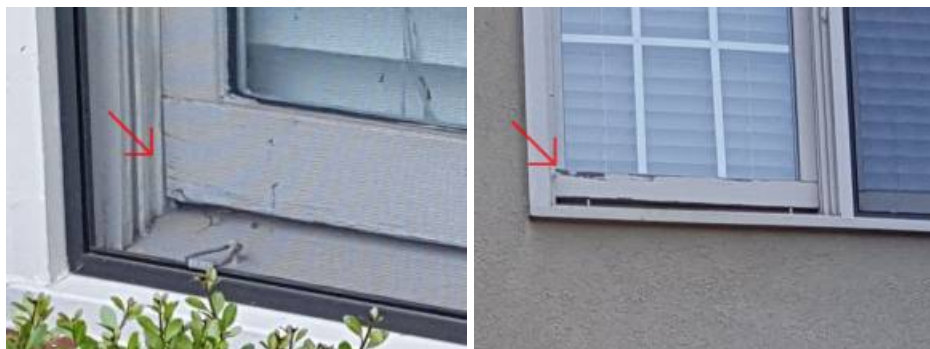
## 4.8 Exterior Door and Window Condition:

Some wood rot noted mainly around some of the windows.

One of the windows on the left side of the home was missing the screen and has paint peel down to bare wood and the beginning stages of wood rot.

As with the home trim, I recommend the windows and doors be cleaned, repaired and re-painted.

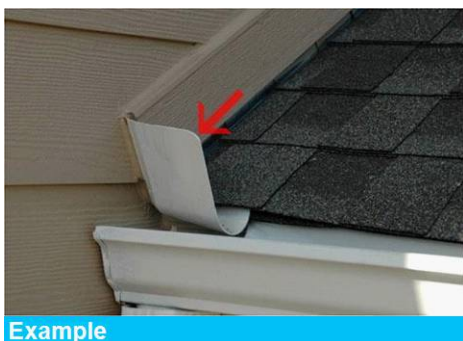
There was not the required kick out flashing installed on the roof section.

I recommend this be installed.

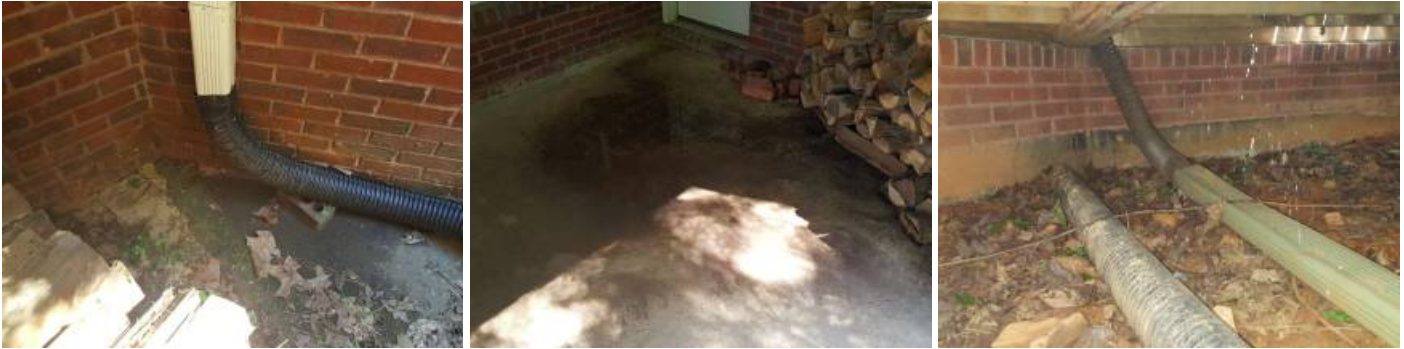
It appears the downspout at the right rear corner of the home is leaking onto the rear patio. The downspout extension under the rear deck is not secured in the drain tube. I recommend ensuring all downspouts are firmly attached to the drain tubes.

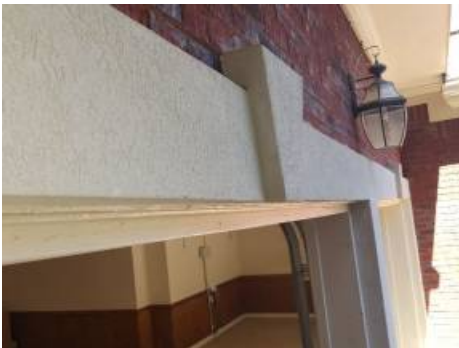
#### 6.3 Garage Door Exterior Condition:

There are seam cracks on the right garage door.

I recommend these be repaired or the door replaced.

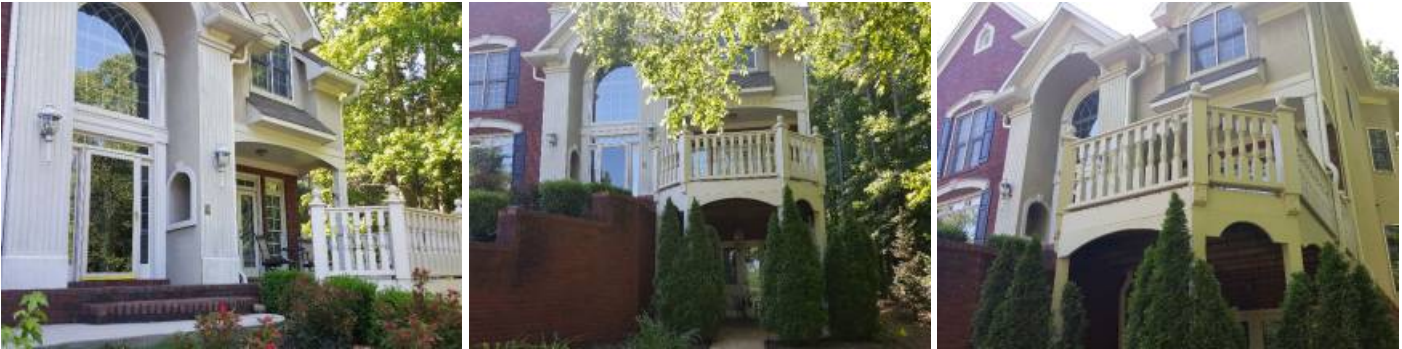
#### 7.1 Type:

The left side of the front porch is constructed of brick.  
The right side of the porch is constructed of wood.

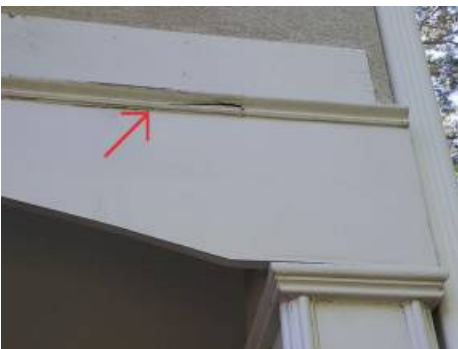
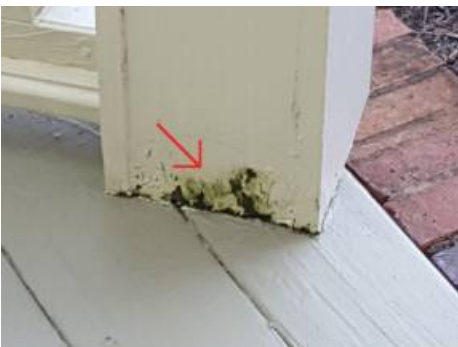
#### 7.3 Overall Condition:

There is some wood rot in the trim over the porch.  
There is wood rot at the base of the porch posts.  
I recommend the trim and posts be cleaned, repaired and re-painted as the home's trim.

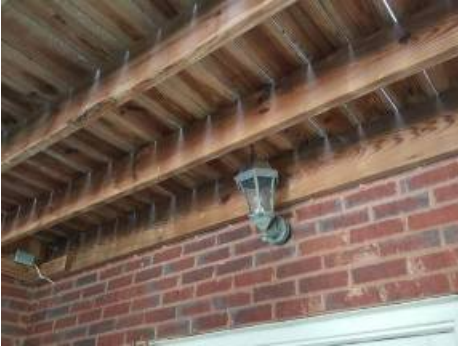
## 7.5 Ledger, Rim and Joist Attachment:

The joists are only toe nailed to the ledger board with a support post underneath. Today's standards call for each joist to have a hanger bracket installed securing it against the ledger board. This helps to eliminate the possibilities of the joist coming away from the ledger board.

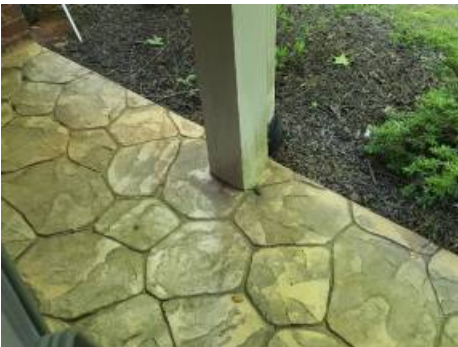
## 7.8 Support Posts Footings:

The porch support posts are sitting on the porch itself.  
There is not way to determine if there is an existing footer.

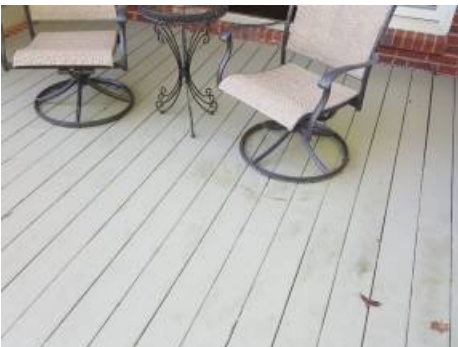
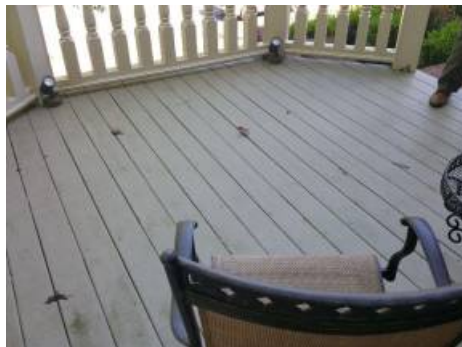
## 7.9 Surface- Material and Condition:

The right side surface boards are constructed of wood.

The brick has several mortar carracks and voids.

I recommend the porch surface be accessed and repaired by a qualified mason.

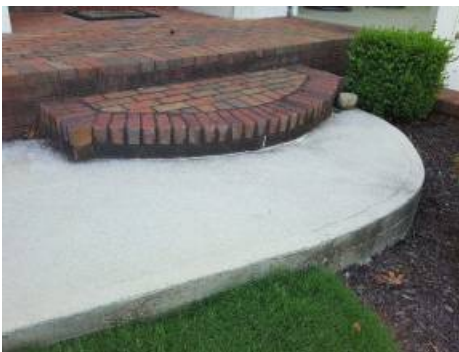
## 7.11 Stair Description and Condition:

The tread is constructed with brick. Overall the step appears to be in good condition.

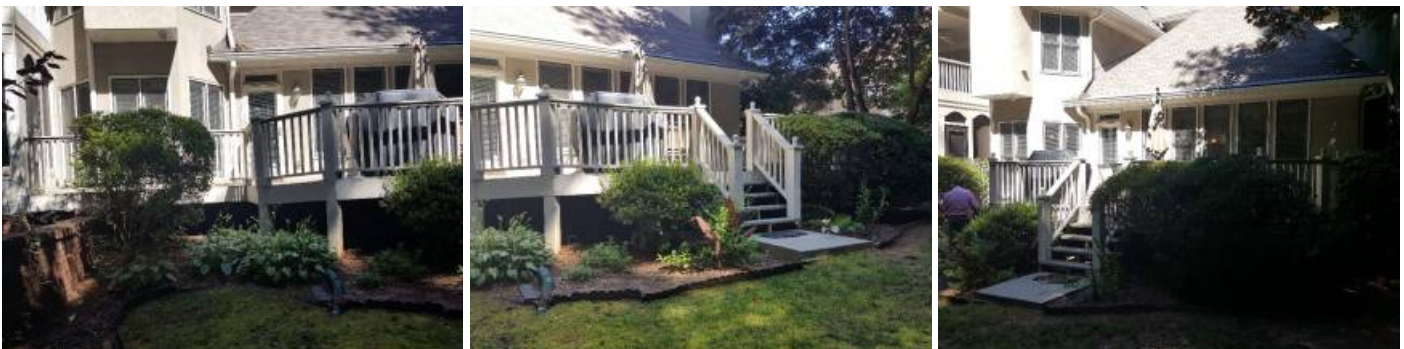
### 7.12 Type:

The rear deck is constructed of wood.

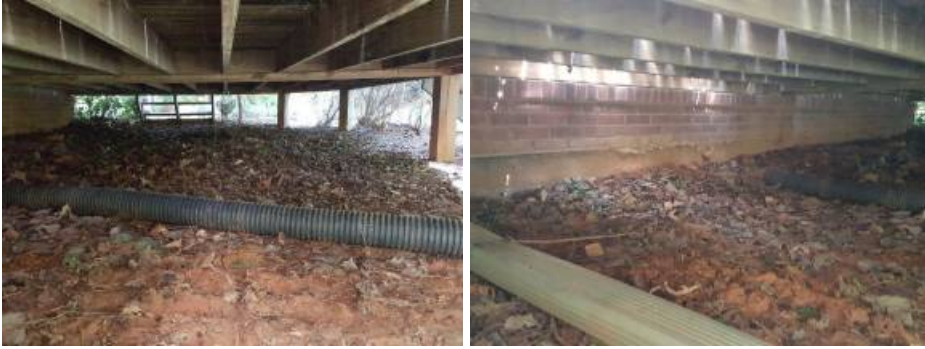
### 7.13 Overall Condition:

Appears to be in good condition overall.

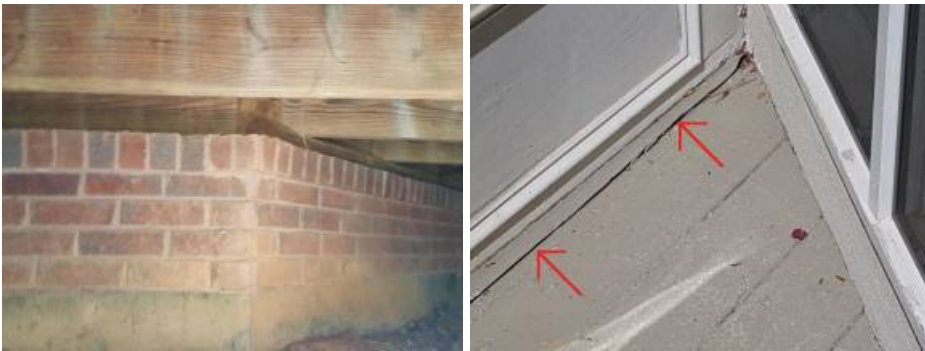
## 7.14 Ledger - Bolting and Flashing:

The ledger board is bolted to the home.

There does not appear to be flashing installed properly across the porch between the ledger board and the siding above. This can cause water to run under the siding into the home.

A qualified contractor should assess this and install the required flashing above the ledger board where necessary.

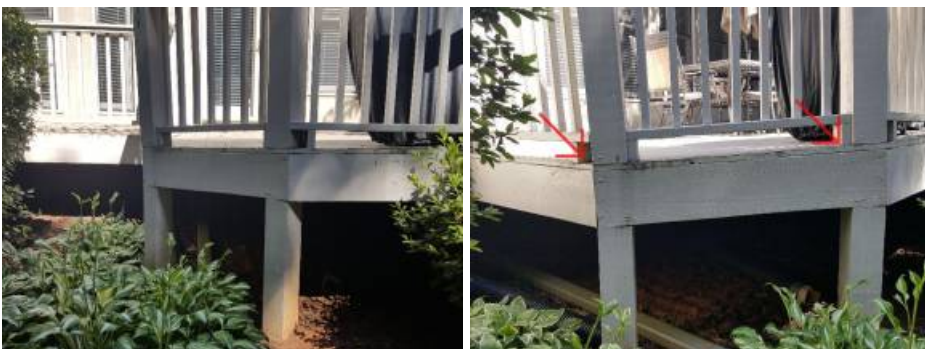
## 7.15 Ledger, Rim and Joist Attachment:

The joists are only toe nailed to the ledger board with a support post underneath. Today's standards call for each joist to have a hanger bracket installed securing it against the ledger board. This helps to eliminate the possibilities of the joist coming away from the ledger board.

The porch surface on the angled rear section appears to have dropped or shifted.

I recommend a qualified deck contractor access this condition and make the necessary repairs.

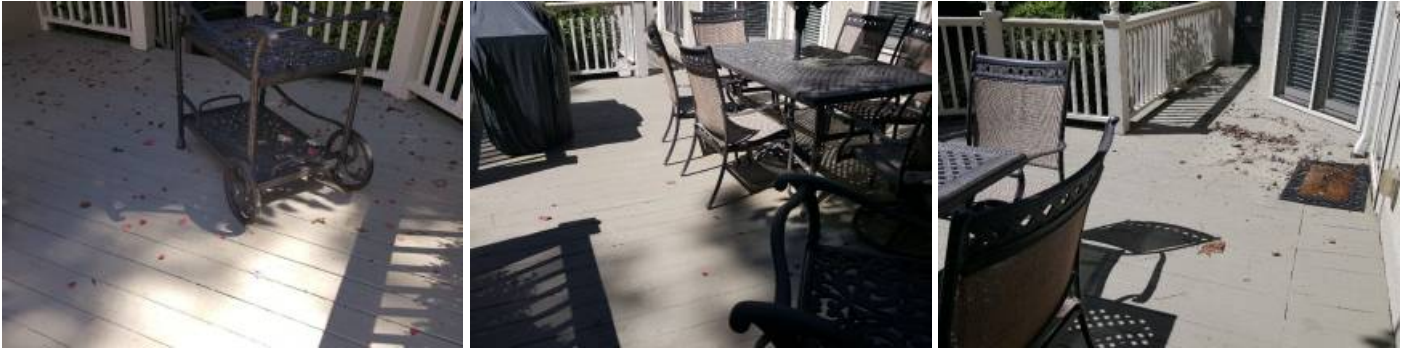
## 7.19 Surface- Material and Condition:

The surface boards are constructed of wood. The surface appears to be in good condition overall.

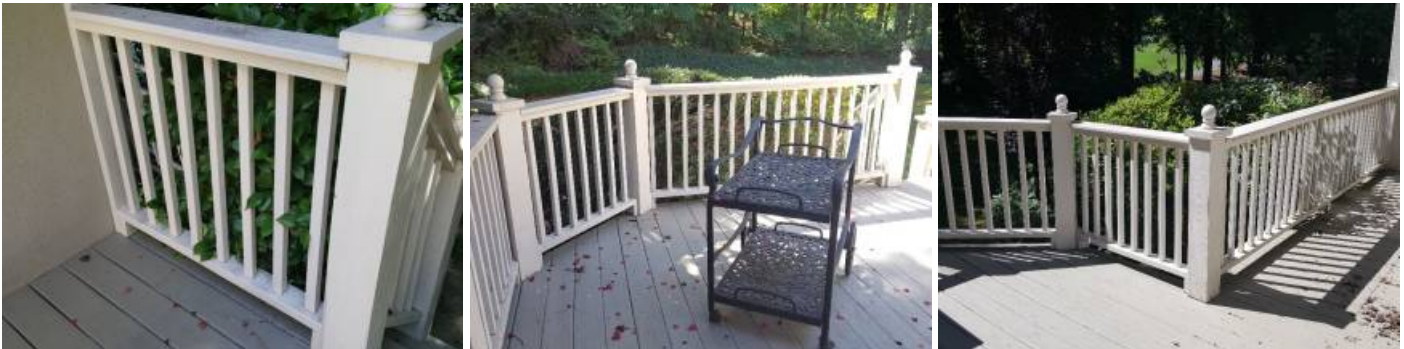
## 7.20 Guard/Railing:

The handrail appeared to be in good condition overall.

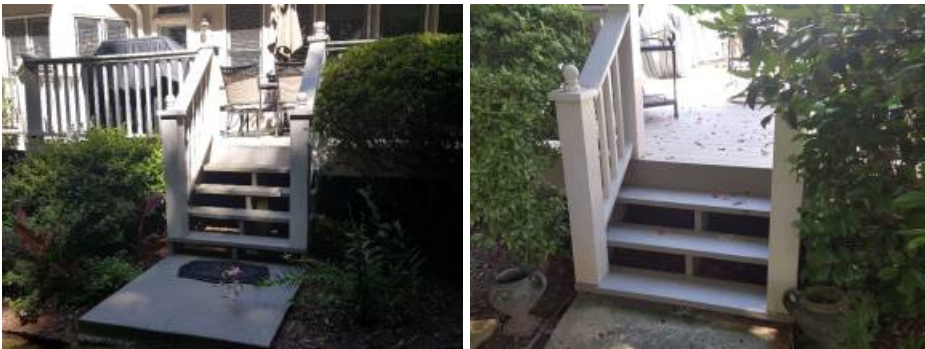
## 7.21 Stair Description and Condition:

There were multiple sets of stairs attached to the deck or porch. The stairs are constructed of wood. Overall the stairs appear to be in good condition, The handrail appeared to be in good condition.

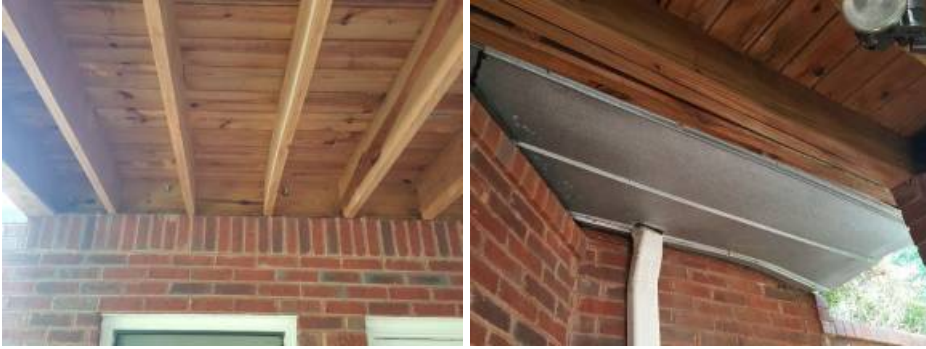
## 7.25 Ledger - Bolting and Flashing:

The ledger board is bolted to the home.

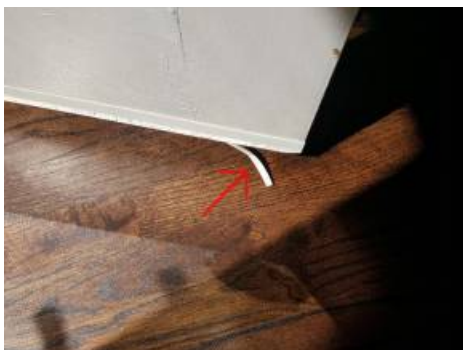
The rear door seal is damaged or missing.

I recommend replacing the seal.

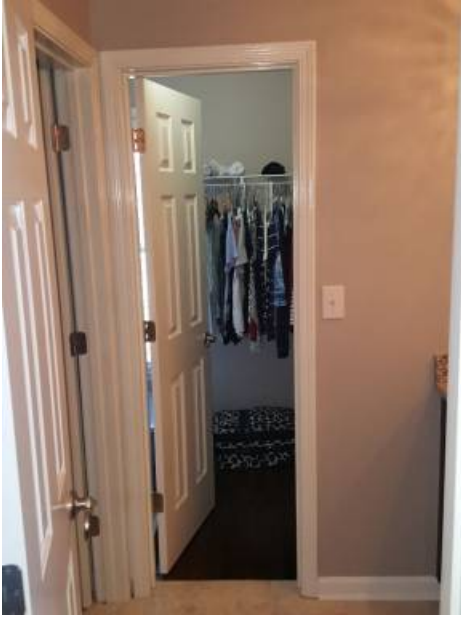
#### 8.7 Interior Door Condition:

The corner bedroom closet door does not latch, repair as required.

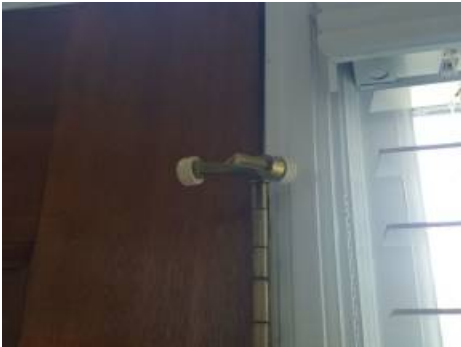
## 8.8 Door Stops:

Some of the wall door stops were missing through out the home. Instead they had a top hinge stop. These are not as good and can cause damage to the door. Replace as needed.

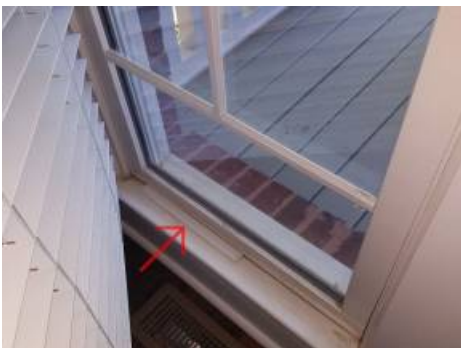
### 8.10 Window Condition:

A representative sampling of the window operation was tested. Windows as a grouping are generally operational. One of the vertical trim pieces has come loose in the front living room window.

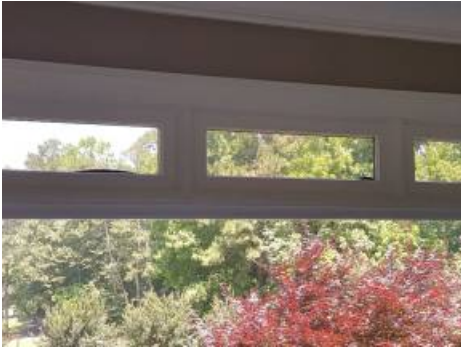
### 8.11 Window Seals:

The rubber seals on some of the windows are beginning to pull inwards from the pressure created between the two pieces of

glass. This does not necessarily mean the Integrity of the seal is blown. Continue to watch these windows for any signs of condensation or moisture in between the glass.

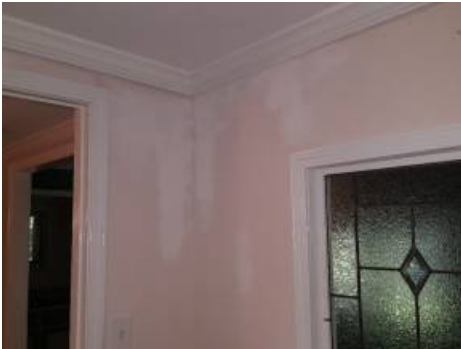
### 8.13 Condition:

General condition appears serviceable, Typical sheetrock cracks noted. This is normal and can easily be repaired when painting.

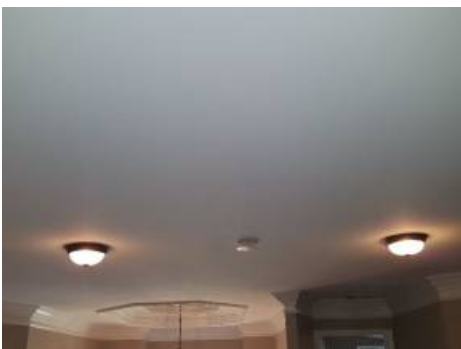
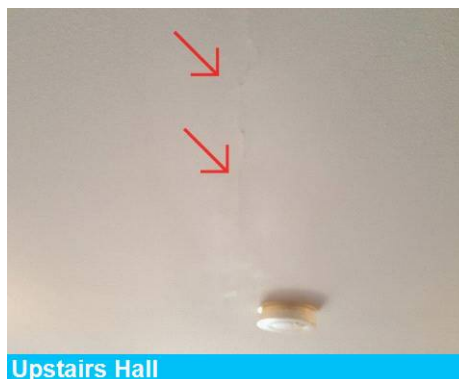
### 8.15 Condition:

General condition appears serviceable, Typical sheetrock cracks noted. This is normal and can easily be repaired when painting.

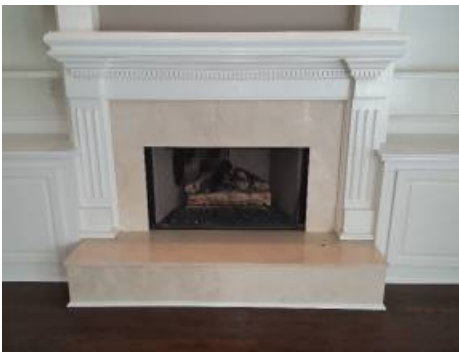
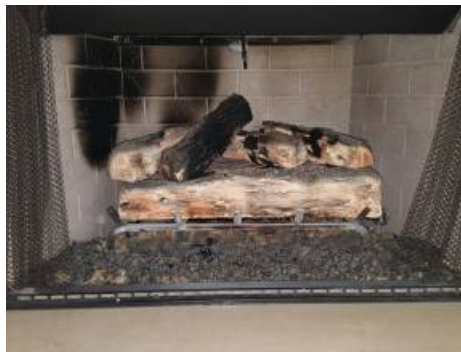
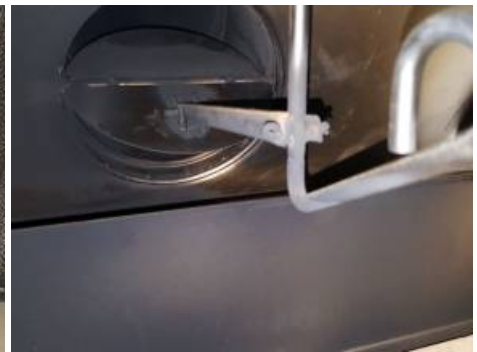
### 8.20 First Location:

There is a fireplace in the living room.

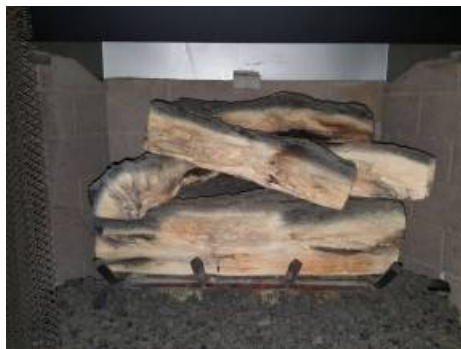
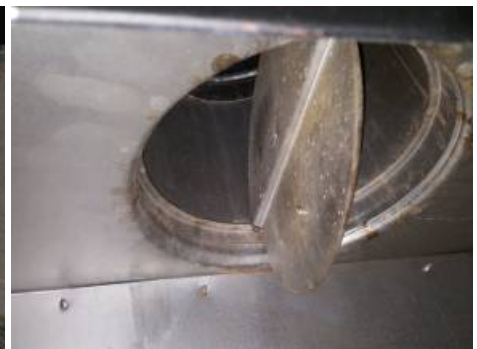
### 8.24 Second Location:

There is a fireplace in the bedroom.

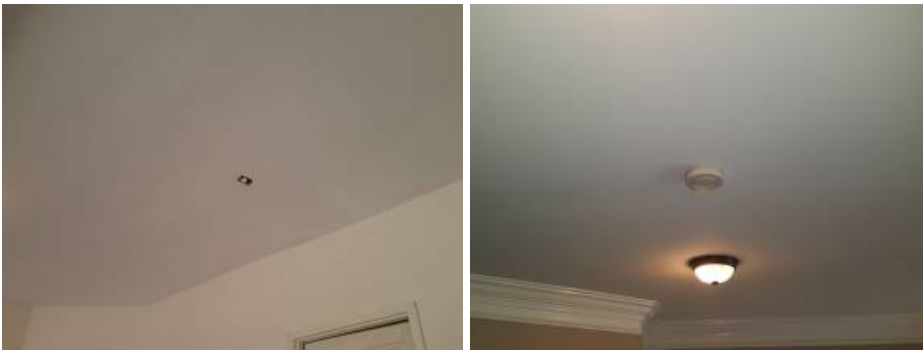
2. The smoke detector in the garage was not attached to the base.

I recommend the unit be replaced and re-tested.

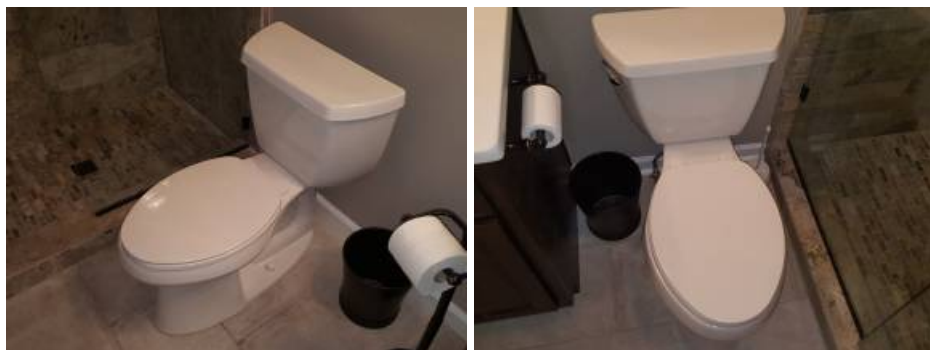
#### 10.3 Condition Of Toilet:

The toilet was loose at the floor in the upstairs hall bathroom and in the basement bathroom.

I recommend this be repaired by a qualified plumber.

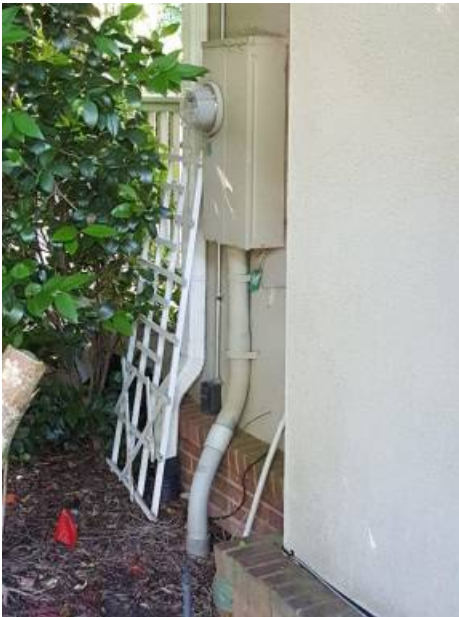
#### 11.1 Type:

The main electrical power comes into the home underground to the meter base.

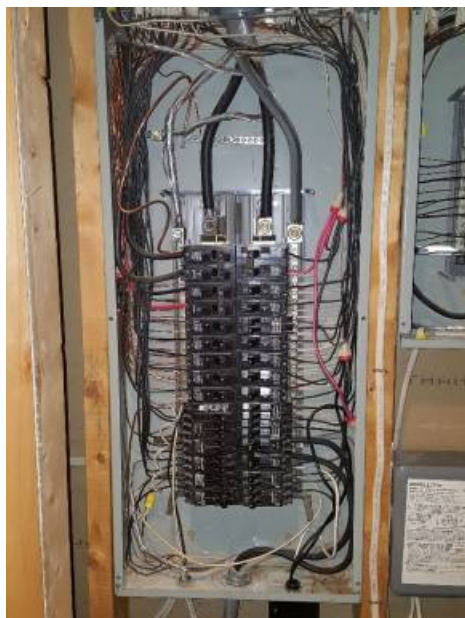
The main panel is located in the basement.

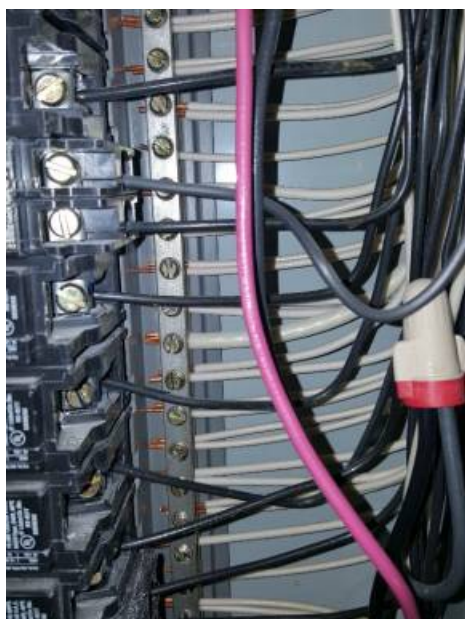
It is important by today's standards in all panels to install each common (white) wire to it's own individual screw on the common bus bar.

The common wires in this panel do not appear to be properly connected to the bus bar. This was not required when the home was built.

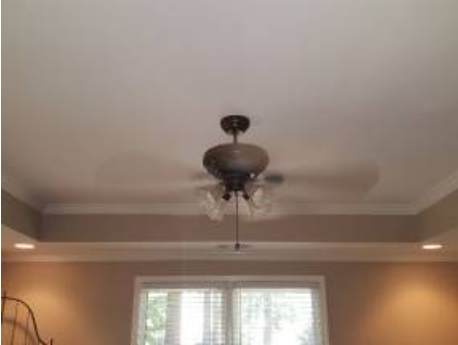
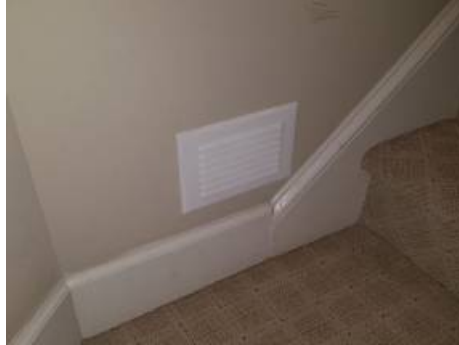
### 11.11 Lighting and Switches:

Some of the lights did not work. Possibly just the bulbs.

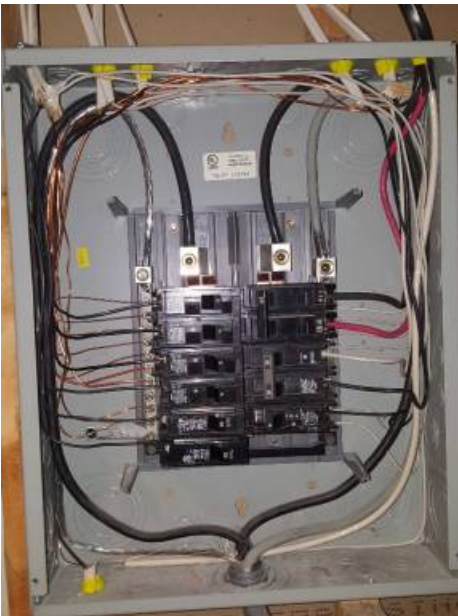
### 11.12 Subpanel Location:

The sub panel is located next to the main panel.

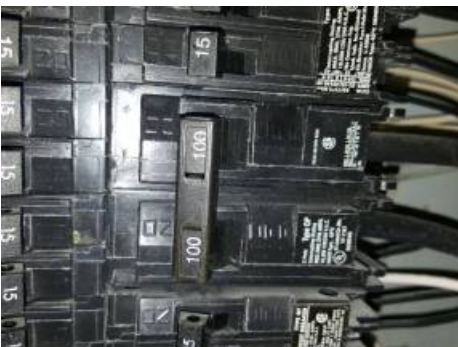
### 11.13 Subpanel Breaker:

The sub panel main breaker size in amps is, 100.

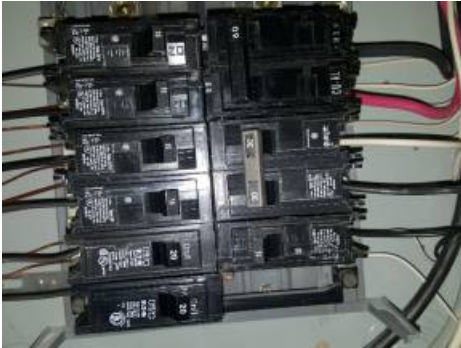
## **11.16 Sub Panel Bus Bars:**

It is important in a sub panel to completely separate the common (white) wires from any ground. This sub panel appears to be properly bonded.

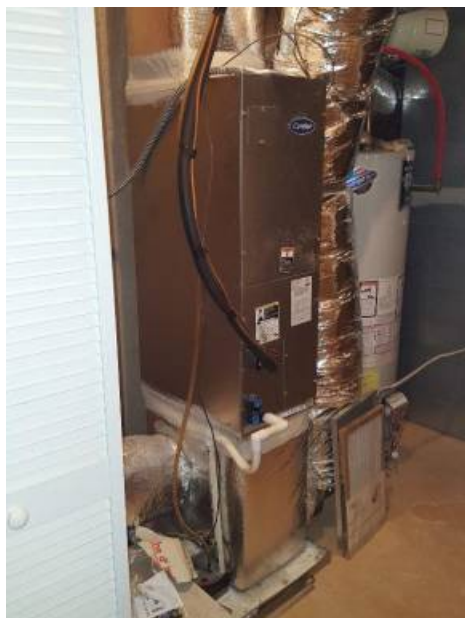
#### 12.1 Location Of First Heat Unit:

The furnace is located in the basement.

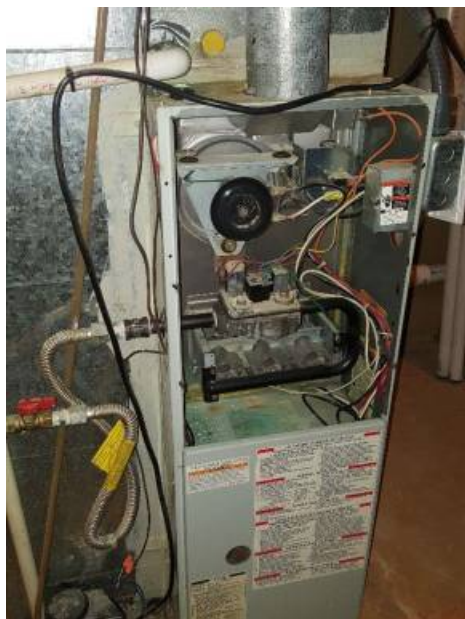
### 12.16 Location Of Second Heat Unit:

Furnace is located in the basement.

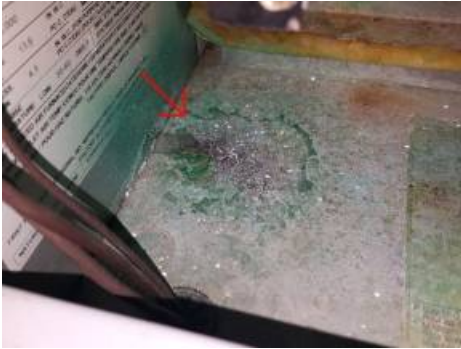
**12.28 Air Conditioner Coil:**

There was leaking noted inside the burn chamber.

I recommend the unit be serviced and accessed and repaired by a qualified HVAC technician.

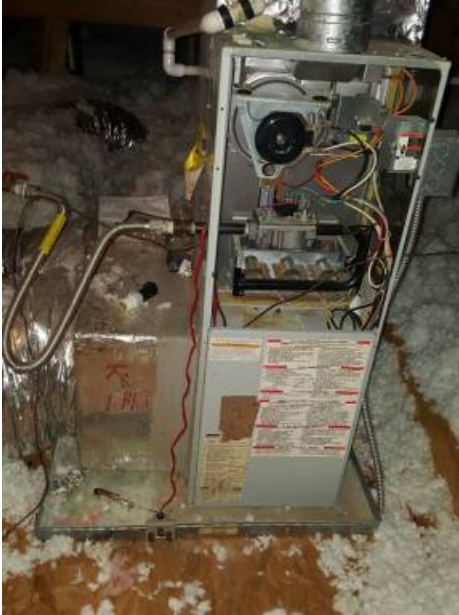
Furnace is located in the attic.

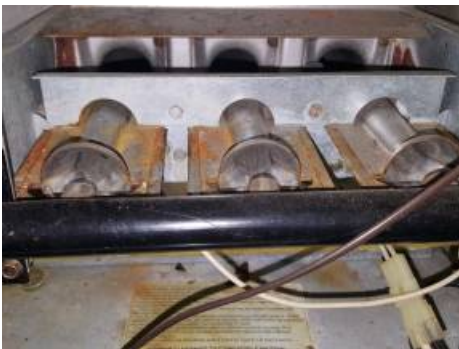
**12.43 Burners/Heat Exchangers:**

Burner Flame(s) appear typical, Excessive scale and corrosion is noted in the burn chamber. I recommend a licensed HVAC contractor access this condition and make the necessary repairs.

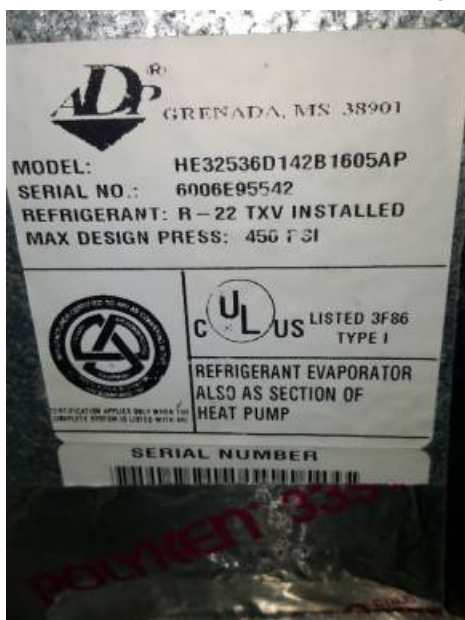
**12.48 Air Conditioner Coil:**

The unit coil appeared to be in good condition with no apparent leaking.

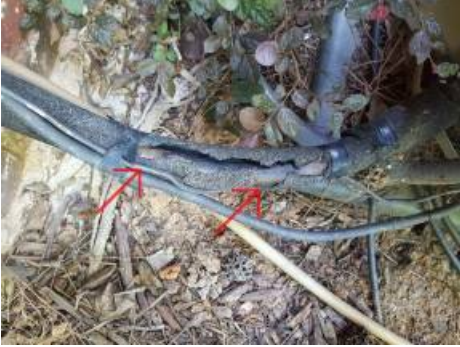
## 12.67 Coolant Lines:

The insulation for the lines is worn and torn. I recommend replacing the insulation.

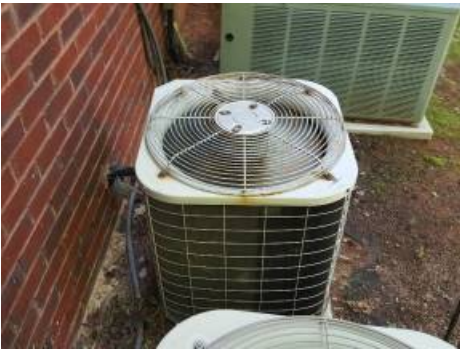
### 12.68 Location:

On the exterior, side of home, Middle unit.

There was some rust on the unit,  
It is older.

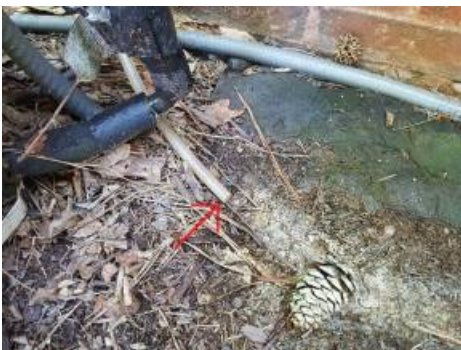
The condensation line is too close to the foundation wall. I recommend extending the condensate line out 2-3 feet from the

foundation to prevent water from running down the foundation wall.

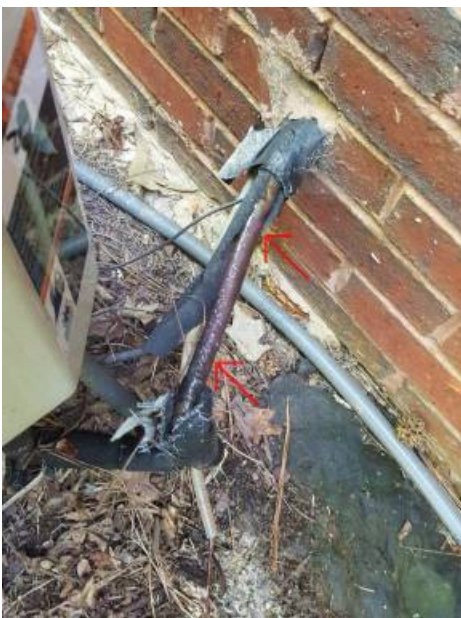
## 12.80 Coolant Lines:

The insulation for the lines is worn and torn. I recommend replacing the insulation.

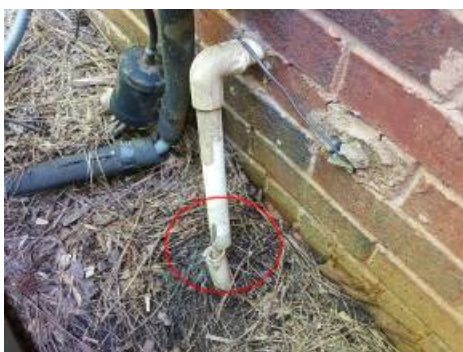
Condensate line is broken or disconnected. Repair as required.

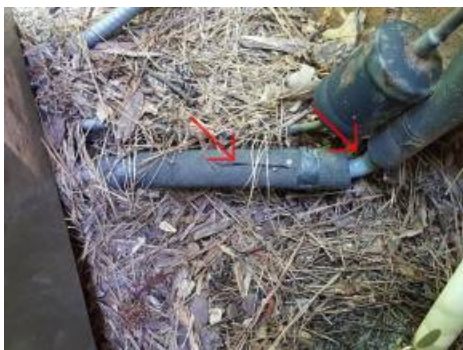
**12.93 Coolant Lines:**

The insulation for the lines is worn and torn. I recommend replacing the insulation.

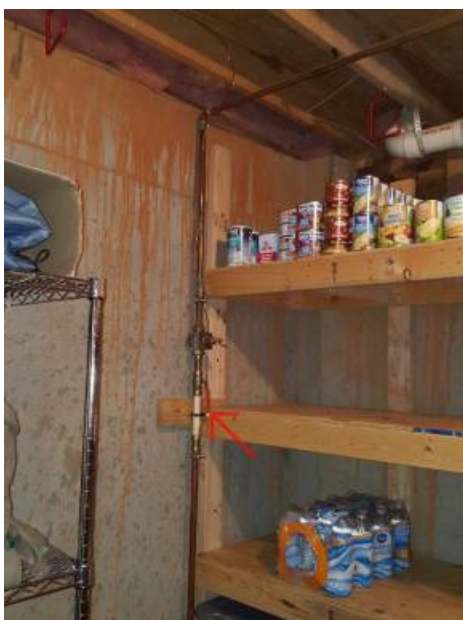
#### 13.2 Main Water Cut Off Location:

The main water cut off is in the basement. The required pressure regulator was noted.

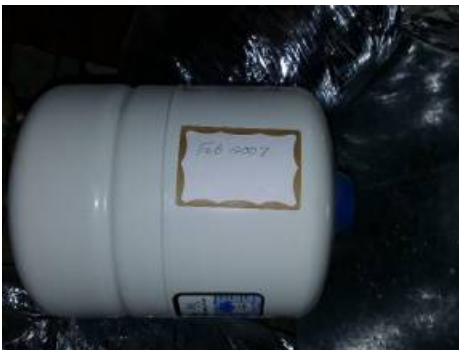
The water heater appeared to be in good condition. The TPR valve (Temperature Pressure Relief) was noted, not tested. The line appears proper and as it should. A water shutoff valve is installed, The flue vent was intact, properly secured to the top of the tank and at the joints. Expansion tank is present.

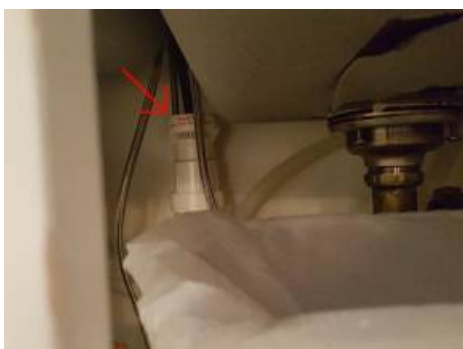
## 14.3 Comments:

Note to client: There was an air admittance valve (AIV) commonly referred to as a "studor" vent located under the kitchen sink.

It is important that you as a homeowner know it is there in the event there is any type of problem.

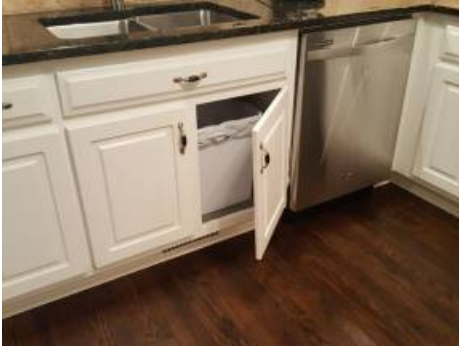
The cabinets, doors, and drawers are satisfactory in both appearance and function. One of the cabinet door hinges is broken. Repair as required.

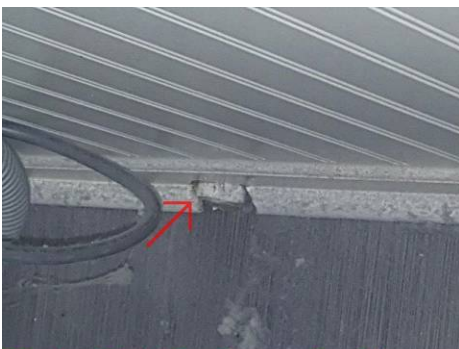
Washer Drain Pan Connection Shown

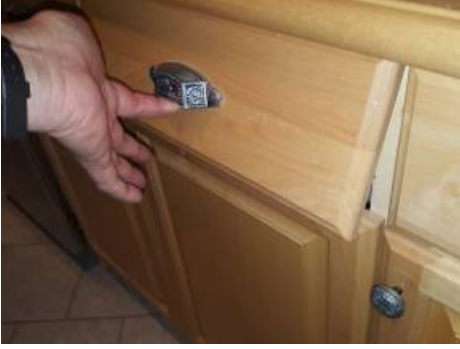
Satisfactory - The cabinets, doors, and drawers are satisfactory in both appearance and function.  
One of the fronts is loose.  
Re-nail as required.

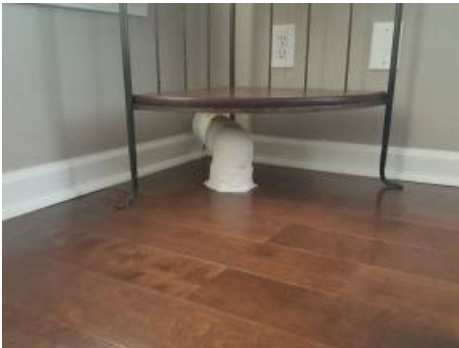
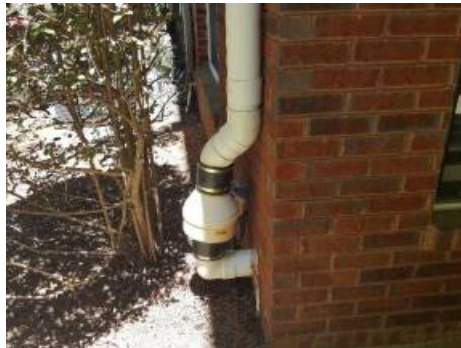
#### 17.3 Comments:

There was a radon mitigation system in place in the basement running on the exterior of the right rear corner of the home. I recommend asking the seller for the paper work on this system.

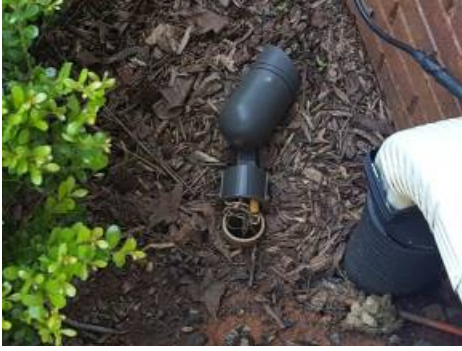
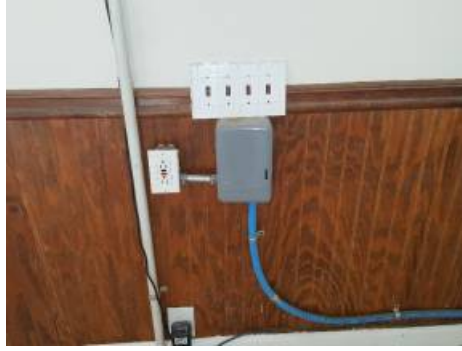
There was an outside lighting system noted.

One of the lights in the front appeared broken.

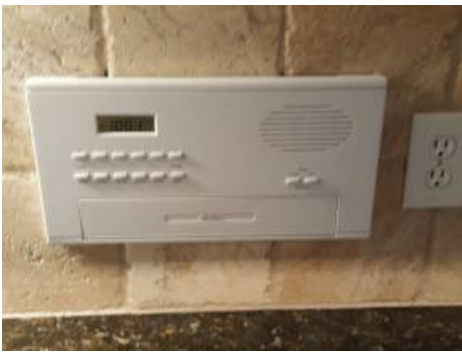
17.5

## INTERCOM SYSTEM:

There was an intercom system noted in the home.

This system was not inspected, it is beyond the scope of the inspection.
