FIBER POST APPLICATION

Hakan Kamalak¹, Mehmet Gökhan Tekin²

1.DDS, İnönü University, Faculty of Dentistry, Department of Restorative Dentistry, Malatya, TURKEY

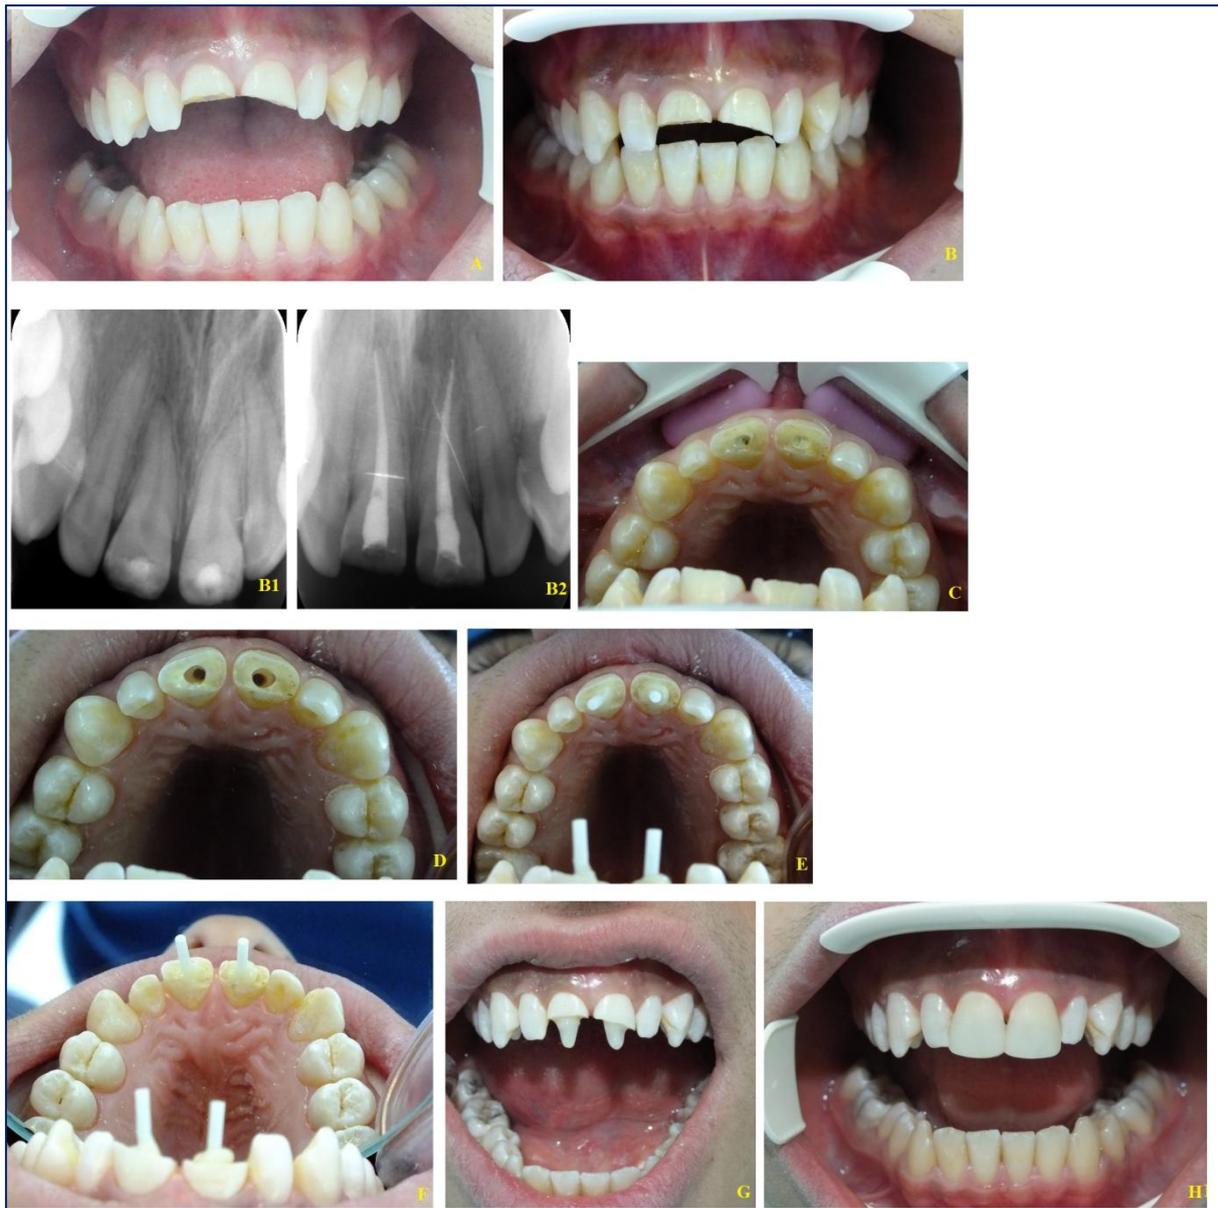
Figure 1. A: The intraoral clinical picture of patient, B: clinical appearance of patient's teeth, B1: Posttraumatic radiographs and the expansion in lamina dura, B2: The radiographs taken after root canal therapy, C: The view from the palatal teeth, D: the root canal treatment was extracted with drills which are equal to the diameter and length of fiber post. E. and F. : Fiber posts were inserted into the slots opened with Driller. G: The around of fiber post was enclosed with flowable composite them. H: Fibers which were closed with fluent composite were restored with condensed composite using layering techniques.

In this case report, a high school student consulted Inonu University, Faculty of Dentistry, Department of Restorative Dentistry owing to fractures and pain related to trauma occurring on upper central teeth. After the anamnesis, it was determined that the fractures were lost and the patient came to the clinic just after the trauma and the patient was found not to be of any systemic disorders. Not any pathology was found in extraoral examination. In radiographs taken from the patient was observed thickening in the lamina dura and perforation in pulp.(Figure 1-B1) The patient was diagnosed with complicated crown fracture. Following root canal therapy of the two top central tooth (Figure 1-B2), these teeth were restored by fiber supported Postle and reintegrated aesthetics and function (Figure 1-H).

After inserting the posts into the pulpal canal, the transparent matrix band has been located on the mesial and distal ridges and has been fastened with appropriate wedges. Then, it was restored using composite resin by layering. At last, the restoration surfaces were polished with finishing discs (Sof-lex, 3M ESPE, USA). The patients were evaluated after nine months and aesthetically not any broken or decaying teeth were determined.
