Wetland and Surface Water Delineation Report

**US 30 Corridor Improvements - Western Section
North Versailles and North Huntingdon Townships
Allegheny and Westmoreland Counties, Pennsylvania**

**Engineering District 12-0
825 N. Gallatin Ave. Ext.
Uniontown, PA 15401**

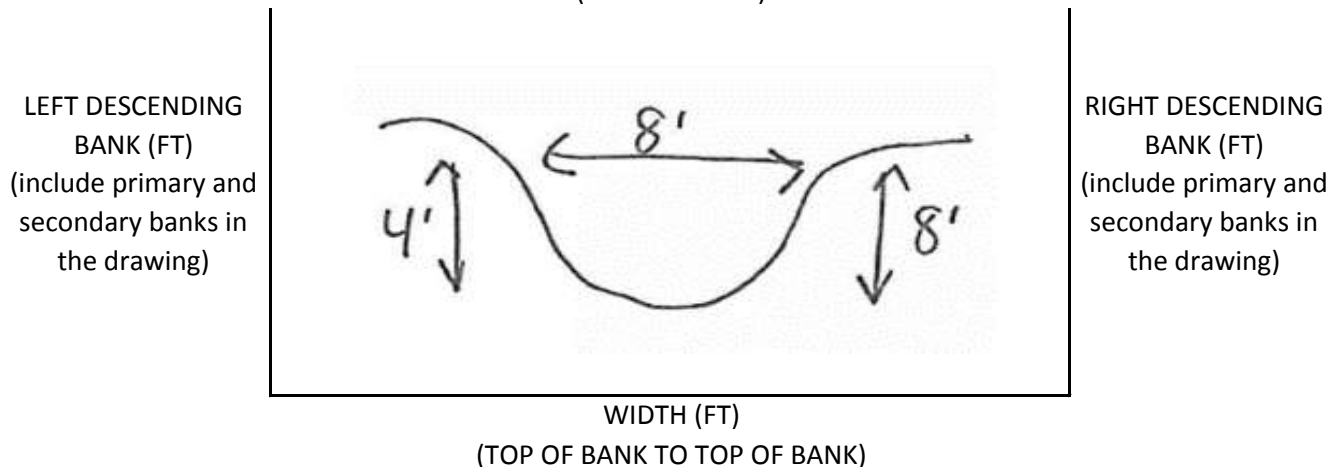
CROSS SECTIONAL DIAGRAM

BANK WIDTH 8' WATER WIDTH N/A NO WATER Pooled
 CHANNEL DEPTH 4-8' WATER DEPTH N/A

Notes: Water located in channel approx. 30 yards downstream of study area limit.

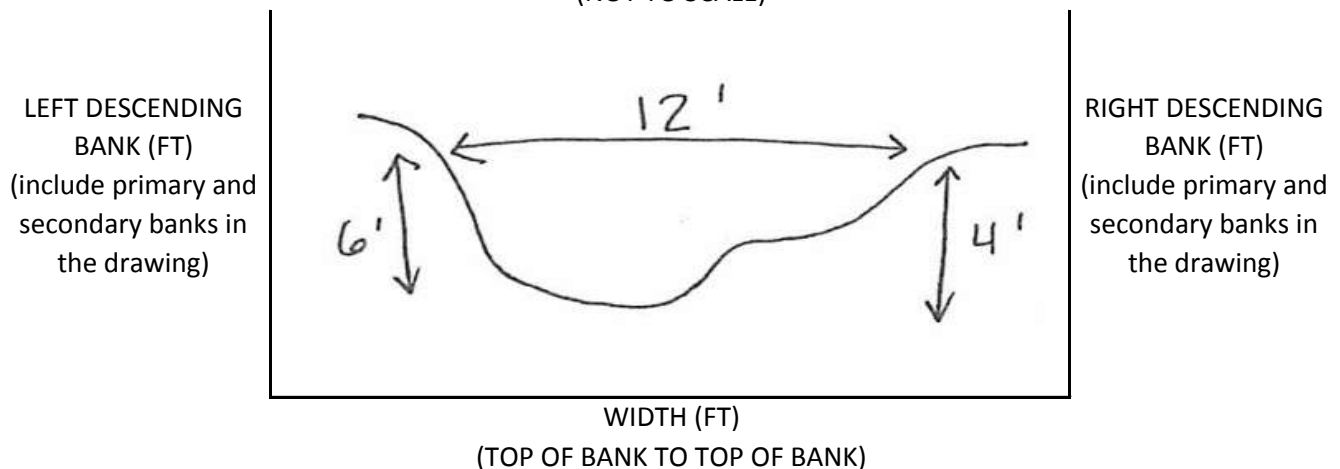
CROSS SECTIONAL DIAGRAM
(NOT TO SCALE)

BANK WIDTH **12'** WATER WIDTH **N/A** NO WATER **X**
 CHANNEL DEPTH **6-4'** WATER DEPTH **N/A**

Notes: Garbage accumulated in channel

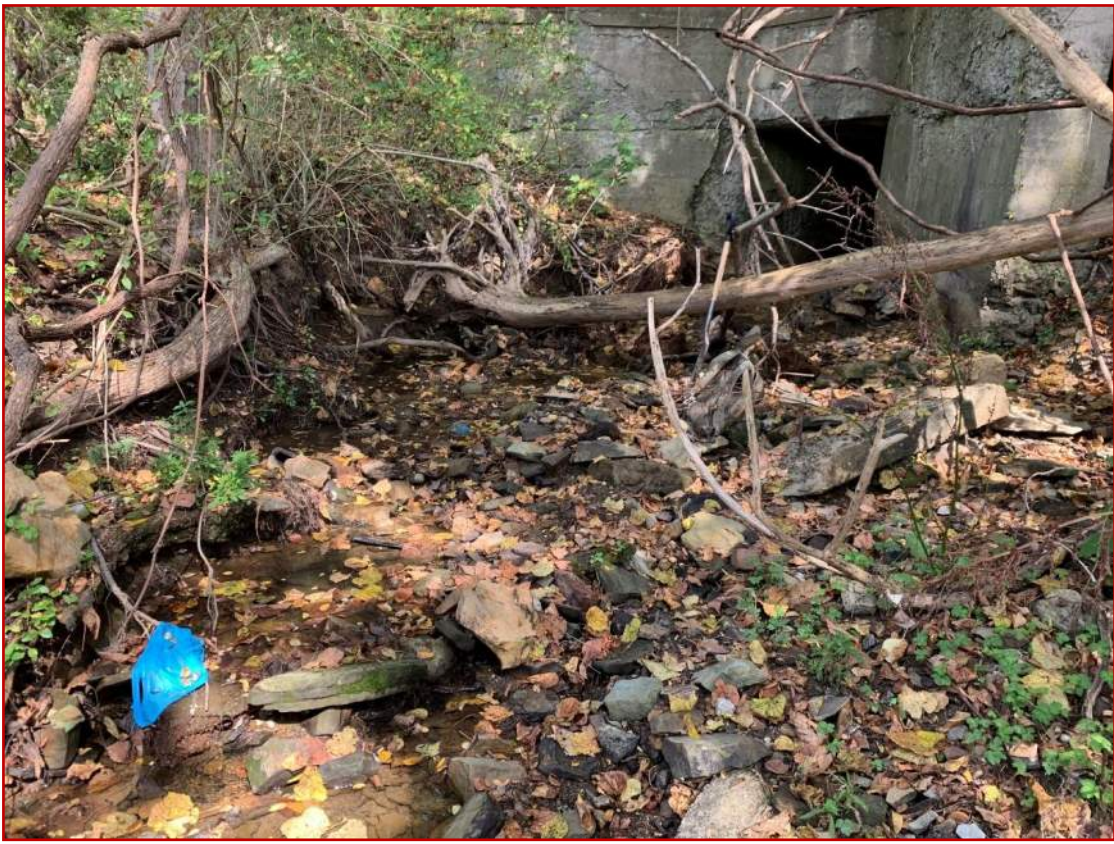
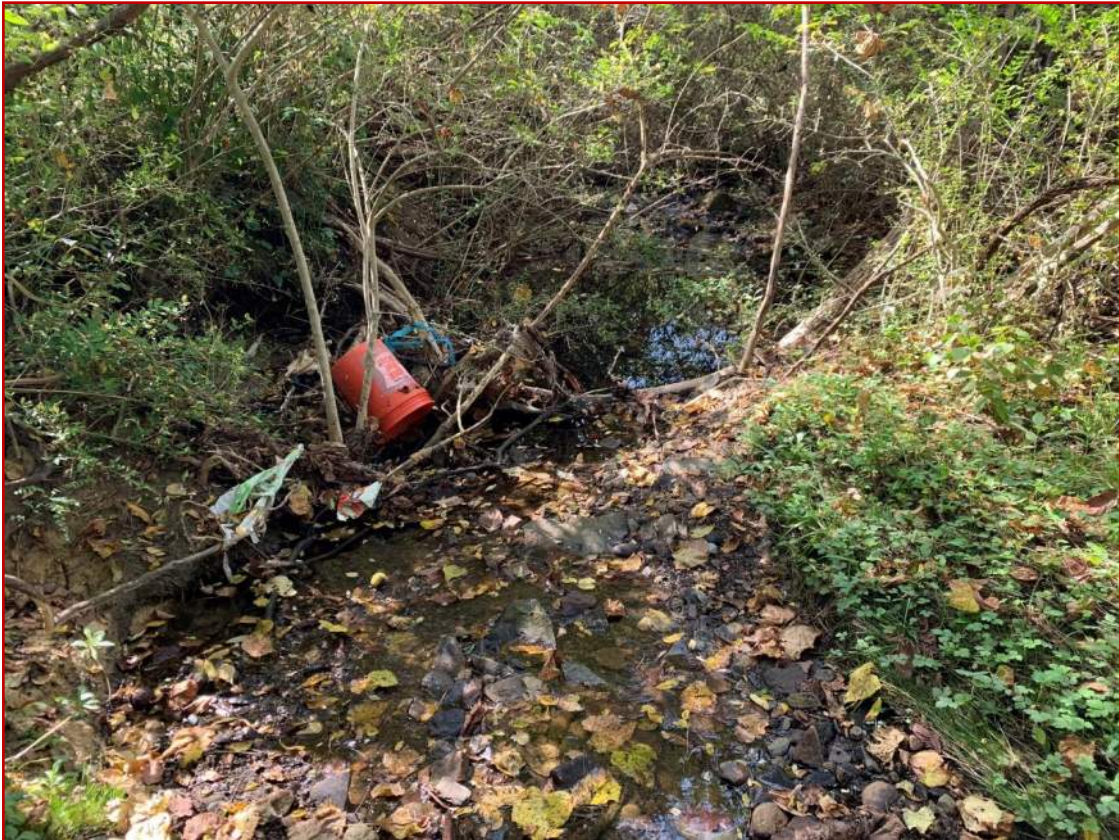
Photo 1: UNT 1 to Jacks Run – Facing Upstream (9.17.19)

Photo 2: UNT 1 to Jacks Run – Facing Downstream (9.17.19)

UNT 1 to Jacks Run (101382) is a perennial stream located on the western side of the project area. UNT 1 to Jacks Run flows in a southern direction through the project area. The bank width for UNT 1 to Jacks Run is approximately 18-feet and the channel depths are 5-feet (left descending bank) and 6-feet (right descending bank) respectively. UNT 1 to Jacks Run had a water depth of 2-inches and a water width of 3-feet at the time of investigation. The substrate in the stream consists of a mixture of cobble (60%), boulders (30%), and silt (10%) with 30% embeddedness. No macroinvertebrate orders were observed during the field view. The lack of macroinvertebrates could be attributed to assumed poor water quality by urbanization within the project area. No fin fish species were observed.

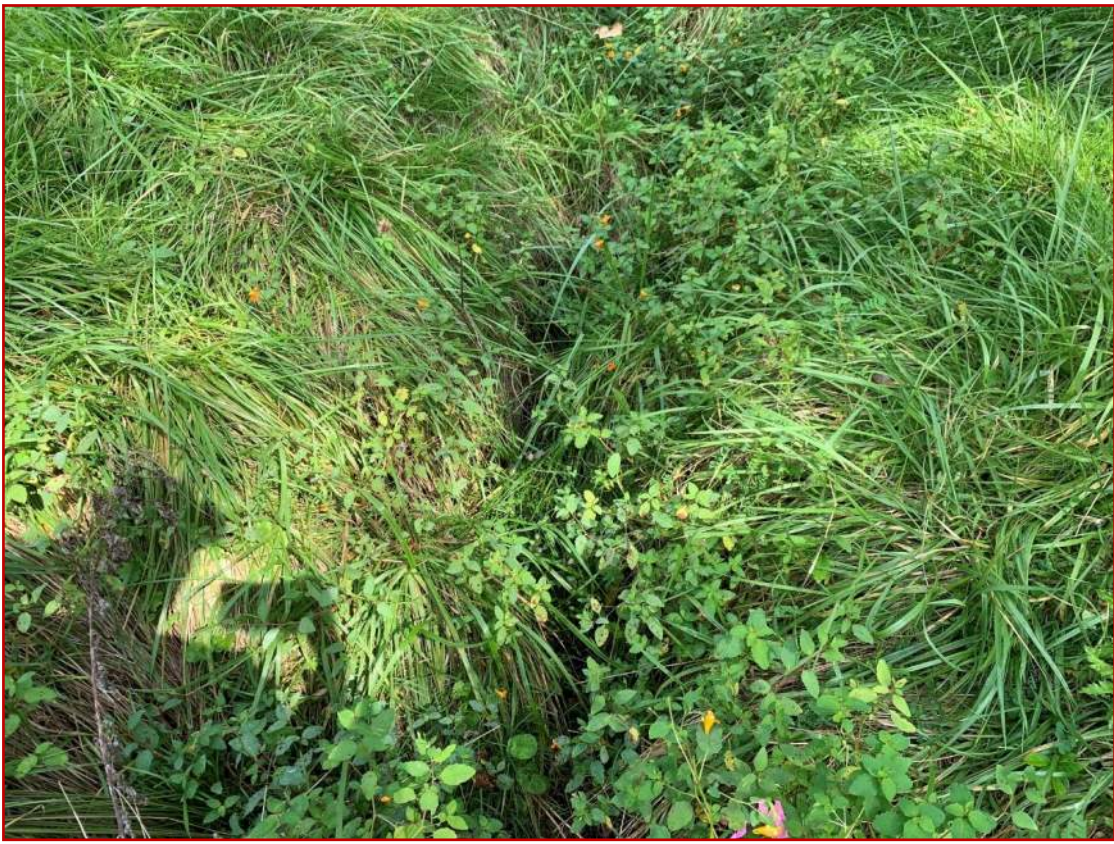
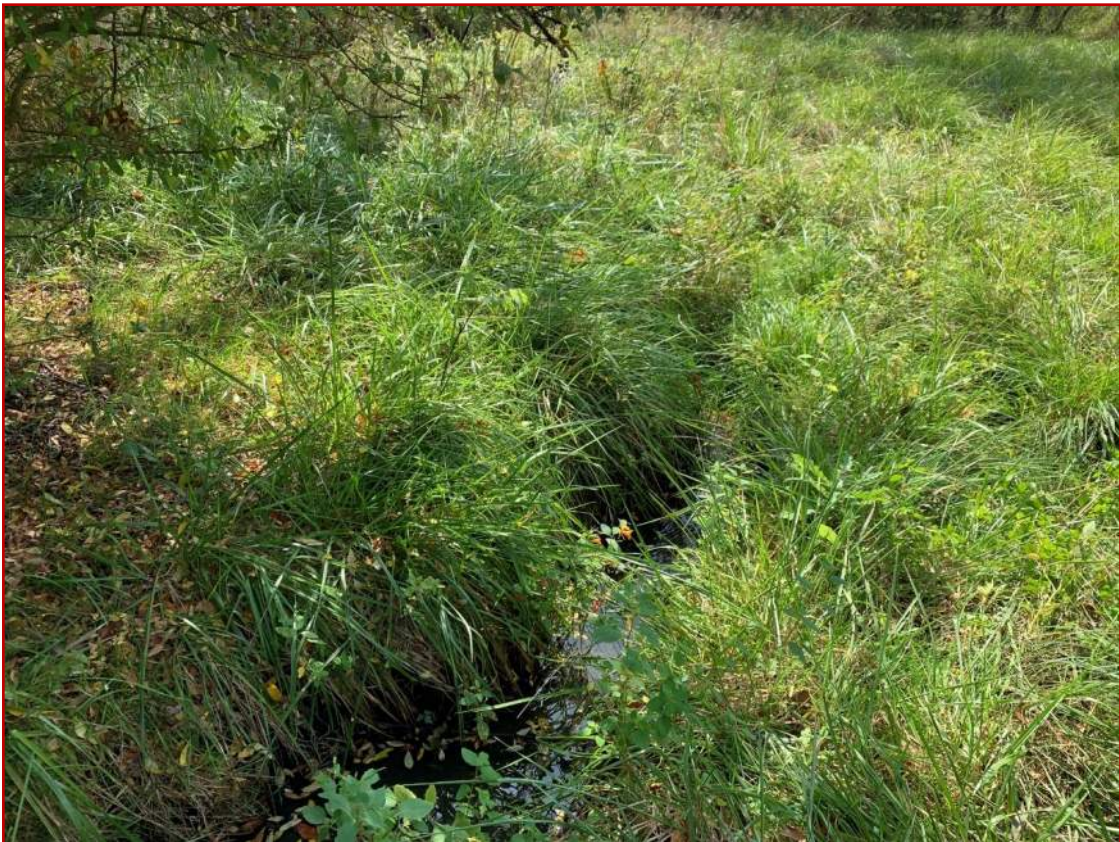
Photo 3: UNT 2 to Jacks Run – Facing Upstream (9.17.19)

Photo 4: UNT 2 to Jacks Run – Facing Downstream (9.17.19)

UNT 2 to Jacks Run (101382) is an intermittent stream located on the western side of the project area. UNT 2 to Jacks Run flows in a southeastern direction through the project area to its confluence with UNT 1 to Jacks Run. The bank width for UNT 2 to Jacks Run is approximately 2-feet and the channel depth is 3-feet. UNT 2 to Jacks Run had a water depth of 1-inch and a water width of 8-inches at the time of investigation. The substrate in the stream consists of a mixture of muck (40%), detritus (20%), gravel (20%), and silt (20%) with 5% embeddedness. No macroinvertebrate orders were observed during the field view due to the presence of abandoned mine drainage. No fin fish species were observed.

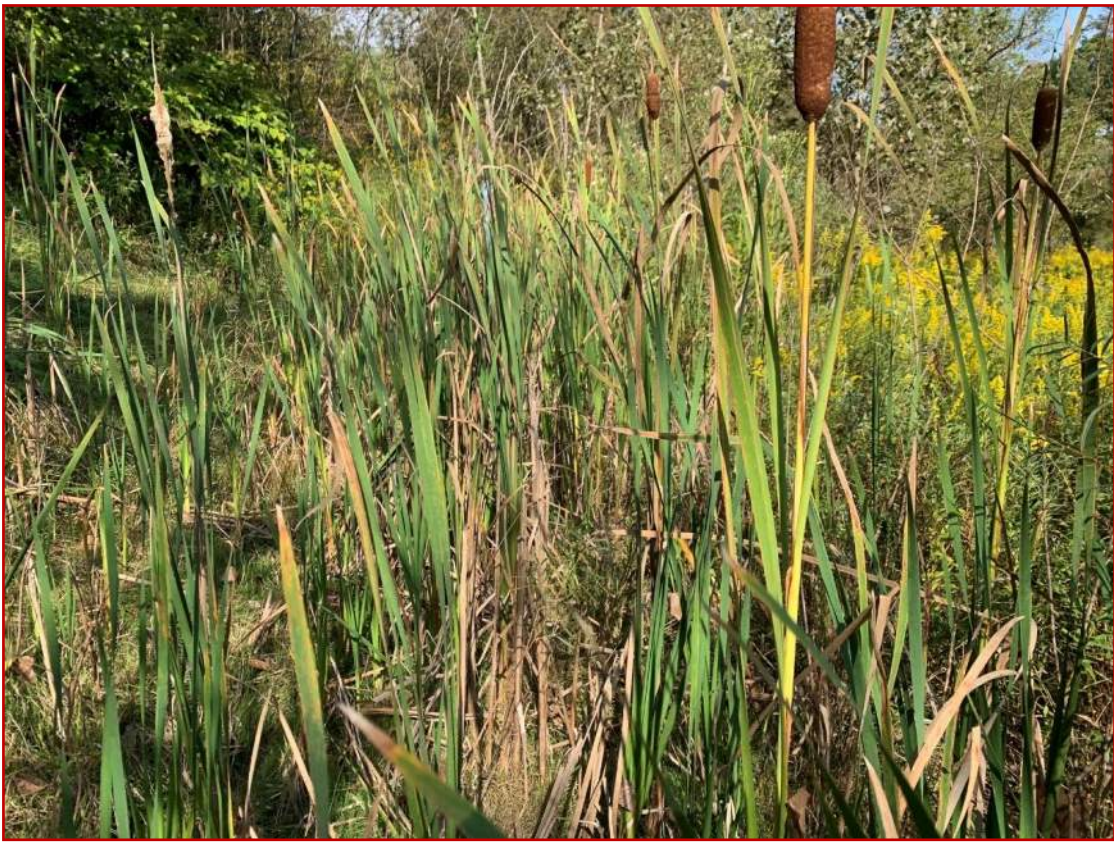
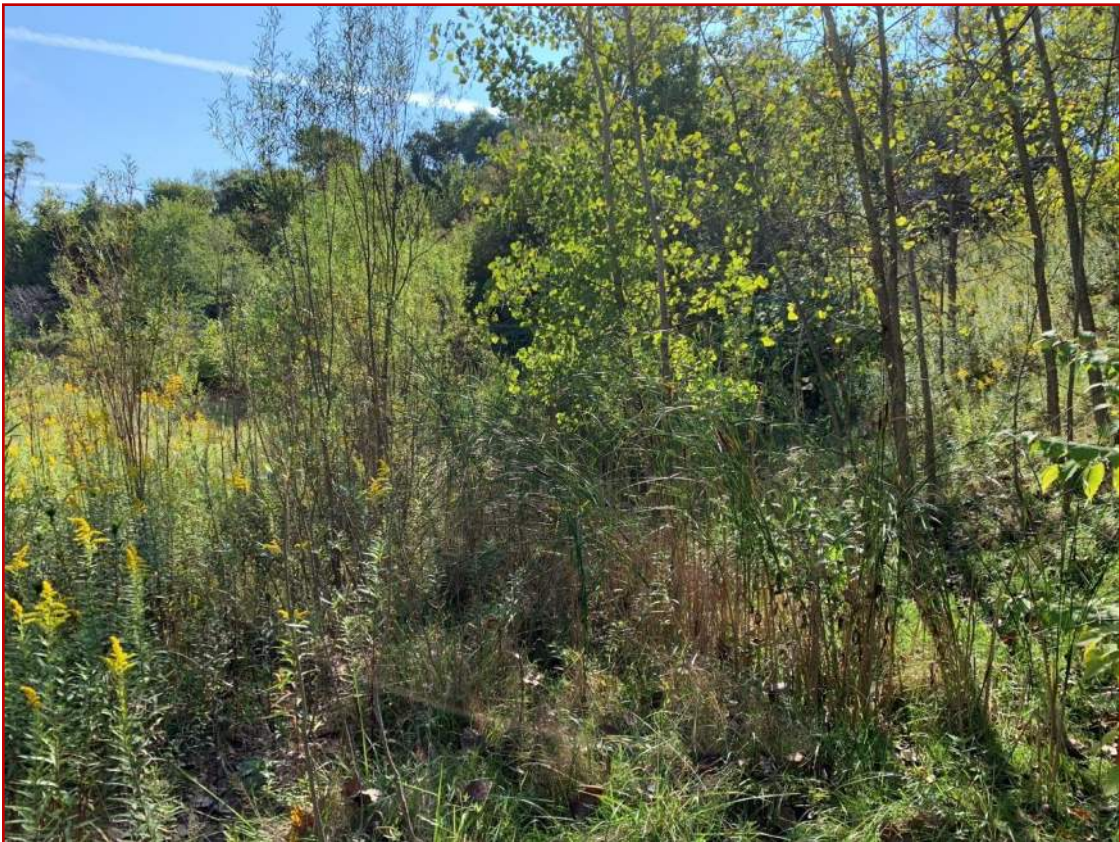
Photo 5: Wetland WL6 – Facing North (9.17.19)

Photo 6: Wetland WL6 – Facing Southeast (9.17.19)

WL6 is classified as a PEM wetland located entirely within the project study area and is approximately 0.04 acres in size. Primary wetland hydrology indicators observed within this wetland include surface water and saturation with drainage patterns as a secondary indicator. Wetland hydrology is present within WL6.

Dominant vegetation observed within this wetland includes silky willow (*Salix sericea*, OBL) and broadleaf cattail. The vegetation observed within this wetland meets the Rapid Test for Hydrophytic Vegetation. Hydrophytic vegetation is dominant within this wetland.

The soil test pit identified one soil horizon. The soil horizon from 0-14 inches had a matrix color of 10YR 5/1 (80%) with redox features the color of 7.5YR 4/4 (20%) and a clay loam texture. The soil matrix colors and features indicate this is a hydric soil. Hydric soil indicators observed within this wetland meet the description of *Indicator F3: Depleted Matrix*. A restrictive layer of rock was reached at 14 inches.

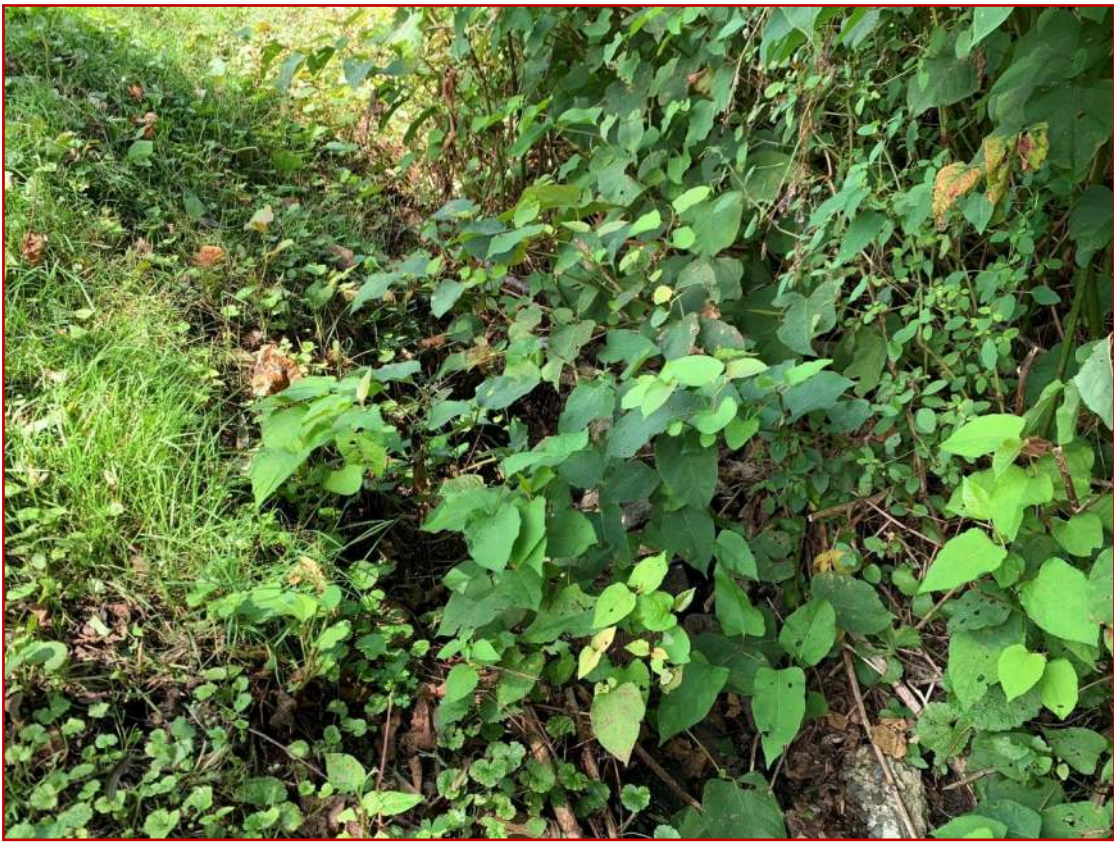
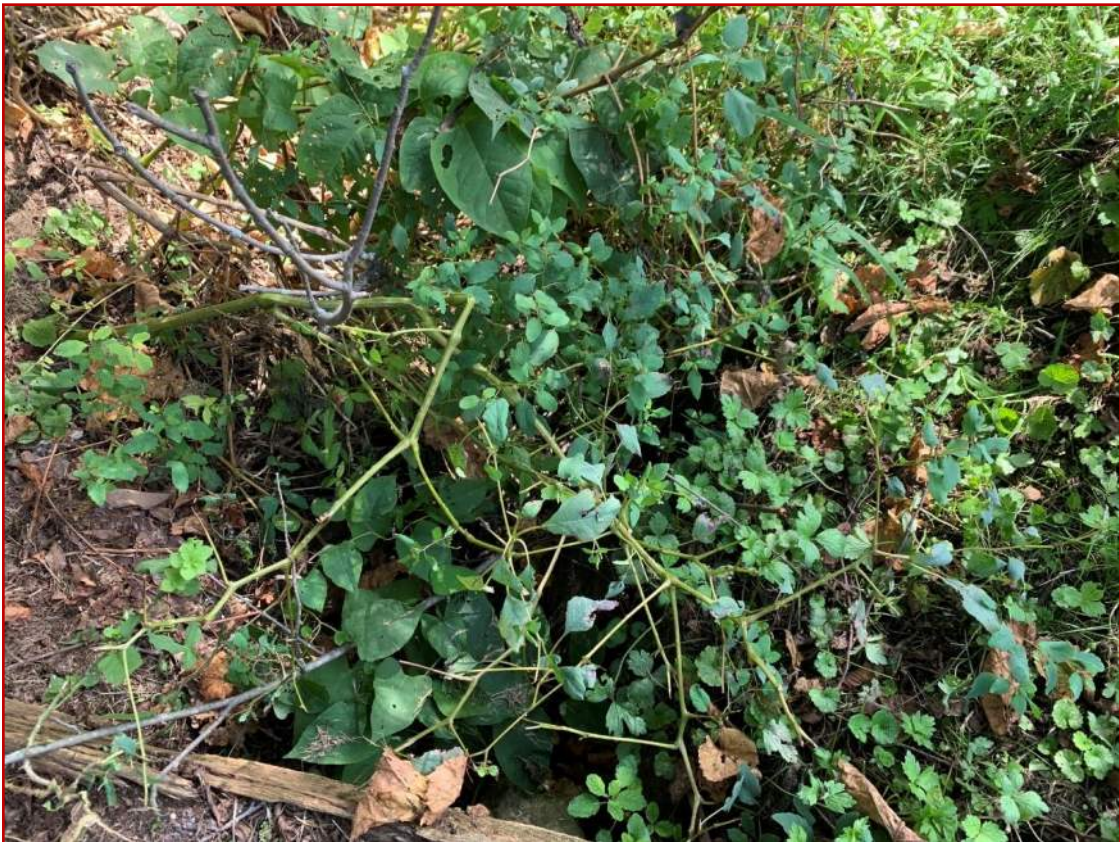
Photo 7: UNT 6 to Jacks Run – Facing Upstream (9.17.19)

Photo 8: UNT 6 to Jacks Run – Facing Downstream (9.17.19)

UNT 6 to Jacks Run (101382) is an ephemeral channel located on the western side of the project area. UNT 6 to Jacks Run flows in a southeastern direction through the project study area to its confluence with UNT 7 to Jacks Run. The bank width for UNT 6 to Jacks Run is approximately 8-feet and the channel depths are 4-feet (left descending bank) and 8-feet (right descending bank) respectively. UNT 6 to Jacks Run contained pooled water approximately 30 yards downstream of the project area boundary at time of investigation. The substrate in the channel consists of a mixture of detritus (25%), gravel (25%), sand (20%), cobble (15%), and silt (15%) with 10% embeddedness. No macroinvertebrate orders were observed during the field view. No fin fish species were observed.

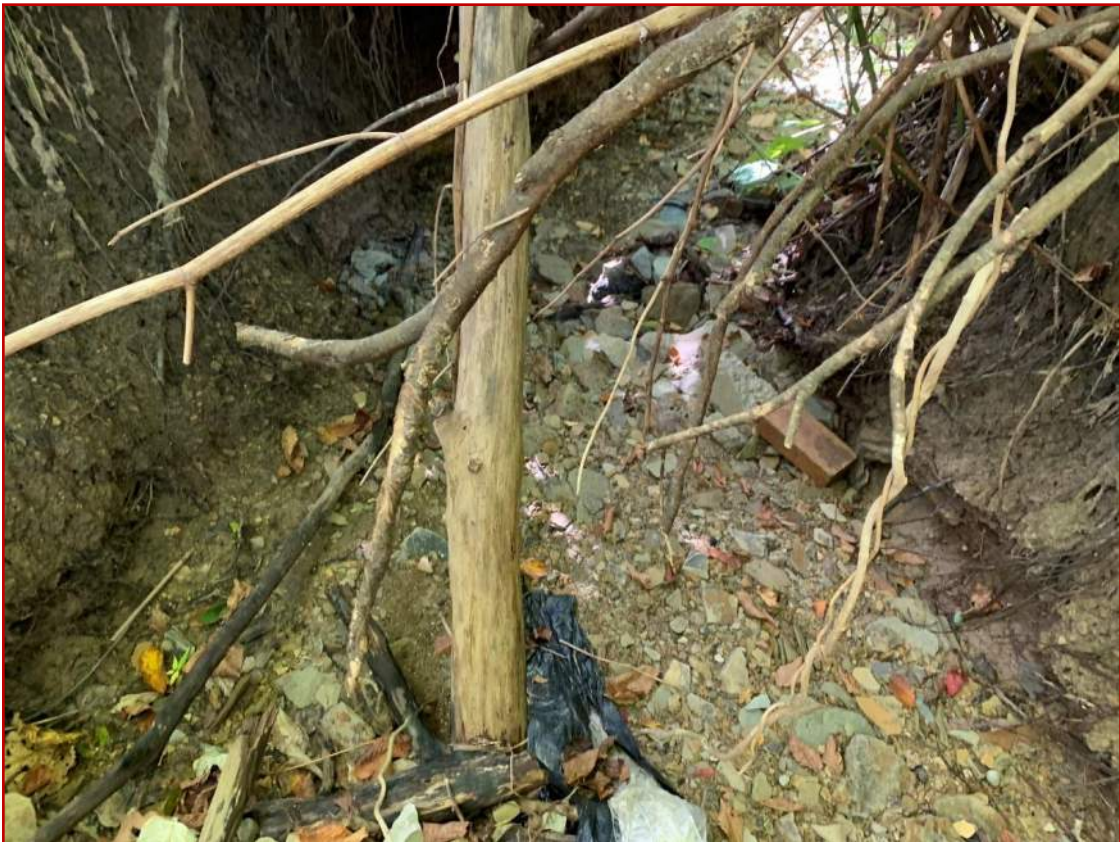
Photo 9: UNT 7 to Jacks Run – Facing Upstream (9.5.19)

Photo 10: UNT 7 to Jacks Run – Facing Downstream (9.5.19)

UNT 7 to Jacks Run (101382) is an ephemeral channel located on the western side of the project area. UNT 7 to Jacks Run flows in a southwestern direction through the project area. The bank width for UNT 7 to Jacks Run is approximately 6-feet and the channel depth is 6-feet. UNT 7 to Jacks Run did not have water present during the time of investigation. The substrate in the channel consists of a mixture of cobble (80%), boulders (10%), and detritus (10%) with 20% embeddedness. No macroinvertebrate orders were observed during the field view. No fin fish species were observed.

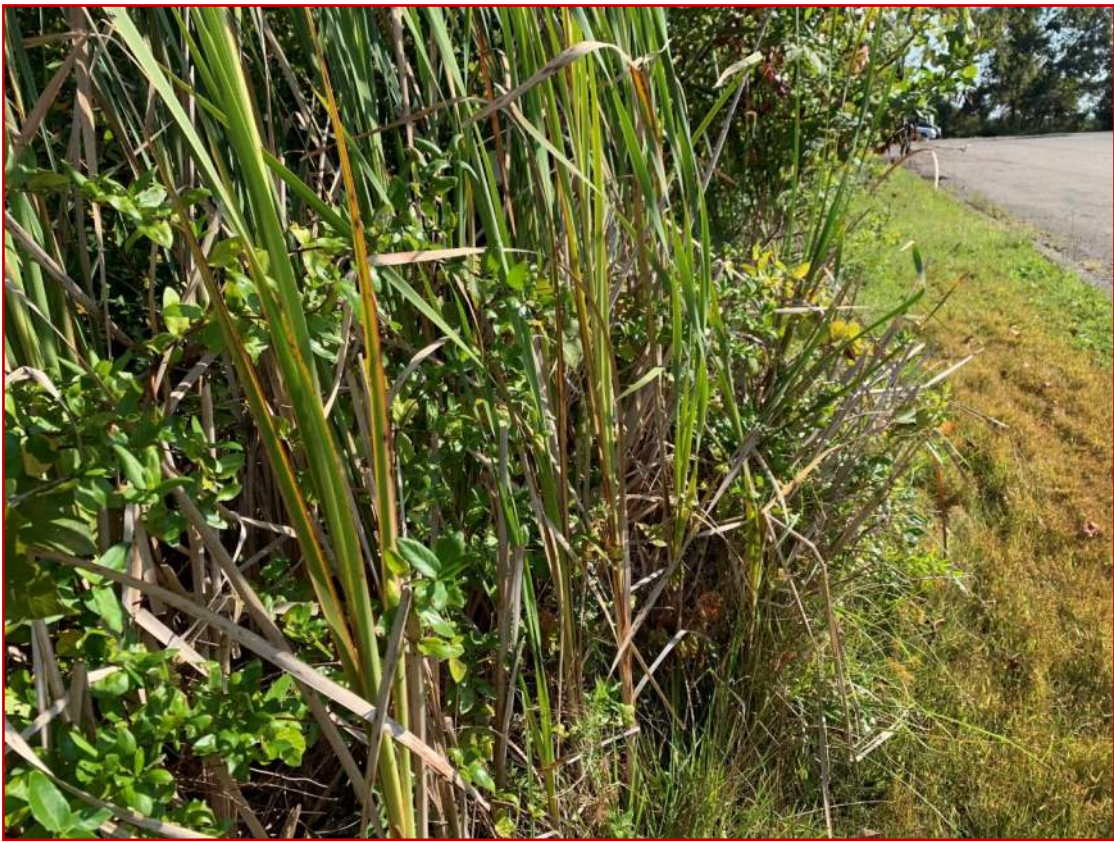
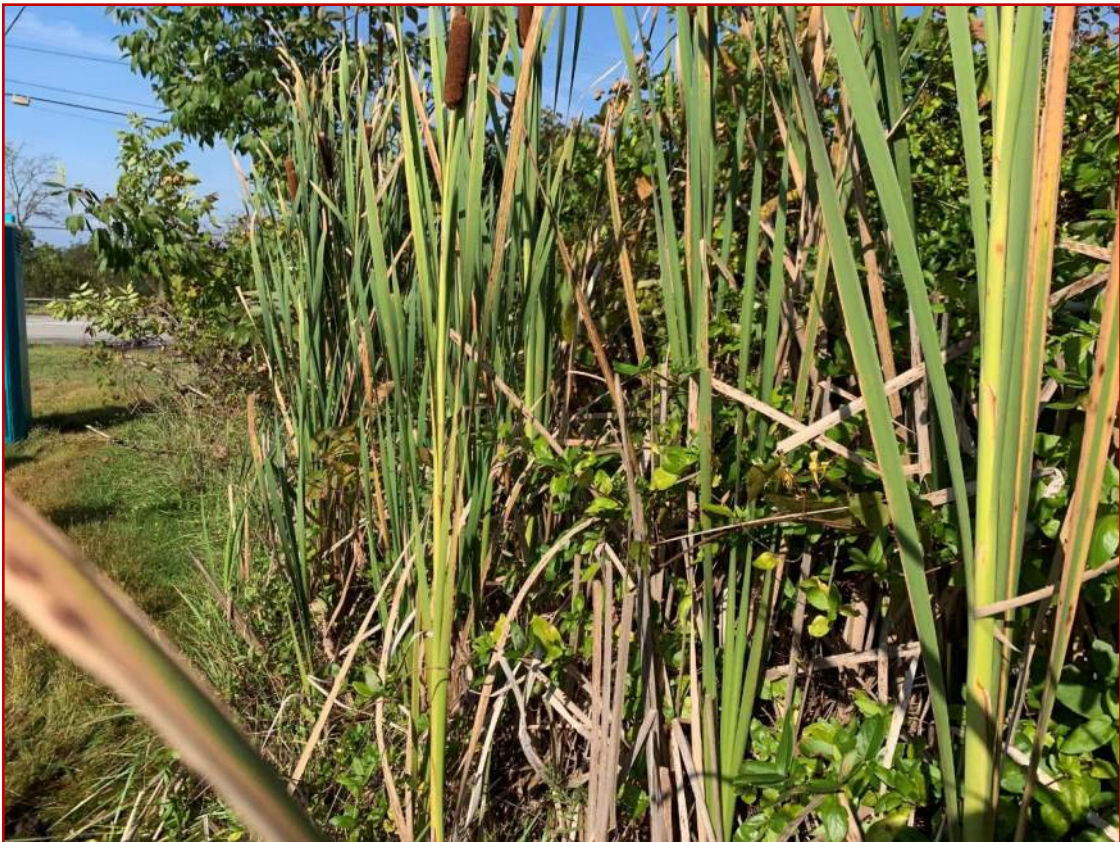
Photo 11: Wetland WL5 – Facing Northeast (9.17.19)

Photo 12: Wetland WL5 – Facing Southwest (9.17.19)

WL5 is classified as a PEM wetland located entirely within the project study area and is approximately 0.002 acres in size. The primary wetland hydrology indicator observed within this wetland is saturation. Wetland hydrology is present within WL5.

Dominant vegetation observed within this wetland include broadleaf cattail. The vegetation observed within this wetland meets the Rapid Test for Hydrophytic Vegetation. Hydrophytic vegetation is dominant within this wetland.

The soil test pit identified one soil horizon. The soil horizon from 0-16 inches had a matrix color of 10YR 2/2 (95%) with redox features the color of 5YR 4/6 (5%) and a silt loam texture. The soil matrix colors and features indicate this is a hydric soil. Hydric soil indicators observed within this wetland meet the description of *Indicator F6: Redox Dark Surface*. A restrictive layer of rock was reached at 16 inches.

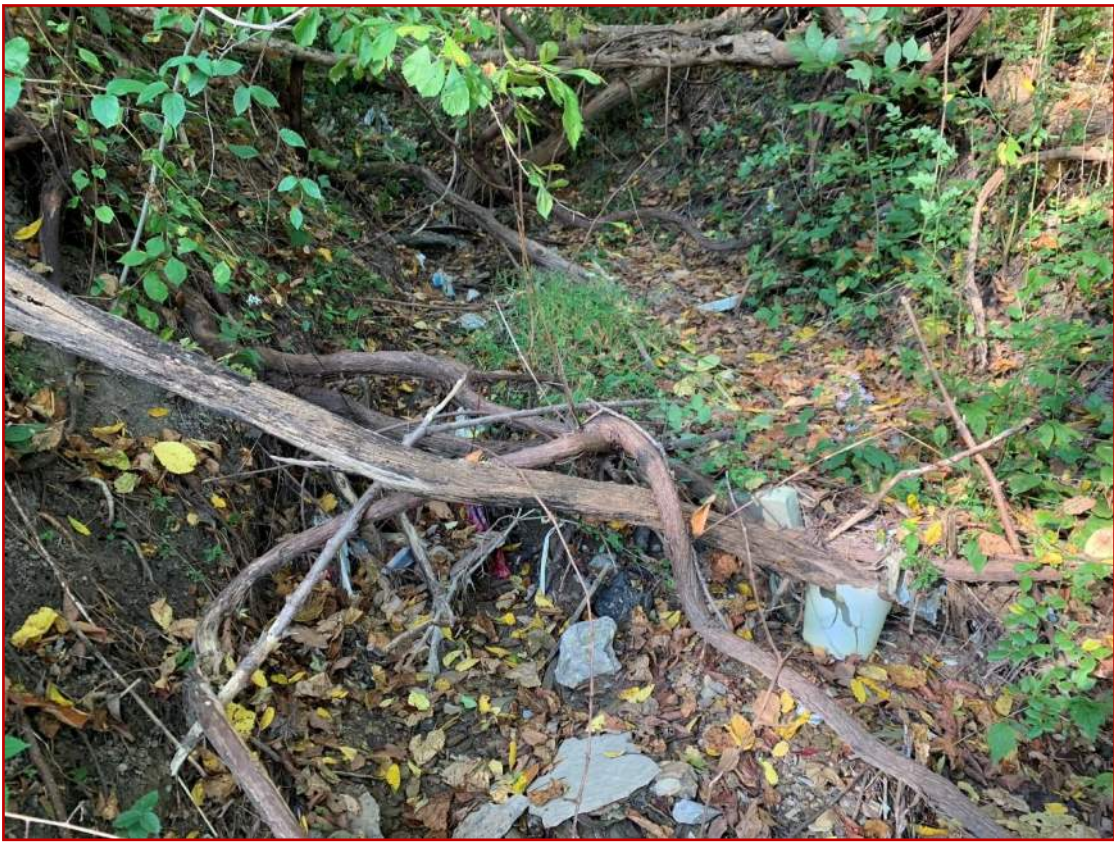
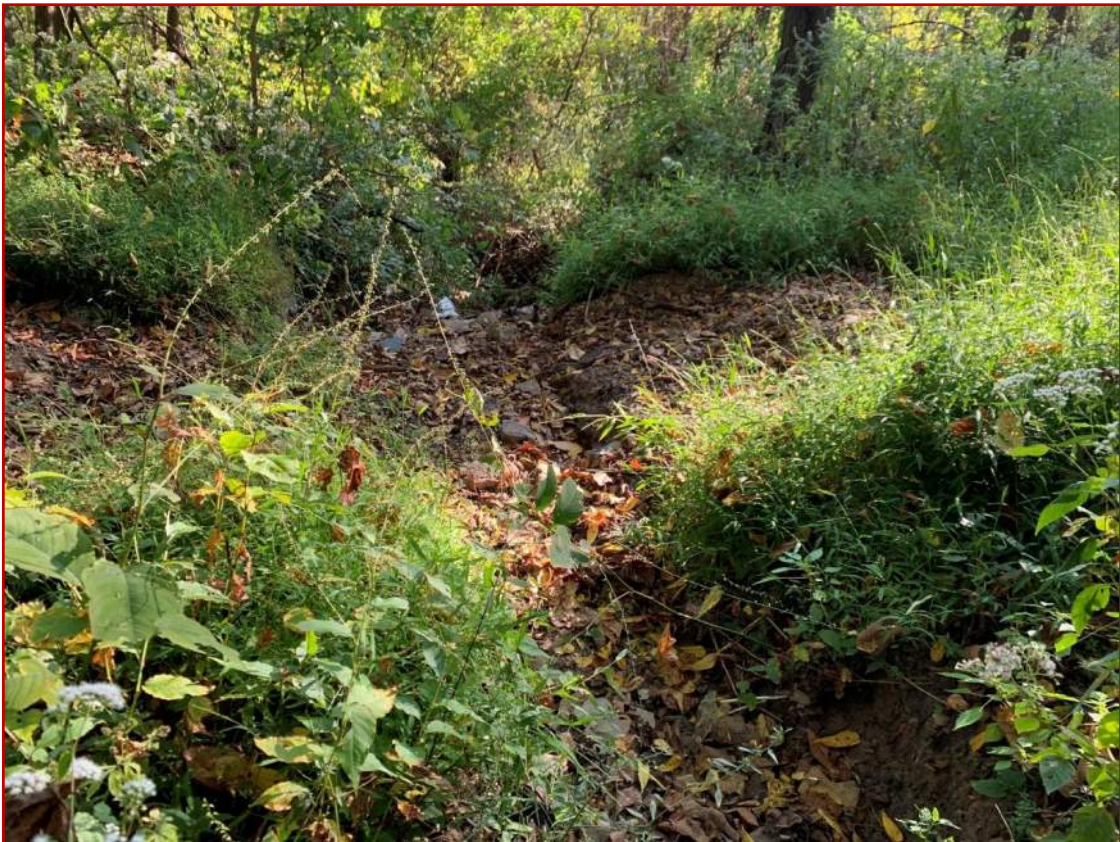
Photo 13: UNT 2 to Brush Creek – Facing Upstream (9.17.19)

Photo 14: UNT 2 to Brush Creek – Facing Downstream (9.17.19)

UNT 2 to Brush Creek (21275) is an ephemeral channel located on the eastern side of the project area. UNT 2 to Brush Creek flows in a northeastern direction through the project area and flows into Wetland WL-4. The bank width for UNT 2 to Brush Creek is approximately 12-feet and the channel depths are 6-feet (left descending bank) and 4-feet (right descending bank) respectively. UNT 2 to Brush Creek did not have water present at the time of investigation. The substrate in the channel consists of a mixture of cobble (40%), detritus (20%), gravel (20%), and sand (20%) with 10% embeddedness. No macroinvertebrate orders were observed during the field view. No fin fish species were observed.

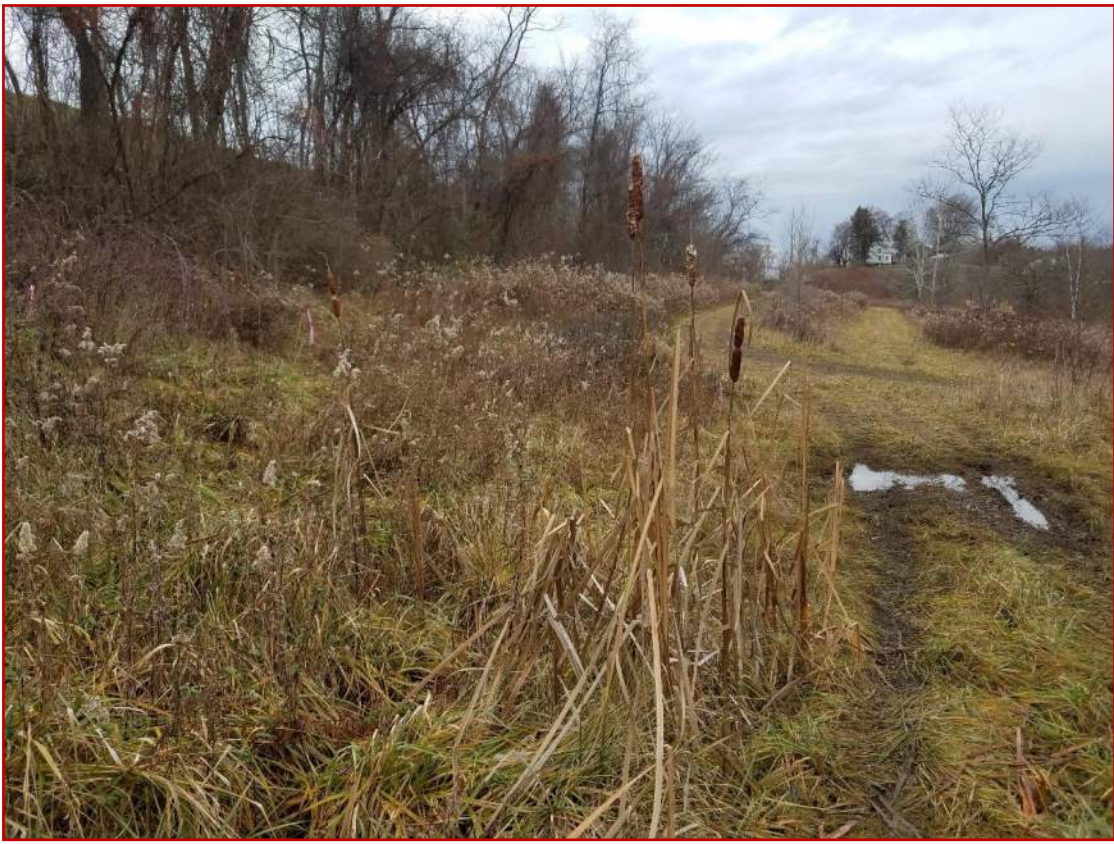
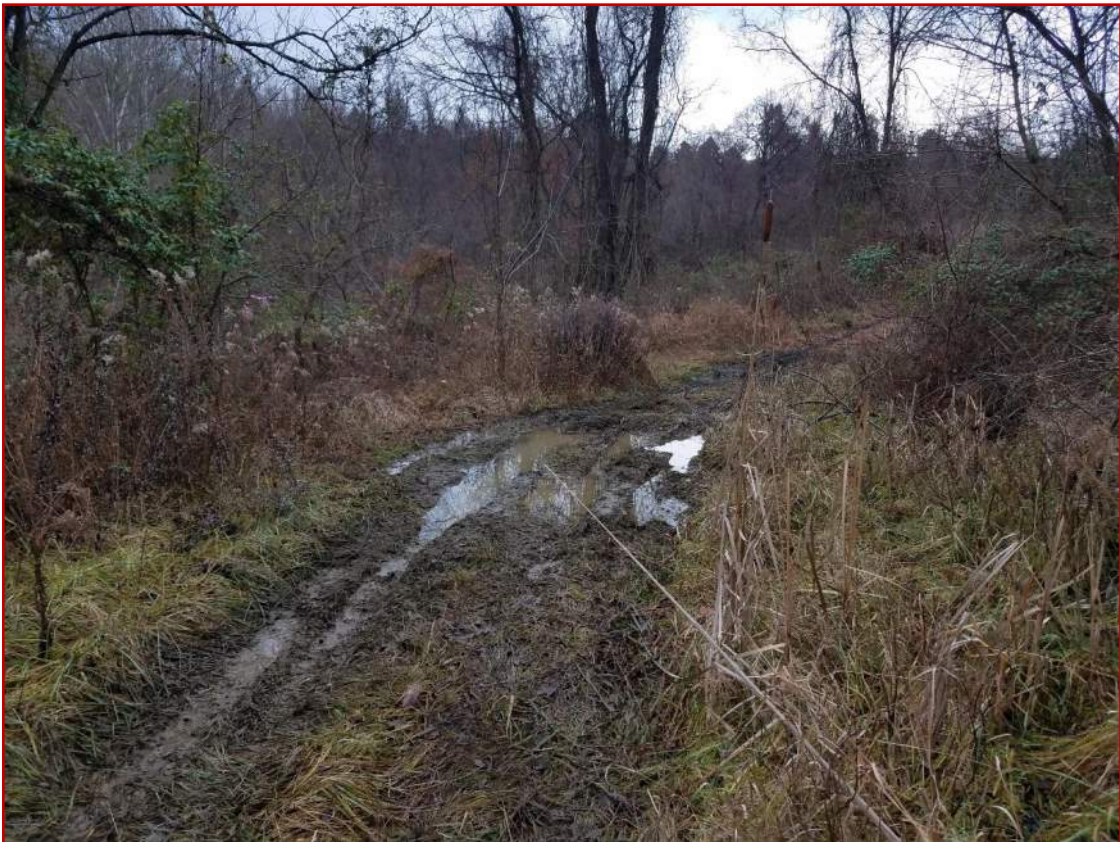
Photo 15: Wetland WL4 – Facing Northwest (12.6.19)

Photo 16: Wetland WL4 – Facing Southeast (12.6.19)

WL4 is classified as a PEM wetland located entirely within the project study area and is approximately 0.09 acres in size. WL4 contained an upland inclusion of approximately 0.01 acres. The primary wetland hydrology indicator observed within this wetland is surface water with drainage patterns as a secondary indicator. Wetland hydrology is present within WL4.

Dominant vegetation observed within this wetland includes silky dogwood (*Cornus amomum*, FACW) and broadleaf cattail (*Typha latifolia*, OBL). The vegetation observed within this wetland meets the Rapid Test for Hydrophytic Vegetation. Hydrophytic vegetation is dominant within this wetland.

The soil test pit identified two soil horizons. The first soil horizon from 0-2 inches had a matrix color of 5Y 3/1 (80%) with redox features the color of 7.5YR 4/4 (20%) and a silt loam texture. The second soil horizon from 2-18 inches had a matrix color of 10YR 5/1 (70%) with redox features the color of 10YR 5/6 (30%) and a clay loam texture. The soil matrix colors and features indicate this is a hydric soil. Hydric soil indicators observed within this wetland meet the description of *Indicator F3: Depleted Matrix*.

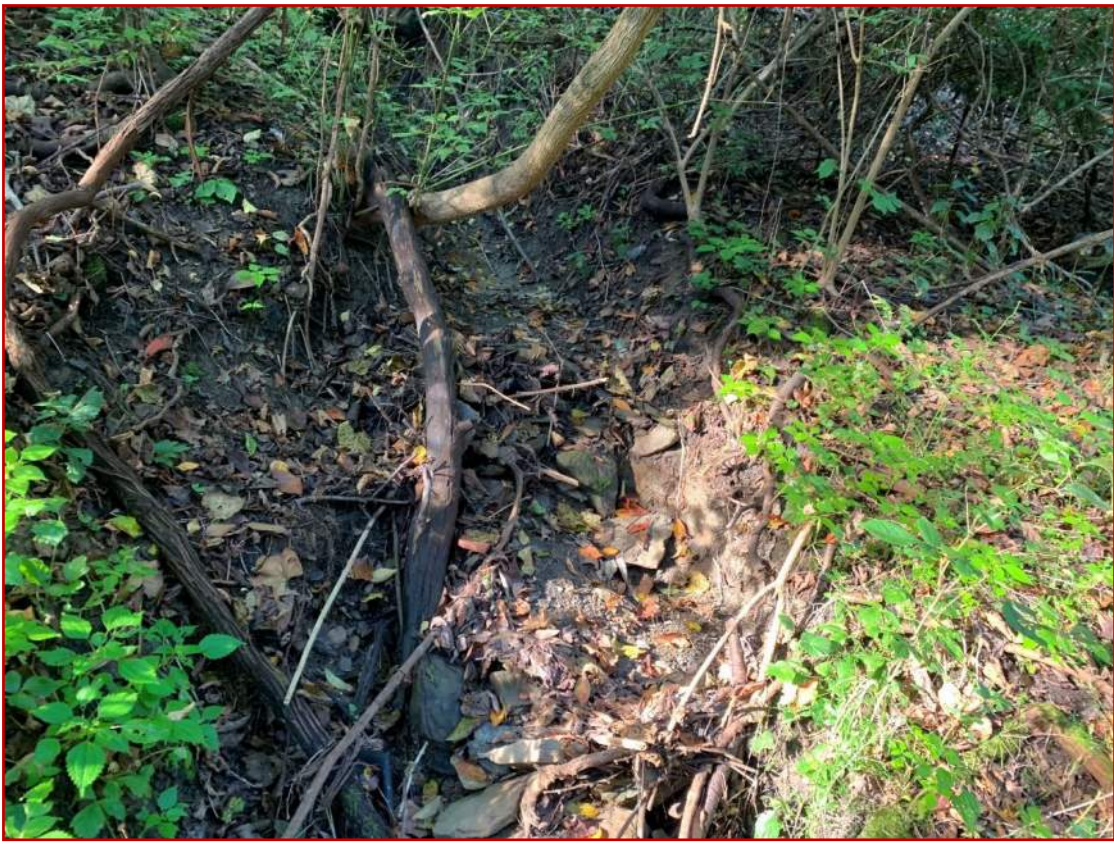
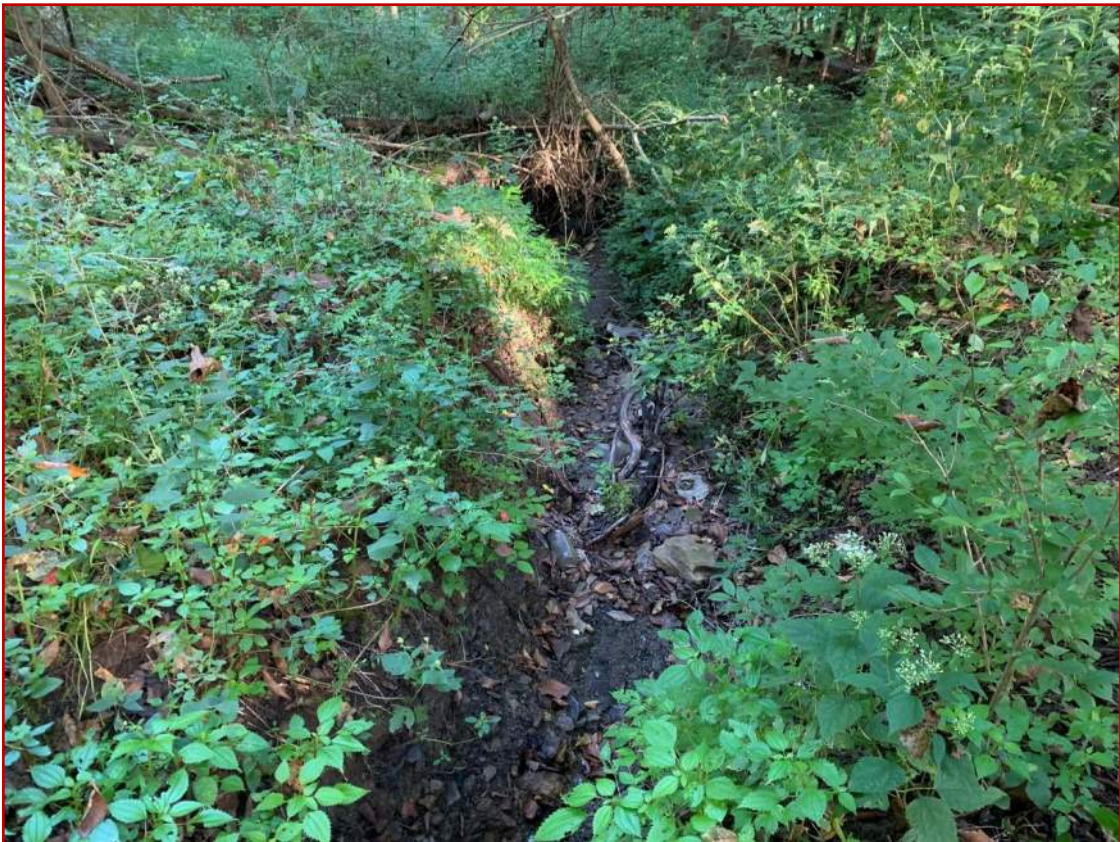
Photo 17: UNT 1 to Brush Creek – Facing Upstream (9.5.19)

Photo 18: UNT 1 to Brush Creek – Facing Downstream (9.5.19)

UNT 1 to Brush Creek (21275) is an ephemeral channel located on the eastern side of the project area. UNT 1 to Brush Creek flows in a northern direction through the project area. The bank width for UNT 1 to Brush Creek is approximately 3-feet and the channel depth is 2-feet. UNT 1 to Brush Creek did not have water present at the time of investigation. The substrate in the channel consists of a mixture of gravel (40%), cobble (20%), sand (15%), silt (15%), boulders (5%), and detritus (5%) with 20% embeddedness. No macroinvertebrate orders were observed during the field view. No fin fish species were observed.

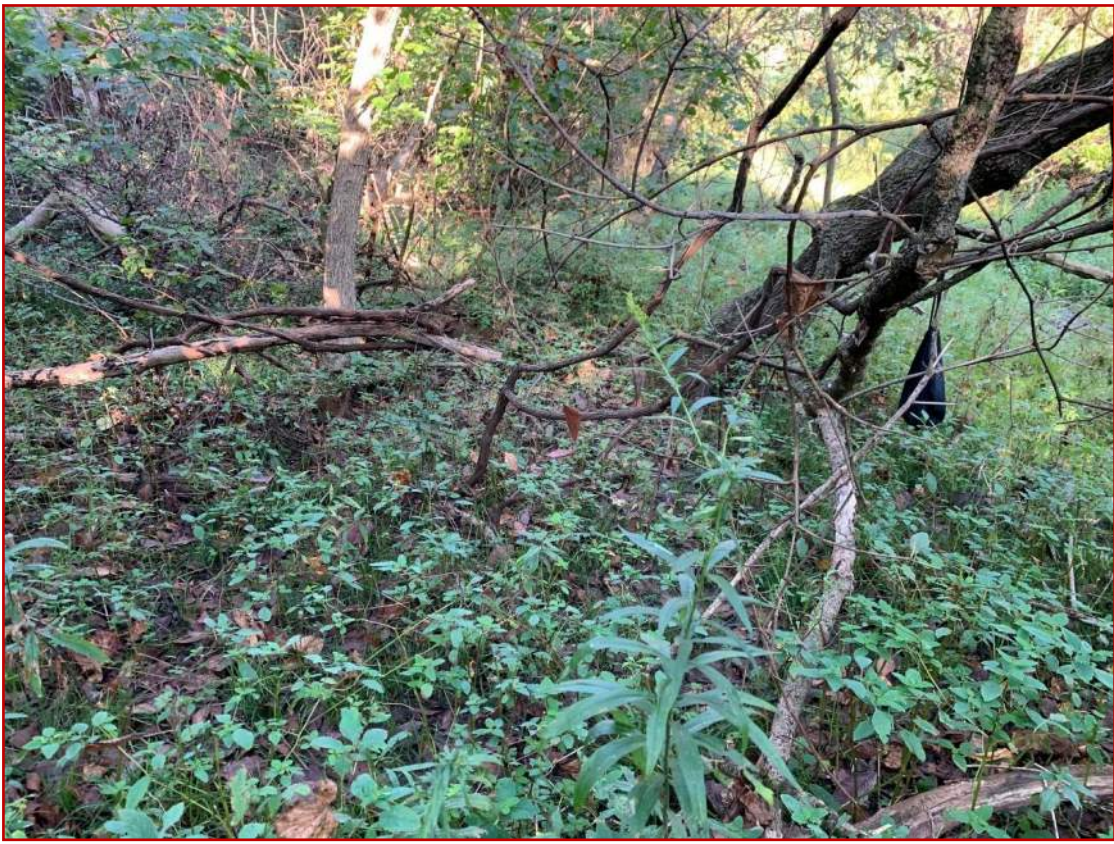
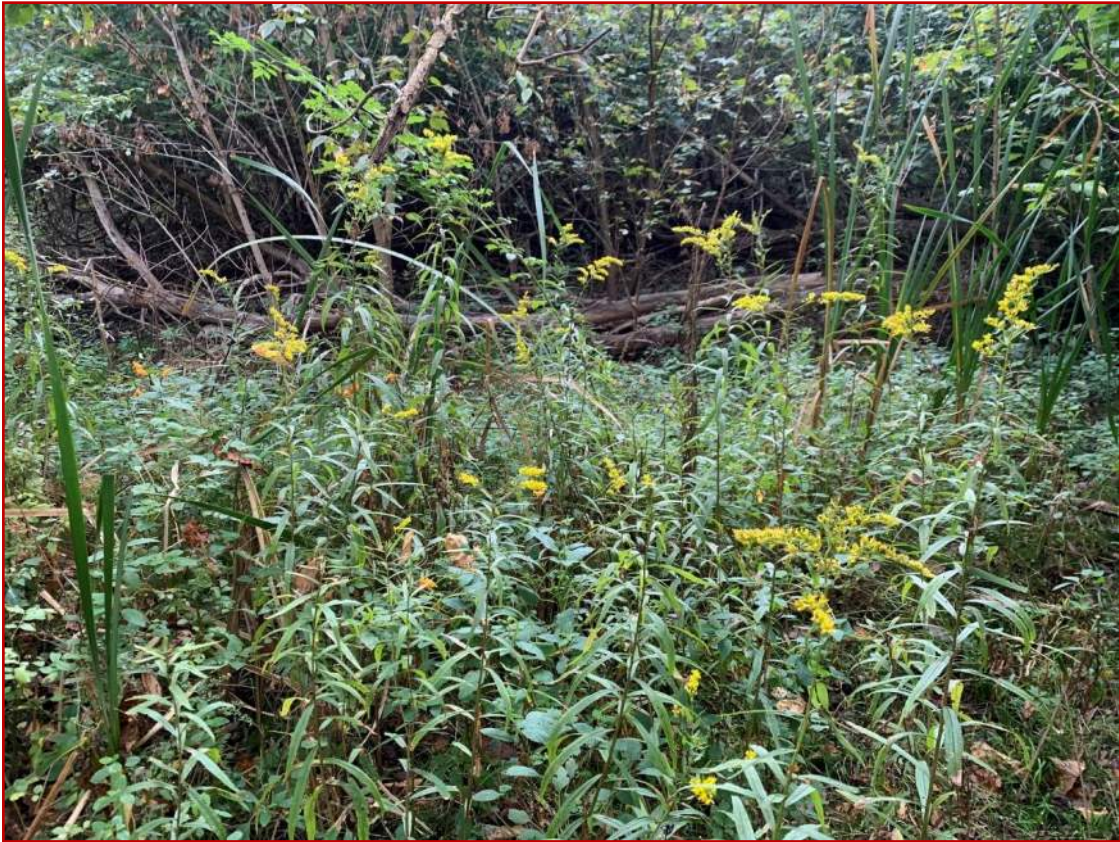
Photo 19: Wetland WL3 – Facing North (9.17.19)

Photo 20: Wetland WL3 – Facing East (9.17.19)

WL3 is classified as a PEM wetland located entirely within the project area and is approximately 0.03 acres in size. The primary wetland hydrology indicator observed within this wetland is saturation. Wetland hydrology is present within WL3.

Dominant vegetation observed within this wetland includes quaking aspen (*Populus tremuloides*, FAC) and jewelweed (*Impatiens capensis*, FACW). The vegetation observed within this wetland meets the Dominance Test. Hydrophytic vegetation is dominant within this wetland.

The soil test pit identified two soil horizons. The first soil horizon from 0-8 inches had a matrix color of 2.5Y 3/1 (80%) with redox features the color of 10YR 4/6 (20%) and a clay loam texture. The second soil horizon from 8-18 inches had a matrix color of 10YR 4/1 (90%) with redox features a color of 10YR 4/4 (10%) and a clay loam texture. The soil matrix colors and features indicate this is a hydric soil. Hydric soil indicators observed within this wetland meet the description of *Indicator F3: Depleted Matrix*.
