Wetland and Surface Water Delineation Report

**US 30 Corridor Improvements - Western Section
North Versailles and North Huntingdon Townships
Allegheny and Westmoreland Counties, Pennsylvania**

**Engineering District 12-0
825 N. Gallatin Ave. Ext.
Uniontown, PA 15401**

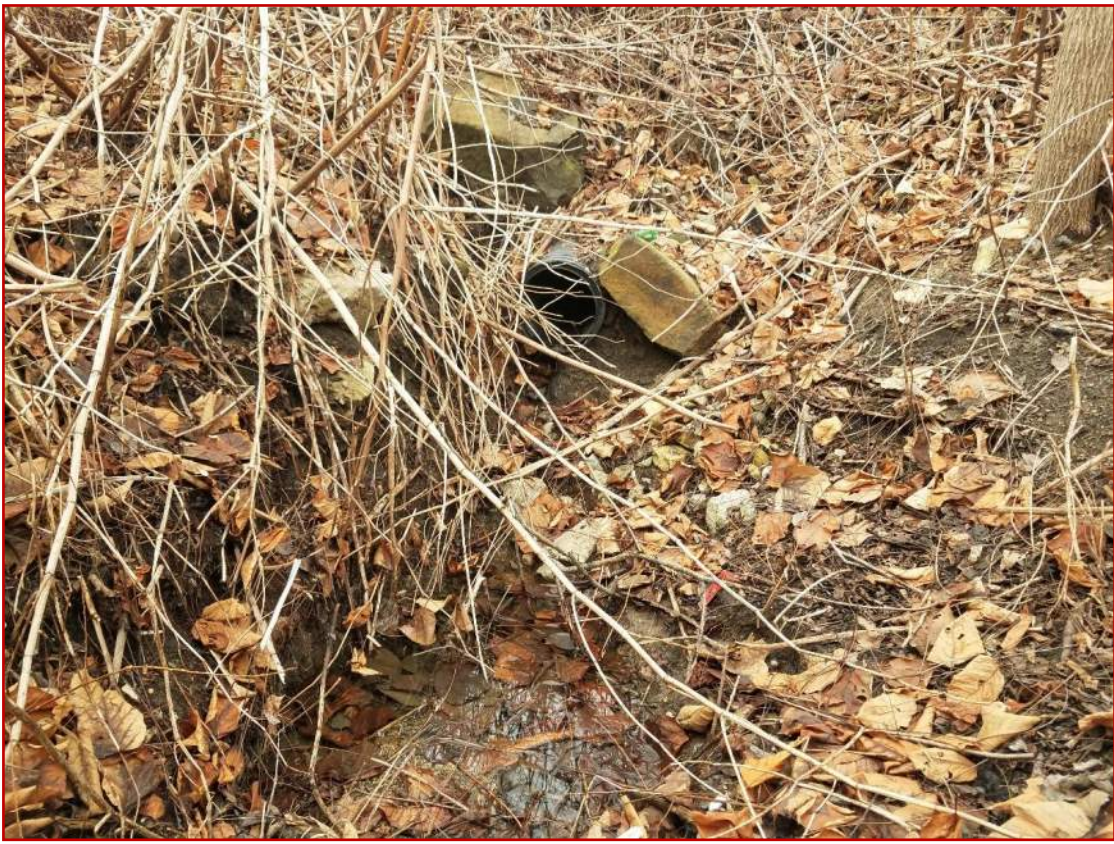
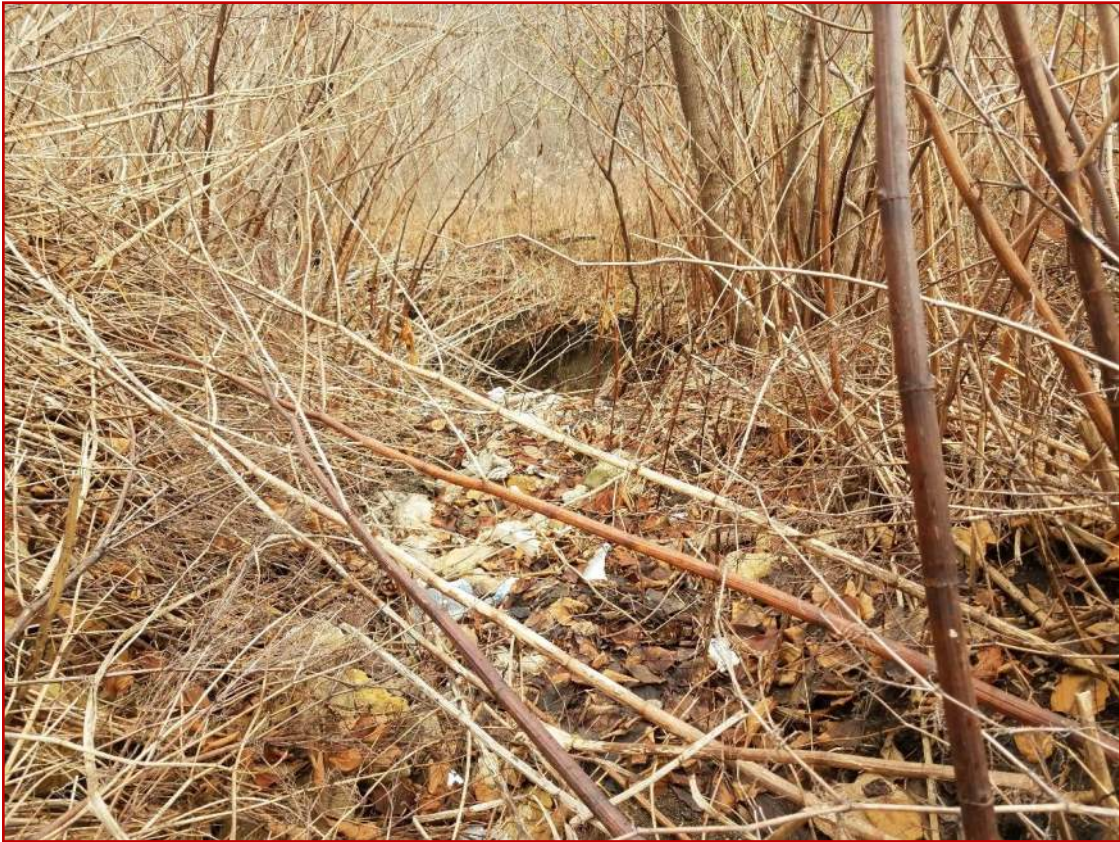
Photo 21: UNT 3 to Brush Creek – Facing Upstream (12.6.19)

Photo 22: UNT 3 to Brush Creek – Facing Downstream (12.6.19)

UNT 3 to Brush Creek (21275) is an ephemeral channel located on the eastern side of the project area. UNT 3 to Brush Creek flows in a northeastern direction on the eastern edge of the project area. The bank width for UNT 3 to Brush Creek is approximately 3-feet and the channel depth is 2-feet. UNT 3 to Brush Creek had a water depth of 2-inches and a water width of 2-feet at the time of investigation. The substrate in the channel consists of a mixture of cobble (30%), boulders (20%), clay (20%), gravel (20%), and sand (10%) with 20% embeddedness. No macroinvertebrate orders were observed during the field view. No fin fish species were observed.
