Azure Estates HOA

Level 2 Reserve Study

Report Period - 1/1/2019 to 12/31/2019

Executive Summary - Azure Estates HOA - ID # 10955

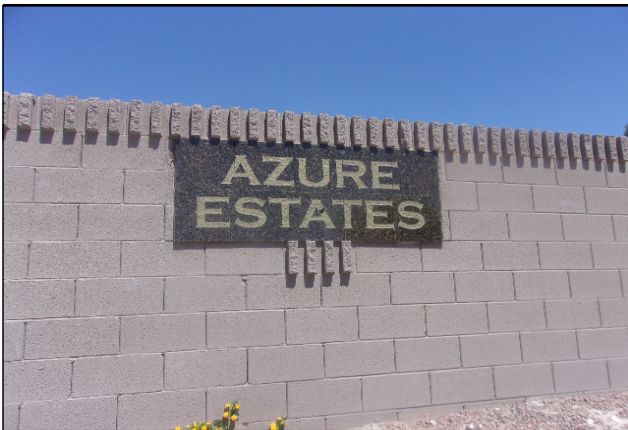
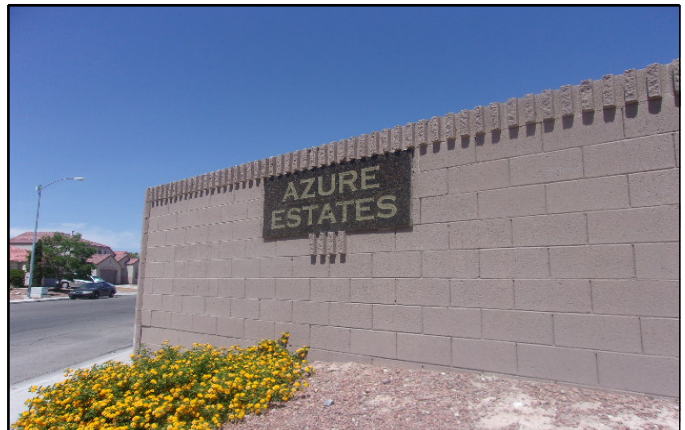
Comp # 801 Monument Signs - Replace

Location: Entrances to community

Quantity: (5) Monument Signs

Monument signs are in good condition. We recommend funding to replace these monuments approximately every 15 to 20 years.

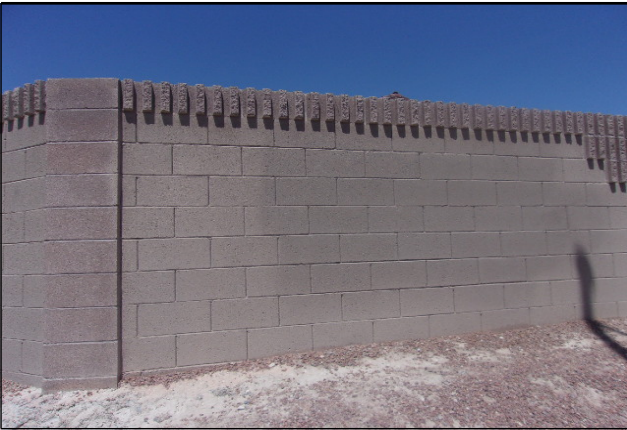
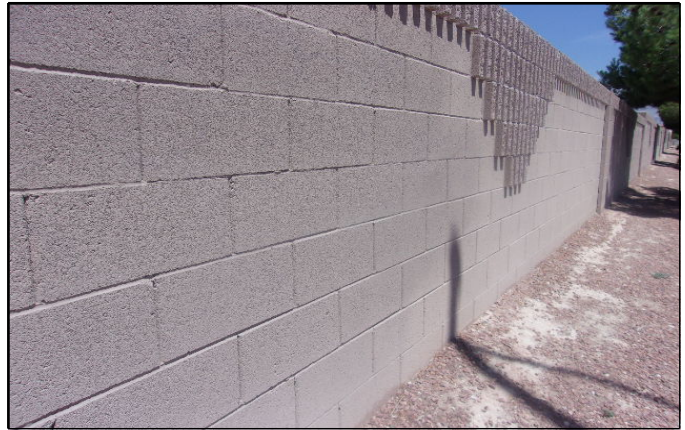
Comp # 1005 Block Wall - Repair

Location: Common Area

Quantity: Approx 3,660 Linear ft.

No expectation to completely replace walls. Expect to make local repairs as necessary as an operating expense and funding for an allowance to make more significant repairs approximately every 20 years.

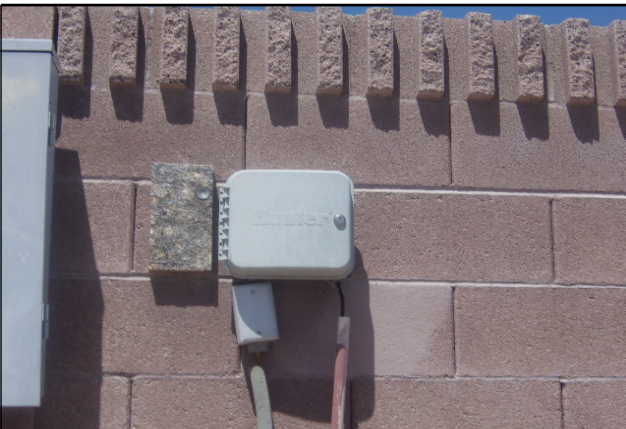
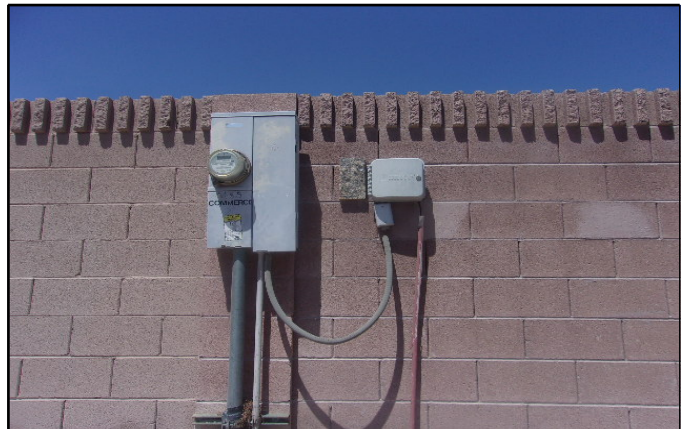
Comp # 1701 Irrigation System - Refurbish

Location: Common Area

No problems with the irrigation system reported. No expectation to completely replace this system. We recommend funding for an allowance to replace any individual components as well as generally update and refurbish this system approximately every 10 years. Remaining useful life based on current age and condition.

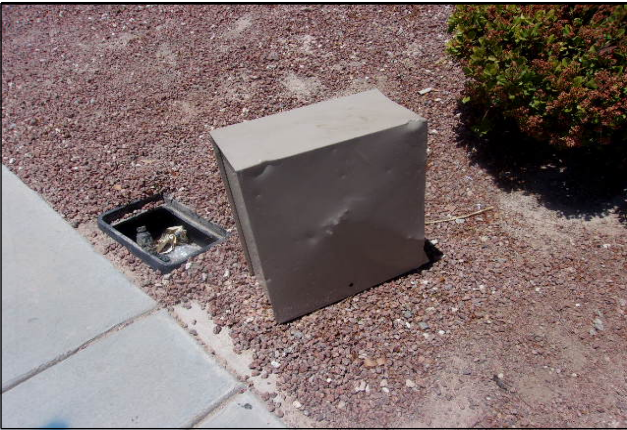
Comp # 1706 Backflow Devices - Repair/Replace

Location: Common area

No problems noted or reported with the backflow devices. No expectation to replace all the devices at the same time. We recommend funding to replace one valve approximately every four years.

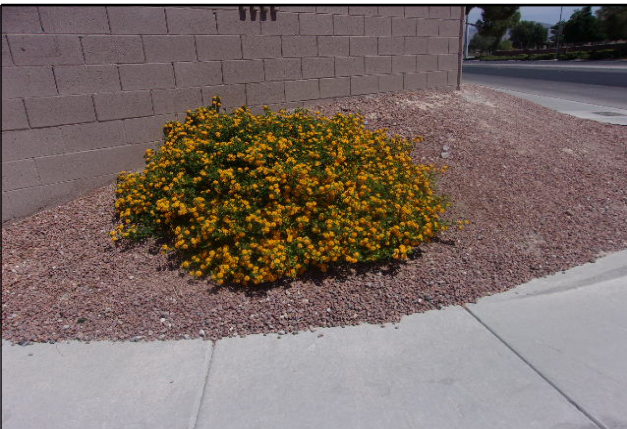
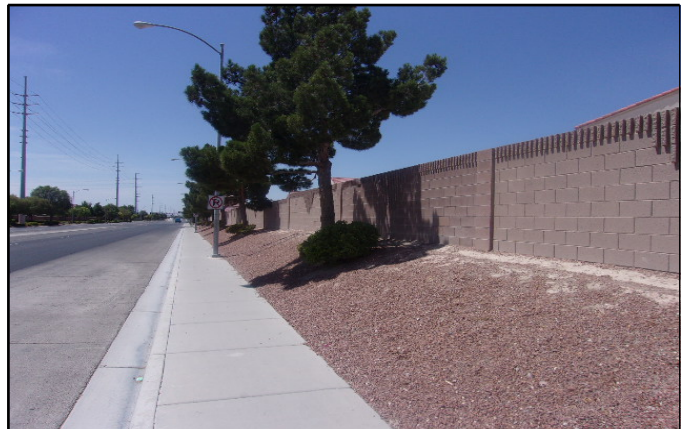
Comp # 1812 Landscaping - Renovate

Location: Common Area

No expectation to completely replace the landscaping. We recommend funding for an allowance to generally refurbish the landscaping, make local tree replacements, and make upgrades to the irrigation system and landscape lighting approximately every 5 years. Replace irrigation clocks, valves, etc. as necessary as an operating expense.
