REPLACE FRONT BEARING ON 2023 & NEWER BC-8, 15 & 25 ROASTERS

IF YOUR FRONT BEARING BEGINS TO MAKE NOISES WHEN DRUM IS TURNING (IF HEATED OR COLD) YOU SHOULD CHECK FRONT BEARING & GREASE IF NEEDED. IF NOISE PERSISTS EVEN AFTER GREASING HERE ARE INSTRUCTIONS ON REPLACING BEARING:

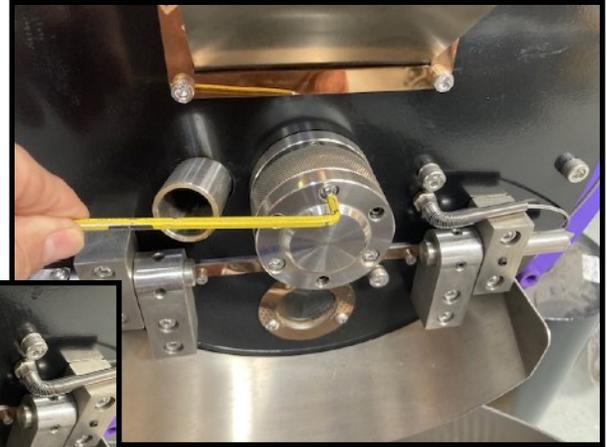
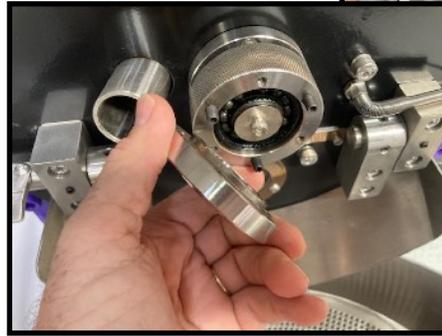
1. REMOVE FRONT BEARING COVER

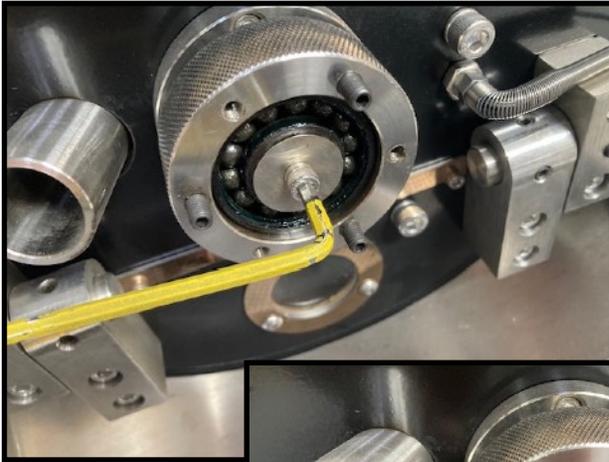
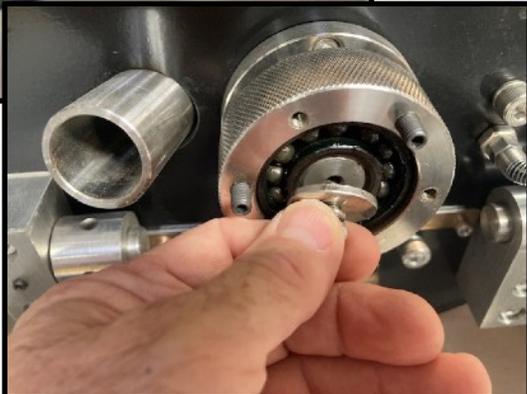
2. REMOVE FRONT CAP

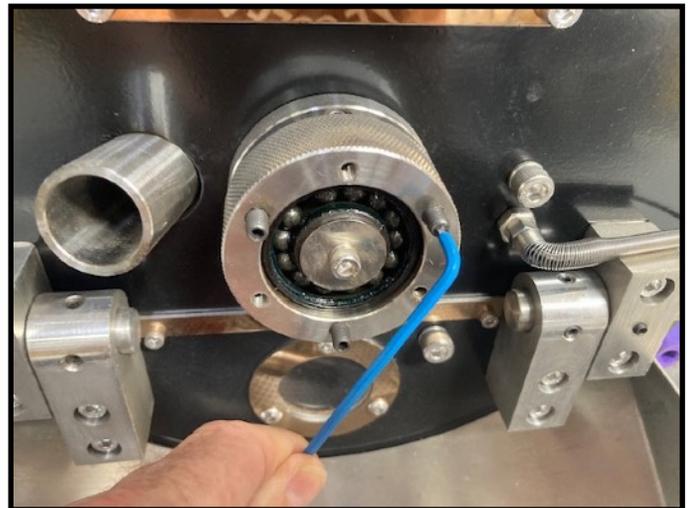
3. LOOSEN BUT DON'T REMOVE SET SCREWS

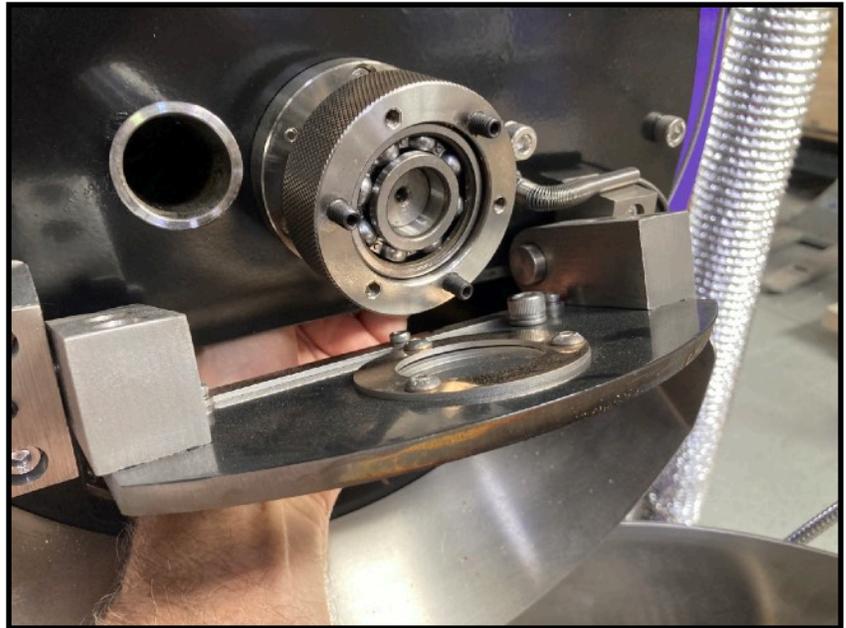
4. UNSCREW COUNTER CLOCKWISE HOLDER: YOU MAY NEED HOLD UP DRUM SHAFT FROM INSIDE DRUM WHILE REMOVING & REINSTALLING HOLDER

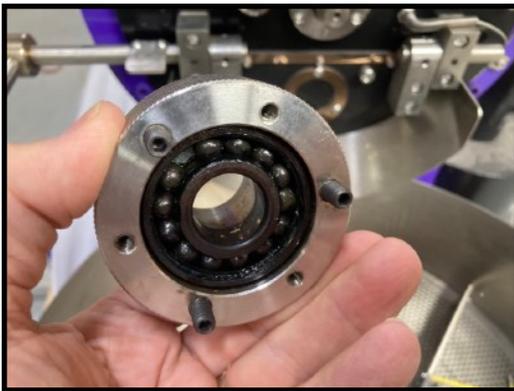
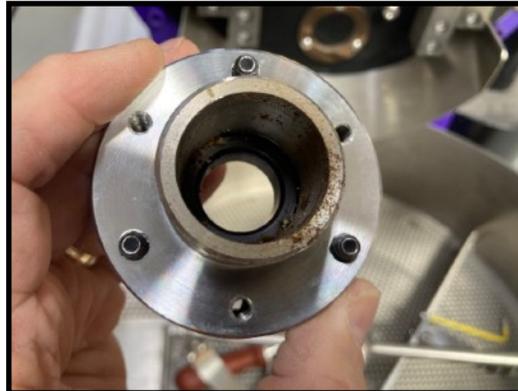
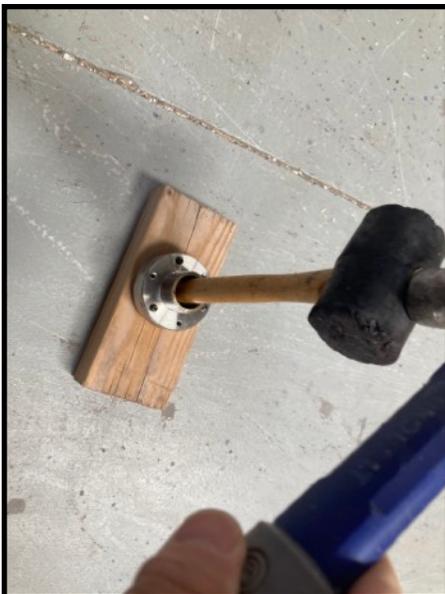
5. AFTER REMOVED PREPARE TO REMOVE OLD BEARING FROM HOLDER BY TAPPING IT OUT

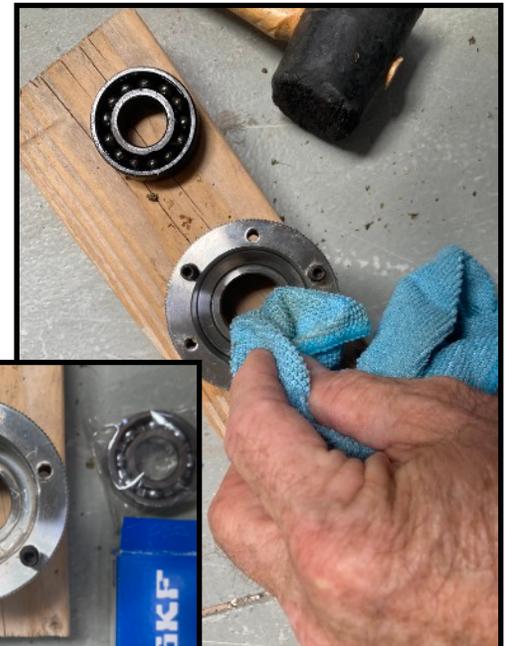
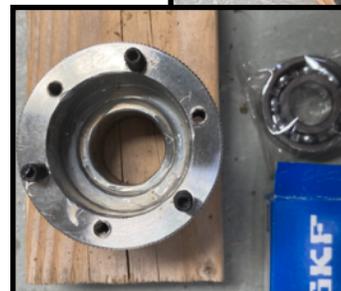
6. SET HOLDER ON A BLOCK OF WOOD AND USING A WOOD HANDLE OR WOOD DOWEL ROD TO TAP OLD BEARING OUT OF HOLDER

7. CLEAN INSIDE HOLDER & APPLY A THIN LAYER OF GREASE INSIDE COVER

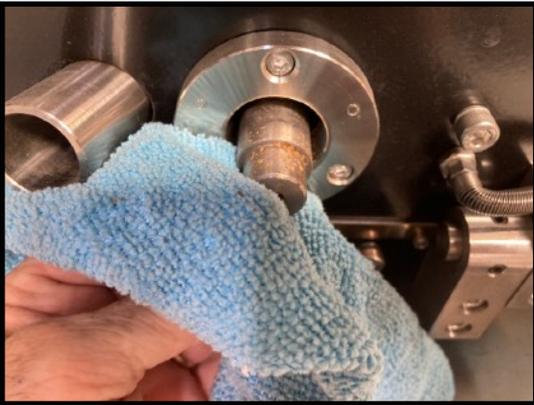
8. CLEAN DRUM SHAFT OF DEBRIS. IF YOU LIKE YOU CAN PUT A THIN COATING OF GREASE ON SHAFT

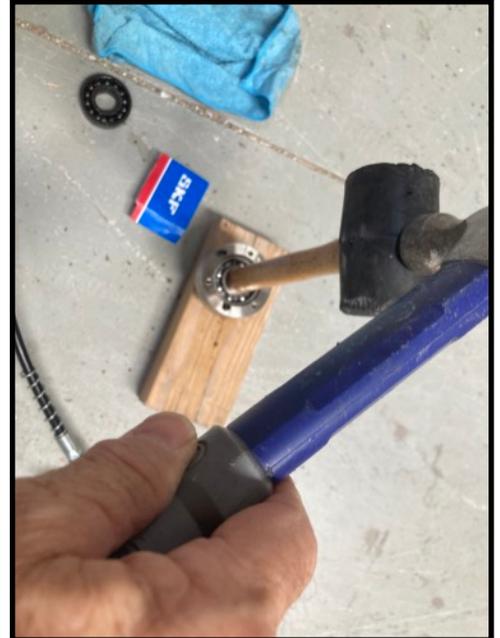
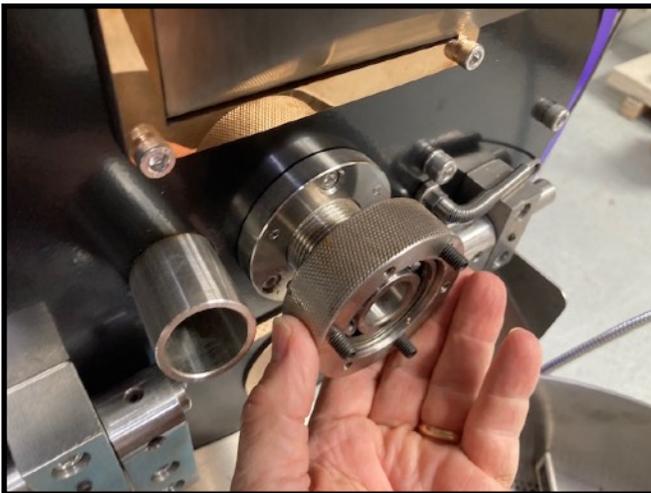
9. INSTALL NEW BEARING INTO HOLDER TAPPING IT INTO PLACE

10. REINSTALL BEARING IN BEARING HOLDER TURNING CLOCKWISE. (YOU MAY NEED TO LIFT DRUM SHAFT UP TO SCREW HOLDER IN COMPLETELY

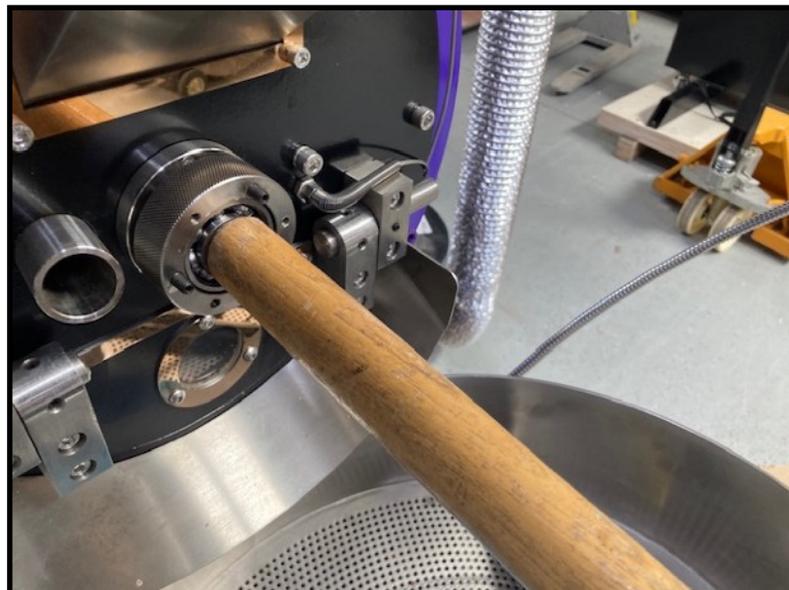
11. IF NEEDED YOU MAY TAP BEARING FURTHER INTO HOLDER IF NOT FULLY INSERTED

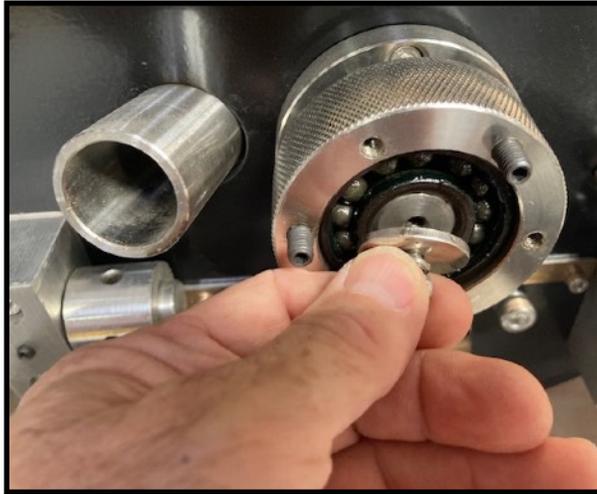
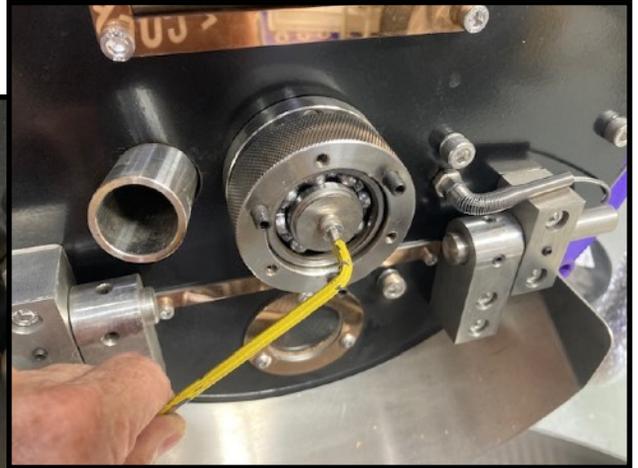
12. REINSTALL CAP OVER BEARING

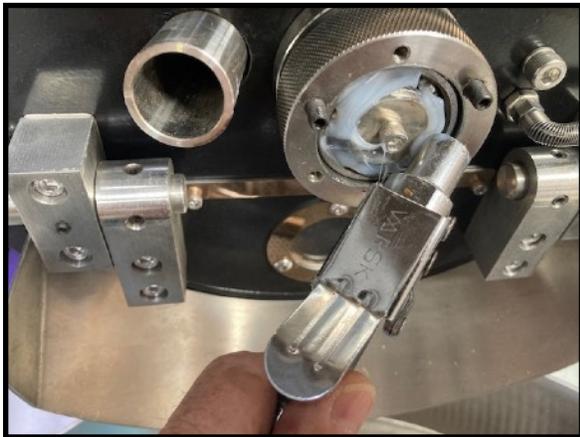
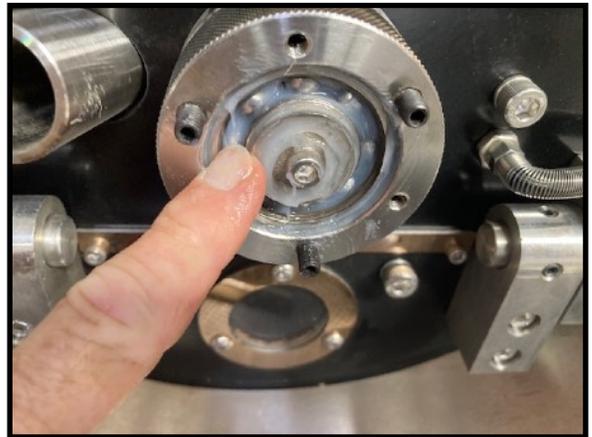
13. GREASE NEW BEARING

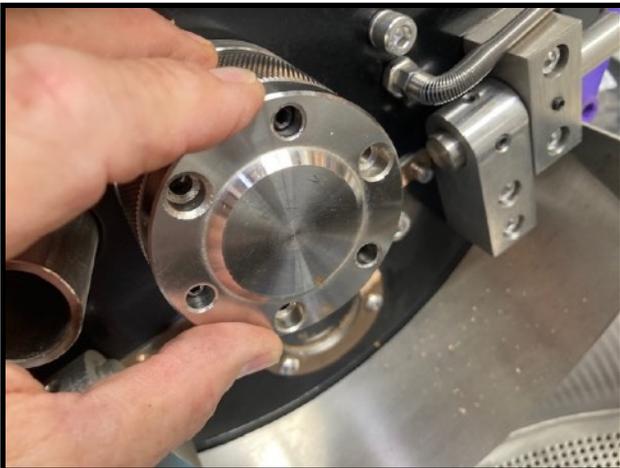
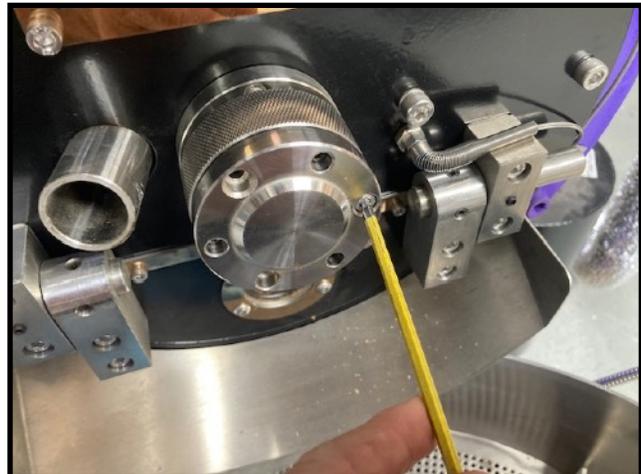
14. REINSTALL COVER & ADJUST SET SCREWS AS NEEDED. THEN RUN ROASTER DRUM IN BOTH COLD AND A HEAT TEST TO
