Report: cf14g105

Confidential Inspection Report

123 Any Street, Nantucket, MA 02554

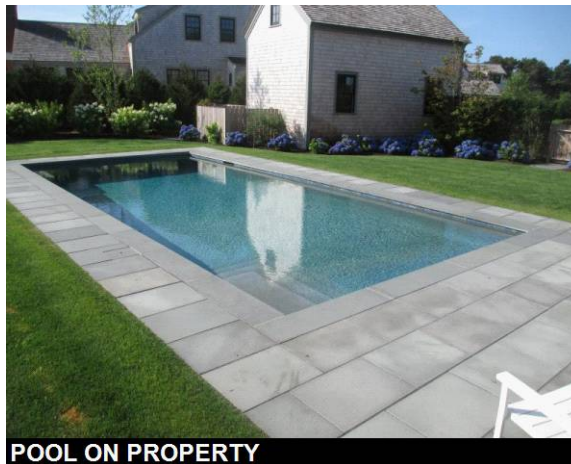
POOL ON PROPERTY

Recommendation: You should review all data regarding the age of the pool components, opening & closing procedures and general maintenance requirements with the owner **NOW**. You should consult a qualified pool professional for evaluation of the pool surroundings, systems and components before the expiration of the inspection contingency period. If the pool is in a closed or in a seasonal **shut-down** condition, you should inform your attorney and discuss options regarding your financial protection until such time as the pool can be seasonally evaluated.

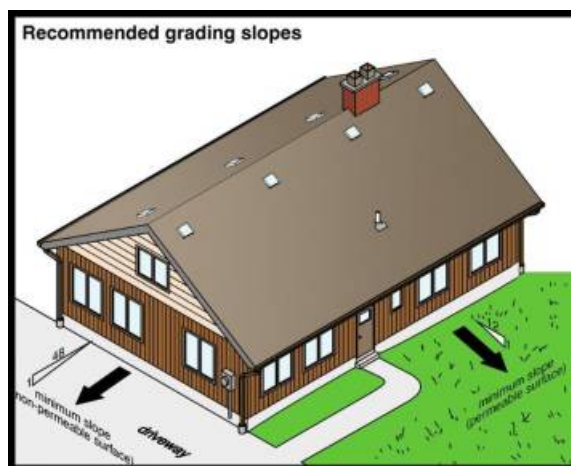
DRAINAGE PROBLEMS:

Observation: There is evidence of "**reversed grading**" along the perimeter of the foundation at: The front inside corner of the house

Analysis: Reversed grading means that the yard, gardens, walks, patio or driveway have an improper pitch that directs and

retains surface water and roof drainage water near the foundation, rather than away from it. When excessive water soaks into the ground near the foundation there is a risk of wet basement or wet crawl space problems, interior water damage and mold. Repair is needed.

Recommendation: You should ask a landscape contractor or an engineer to design a "**water management plan**" designed to remove surface water and roof water from the property. You would be wise to complete this research **NOW** in order to determine the impact on your budget.

- Elevating the earth along the foundation to create a positive grade away from the home.
- Lowering the elevation of the yard to create a positive grade away from the home.
- Installing a French drain along the foundation to a gravity outlet.

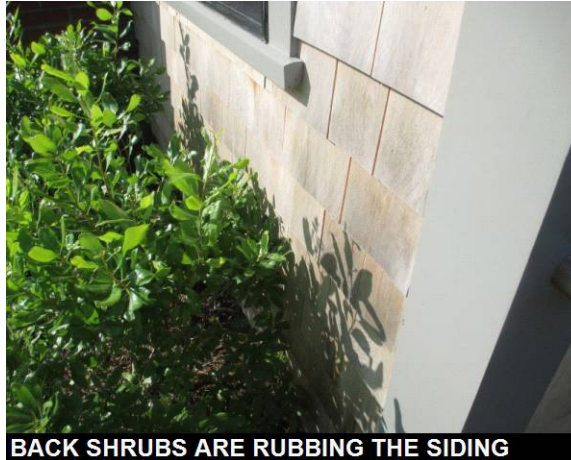
Observation: The shrubs along the perimeter of the foundation are in contact with the home.

**BACK SHRUBS ARE RUBBING THE SIDING**

Recommendation: You should hire a landscaper to prune, remove or replace the shrubbery as required to provide a working clearance (24") between the shrubs and the home. Once the problem is corrected, the foundation, basement windows and lower siding & trim should be re-inspected for defects that were **obstructed** at the time of inspection. Be advised that major trees should be at least 20 feet from the home to prevent storm damage and siding and trim should have a minimum 6" clearance from the soil. **WARNING** - be on alert for hidden bees nests. If through your negotiations access becomes possible, components become **readily accessible**, repairs are done or systems are restored, you may desire to schedule a "return visit" inspection with this office, at an additional charge, prior to purchase.

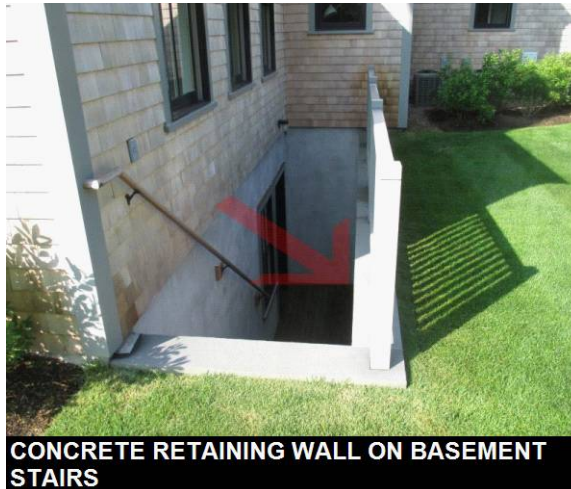
**CONCRETE RETAINING WALL ON BASEMENT STAIRS**

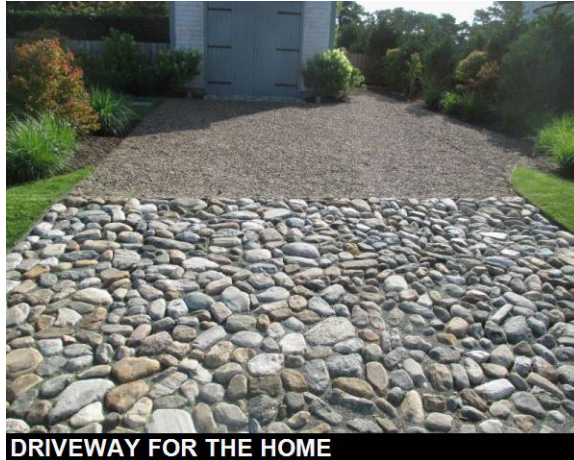
DRIVEWAY FOR THE HOME

Gravel with a cobble stone apron (Note: Gravel driveways present seasonal problems with gravel migration, rutting and snow removal. Consider optional updating to asphalt. Seek estimates if desired.) Web Resource:

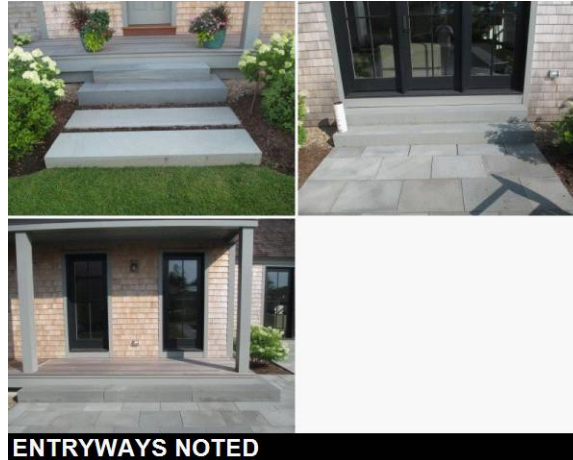
Stone steps & stoop missing hand rail. Add hand rail for safety if there are more than 3 risers or if the platform is more than 30 from the ground.

Recommendation: You should hire a licensed and insured contractor to install a handrail **NOW** for safety.

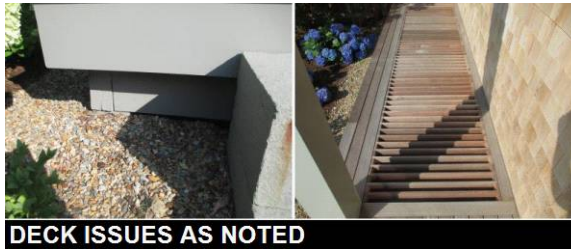
DECK ISSUES AS NOTED

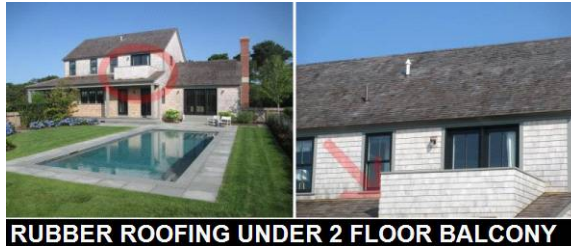
Analysis: The true condition of the roof covering at this area is undetermined.

Recommendation: Further close up or on-roof inspection is advised.

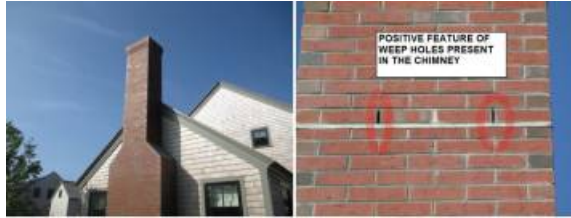
Brick chimney with a suspected clay lined flue where **readily accessible** only.

(Note: The presence of a flue liner and the condition of the interior of the chimney are undetermined. A Level 2 inspection of the interior chimney is advised during every real estate transfer to ensure safety.)

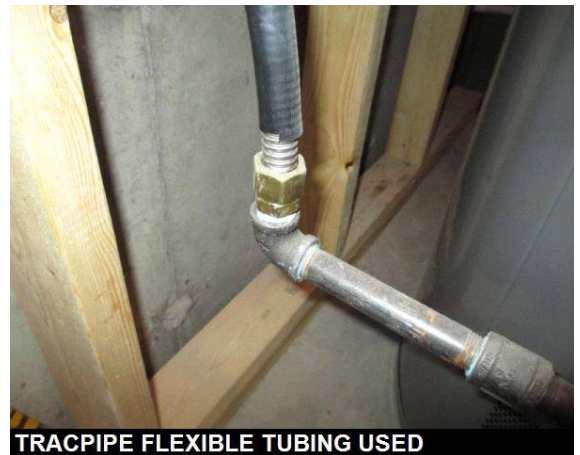
COMMENT: While bonding may not be required in MA, the Company advises that the TracPipe be bonded back to the main panel for security.

TRACPIPE FLEXIBLE TUBING USED

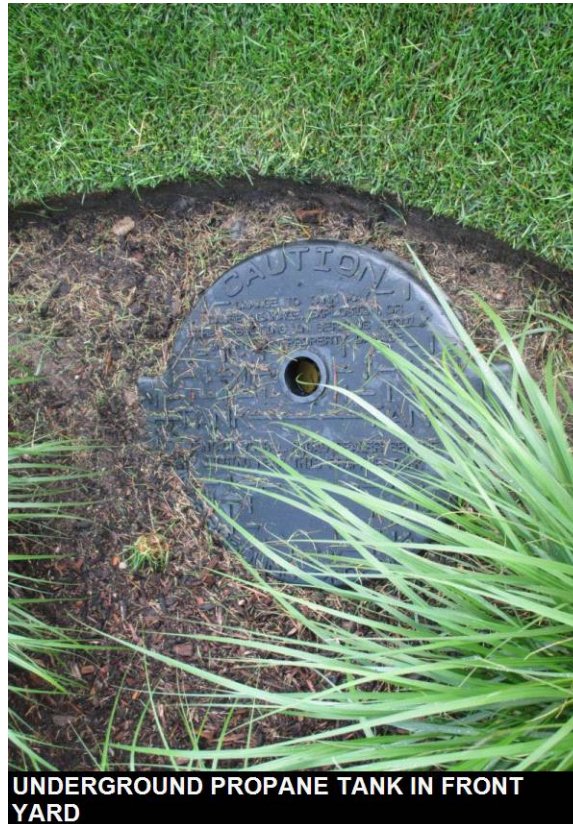
The main fuel shut-off valve is located at the outside propane tank(s). (Notice: You should ask the owner or his / her representative if the propane tank(s) is owned or rented.)

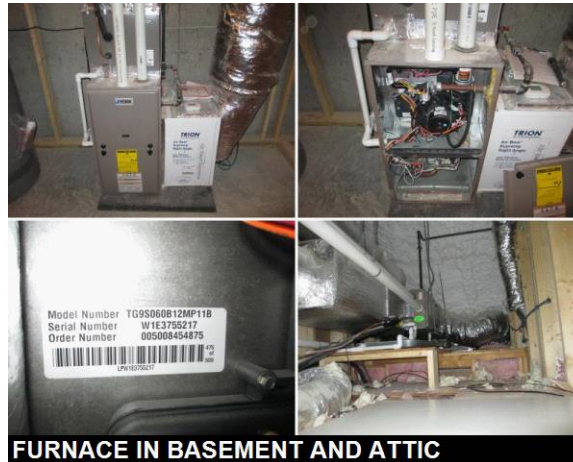
FURNACE IN BASEMENT AND ATTIC

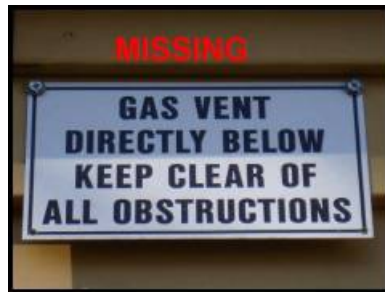
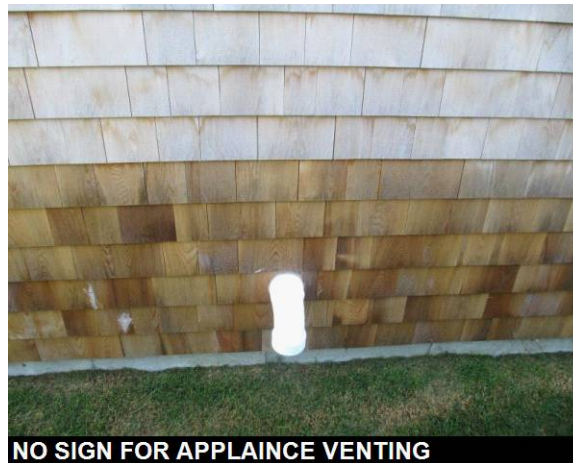
NO SIGN FOR APPLAINE VENTING

Recommendation: Install the required warning sign **NOW** for safety.

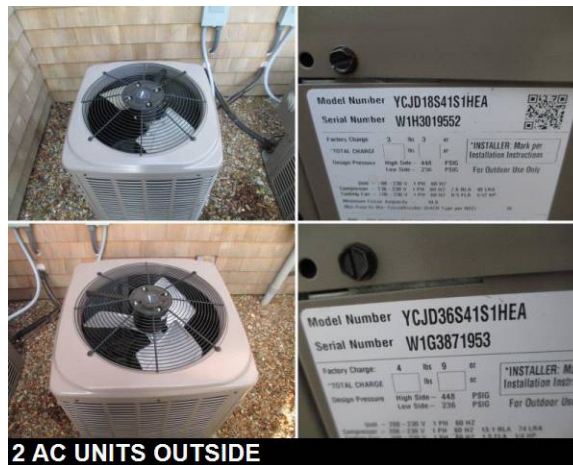
2 AC UNITS OUTSIDE

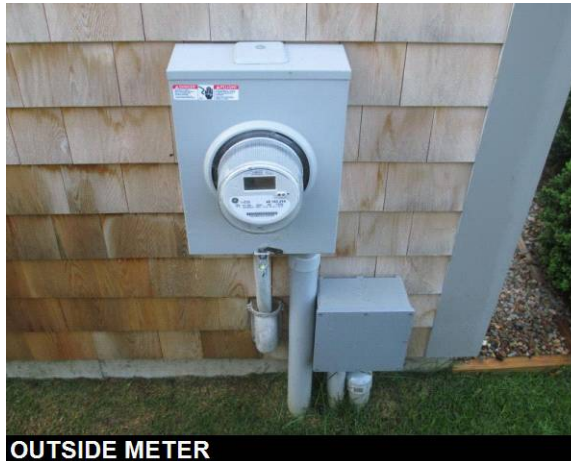
Observation: The home has an outside meter. (Note: The meter box belongs to the homeowner.)

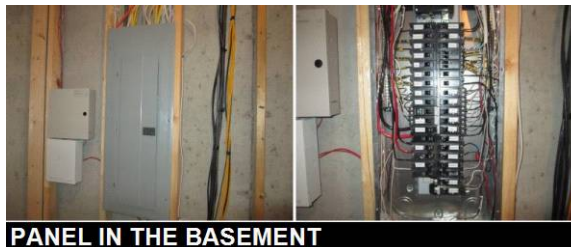
Basement.

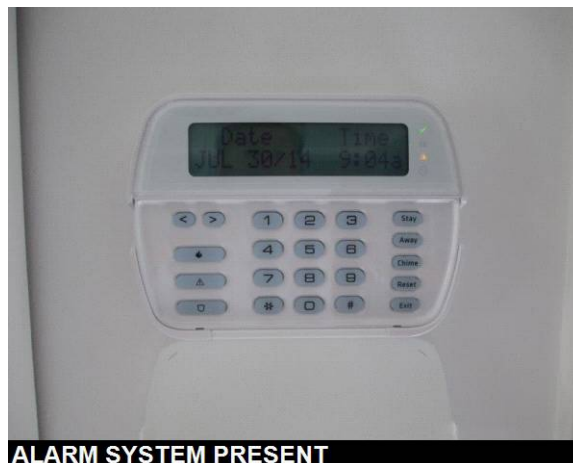
ALARM SYSTEM PRESENT

SECURITY ALARM SYSTEM PRESENT.

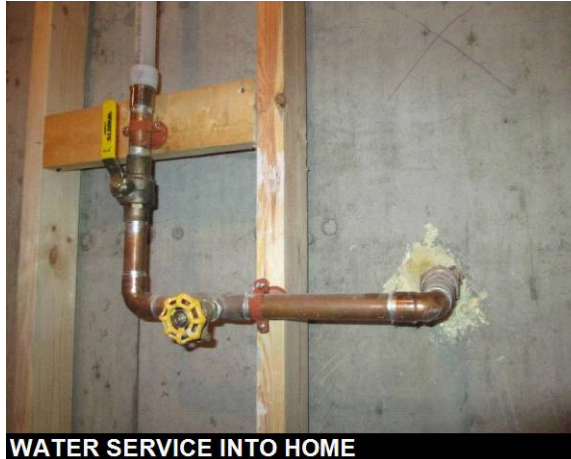
WATER SERVICE INTO HOME

Observation: A water meter indicates that the home has a public water service connection to a street main. NOTE: Massachusetts has a "**sunshine law**" that allows you to go to the water supplier and ask for a copy of the most recent water test near the home your are purchasing. The report does not necessarily indicate the quality of the water at the home site, but it may help in determining if a private filtration system is needed and what type of filtration may be helpful.

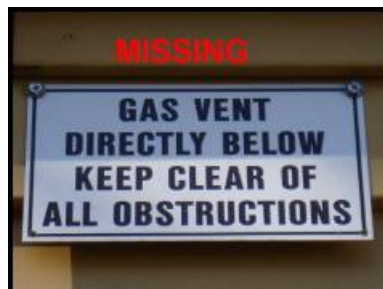
SAFETY ALERT: Outside wall vents can be blocked by snow, causing deadly carbon monoxide to backup into the home. When a vent is less than 7 feet above grade, a tag is required on the exterior side of the building at a minimum height of 8-feet above grade directly in line with the exhaust vent. The sign should read, in print size no less than 1/2 inch in size, **"GAS VENT DIRECTLY BELOW. KEEP CLEAR OF ALL OBSTRUCTIONS."**

Recommendation: Install the required warning sign **NOW** for safety. (See illustration)

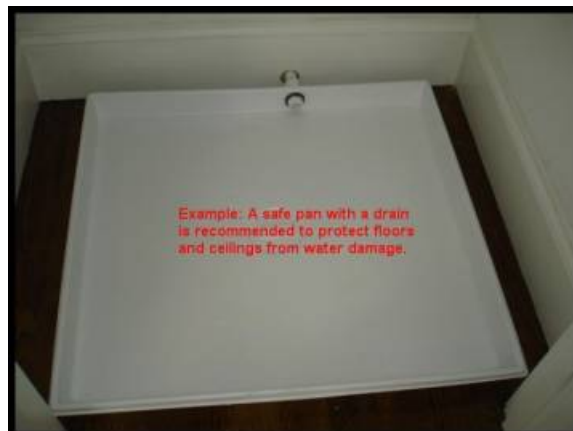
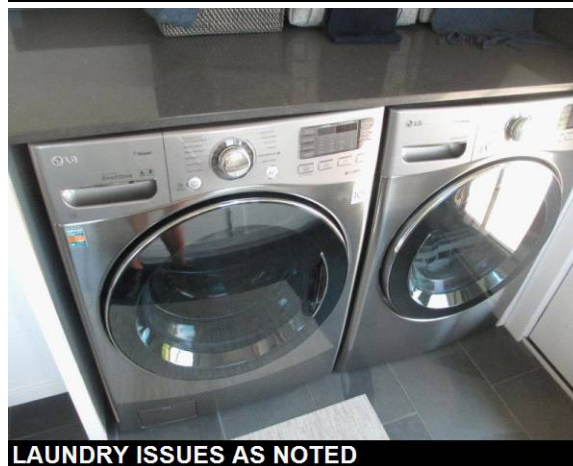
LAUNDRY ISSUES AS NOTED

Recommendation: While not required, you may want to hire a plumber to relocate the washing machine supply valves to simplify shutting them off and thereby preventing possible water damage. Braided stainless steel fill hoses are advised. Consult a plumber for a cost estimate as elected.

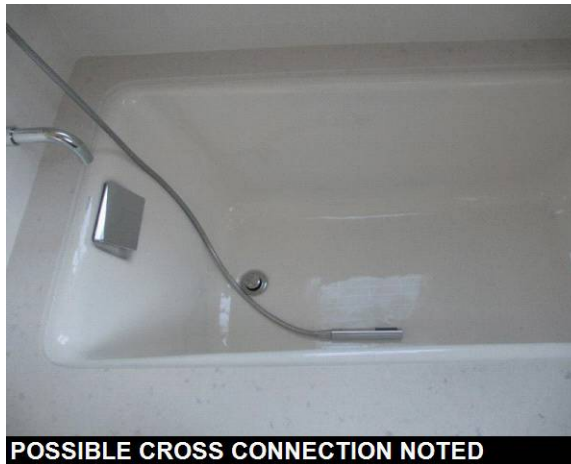
POSSIBLE CROSS CONNECTION NOTED

Recommendation: A plumber is needed to perform urgent safety repairs.

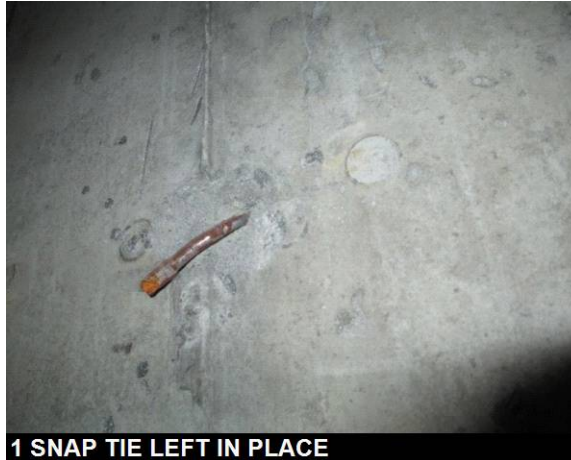
1 SNAP TIE LEFT IN PLACE

Recommendation: As a safety priority, I advise that all remaining exposed snap ties be removed and that the ends of each rod be sealed with hydraulic cement to retard water infiltration.

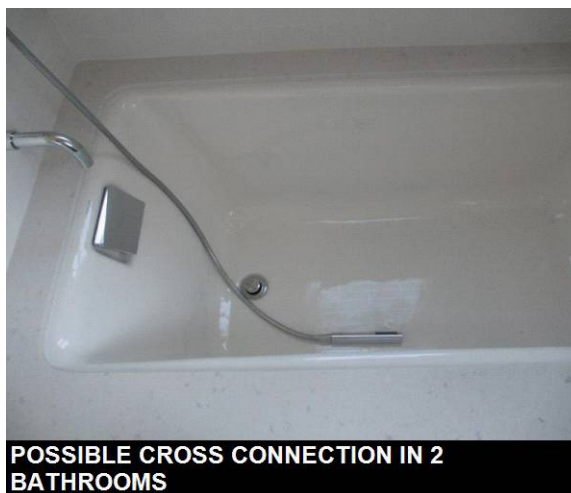
Analysis: This problem is called a "cross connection," as there is a risk of potable (clean water) mixing with non-potable (dirty) water and polluting the public water supply. In a neighborhood fire situation, backsiphonage (negative pressure) may occur when the fire department attaches hoses to hydrants. The backsiphonage can draw the dirty bath water into the handheld showerhead and water supply creating a sanitary hazard. Repair is needed.

Recommendation: I advise that a handheld showerhead with a shorter hose be installed or that the handheld showerhead be removed.

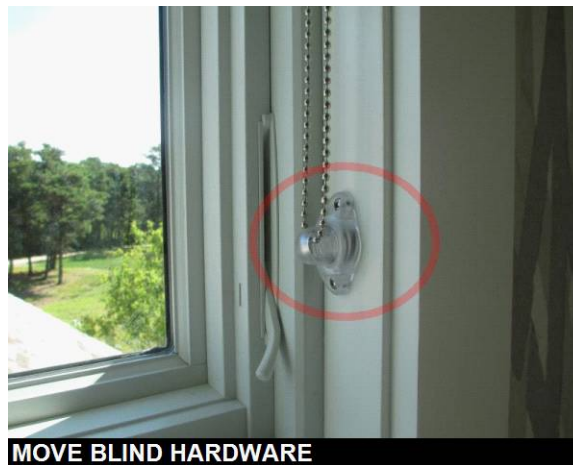
Analysis: Window trim repairs are needed.

Recommendation: You should hire a window contractor to provide a cost estimate for trim repairs or as needed to restore the smooth opening and closing function of each window. Seek a cost estimate **NOW** in order to determine the impact on your budget.

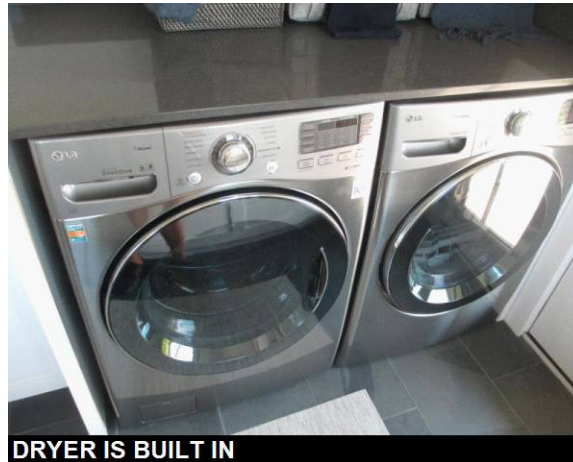
** **FUNCTIONAL with EXCEPTIONS noted:**

UNKNOWN AS THE DRYER IS INSTALLED INSIDE OF A BULTIN AREA. THE INSPECTOR WAS UNABLE TO VERIFY THE TYPE OF VENTING USED.

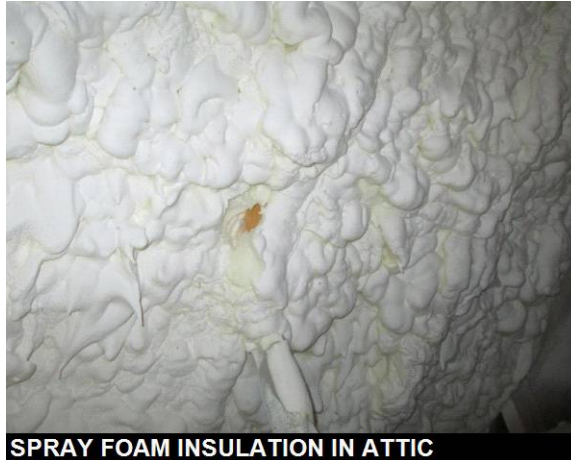
SPRAY FOAM INSULATION IN ATTIC
