8 POTENTIAL ISSUES ENCOUNTERED DURING INSTALLATION OF AIR AND WEATHER-RESISTIVE BARRIERS

Potential Issues Encountered During Installation of Air and Weather-Resistive Barriers

By Karl Schaack, RRC, PE

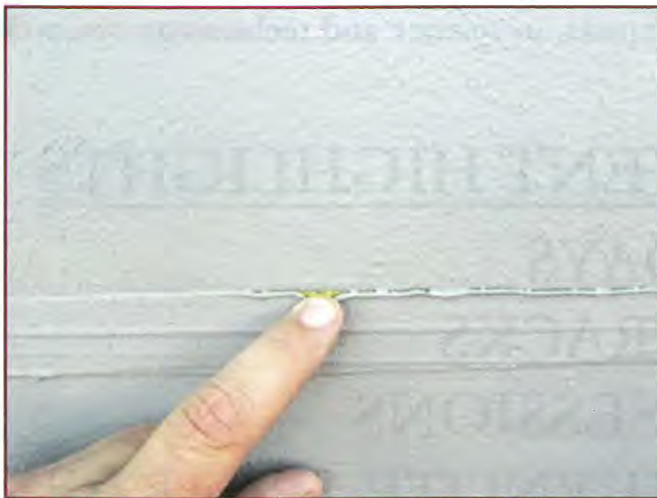
Figure 1 – Exposed face of sheathing along heavy build of sealant at joint.

result in heavy applications of the product with profiled (thick) edges, in lieu of feathered edges. When the fluid-applied air barrier is applied over the heavily treated joints—particularly during spray-applied applications—the heavy-build treatment can act as a shield, blocking the fluid from reaching the surface of the sheathing, unless the applicator takes the time to apply the material in a multidirectional method (Figure 1). Even during roller applications, the high-build edges can act as a bridge when the roller is brought across the material, and the sheathing facer—located directly along the sides of the sealant—does not receive a proper application of the fluid material.

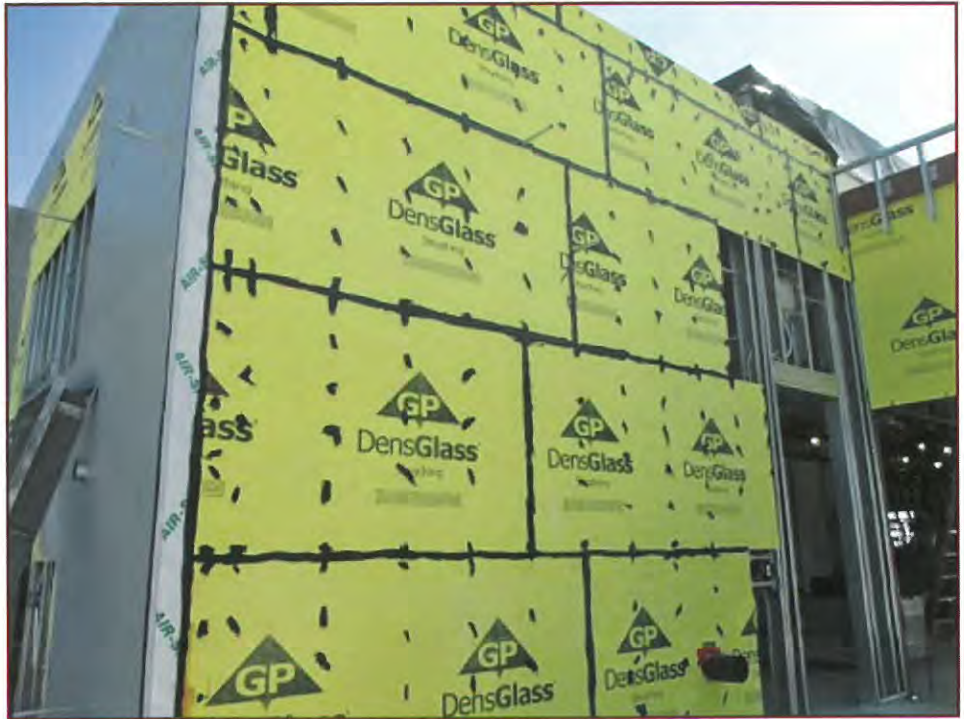
Pretreating heads of fasteners used to secure sheathing to framing is commonly recommended by air barrier manufacturers when the fastener is overdriven and fractures the fiberglass facer on the sheathing. Even when the fastener head is properly seated flush with the surface of sheathing, the formed indentations in the head of a Phillips screw can draw the fluid material down into the indentations, pulling the material from the screw head and resulting in small voids around the perimeter of the head (Figure 2). Since holes in the air barrier due to inconsistencies at fastener heads are found to be very prevalent, pretreating of each and every fastener head is highly recommended so as to alleviate judgment calls by the applicator on which specific fasteners need treatment. Furthermore, since sheathing joints are required to be pretreated, applying additional material over fastener heads at that same time does not involve significantly more time and material compared to the effort required to go back and search and identify voids at heads and then to perform respective repairs (apply additional material). See Figure 3.

Figure 3 – Pretreatment of sheathing joints and fastener heads.

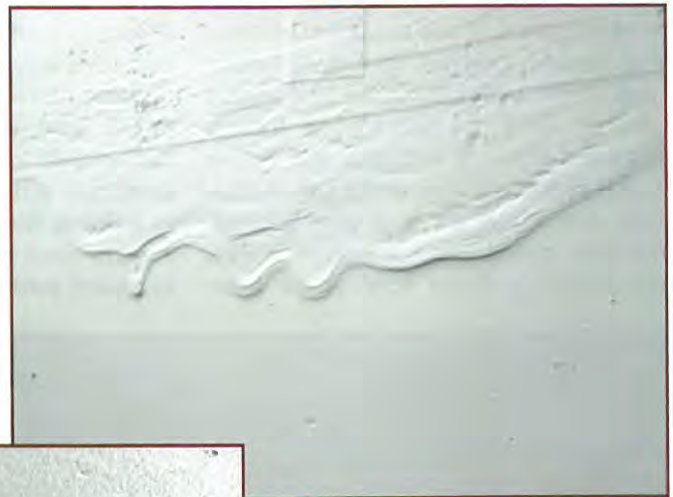
cause the material to become “heavy” and run or slough off of the substrate (Figure 4). Applying an inadequate amount of material will obviously result in a finished product that does not meet specifications or performance requirements. Spray equipment is often utilized by contractors for enhanced production during application. A condition observed with spray-applied products is the creation of “craters” in the applied barrier material (Figure 5). This condition occurs when globs or

Figure 4 – Sloughing of excessive application of fluid-applied air barrier.

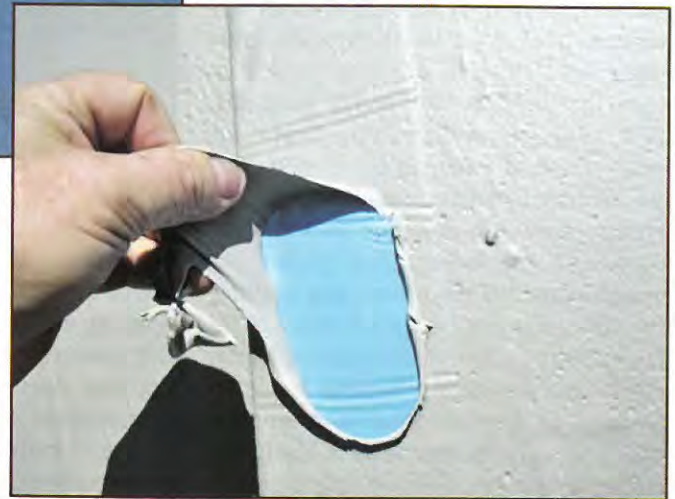
Figure 7 – Delamination of fluid-applied air barrier from transition membrane sheet.

without the use of primer applied onto the surface of the film. Without proper preparation, the fluid-applied air barrier can easily be peeled off of the sheet membrane (Figure 7). Another material option to enhance the opportunity to achieve proper bond of the air barrier could involve the use of a transition membrane with a metallic-film (aluminum or stainless steel) facer, in lieu of the polyethylene-faced membrane, so that the fluid-applied material will readily bond to the metallic face.

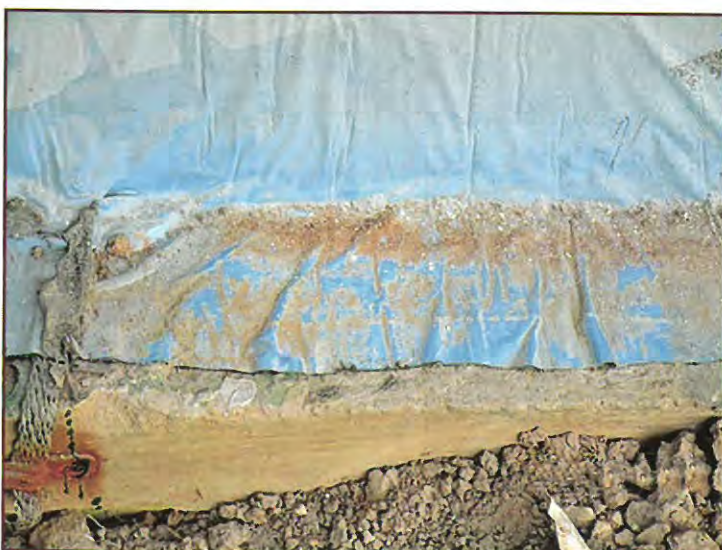
Gypsum Sheathing.”² Sheathing soiled with dirt or other contaminants does not provide a good substrate for achieving proper adhesion of the air barrier. During new construction projects, sheathing that is installed on exterior walls of a building will commonly become contaminated with dirt along the base of the wall due to wet weather and exposed soil conditions. Water that drains freely from the structure and down to the ground can result in splashing of muddied water and dirt up onto the surface of sheathing. This results in an unsatisfactory substrate to receive an air barrier/WRB (Figure 8). Improperly stored sheathing or over-exposure after installation on new construction sites are other common events that result in contaminated products resulting in undesirable conditions to receive applications of new air barriers.

Figure 8 – Soil-contaminated base of wall.

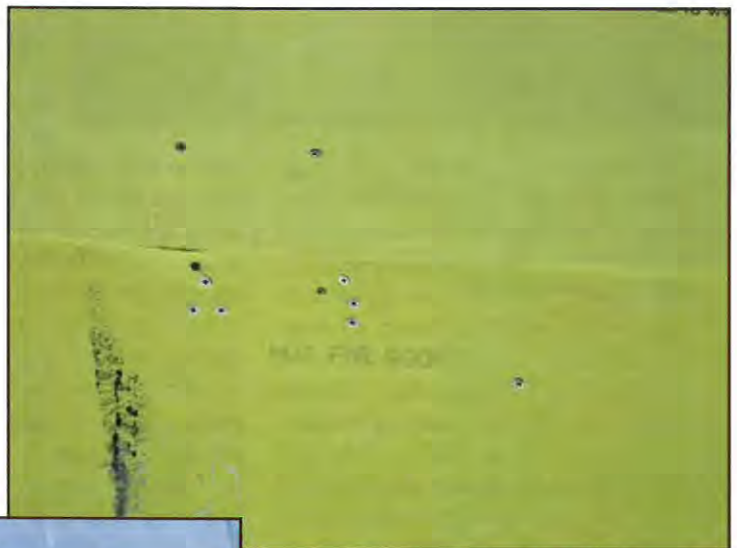
center and no less than ¾ in. from the edges and ends of the panel. Proper attachment and fastener placement rely on the proper positioning of the panels so that the edges are centered over the underlying framing member. Then it is up to the installer to secure the fastener in the proper location. Commonly, fasteners are haphazardly placed too close to the panel edges, which can pulverize the gypsum core, resulting in an inadequate substrate to receive an air barrier/WRB (Figure 10).

Figure 10 – Improperly positioned fasteners in sheathing.

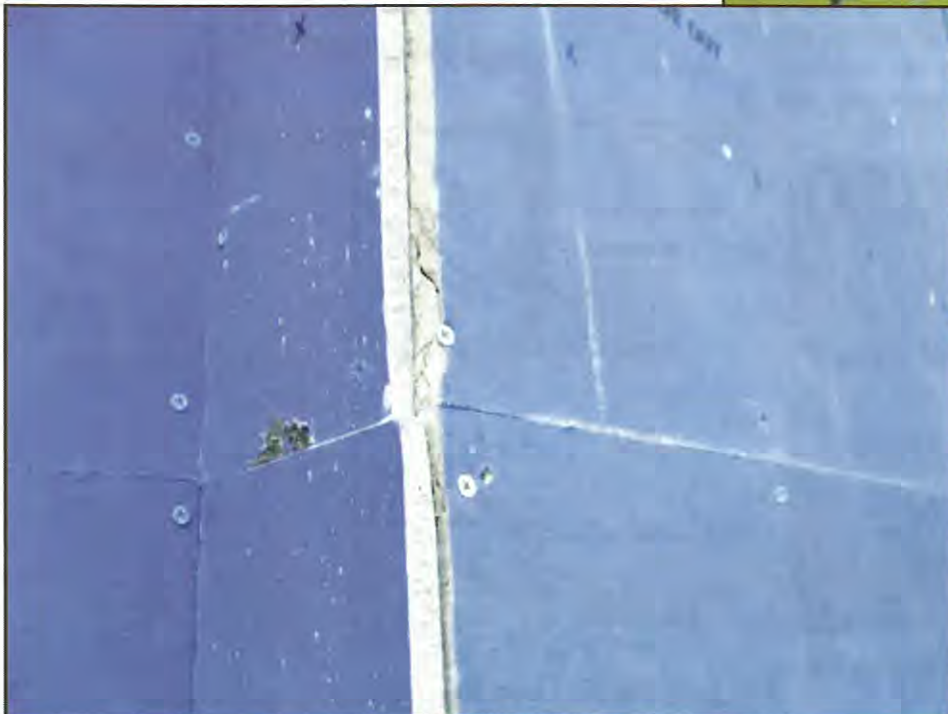
referred to as a “neat 90.” This is critical to providing continuous support around the corners because most fluid-applied air barrier materials cannot span a gap greater than ¼ in. and ½ in. for adhered sheet products. Excessively large joints could cause a self-adhered sheet air barrier to “balloon out” or billow and fail due to excessive internal building pressures at open sheathing joints. Additionally, exposed gypsum core commonly occurs at corners due to installation practices (Figure 9). The gypsum core does not provide a suitable substrate for either fluid-applied or self-adhering WRB product and will require specific treatment (applying sealant, primer/adhesive, etc.) to achieve a proper installation. For fluid-applied air barriers, large joints will require additional preparation with sealants, tapes, fabrics, etc. Joints in sheathing should be butted tight and staggered. Sheathing also needs to be installed flush with the edges of openings to allow the air barrier to wrap inside without resulting in bridging at corners.

Figure 9 – Exposed gypsum core at outside corner of wall.

When sheathing gets damaged during construction, it needs to be replaced in a size that spans stud to stud. Air barriers/WRBs are designed and tested to adhere to the facer, not exposed or damaged gypsum. Consequently, if sheathing is damaged, it needs to be replaced and not just covered up. The attachment of sheathing to framing is well defined by industry guidelines, which typically call for fasteners 8 in. on

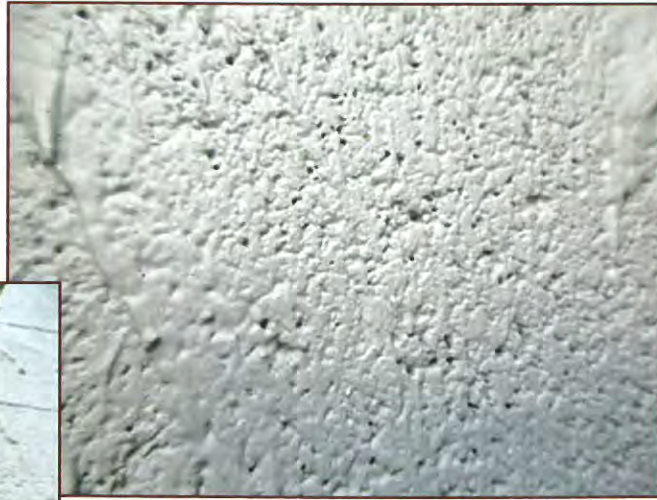
Figure 11 – Void in fluid-applied air barrier at eye hooks of pintle masonry anchor.

face of the CMU. This results in a rough substrate on which it is difficult to properly apply a fluid-applied air barrier, often resulting in voids in the material (Figure 11).

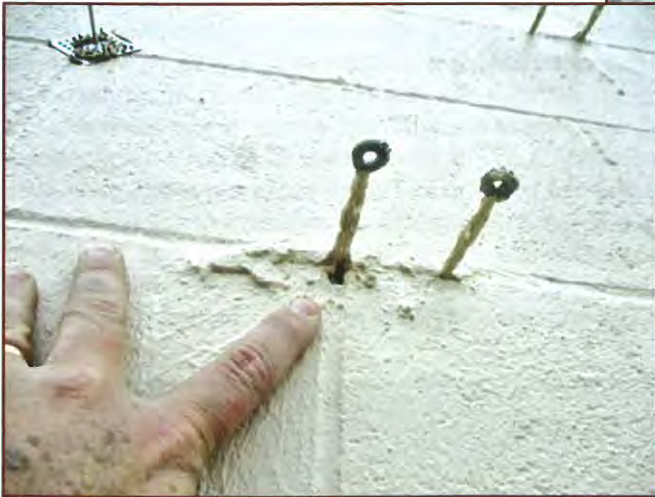
Figure 12 – Voids in fluid-applied air barrier on porous CMU.

sequently requiring more fluid-applied air barrier material to achieve specified coverage (Figure 12).

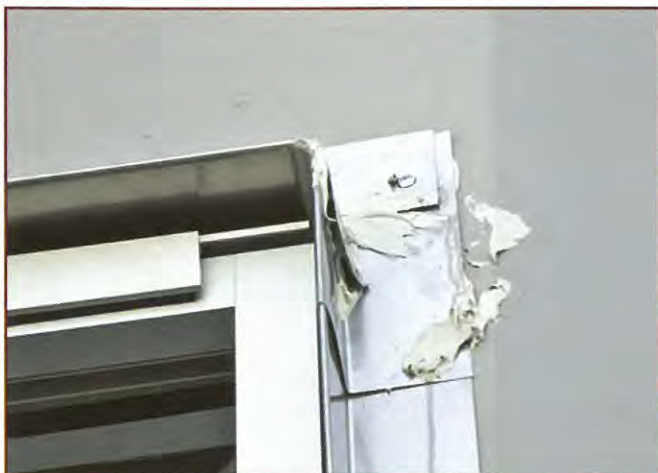
Often the project design requires that window frames are installed to project out from the opening. This practice results in placement of the primary sealant joint in a location out beyond the opening. In this detail, a sheet metal angle is commonly installed around the perimeter of the

Figure 13 – Corner joint of sheet metal flange installed around window opening.

opening to provide a substrate to receive the sealant beyond the opening. The sheet metal angle is installed on top of the WRB applied around the opening, secured to the framing around the opening, and then the flange is stripped into the WRB—typically with a self-adhering transition membrane. A concern with this type of detail is achieving a proper watertight seal at laps and corners in the sheet metal angle (Figure 13). Utilizing pop rivets and sealant sandwiched in the laps may not provide an adequate seal when subjected to testing with a spray wand, and it will definitely not maintain a seal in a pressure chamber. Using stainless steel sheet metal, pop riveting, and soldering the joints can result in watertight joints but requires highly skilled technicians to properly achieve this result.

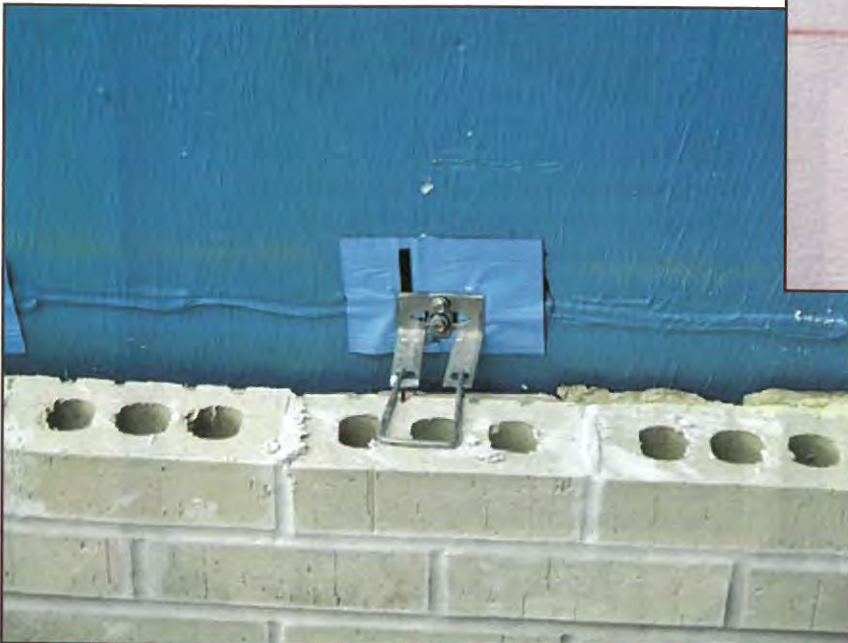
Figure 16 – Cut strip of self-adhered membrane applied on top of fluid-applied air barrier at masonry anchor.

Installation of cut strips of self-adhering sheet, sized to match the compression surface, between the steel girt or tie and the fluid-applied air barrier, can aid in achieving seals at fastener penetration (Figure 16). Additionally, the heads of fasteners may need to be treated with a dollop of compatible sealant or a trowelable version of the liquid membrane to provide a more desirable seal. Another practice could include setting the masonry tie in “wet” fluid-applied WRB when securing to the substrate. Issues are

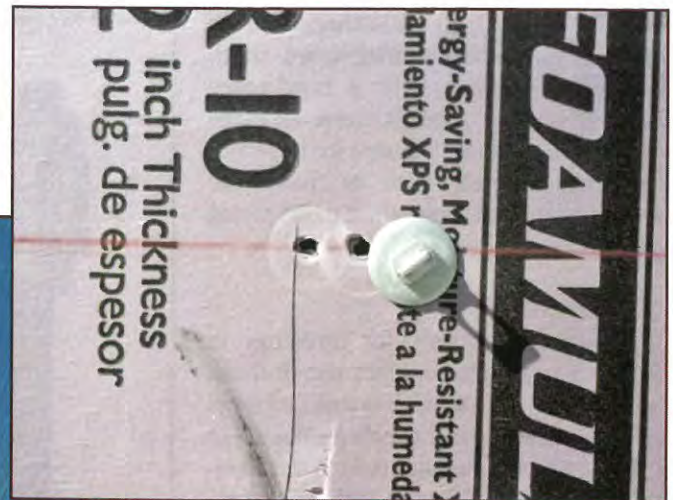
Figure 17 – Multiple screw holes in insulation and underlying WRB.

The use of continuous insulation within the cavity wall has also created some challenges with achieving proper-functioning WRBs. Some assemblies utilize insulation applied on top of the WRB, and then the cladding anchors are installed through the insulation in a "blind" method with the good intention of penetrating into underlying structural elements (Figure 17). Since the insulation is in place, the only possibility to confirm that the fasteners indeed penetrate into the underlying framing is to perform a visual inspection on the interior side of the backup wall prior to installation of interior finishes. Then, if fasteners are found to be improperly installed, the proper corrective measure must be determined.

One corrective method could involve cutting out and retaining a small section or block of the insulation down to the surface of the WRB, applying sealant over the hole in the WRB, and then setting the retained cut block back into the hole, with the intention of also becoming adhered with the sealant. A type of masonry anchor designed for this application has a small aluminum washer with rubber seal intended to create a seal at the top surface of the air barrier/WRB. When this type of fastener is driven through rigid board insulation and does not secure into a framing membrane, the installer realizes this miscue, then withdraws the fasteners to reposition and reinstall, and the washer can slide off of the shank of the fastener and become embedded within the insulation board. Subsequently, when this same fastener is repositioned and reinstalled into a framing member, the washer is no longer present to serve the intended function.

The author believes that installation of anchorage devices directly on top of the surface of the WRB and prior to installation of the insulation can achieve a better-performing assembly with fewer risks of compromising the air barrier/WRB. The rigid insulation is then installed either friction-fit between ties or adhered over the air barrier with an approved adhesive, such as dollops of sealant. Gaps or voids in joints between rigid boards or around penetrations could then be filled with cut slivers of the same insulation or a spray foam type of insulation.
