Rebuttal of Expert Report Entitled, *Analysis of Flood Magnitude and Severity for Land Surrounding the Consent Decree Area, Robert Brace Farm, Waterford, Erie County, Pennsylvania*, Prepared by Dwayne R. Edwards, In Regard to Case United States v. Robert Brace and Robert Brace Farms, Inc., Civ. No. 90-229, W.D. Pa.

Expert Rebuttal Report Prepared for Robert Brace and Robert Brace Farms, Inc.

Prepared by:
Andrew R. Johnson, P.E., CPESC

February 21, 2018

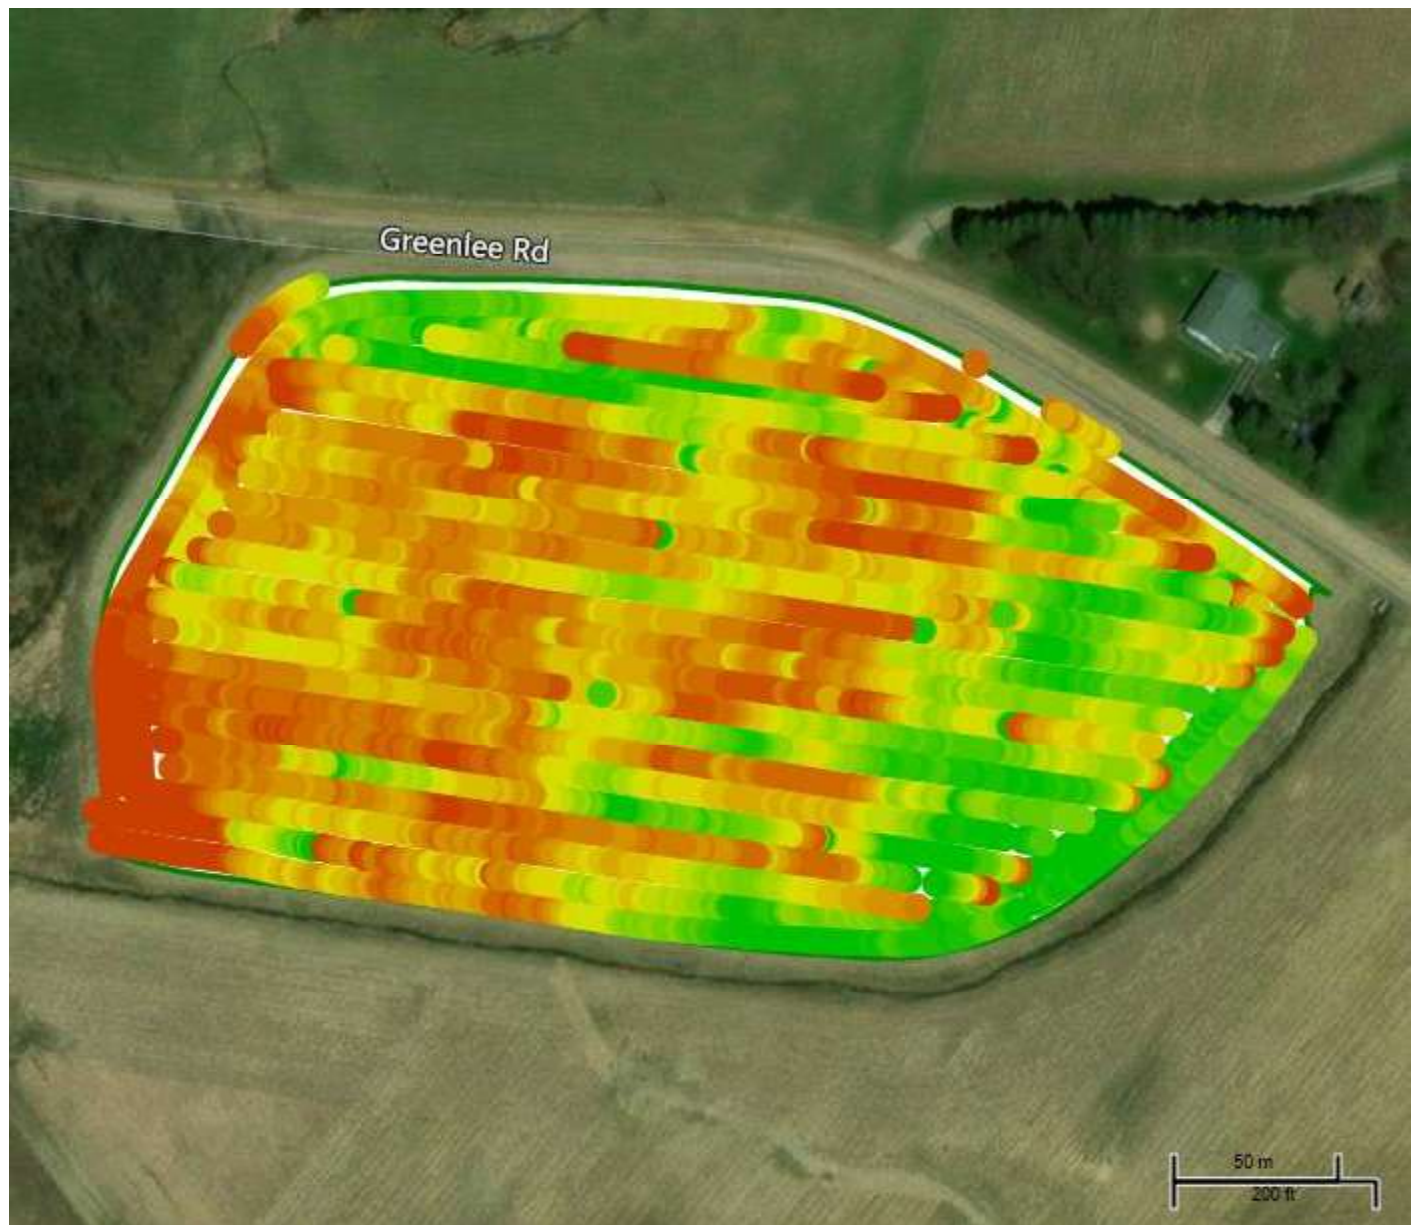
Field: HOMESTEAD 12

Harvest Summary

Total Yield (dry): 425.10 bu

Average Yield: 53.50 bu/acre

the wet areas, as they have observed it routinely for several decades, and then couple that information with supporting scientific evidence such as historical aerial photos and the recent crop yield maps. The historical images are summarized in the EcoStrategies report, and the Centerra Report maps present low crop yield (red areas) and high crop yield (green areas) in the form of “heat maps”. The Centerra Report concludes that the main cause of low crop yields areas on these properties is linked to high soil moisture. The report states that the farm equipment utilizes a moisture monitoring sensor for real time moisture data collection, which is a helpful tool for this study to help quantify the *actual* extent of water damage as it relates to crop yield.

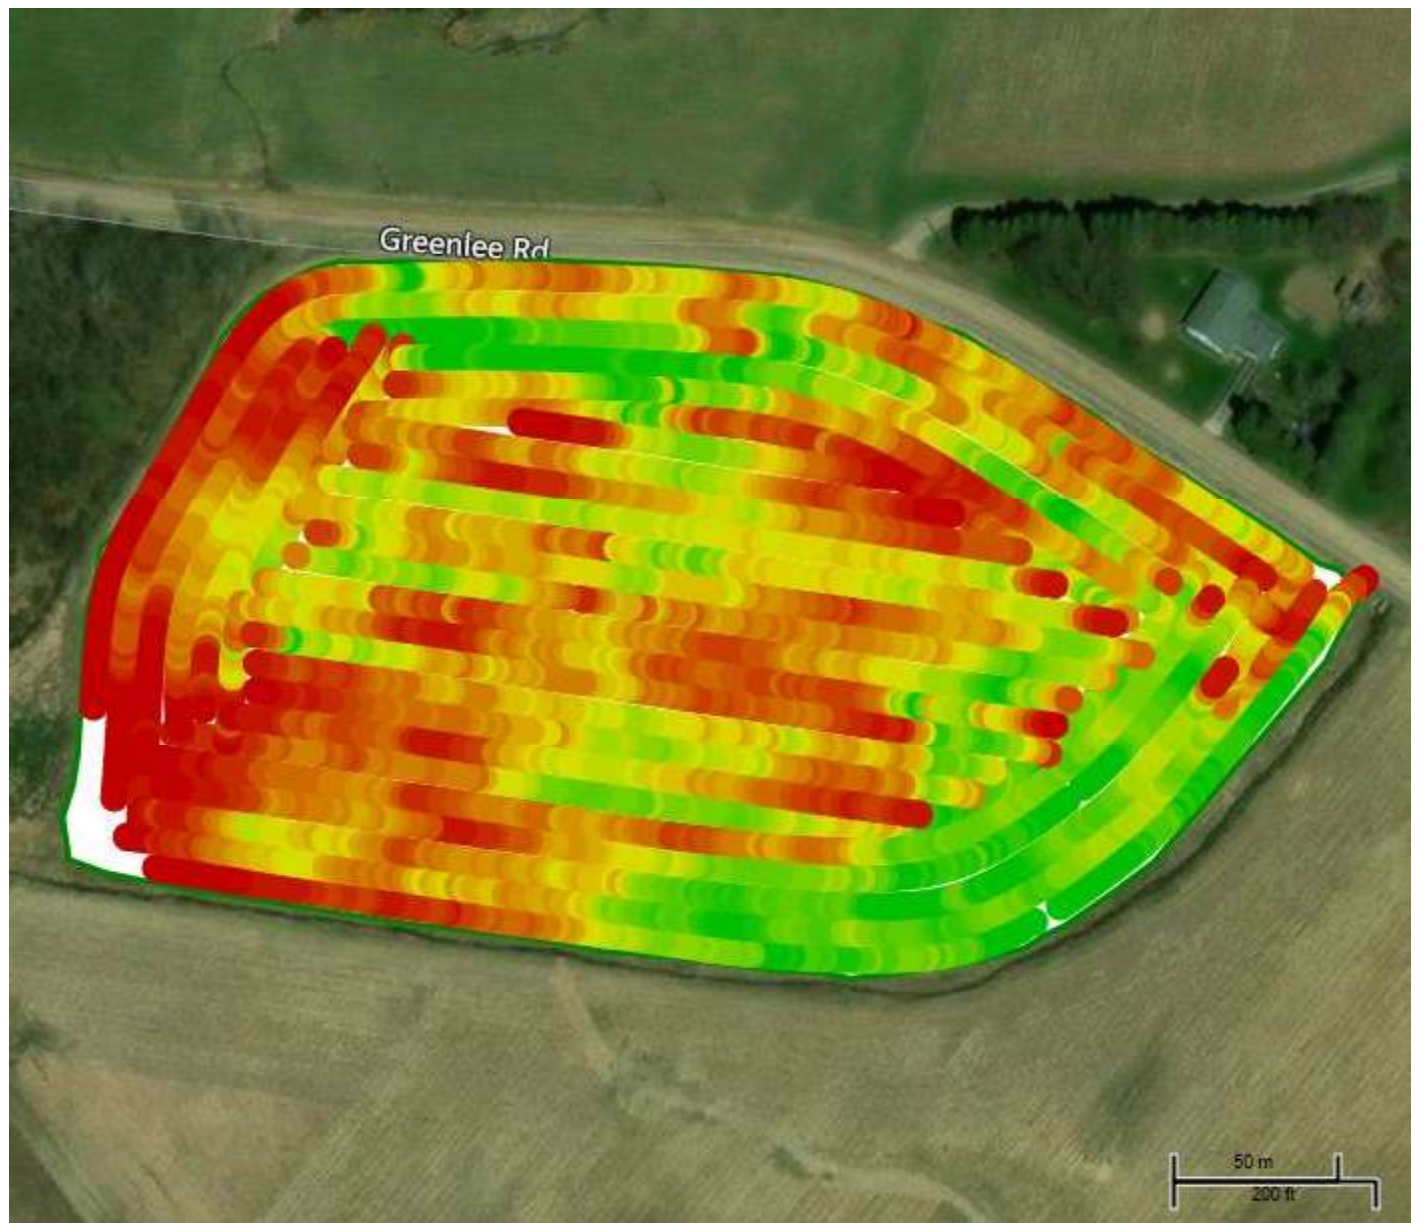
Field: HOMESTEAD 12

Harvest Summary

Total Yield (dry): 702.67 bu

Average Yield: 82.44 bu/acre

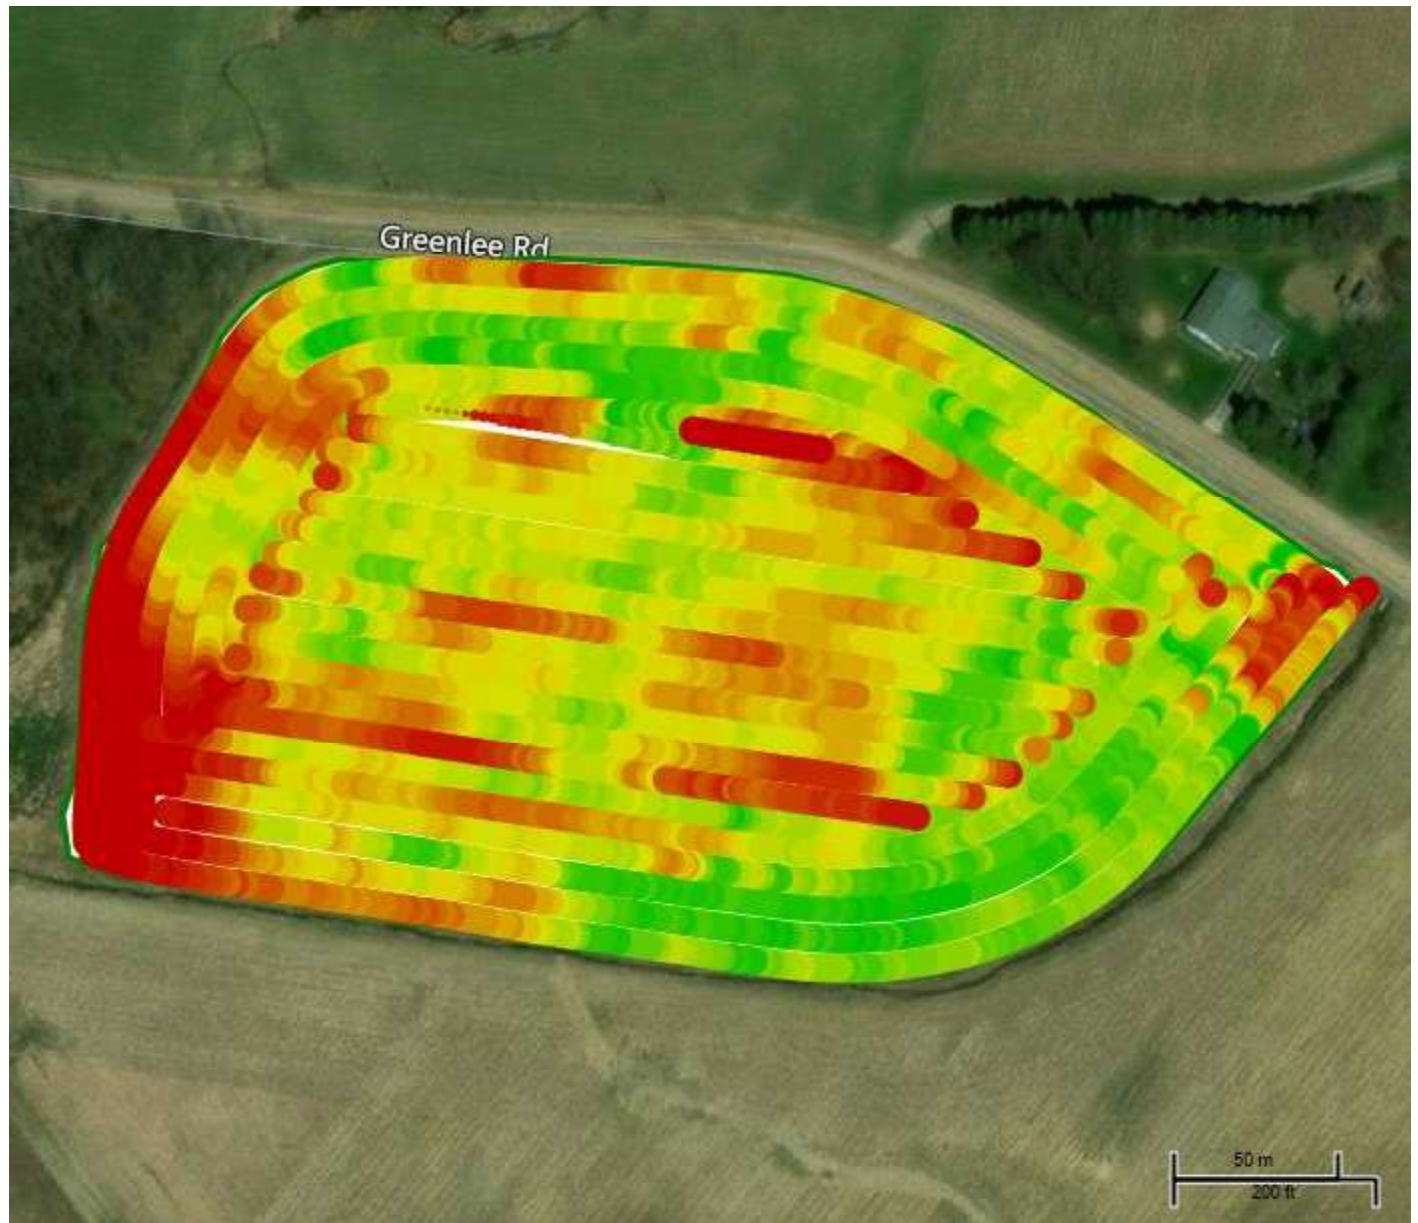
Field: HOMESTEAD 12

Harvest Summary

Total Yield (dry): 1,105.31 bu

Average Yield: 127.42 bu/acre

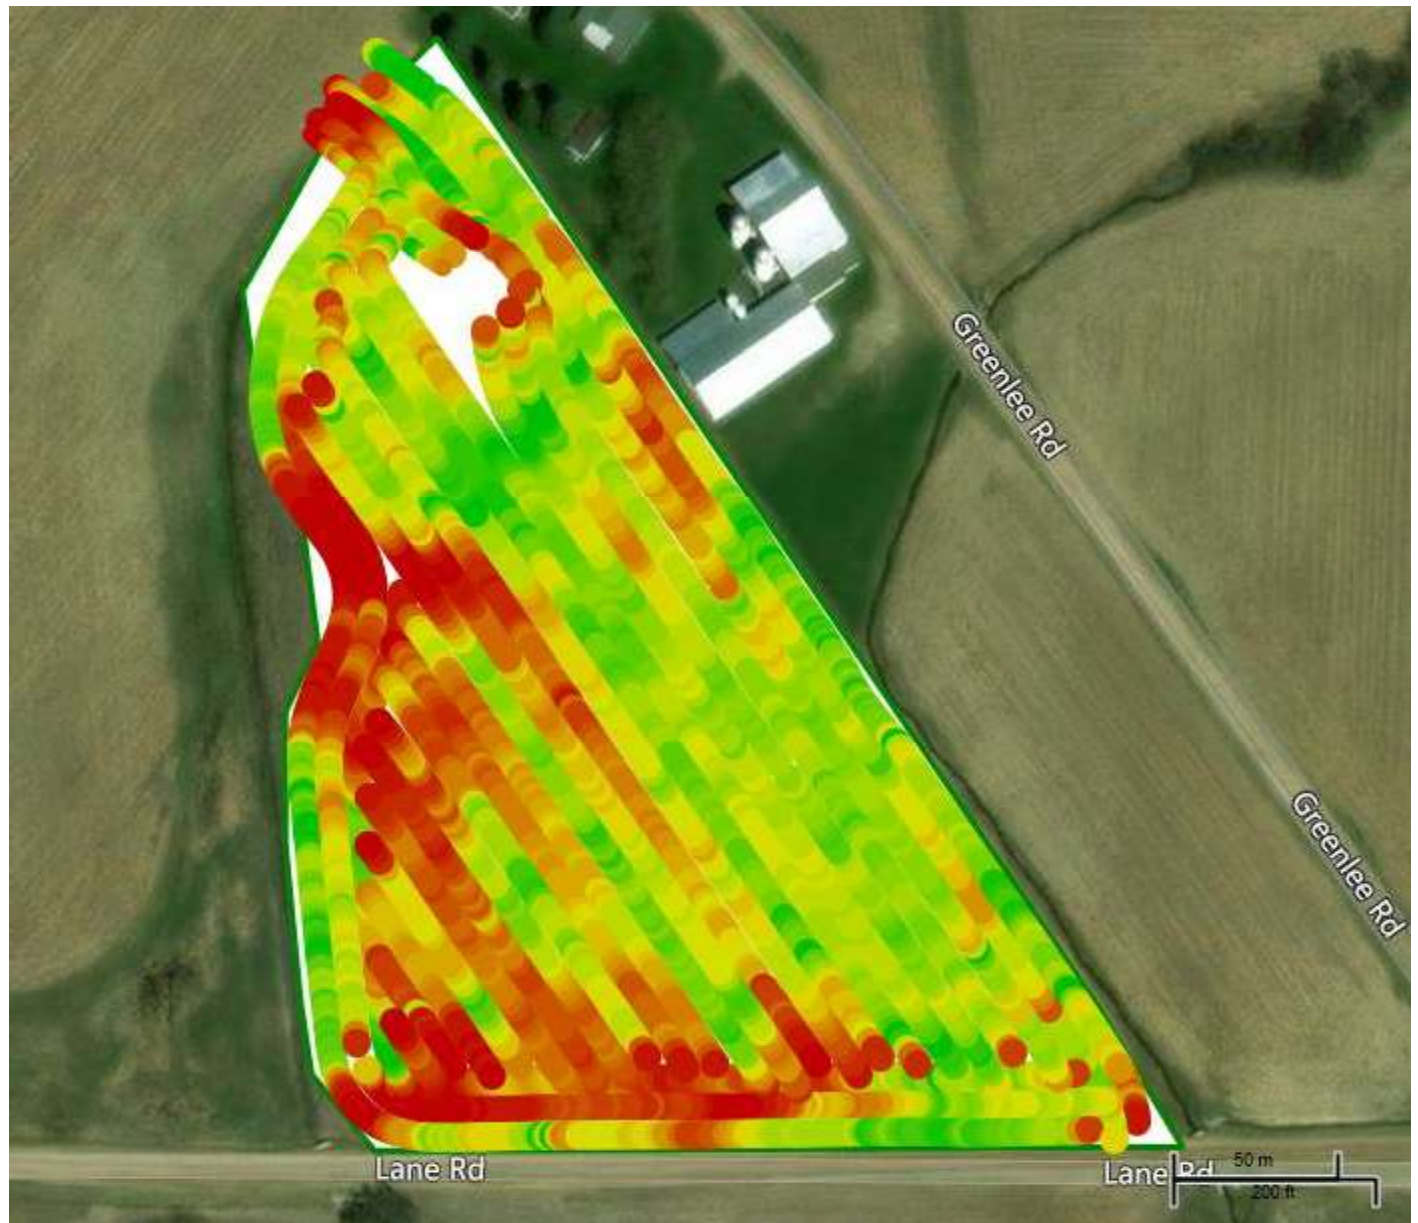
Field: HOMESTEAD 18

Harvest Summary

Total Yield (dry): 1,413.16 bu

Average Yield: 106.62 bu/acre

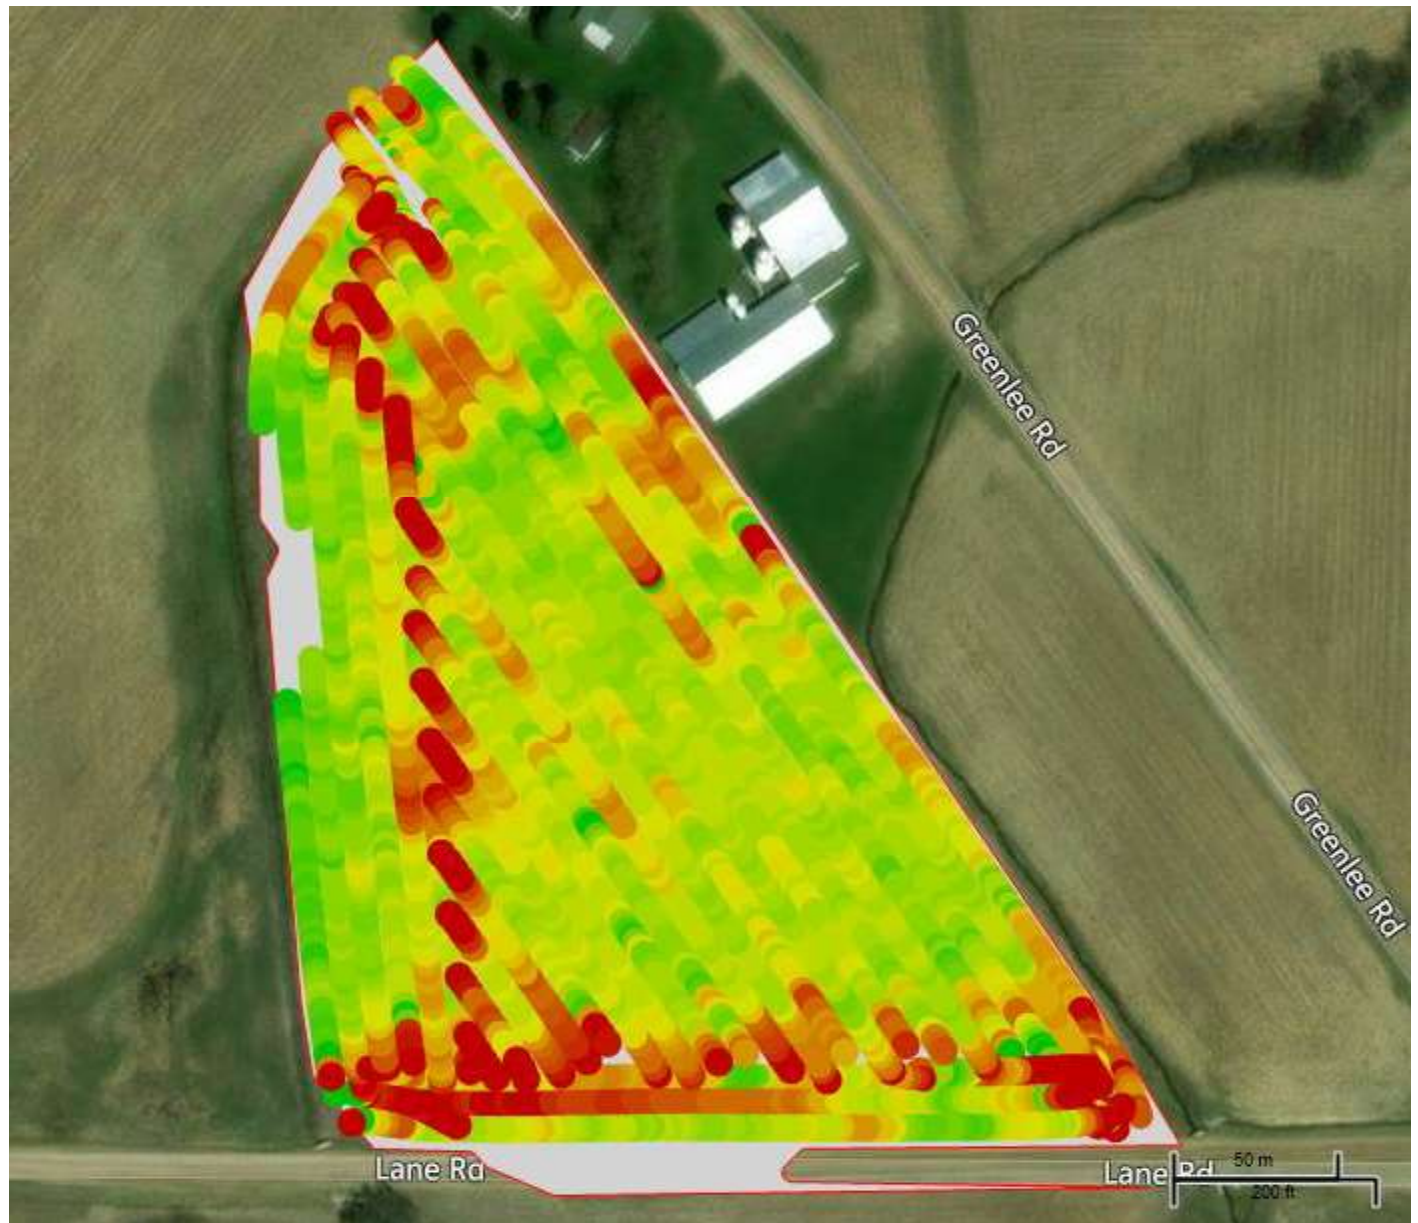
Field: HOMESTEAD 18

Harvest Summary

Total Yield (dry): 1,407.92 bu

Average Yield: 201.83 bu/acre

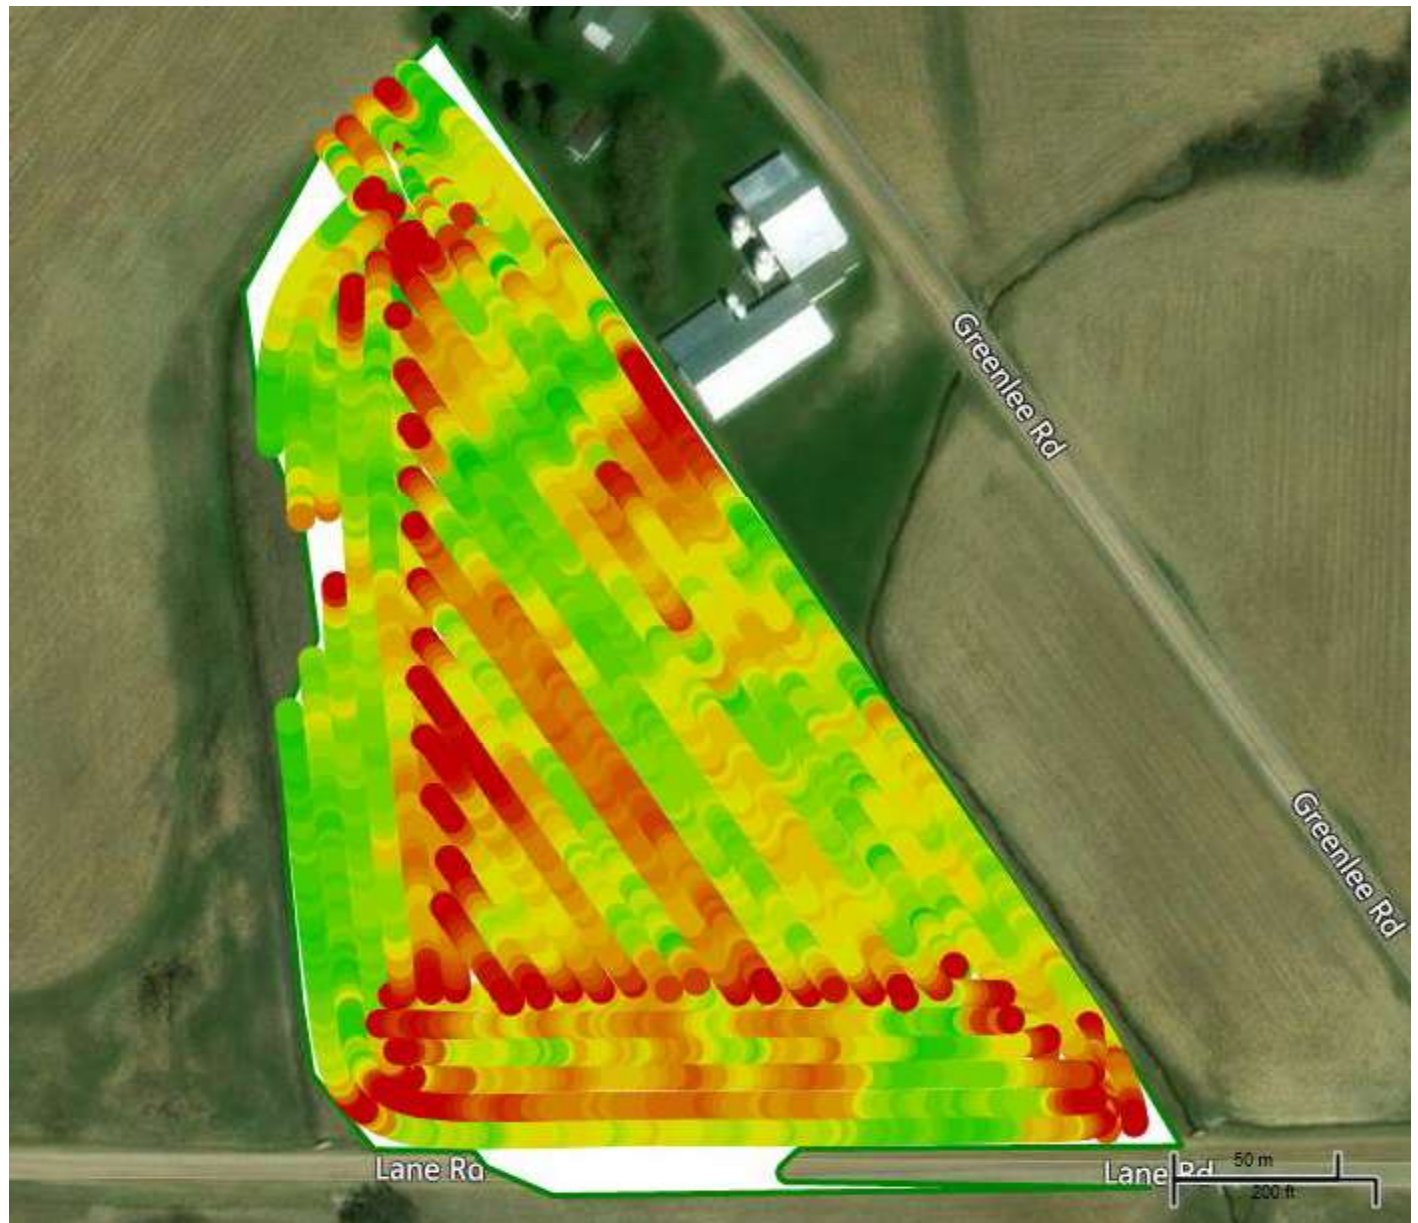
Field: HOMESTEAD 18

Harvest Summary

Total Yield (dry): 1,168.91 bu

Average Yield: 166.66 bu/acre

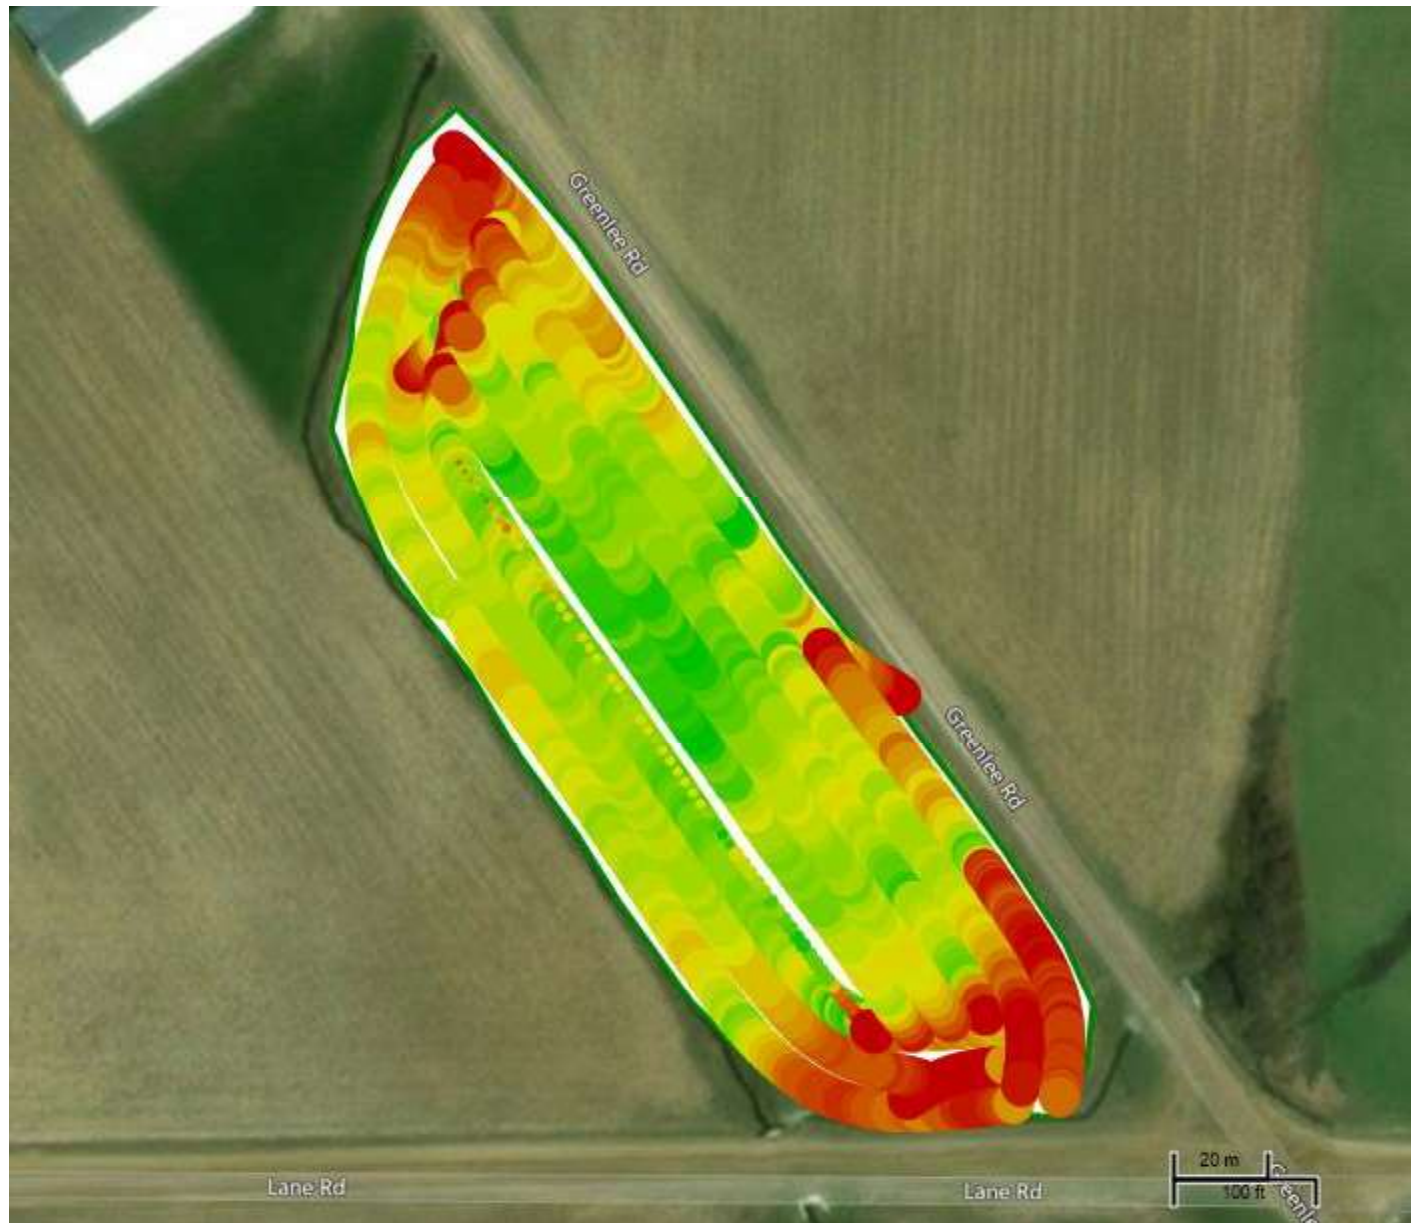
Field: HOMESTEAD 19

Harvest Summary

Total Yield (dry): 275.12 bu

Average Yield: 133.72 bu/acre

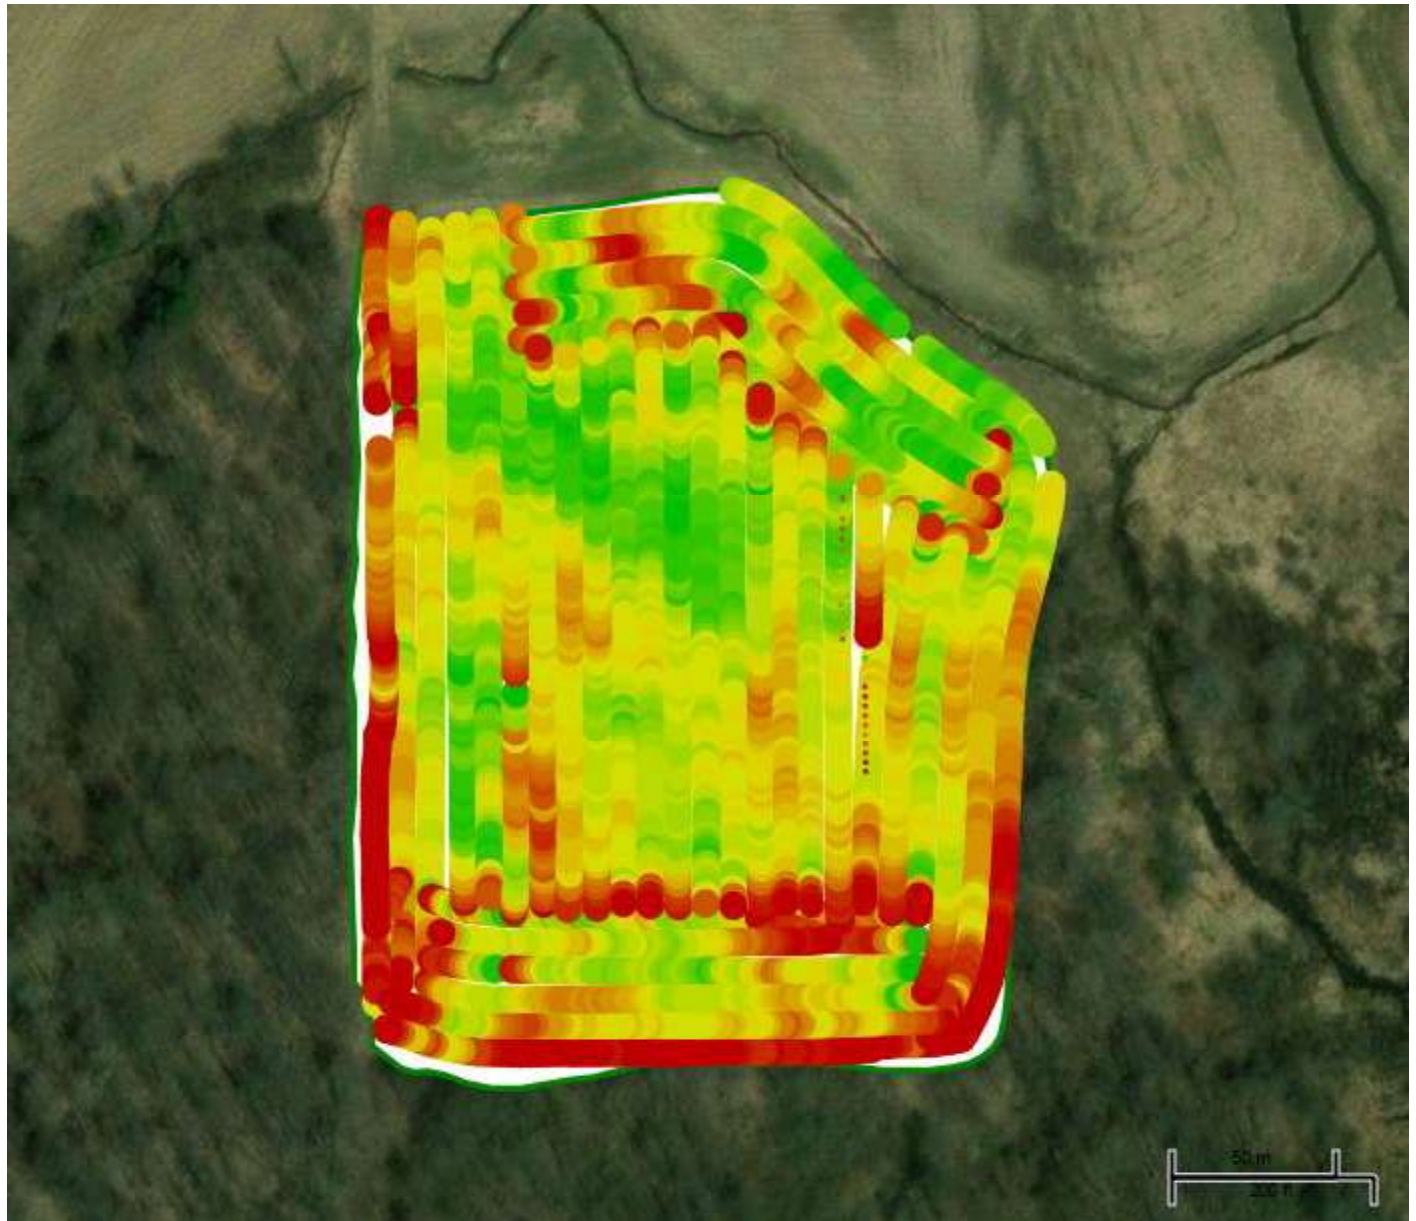
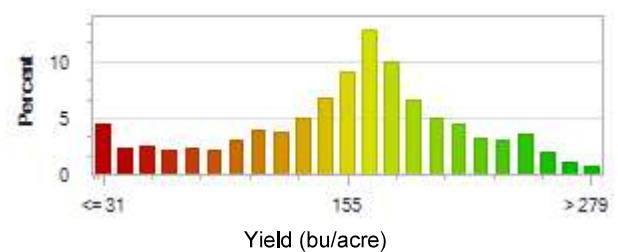
Field: HOMESTEAD 26

Harvest Summary

Total Yield (dry): 1,075.78 bu

Average Yield: 157.62 bu/acre
