**Woody Creek Townhome Association
52nd and Garrison
Arvada, CO 80002**

**Level 1, Premium Reserve Analysis
Report Period – 01/01/16 – 12/31/16**

**First
Draft**

**Date of Property Observation - January 18, 2016
Project Manager - G. Michael Kelsen, RS, PRA
Main Contact Person - Ms. Brenna Krier, Board Member
Report was prepared on - Monday, March 21, 2016**

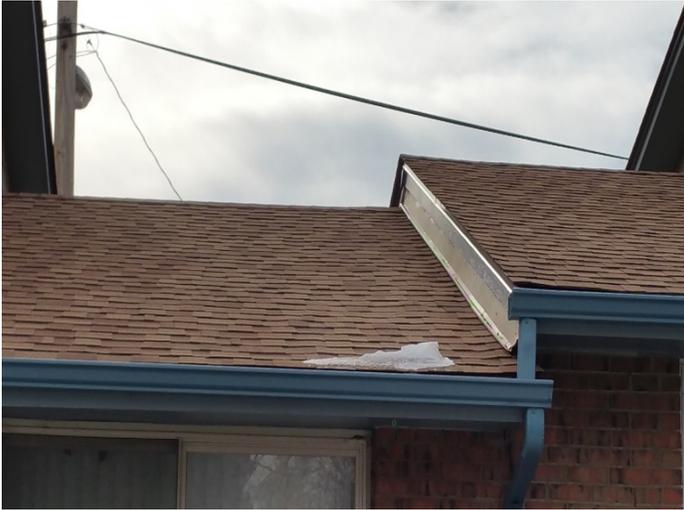
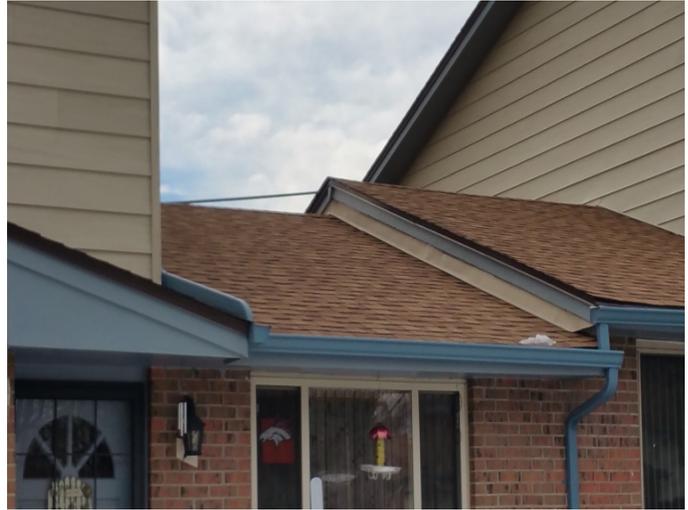
Comp #: 105 Comp Shingle Roof - Replace

- Roof shingles appear to be in good condition with recent replacement.
- It appears this roof material is rated as a 30 - 35 year product. Despite this rating, a life expectancy of 15 - 20 years is expected in this environment.
- Due to the potentially harsh winters, extensive freeze/thaw cycle, and likelihood of hail events over the useful life of the roof, we typically see associations replacing roofs sooner than the manufacturer's suggested useful life.
- Remaining life is based on age of roof and observed conditions.

Location: **Unit building roofs**

\$375/square; Estimate to remove and replace

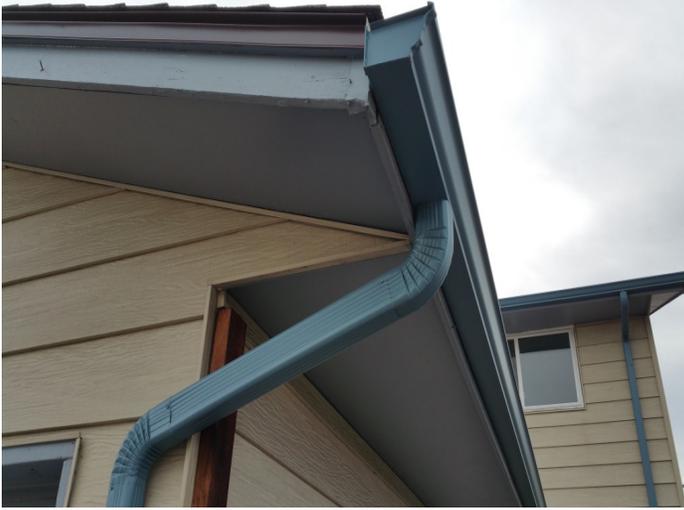
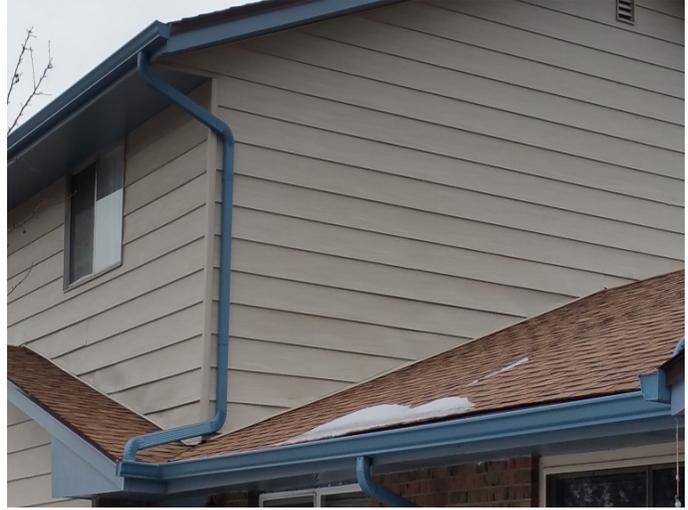
Comp #: 120 Gutters/Downspouts - Replace

- It is typical to replace gutters and downspouts at the same time as roofing materials.
- However, it does not appear these lines were replaced recently along with the roof.
- We recommend cleaning debris out of lines at least twice a year to prevent clogging and moisture retention that can lead to advanced deterioration.
- The average life expectancy for gutter lines ranges between 20 - 25 years depending on the quality of the materials.

\$5.75/LF; Estimate to replace

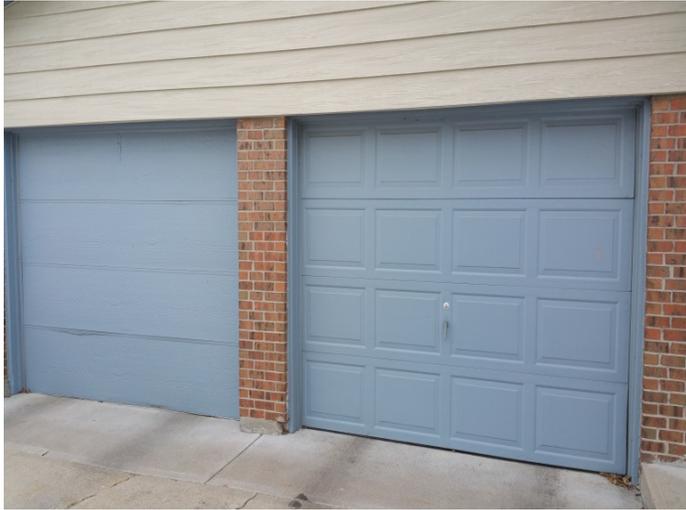
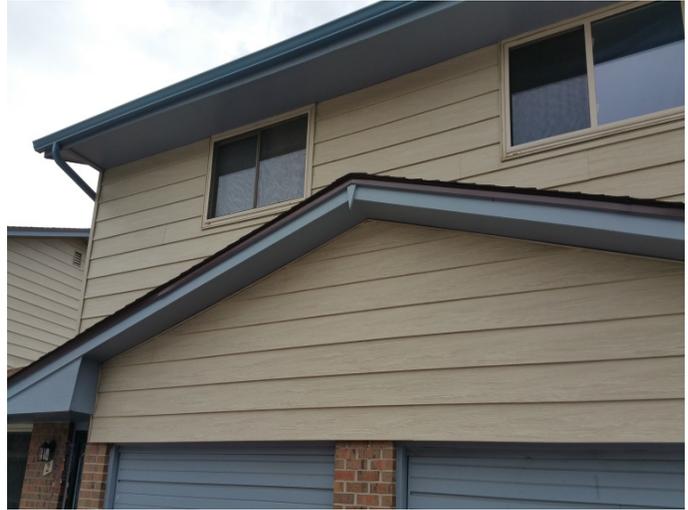
Comp #: 202 Trim Work/Doors - Repaint

- Repaint these surfaces approximately every 4 to 6 years to maintain appearance and protect materials.
- Remaining life based on current age and condition.

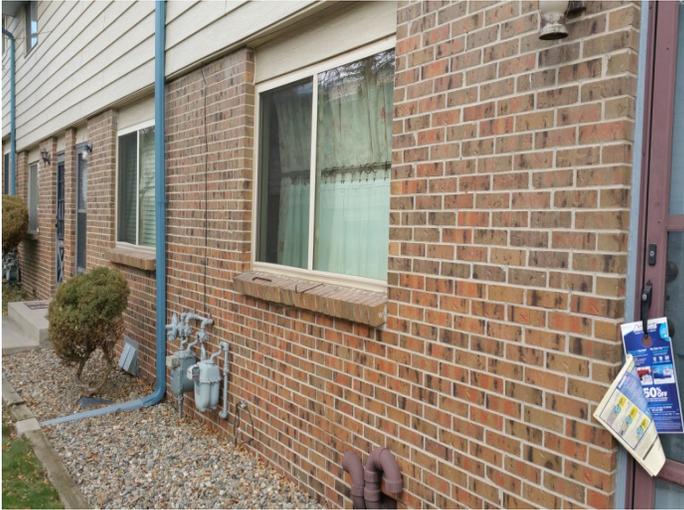
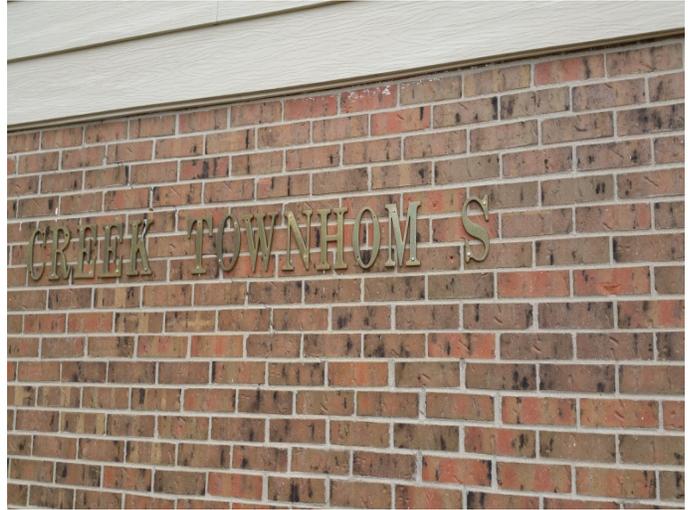
Comp #: 306 Brick - Major Repairs

- Typically, bricks have an extended life expectancy and complete replacement is unlikely.
- There are times where minor repairs may become necessary, but this is unpredictable when and how much would occur.
- Repairs should be handled as a maintenance issue on an as needed basis.
- Reserve funding is not required for this component at this time.
- If it later turns out that frequent repairs are necessary, then funding could be added in future Reserve Study updates.

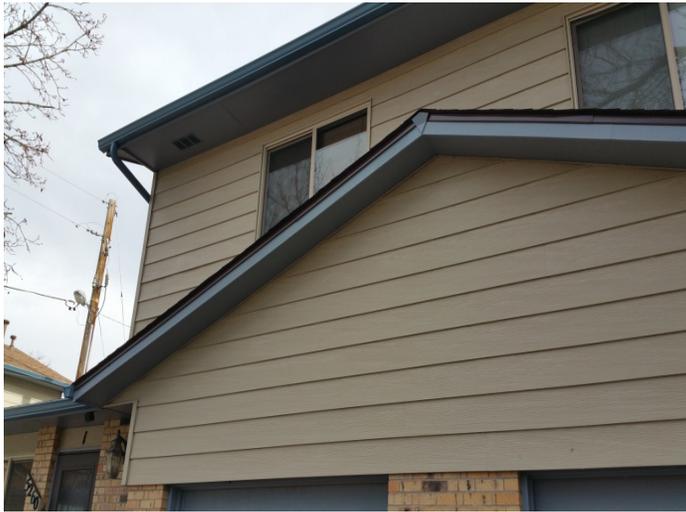
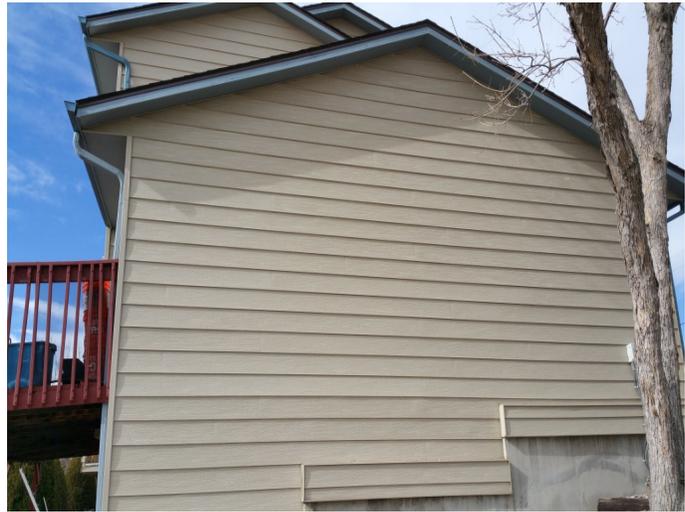
Comp #: 310 Metal Siding - Replace (PH 3)

- There was extensive damage noted on building 5280
- The average life expectancy for this material ranges from 40 - 50 years under normal conditions.
- This material is subject to damage from hail storms, rocks, children, etc.
- Over a period of time, while the siding may still be effective, the appearance becomes deteriorated to a point where replacement is necessary to restore the appearance of the community.
- To ease budgeting concerns, we have cycled replacement to occur over a 3 year period to spread out the expense.

Best Cost: **\$158,550**
\$7.50/GSF; Estimate to replace

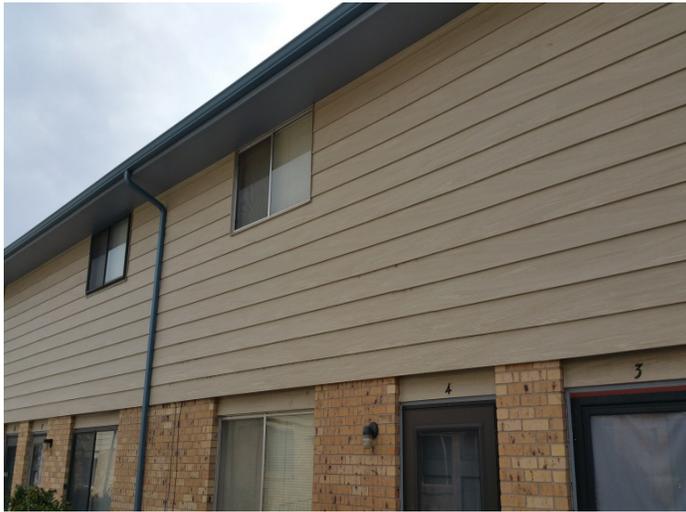
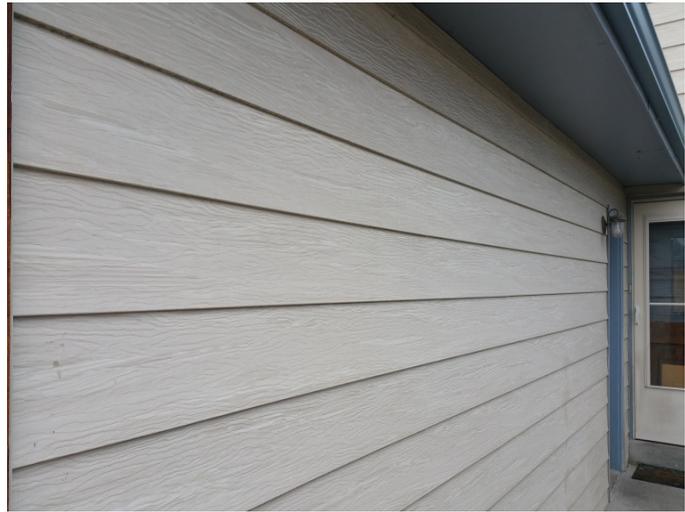
Comp #: 310 Metal Siding - Replace (PH 2)

- There was extensive damage noted on building 5280
- The average life expectancy for this material ranges from 40 - 50 years under normal conditions.
- This material is subject to damage from hail storms, rocks, children, etc.
- Over a period of time, while the siding may still be effective, the appearance becomes deteriorated to a point where replacement is necessary to restore the appearance of the community.
- To ease budgeting concerns, we have cycled replacement to occur over a 3 year period to spread out the expense.

\$7.50/GSF; Estimate to replace

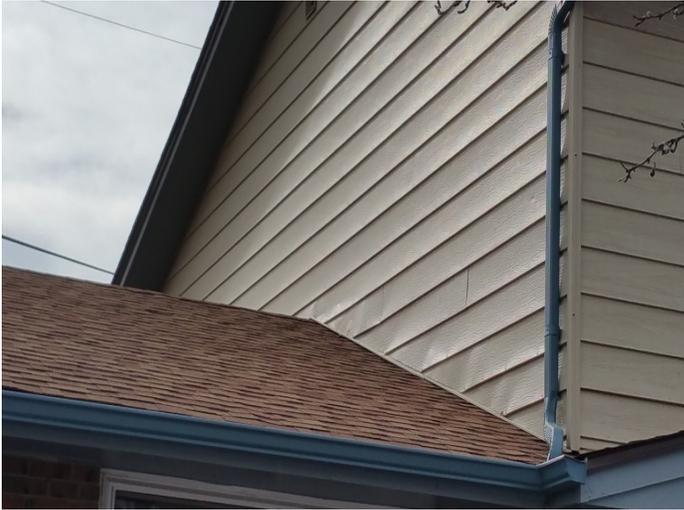
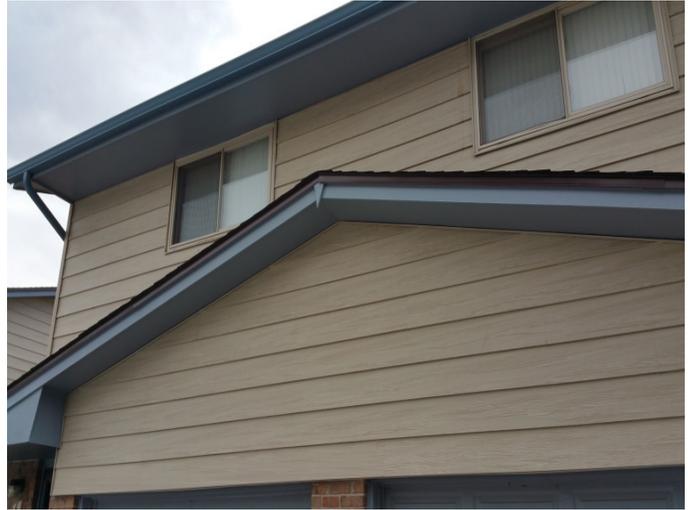
Comp #: 310 Metal Siding - Replace (PH 1)

- There was extensive damage noted on building 5280
- The average life expectancy for this material ranges from 40 - 50 years under normal conditions.
- This material is subject to damage from hail storms, rocks, children, etc.
- Over a period of time, while the siding may still be effective, the appearance becomes deteriorated to a point where replacement is necessary to restore the appearance of the community.
- To ease budgeting concerns, we have cycled replacement to occur over a 3 year period to spread out the expense.

Best Cost: **\$105,425**
\$7.50/GSF; Estimate to replace

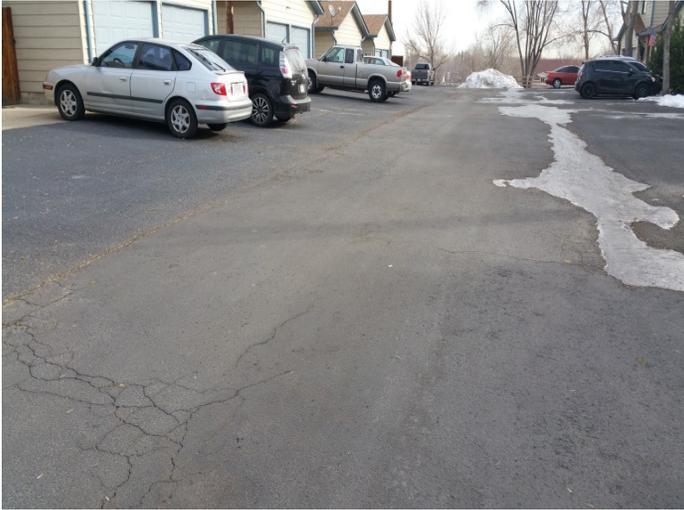
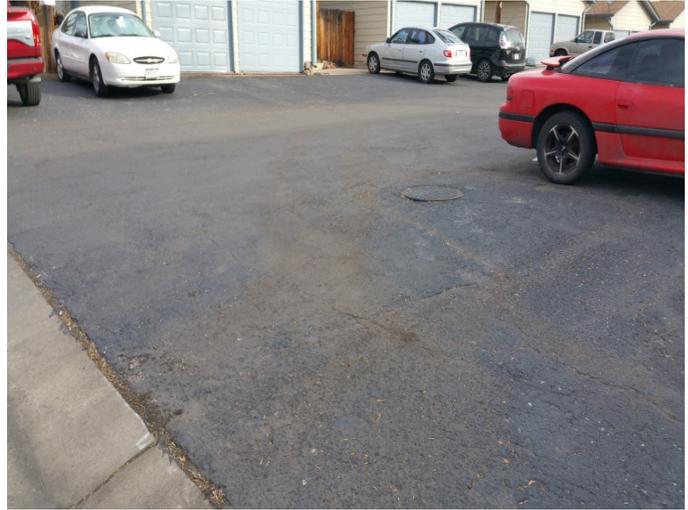
Comp #: 401 Asphalt - Major Overlay (5210)

- This line item is for major replacement of asphalt pavement or a roto mill and resurfacing, the decision regarding which applications and products to use is ultimately up to the BOD and include but are not limited to: double chip seal, mill and overlay, cape seal, hot chip seal or complete reconstruction.
- The costs of these projects vary depending on the product chosen, we have provided an average cost for major replacement or substantial application of a new surface
- Research options and consult a reputable contractor prior to deciding on a product for street/parking resurfacing.
- Area has been split in 3 different sections based on various conditions

\$2.50/GSF; Higher estimate for more repairs

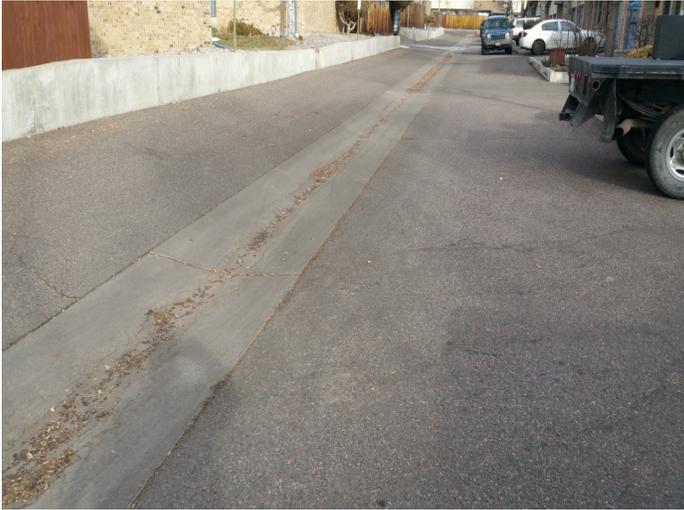
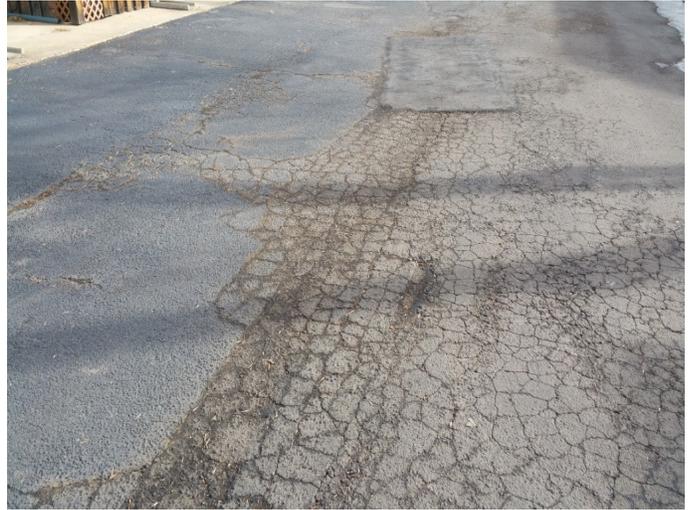
Comp #: 401 Asphalt - Major Overlay (5250/5260)

- This line item is for major replacement of asphalt pavement or a roto mill and resurfacing, the decision regarding which applications and products to use is ultimately up to the BOD and include but are not limited to: double chip seal, mill and overlay, cape seal, hot chip seal or complete reconstruction.
- The costs of these projects vary depending on the product chosen, we have provided an average cost for major replacement or substantial application of a new surface
- Research options and consult a reputable contractor prior to deciding on a product for street/parking resurfacing.
- Area has been split in 3 different sections based on various conditions

\$2.50/GSF; Higher estimate for more repairs

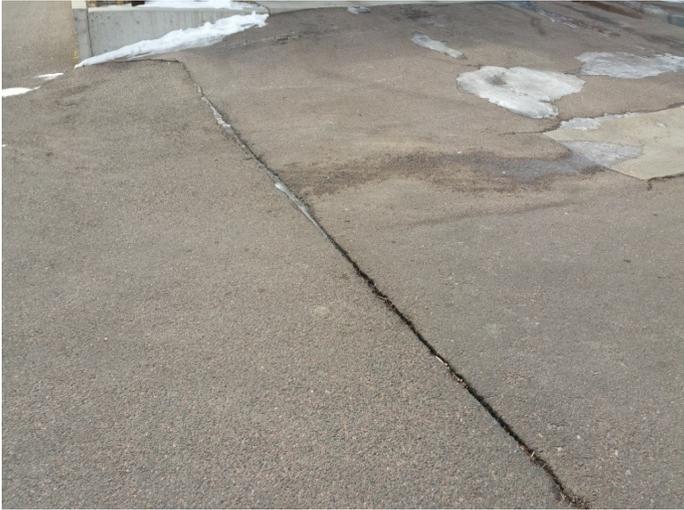
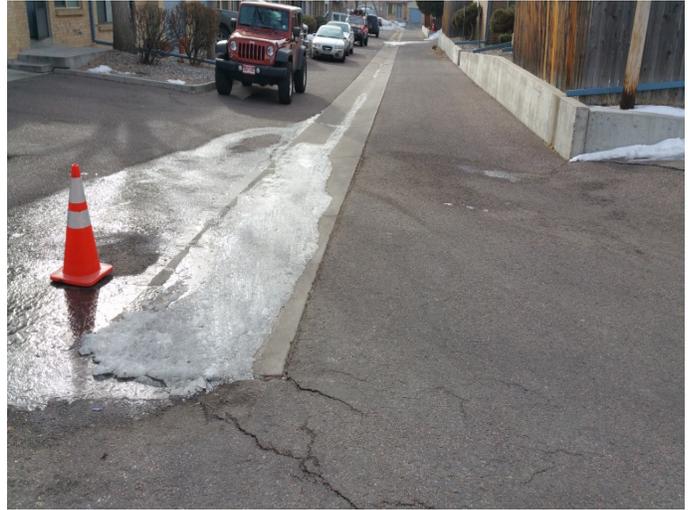
Comp #: 401 Asphalt - Major Overlay (5270)

- This line item is for major replacement of asphalt pavement or a roto mill and resurfacing, the decision regarding which applications and products to use is ultimately up to the BOD and include but are not limited to: double chip seal, mill and overlay, cape seal, hot chip seal or complete reconstruction.
- The costs of these projects vary depending on the product chosen, we have provided an average cost for major replacement or substantial application of a new surface
- Research options and consult a reputable contractor prior to deciding on a product for street/parking resurfacing.
- Area has been split in 3 different sections based on various conditions

\$2.50/GSF; Higher estimate for more repairs

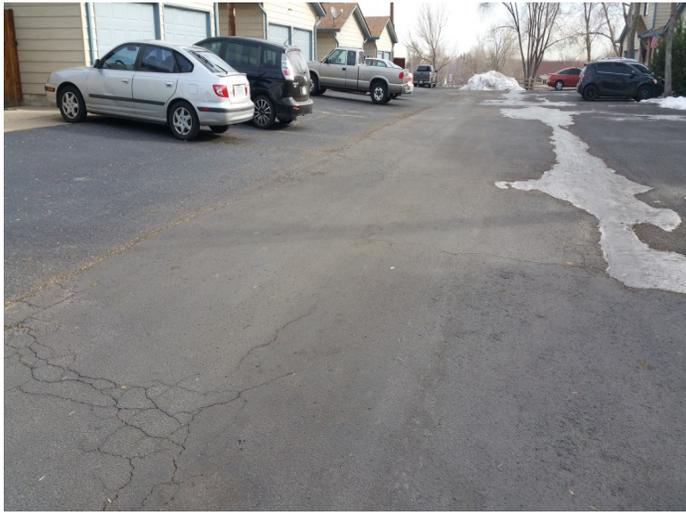
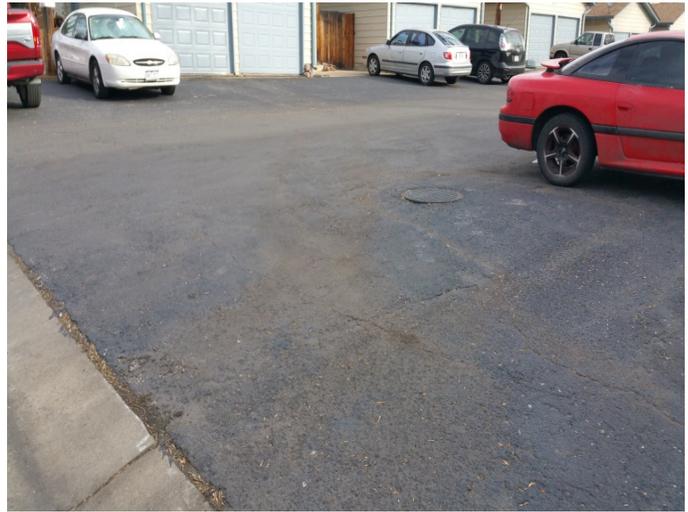
Comp #: 401 Asphalt - Remove and Regrade (5210)

- It was reported the surface needs regrading to improve drainage.
- This is expected to be a one time expense, thus the "99" year udeful life.

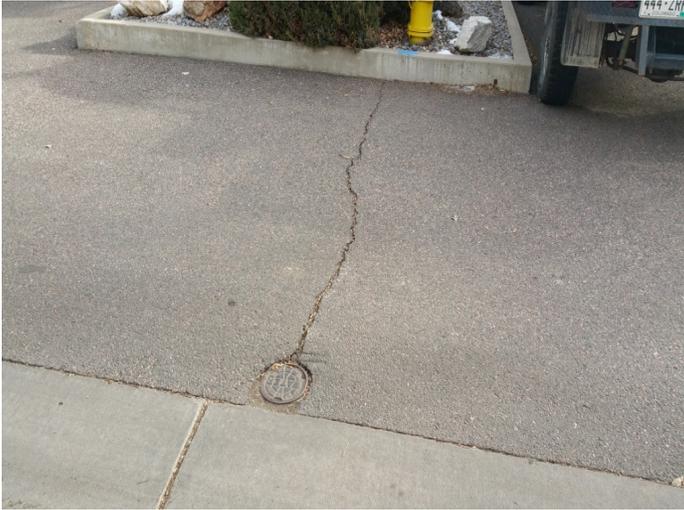
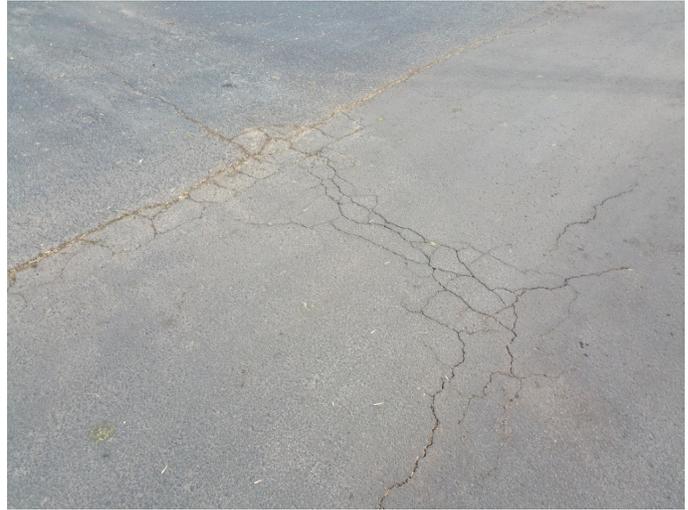
Comp #: 402 Asphalt - Surface Application

- Surface treatments are used to extend the useful life of asphalt and to help maintain aesthetics; there are a broad range of products to choose from so we recommend consulting a reputable contractor for your community's needs.
- The recommendation is an allowance for the mid range surface treatments that are available in today's market.
- Expect to seal coat, chip seal or slurry seal your asphalt every 4 - 5 years, as the asphalt ages it may be necessary to adjust the frequency and or cost of these projects.

\$.30/GSF; Higher est. includes repairs/crack fill

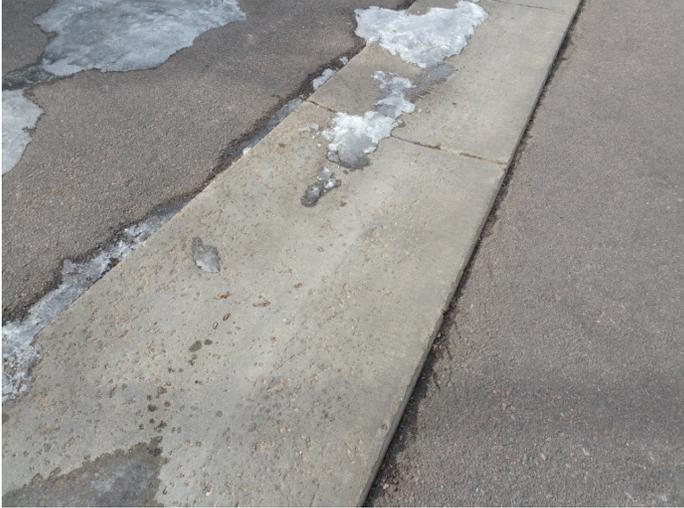
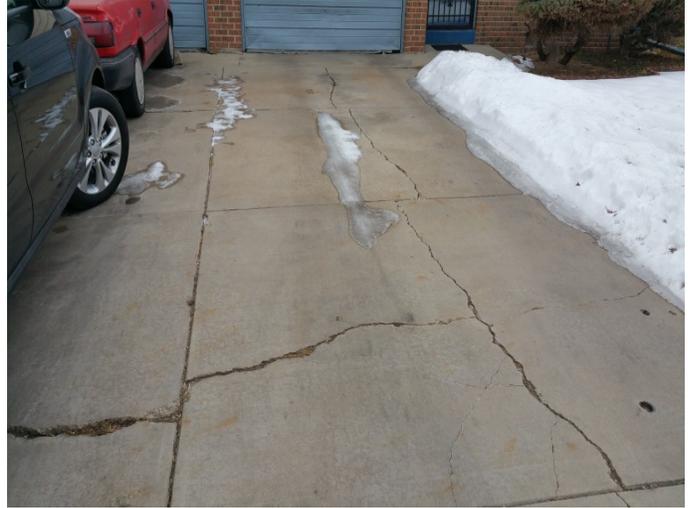
Comp #: 403 Concrete - Repair/Replace

- Several driveways are in poor condition with extensive cracking.
- It is unlikely that all concrete will fail and need to be replaced at the same time, therefore, we recommend reserving an allowance for periodic repairs to a percentage of the total area.
- Coordinate this project with other concrete and/or asphalt projects for best cost estimates based on quantity of work.

Allowance to replace 25% of area every 5 years

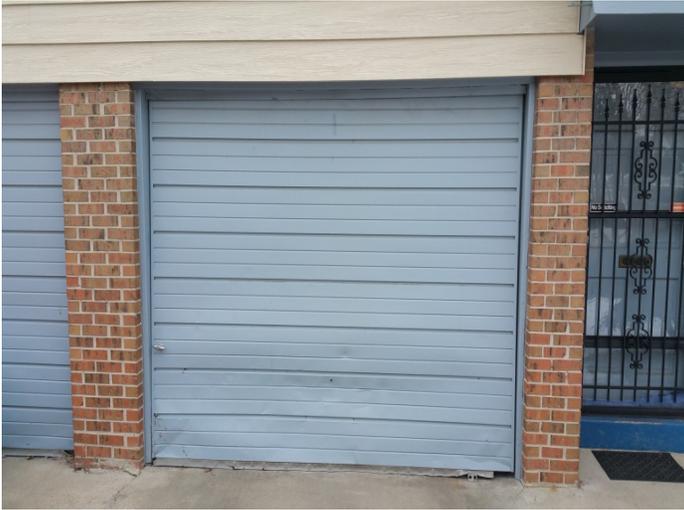
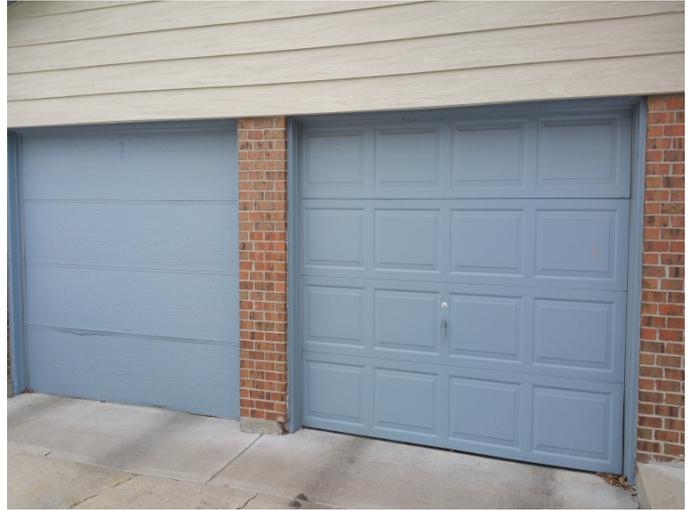
Comp #: 502 Garage Doors - Replace

- The declarations are unclear as to the responsibility of the doors. All doors differ from unit to unit, so it is assumed the unit owner is responsible for replacement.
- Some associations decide to include garage doors as an association expense to obtain the best cost available and to maintain a consistent appearance for the association.
- Unless otherwise noted, Reserve funding will not be included based on the assumption stated above
- We suggest the association establish a design guideline so that when an owner goes to replace a door, it will match and be consistent with the others.

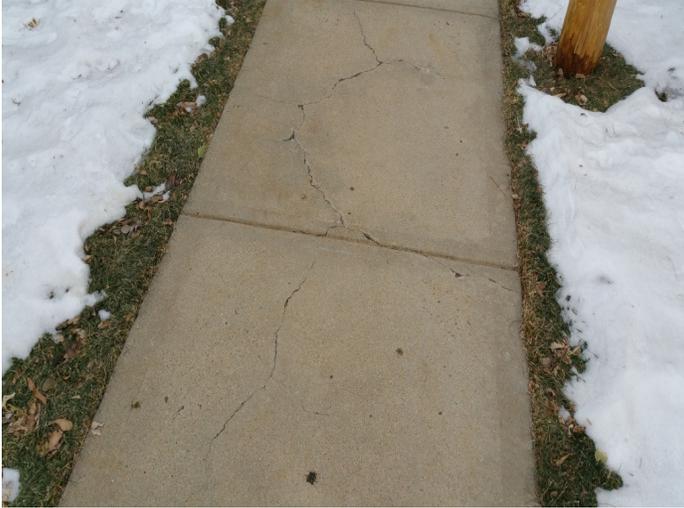
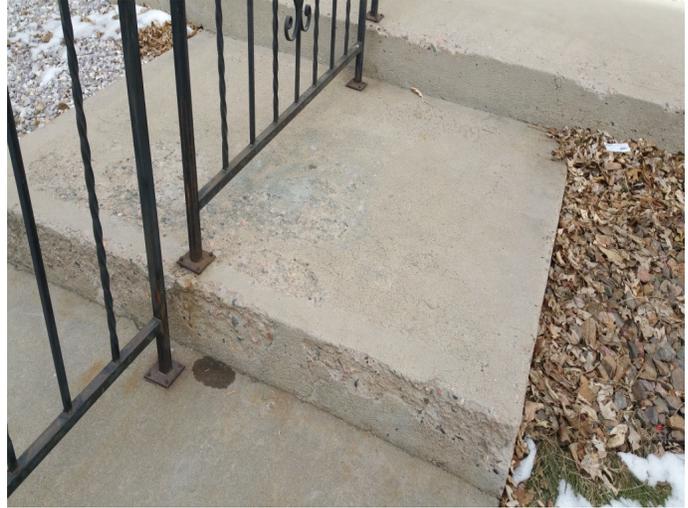
Comp #: 601 Concrete Flatwork - Partial Replace

- Similar to the concrete driveways, it is unlikely that all areas will fail and need to be replaced at the same time.
- Therefore, we set an allowance of 10% of the total area measured (450 GSF) to be repaired every 5 years.
- As the property continues to age, it is likely that the percentage of repairs will need to be adjusted in future Reserve Study updates.

Allowance to repair 10% of area every 5 years

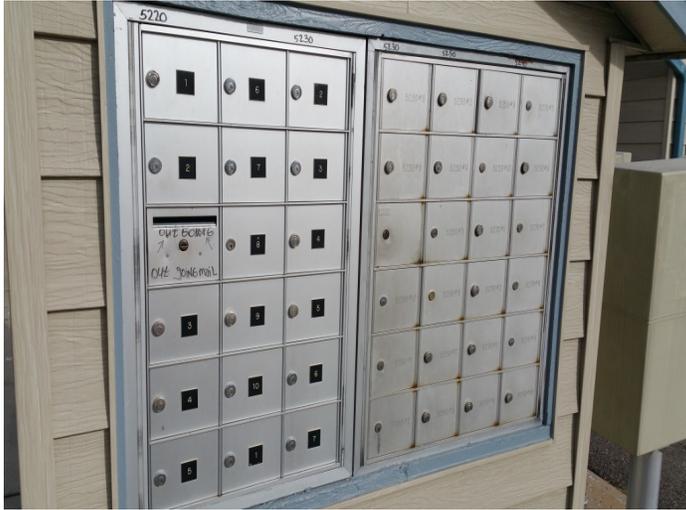
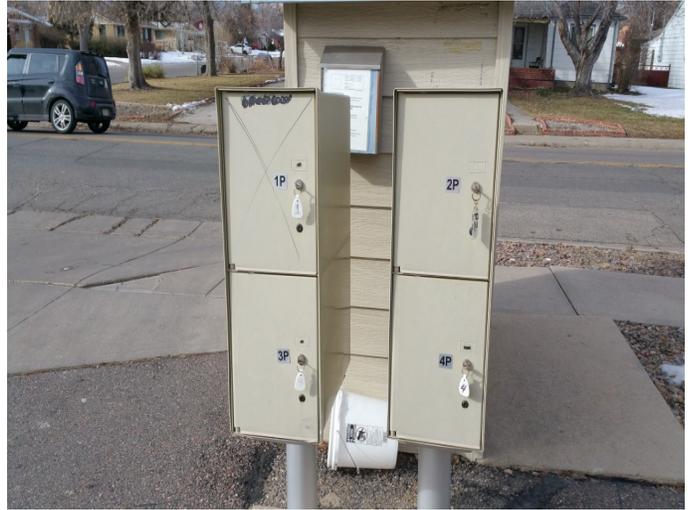
Comp #: 803 Mailboxes - Replace

- Based on our experience, these boxes will have a life expectancy of 20 - 30 years due to location and quality.
- Remaining life is based on age and observed condition.

\$1650/CBU, \$1000/parcel; Average est to replace

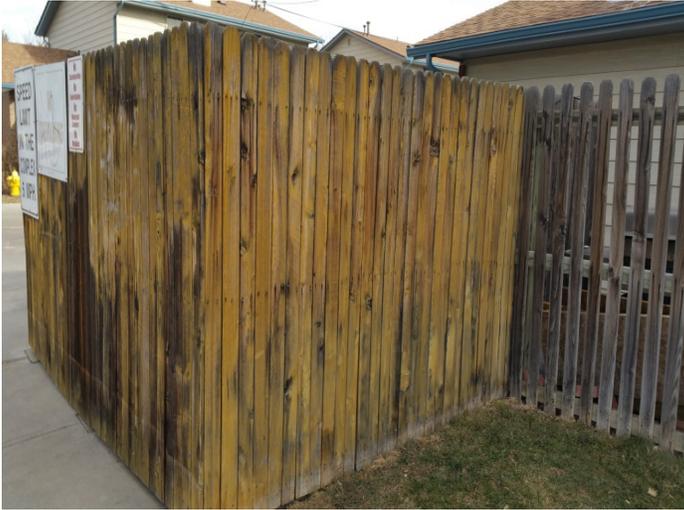
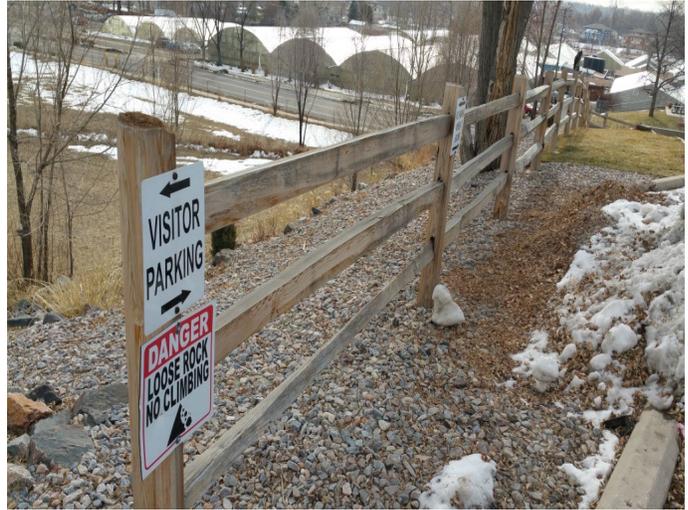
Comp #: 1001 Wood Fencing - Replace

- All privacy fences are different from unit to unit, and not all units contain a privacy fence. Therefore, it is assumed these are the responsibility of each unit.
- The fences included in this item are considered to be the rail fence and the trash enclosures
- The remaining life is based on average conditions for all fences.

Average estimate to replace

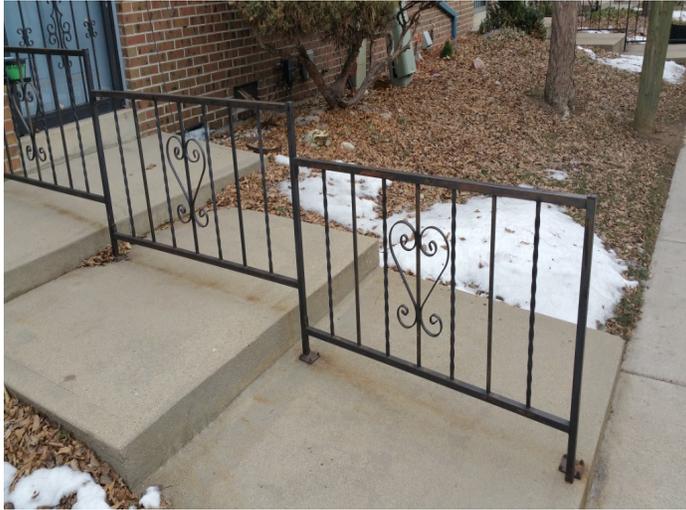
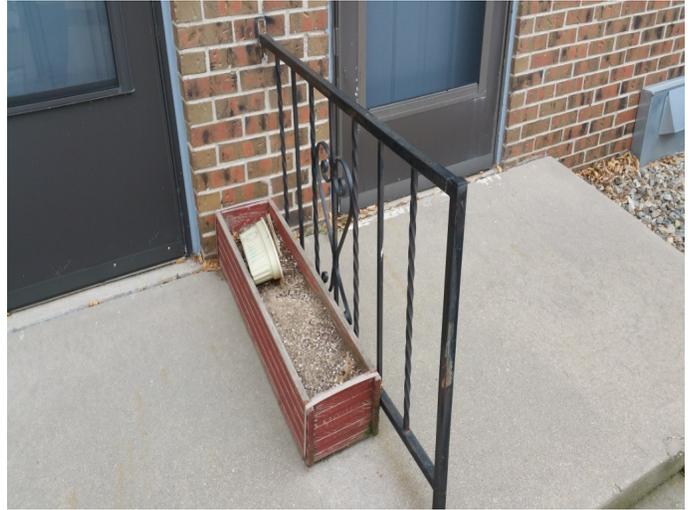
Comp #: 1002 Iron Railing - Replace

- Inconsistent locations throughout the community.
- Assume the responsibility of the individual owners in which these railings serve.
- Therefore, at this time, separate Reserve funding is not required for this component

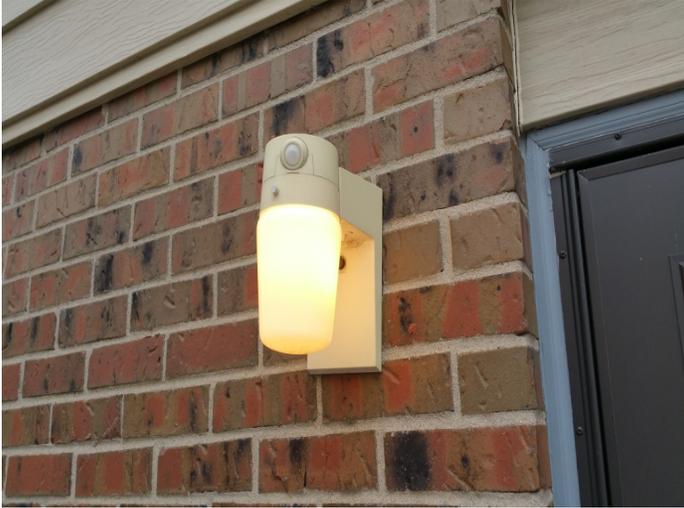
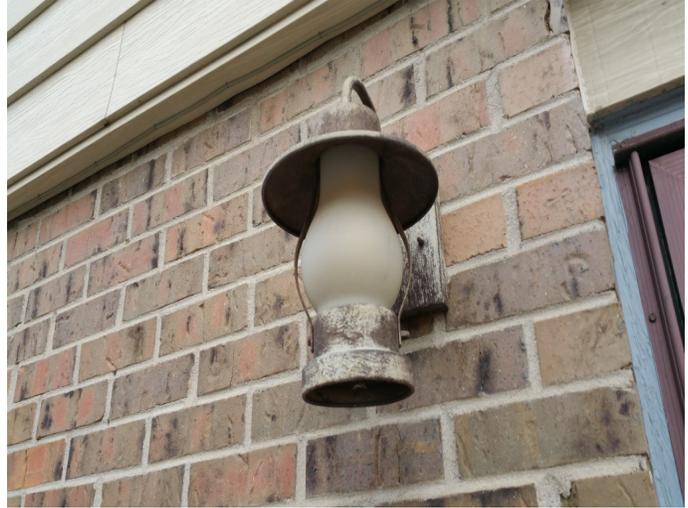
Comp #: 1602 Exterior Wall Mount - Replace

- Fixtures differ from unit to unit.
- Therefore, it is assumed these lights are the responsibility of each owner to replace when necessary.
- Reserve funding is not required for this component at this time unless the association makes a decision to replace as a whole to maintain a consistent appearance.
- If association decides to replace all at the same time, the cost for the replacement will depend on the quality of the fixture installed.

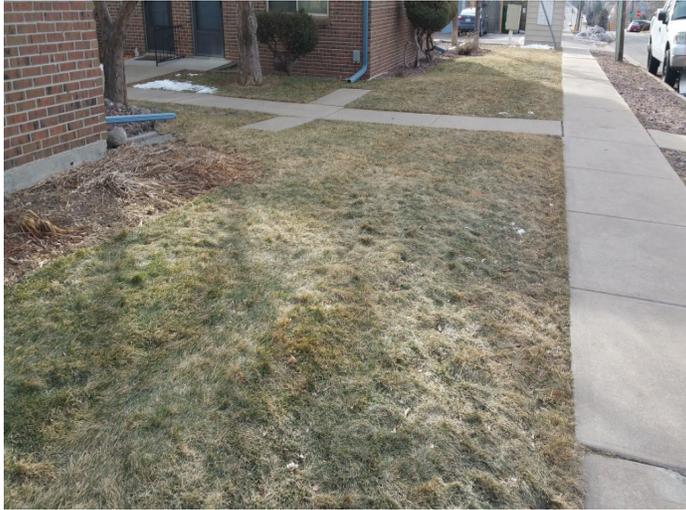
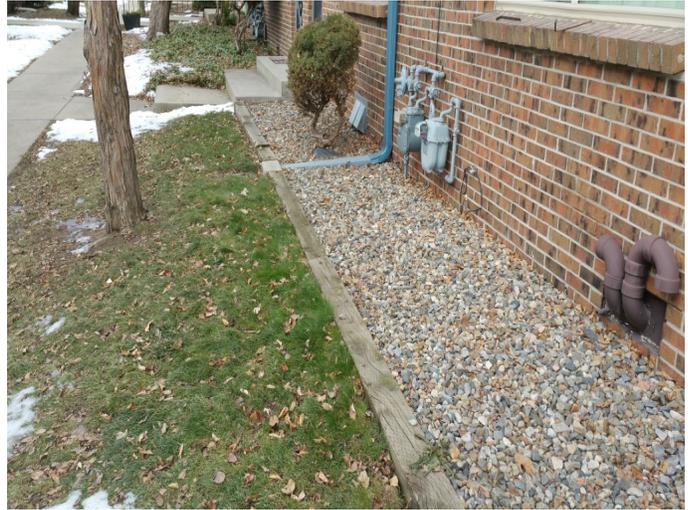
Comp #: 1701 Irrigation System - Partial Rebuild

- This line item is for repairs and replacement that lies outside the scope of routine maintenance: controller replacement, bulk sprinkler head replacement, bulk valve replacement, rerouting lateral lines, rewiring, etc.
- In order to ensure the funds are available for major repairs, we recommend reserving funds for these projects every 4 - 5 years.
- The funding on this line item is for major repairs and is not to be interpreted as complete irrigation system replacement.

Allowance for major repairs and renovating system

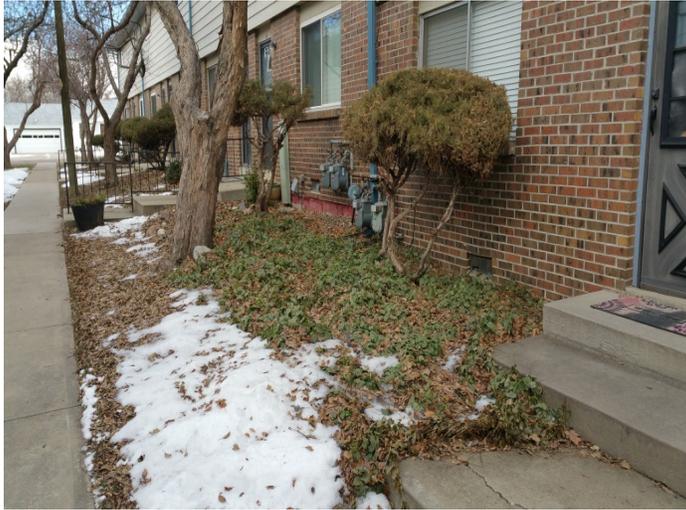
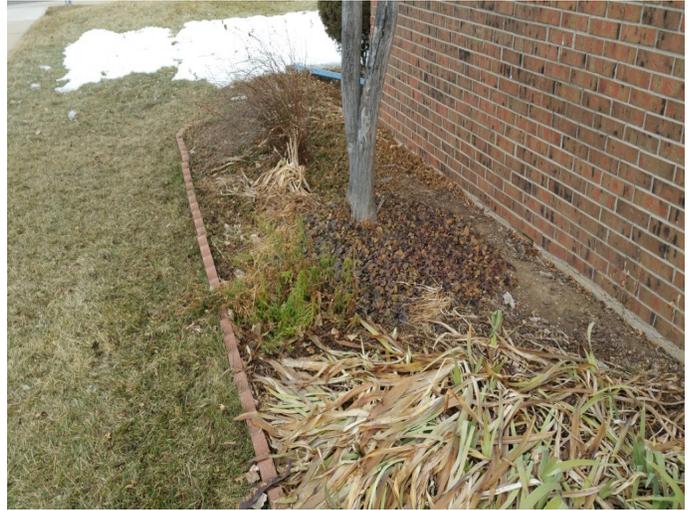
Comp #: 1801 Groundcover - Replenish

- This line item, similar to irrigation repairs, is for projects that lie outside the scope of routine maintenance.
- In order to preserve an attractive curb appeal and to maintain the health of the plants and shrubs, we recommend reserving for refurbishment projects every 5 - 6 years.
- This line item is for cyclical refurbishment and should not be considered as complete landscaping replacement.

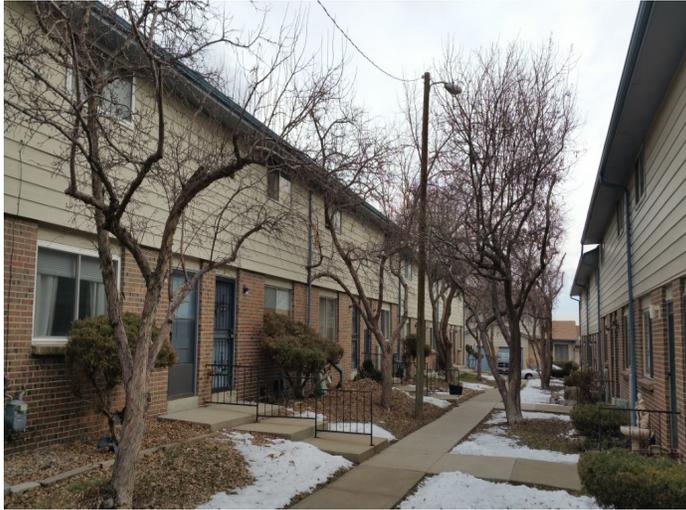
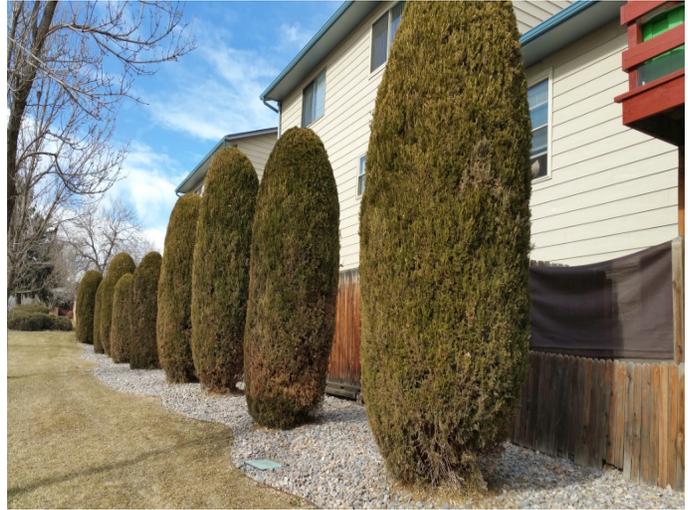
Comp #: 1804 Tree - Replacement

- Trees appeared to be healthy and in good condition at time of site evaluation.
- It is very difficult to predict a replacement cycle for trees as there are several factors such as disease, infestation of insects, heavy snow storms, etc. can all attribute to eventual tree replacement.
- Since it is difficult to predict when the replacement will be necessary, Reserve funding is typically not a factor.
- Therefore, unless requested by the association, Reserve funding will not be included as part of the study for this component.

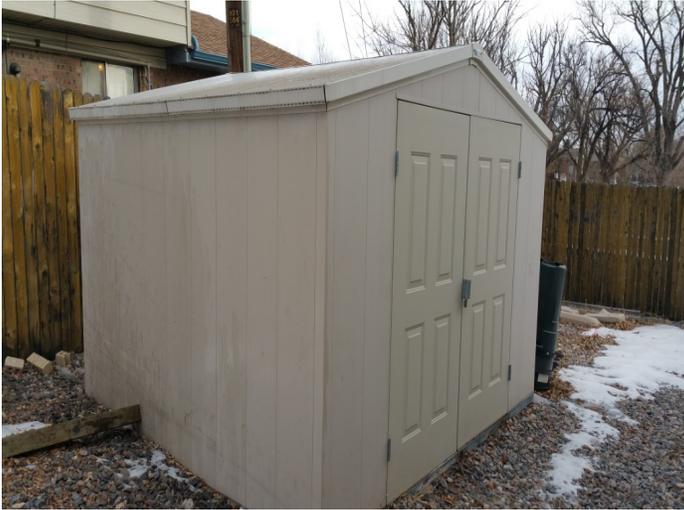
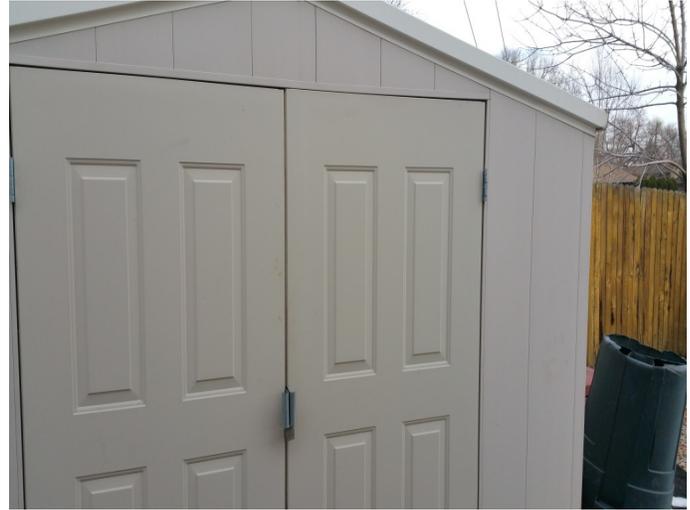
Comp #: 1904 Storage Shed - Replace

- The average life expectancy for these sheds typically ranges from 15 - 20 years under normal conditions.
- The remaining life is based on the observed condition and assumed age of the unit.

Estimate to replace with similar quality
