ARTI Home Inspections, LLC
Property Inspection Report

1234 Anywhere St., Anywhere PA, 19000
Inspection prepared for: John Doe & Jane Doe
Inspection Date: 4/10/2010 Time: 1-3:30pm
Weather: Sunny, 60 degrees

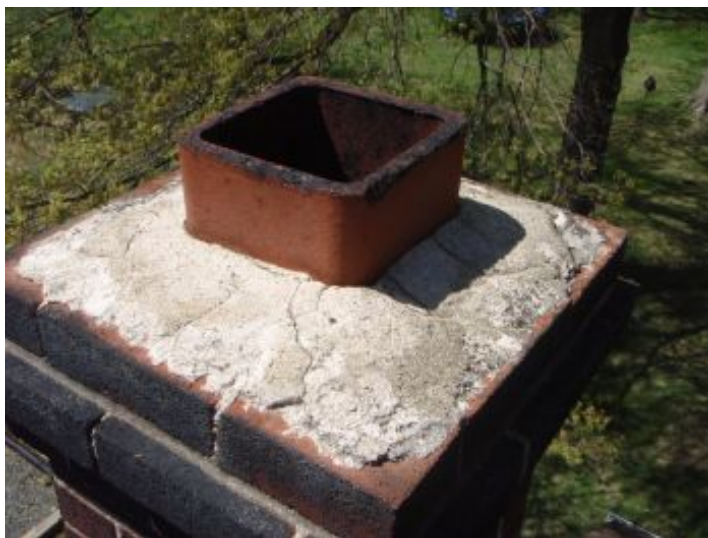
- Raincap missing. A licensed contractor is recommended to add a proper raincap to the chimney flue.
- The chimney crown is cracked. A licensed mason is recommended to repair the crown to prevent future moisture problems.
- **Soot staining noted at the top of the chimney and in the chimney flue. This may be an indication that the heating system is not venting properly. A licensed chimney sweep is recommended to fully evaluate and clean chimney flue. A licensed HVAC contractor is recommended to evaluate and correct any defects in the boiler vent piping, draft and/or burner.**

Soot Staining on the Chimney and Flue

Exterior Areas		
Page 11 Item: 3	Chimney Condition	<ul style="list-style-type: none"> • Soot staining noted at the top of the chimney and in the chimney flue. This may be an indication that the heating system is not venting properly. A licensed chimney sweep is recommended to fully evaluate and clean chimney flue. A licensed HVAC contractor is recommended to evaluate and correct any defects in the boiler vent piping, draft and/or burner.
Garage		
Page 13 Item: 7	120 Volt	<ul style="list-style-type: none"> • The wire sheathing was damaged and improperly repaired at the wire run on the ceiling in the rear section of the garage. A licensed electrician is recommended to replace the damaged wire.
Attic		
Page 16 Item: 5	Exhaust Vent	<ul style="list-style-type: none"> • Exhaust fan duct appears to terminate in attic. Bath fans venting into the attic can increase moisture levels and cause possible mold problems. A licensed roofer is recommended to run bath fan to the exterior of the house.

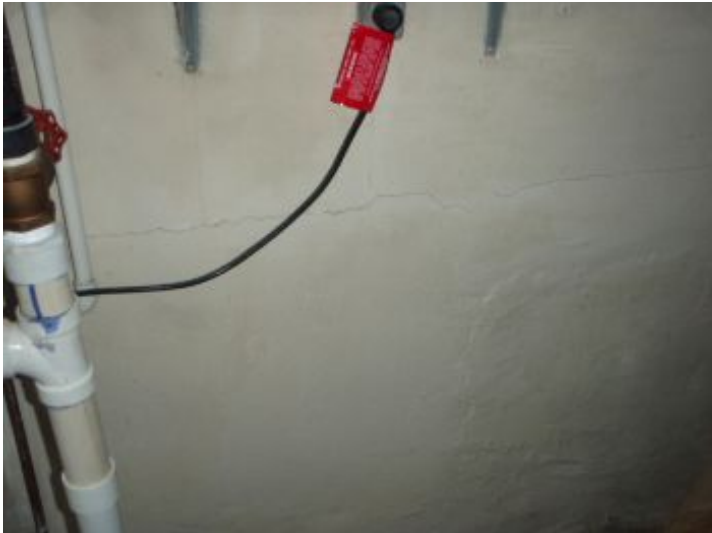
- I was unable to fully evaluate the foundation wall because surface finishes in the basement block access to the foundation wall in the front section of the basement.
- Signs of minor moisture seepage noted.
- The parging shows signs of moderate deterioration. Regular maintenance and repairs is recommended.
- **Horizontal cracking noted in the rear and west facing foundation walls. This is an indication that the foundation walls have been compromised and are bulging. This can happen from hydrostatic pressure from moisture buildup behind the foundation walls. A licensed structural engineer is recommended to fully evaluate the foundation walls. A licensed basement water proofing company is recommended to fully evaluate and correct the exterior drainage.**

Horizontal Cracking Noted in Foundation Wall

Foundation		
Page 17 Item: 1	Foundation Condition	<ul style="list-style-type: none"> • Horizontal cracking noted in the rear and west facing foundation walls. This is an indication that the foundation walls have been compromised and are bulging. This can happen from hydrostatic pressure from moisture buildup behind the foundation walls. A licensed structural engineer is recommended to fully evaluate the foundation walls. A licensed basement water proofing company is recommended to fully evaluate and correct the exterior drainage.
Heat		
Page 23 Item: 3	Venting	<ul style="list-style-type: none"> • An improperly designed damper that can block proper venting was installed in the vent pipe and the oil burning system is missing a proper barometric damper. A licensed HVAC contractor is recommended to fully evaluate and correct all defects in the vent pipe. • The insulation paper located on the vent pipe may contain asbestos. The material was damaged at the time of inspection. This is a possible safety hazard. Suggest further review by a licensed asbestos testing lab be performed prior to closing for repairs/replacement needed to ensure safety.

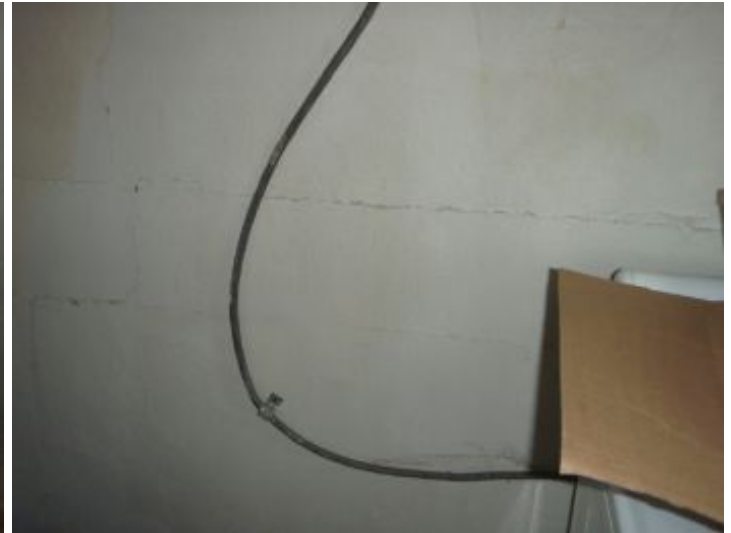
Horizontal Crack in Foundation Wall

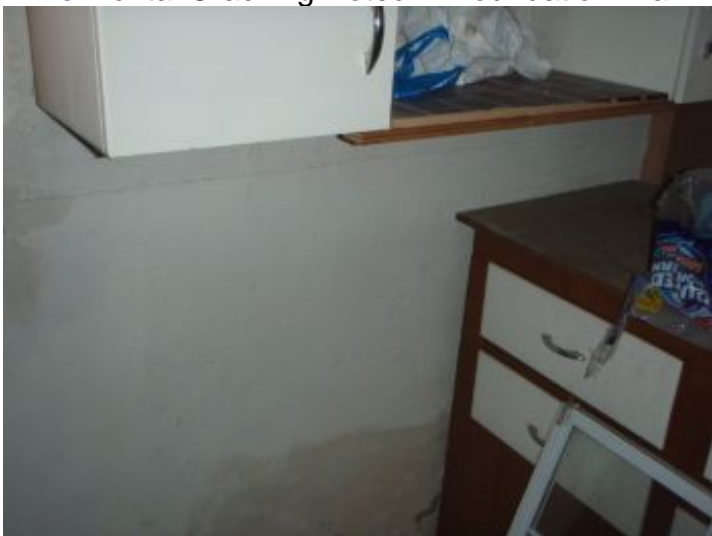
Horizontal Crack in Foundation Wall

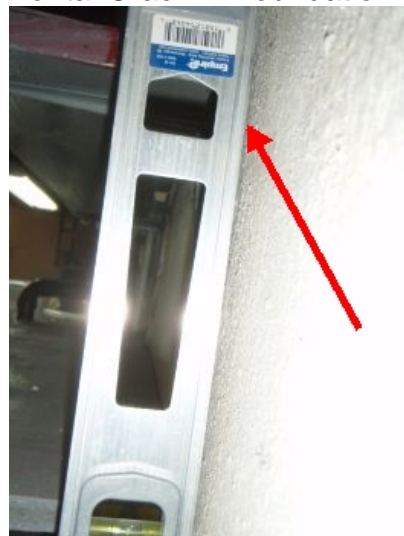
Bulging Foundation Wall

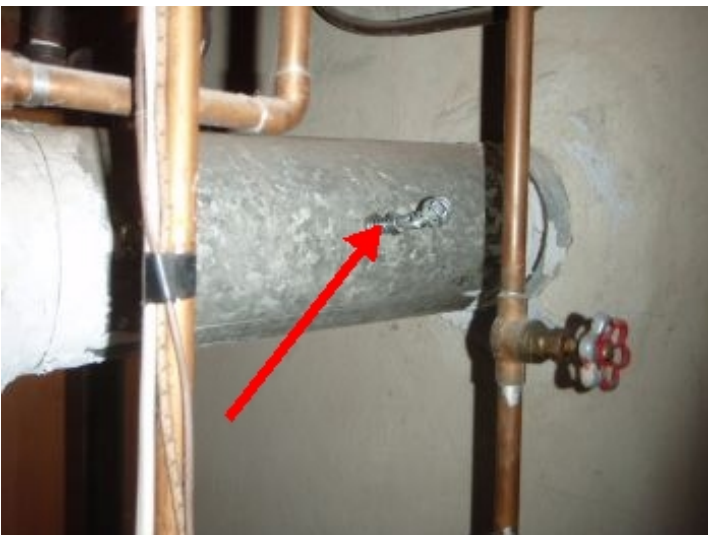
- Vent was not fully visible.
- An improperly designed damper that can block proper venting was installed in the vent pipe and the oil burning system is missing a proper barometric damper. A licensed HVAC contractor is recommended to fully evaluate and correct all defects in the vent pipe.
- The insulation paper located on the vent pipe may contain asbestos. The material was damaged at the time of inspection. This is a possible safety hazard. Suggest further review by a licensed asbestos testing lab be performed prior to closing for repairs/replacement needed to ensure safety.

Improper Damper Installed at Boiler Vent Pipe

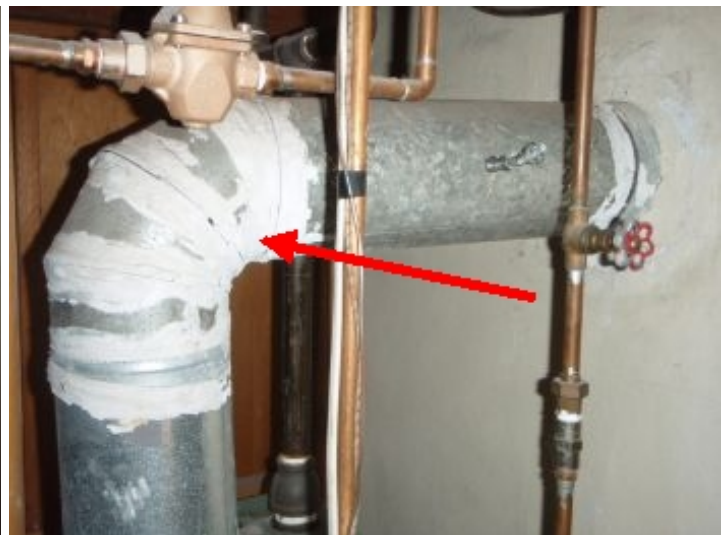
Possible Asbestos Containing Material on Vent Pipe

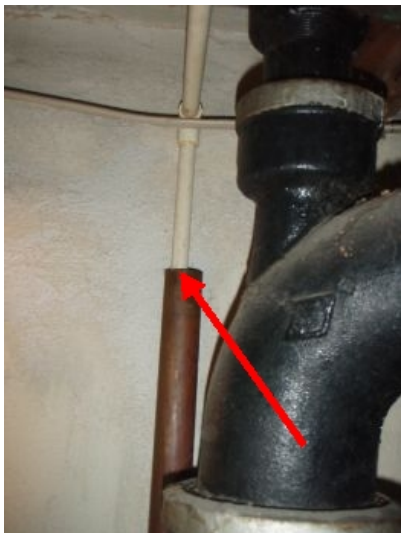
- Minor corrosion noted in the basement.
- **Cross connection noted at the water softener and the neutralizer backwash drains. There should be a proper air gap between the backwash drain lines and the laundry sink and trapped drain above the sink.**

Possible Cross Connection - No Air Gap Between Backwash and Drainpipe

Plumbing		
Page 24 Item: 2	Supply Lines	<ul style="list-style-type: none"> • Cross connection noted at the water softener and the neutralizer backwash drains. There should be a proper air gap between the backwash drain lines and the laundry sink and trapped drain above the sink.
Water Heater		
Page 25 Item: 2	Plumbing	<ul style="list-style-type: none"> • No mixing or tempering valve was located at the hot water supply line off the boiler. The boiler can get very hot and produce scalding temperatures during the winter. A licensed plumber is recommended to add a proper tempering valve.

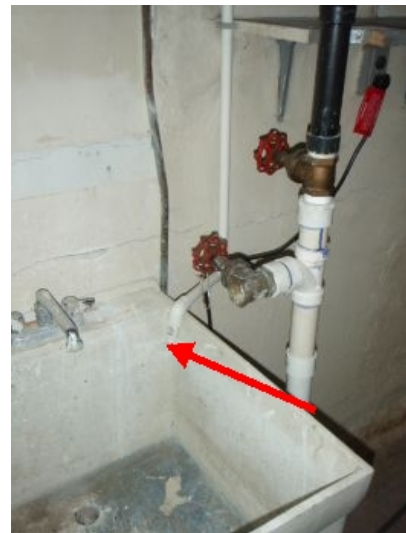
Possible Cross Connection - No Air Gap Between Backwash and Sink Floodline

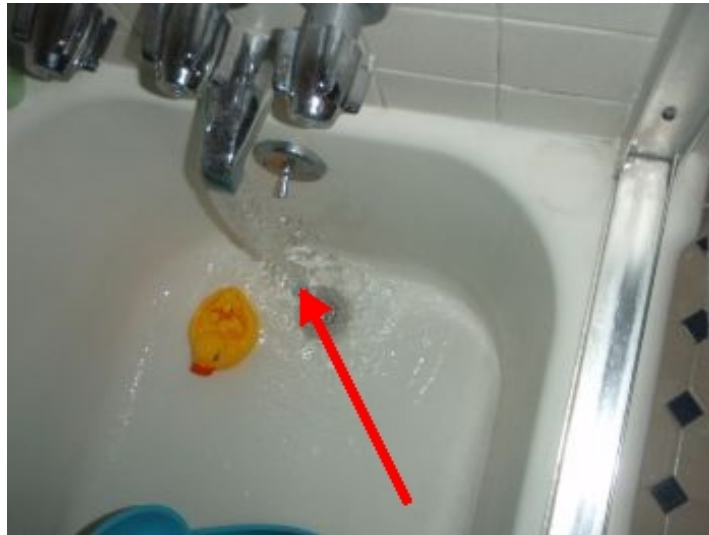
- Tub has been refinished. The finishing is deteriorating and chipped. A licensed bathroom refinisher is recommended to evaluate and properly refinish or replace bathtub.

Tub Finish is Deteriorating

Bathroom 1		
Page 27 Item: 10	Bath Tubs	<ul style="list-style-type: none">• Tub has been refinished. The finishing is deteriorating and chipped. A licensed bathroom refinisher is recommended to evaluate and properly refinish or replace bathtub.
