City of Northfield Downtown Preservation Design Guidelines

Prepared for
The Northfield Heritage Preservation Commission

THOMAS R. ZAHN & ASSOCIATES

AUGUST 2004

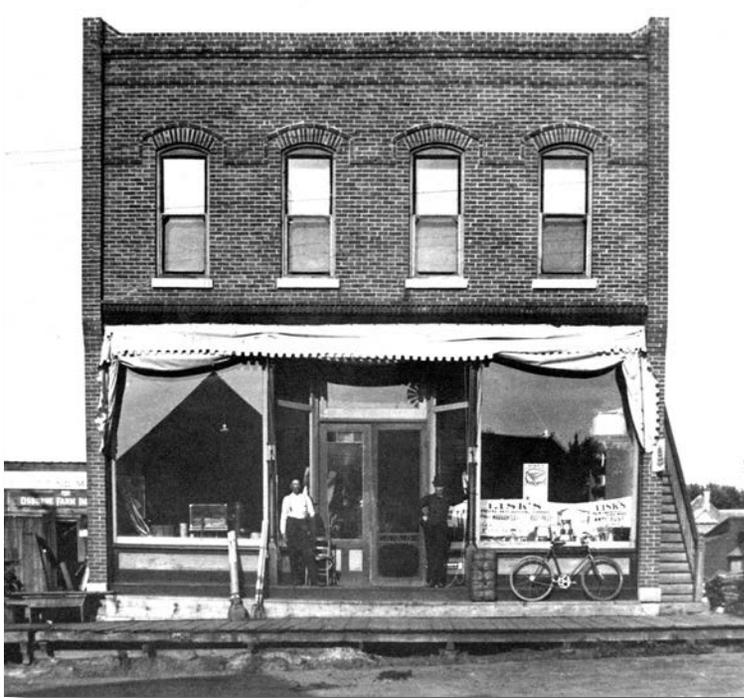
Note the large, oversized display windows, the bulkhead below and the retractable, canvas awning above.

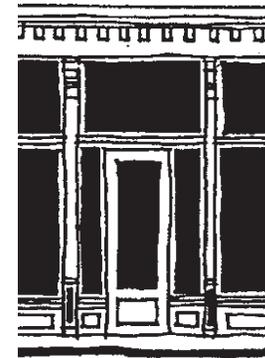
Original storefront doors were typically recessed, constructed of wood with a large window above a single or double panel that complemented the bulkhead design below the display windows

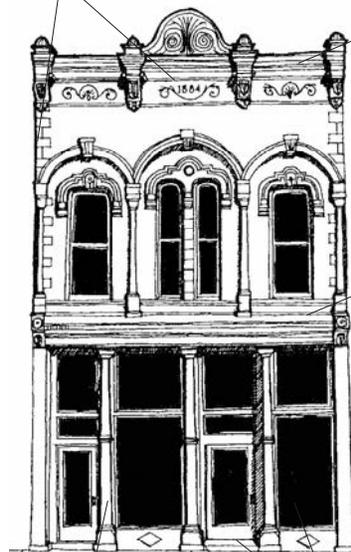
Building Cornice
Visually crowns the building

Storefront Cornice
Visually crowns the storefront

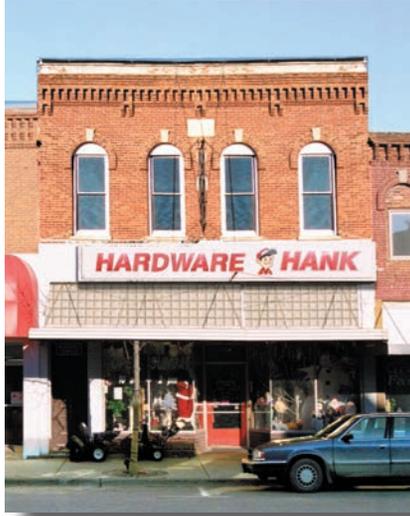
Backlit plastic signs and underlit awnings with lettering are inappropriate for historic buildings.

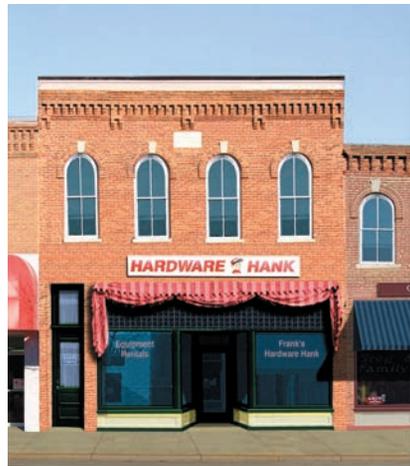
Flat signboards, low-profile projecting signs, painted lettering on the display windows and awning valance are appropriate.

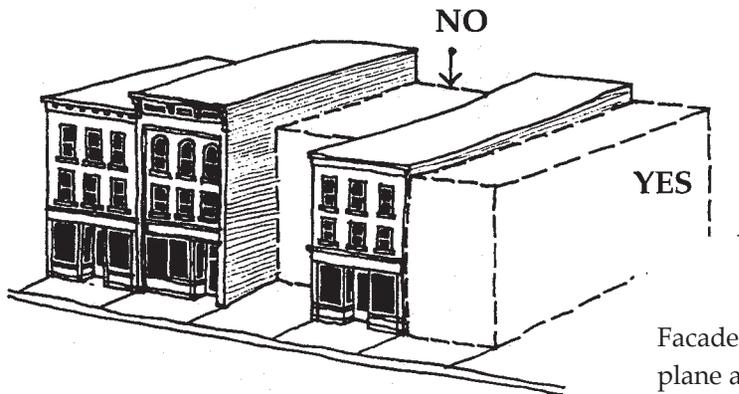
The new facade should be flush with its neighbors.

Facade is set on the same plane as the adjacent buildings

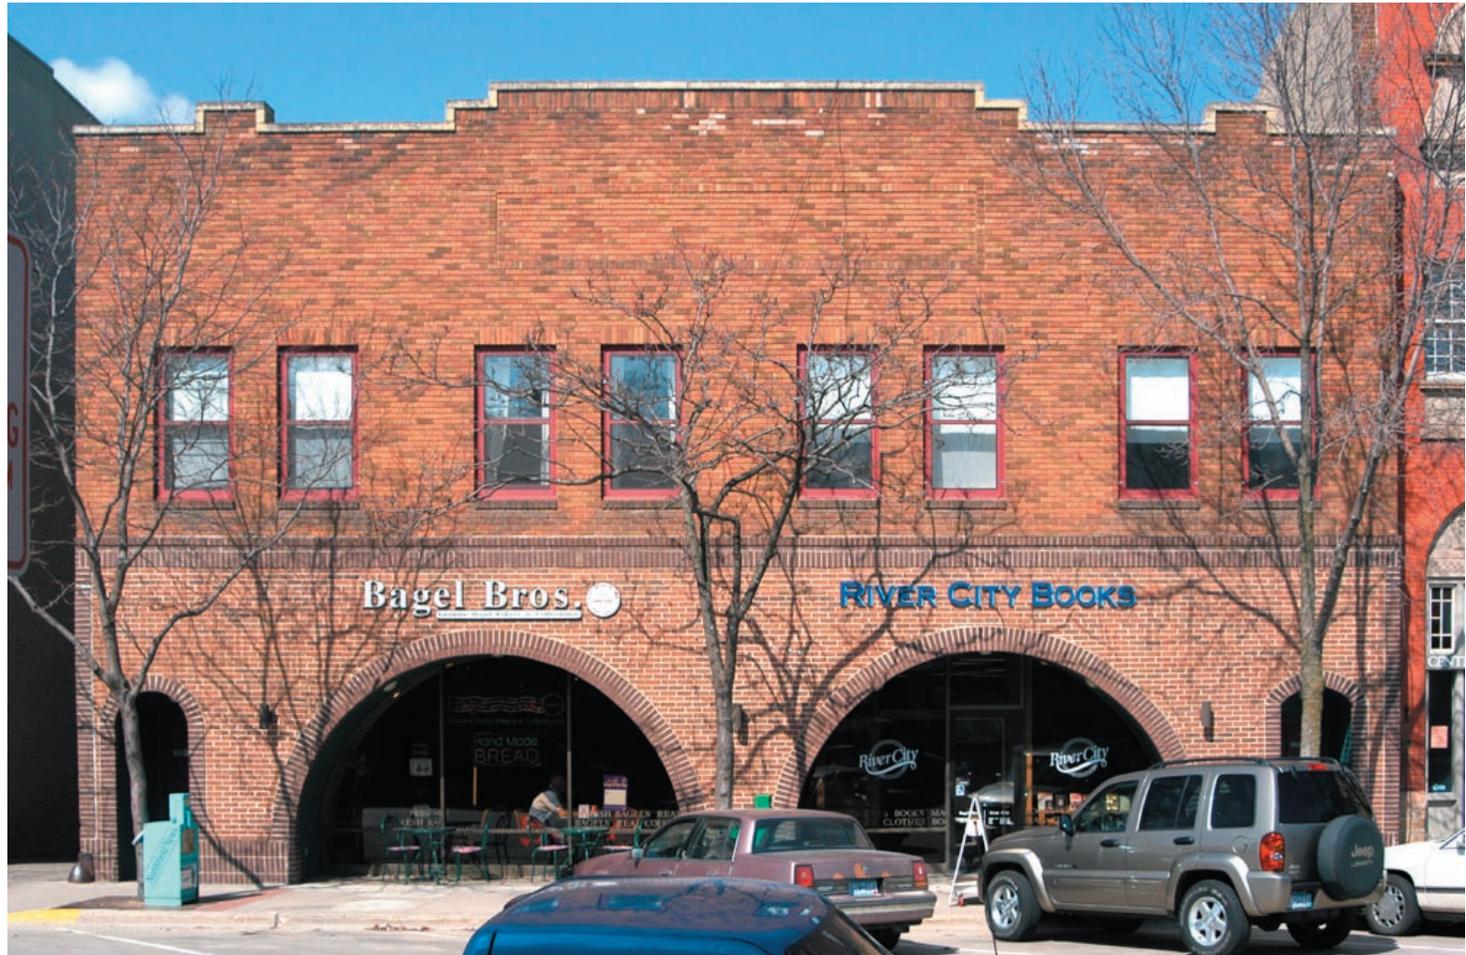
EXISTING CONDITION

The original storefront has been removed and replaced with a modern treatment. The building probably displayed two storefronts with side entrances to the second story units.

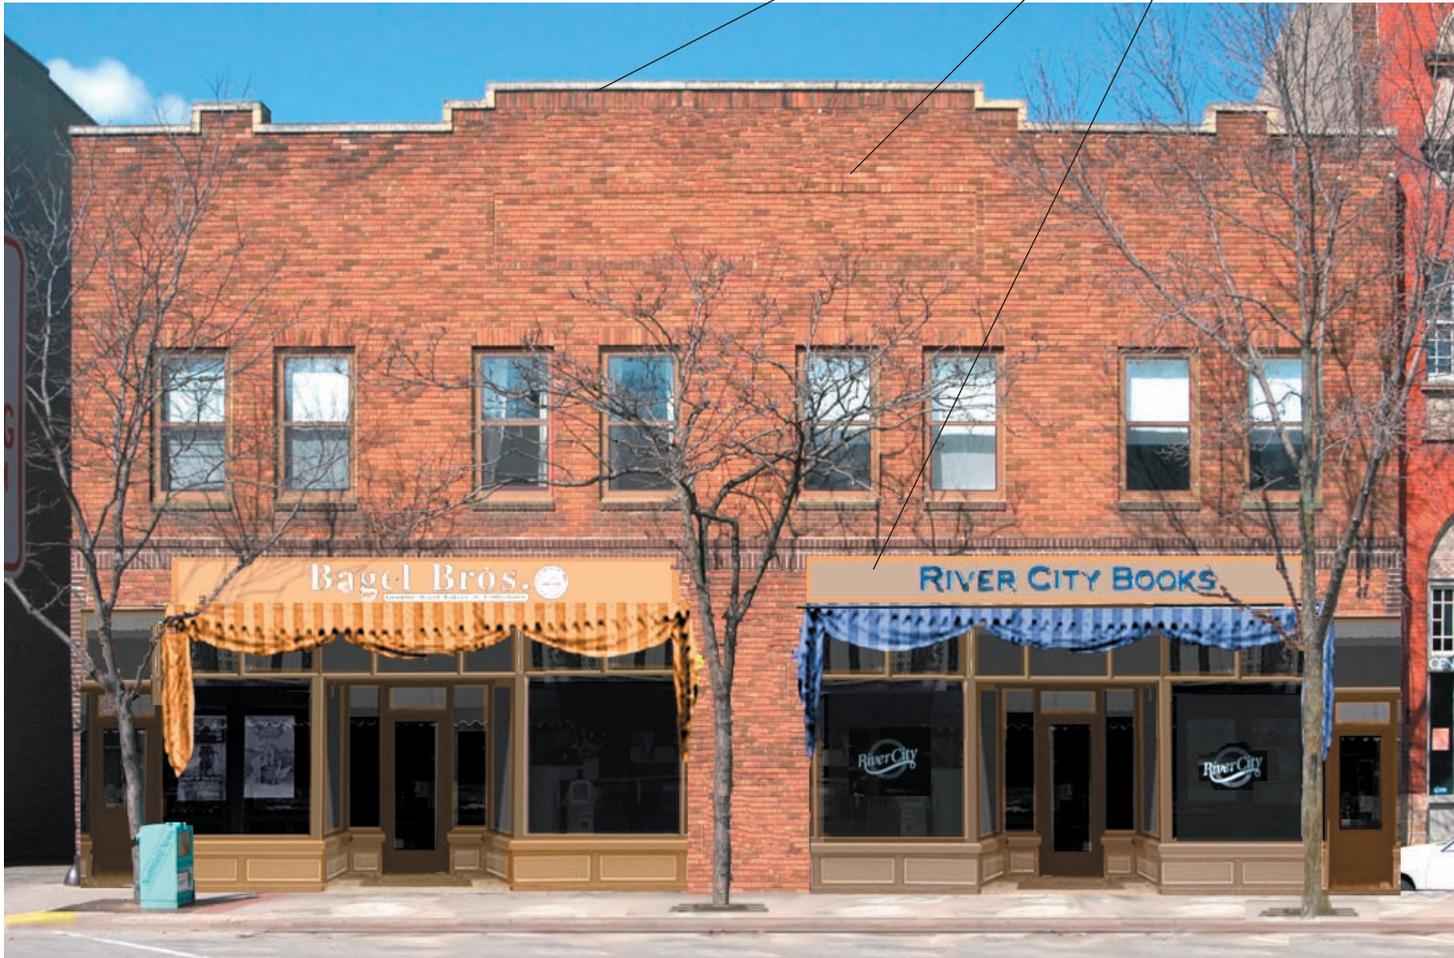
PROPOSED RENOVATION

Place signage over the transoms and awnings.

Hang retractable canvas awnings over the display windows and the store entrances.

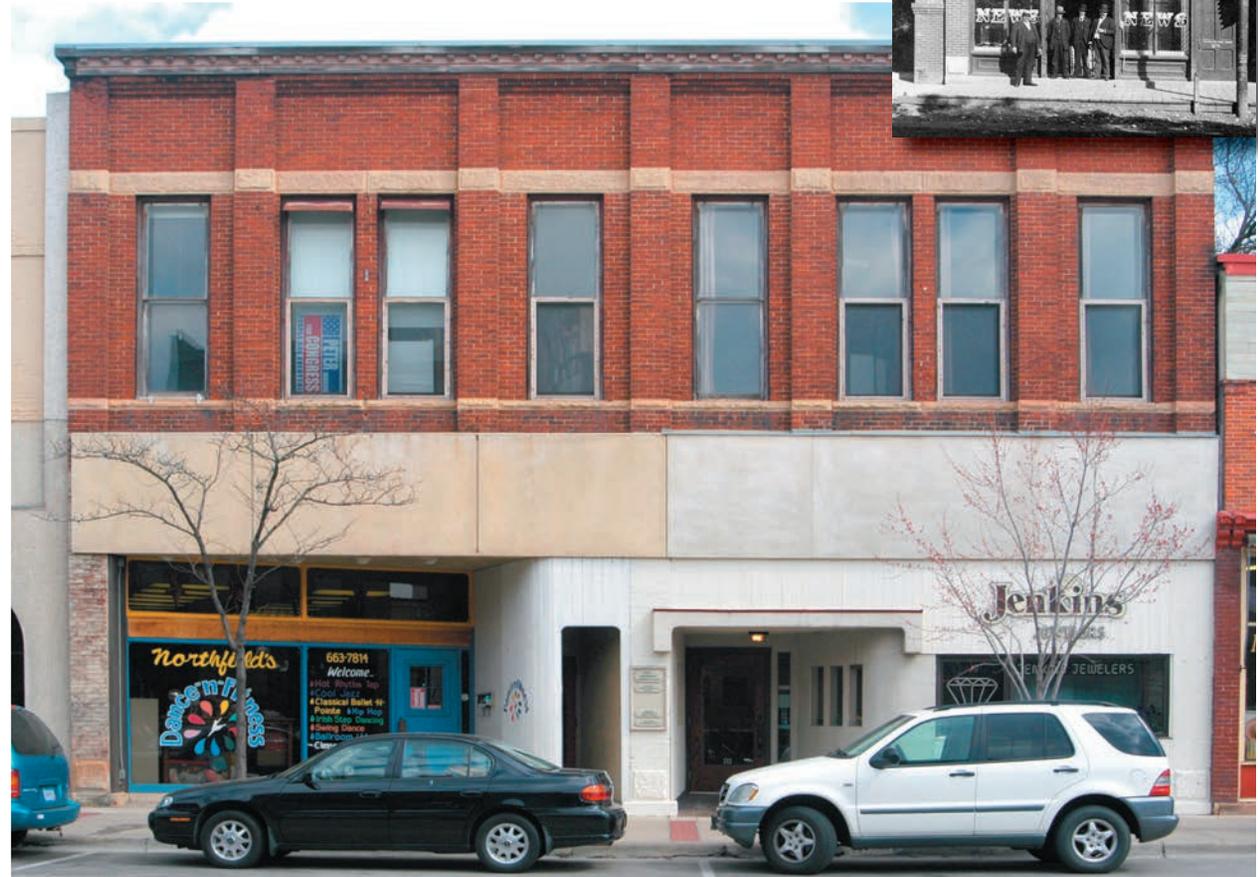
The original storefronts were replaced with the modern compositions in the mid-20th century.

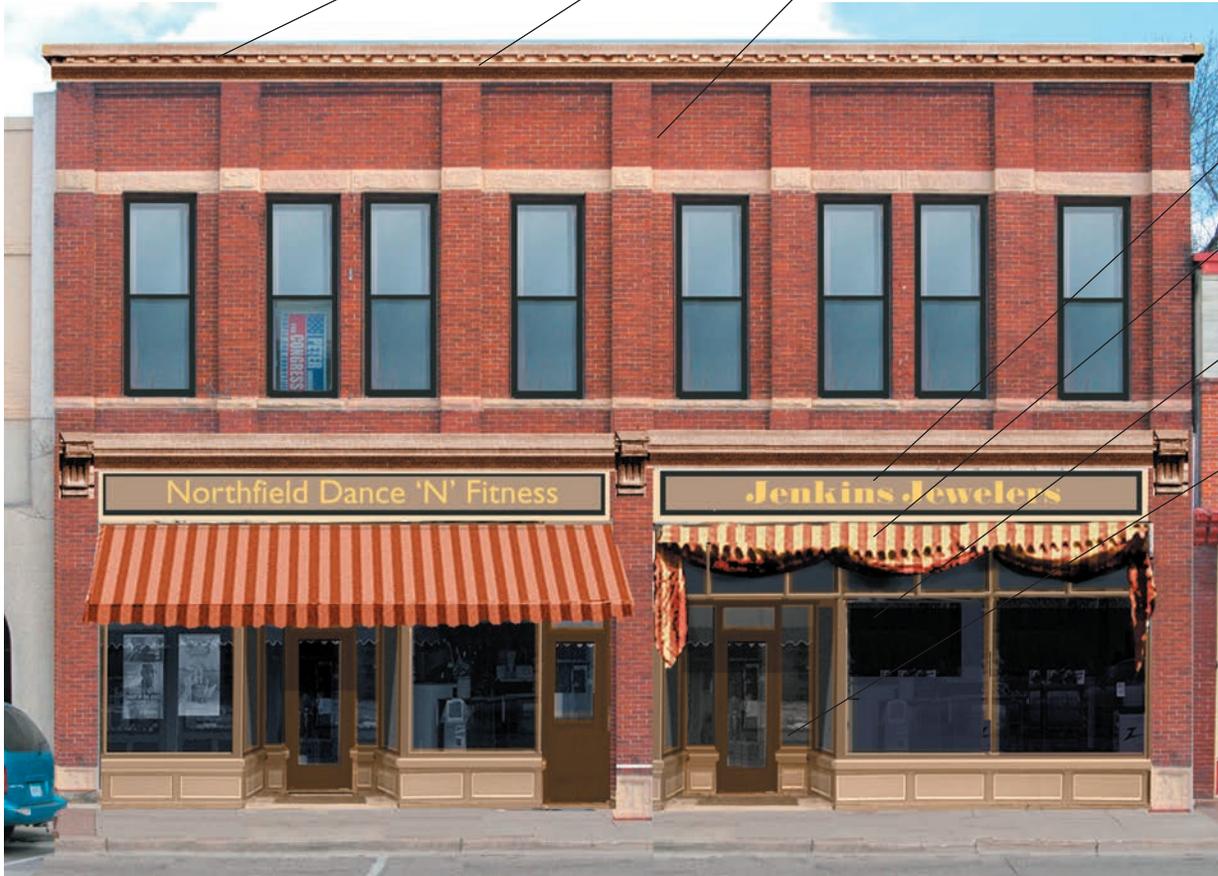
PROPOSED RENOVATION

Repair and repaint existing upper-story windows if possible. Replacement windows should match the original window design in dimensions and profile.

Place signboards over storefront.

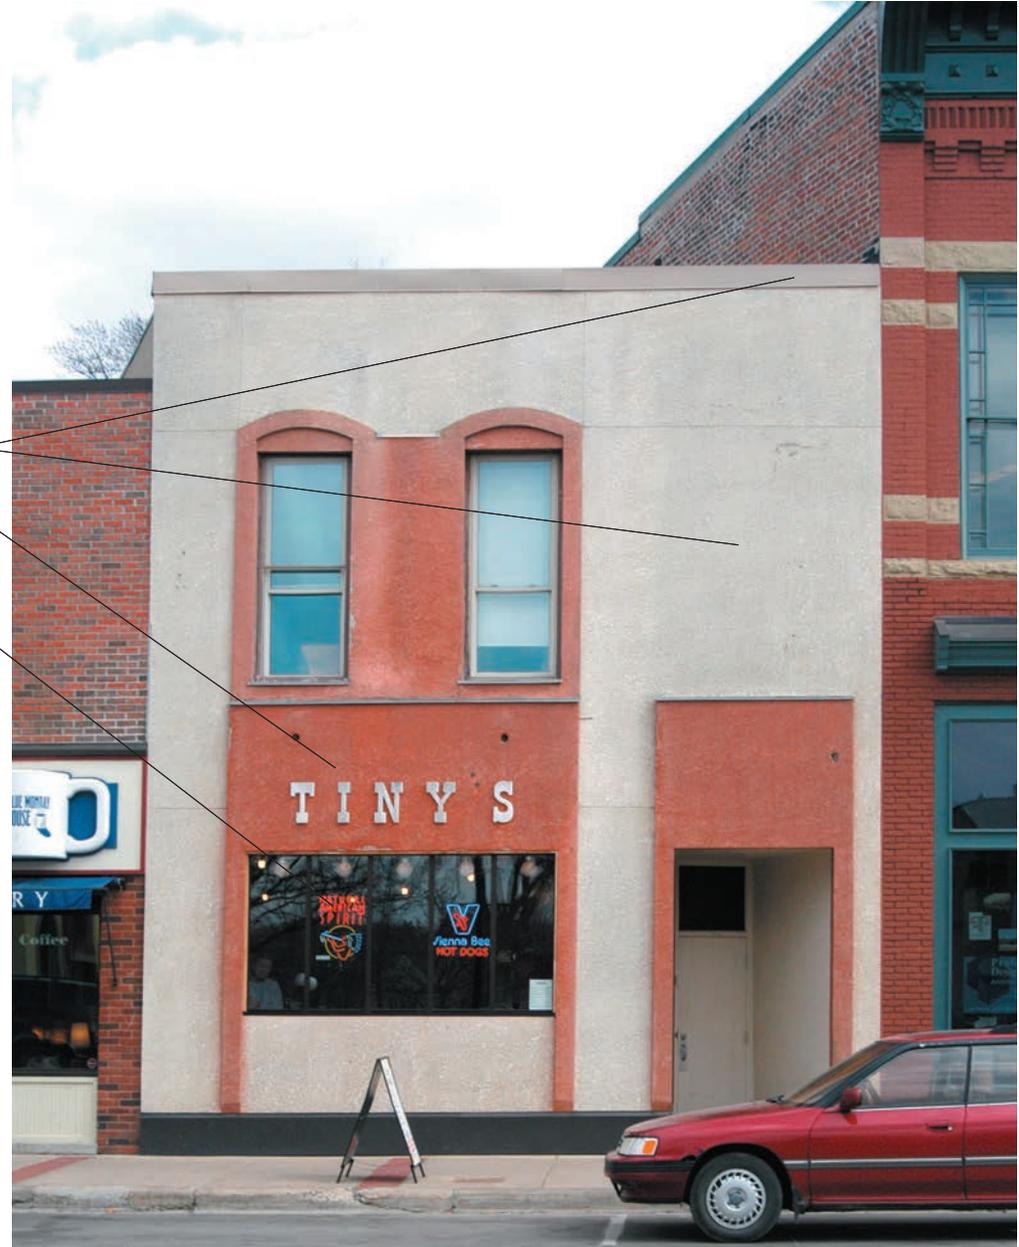
The original storefront has been modified with a down-sized display window.

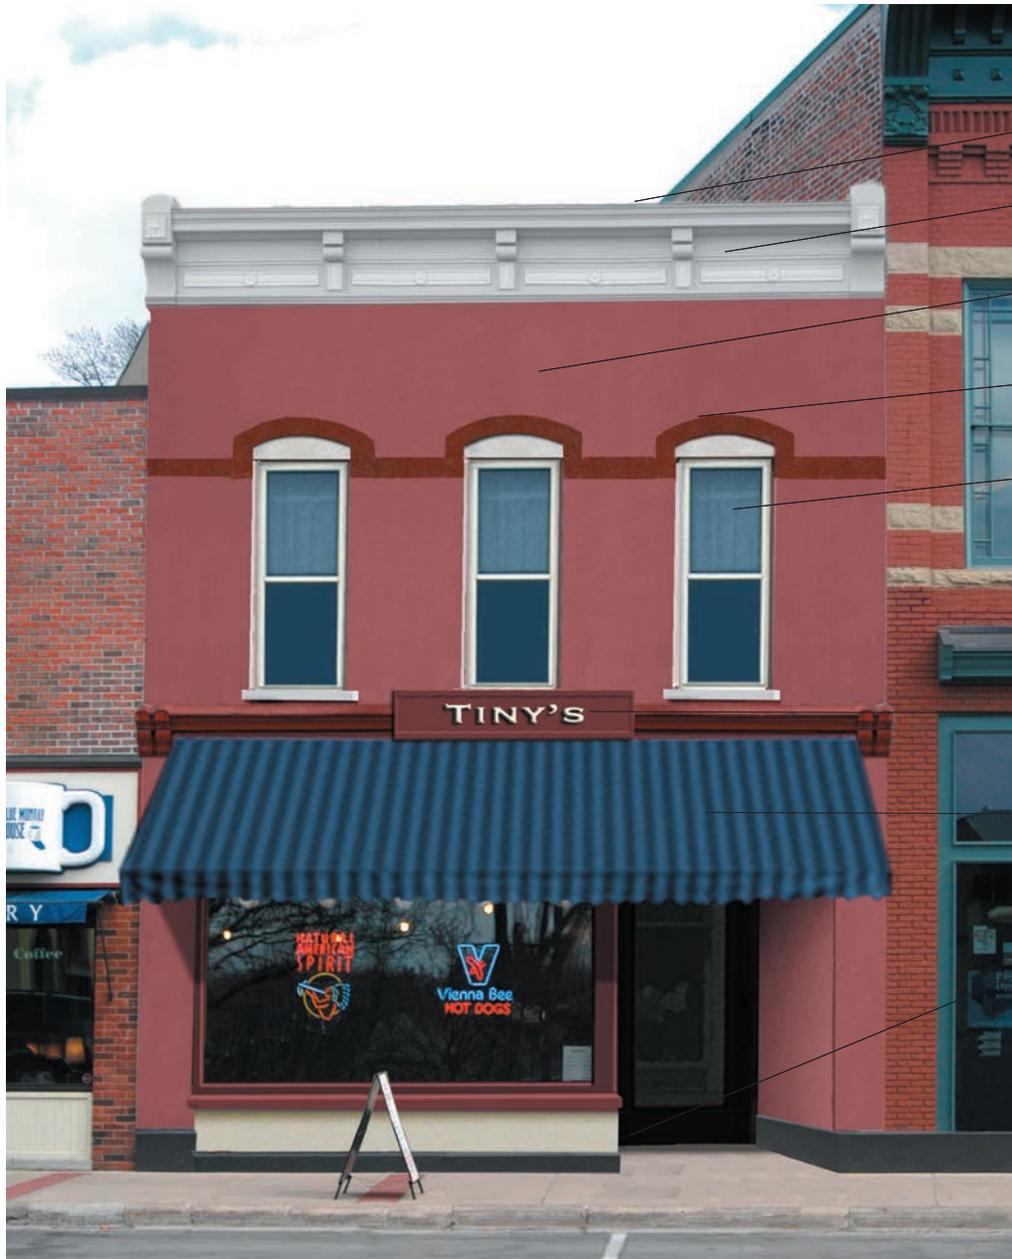
PROPOSED RENOVATION

Inspect roofing and flashing.

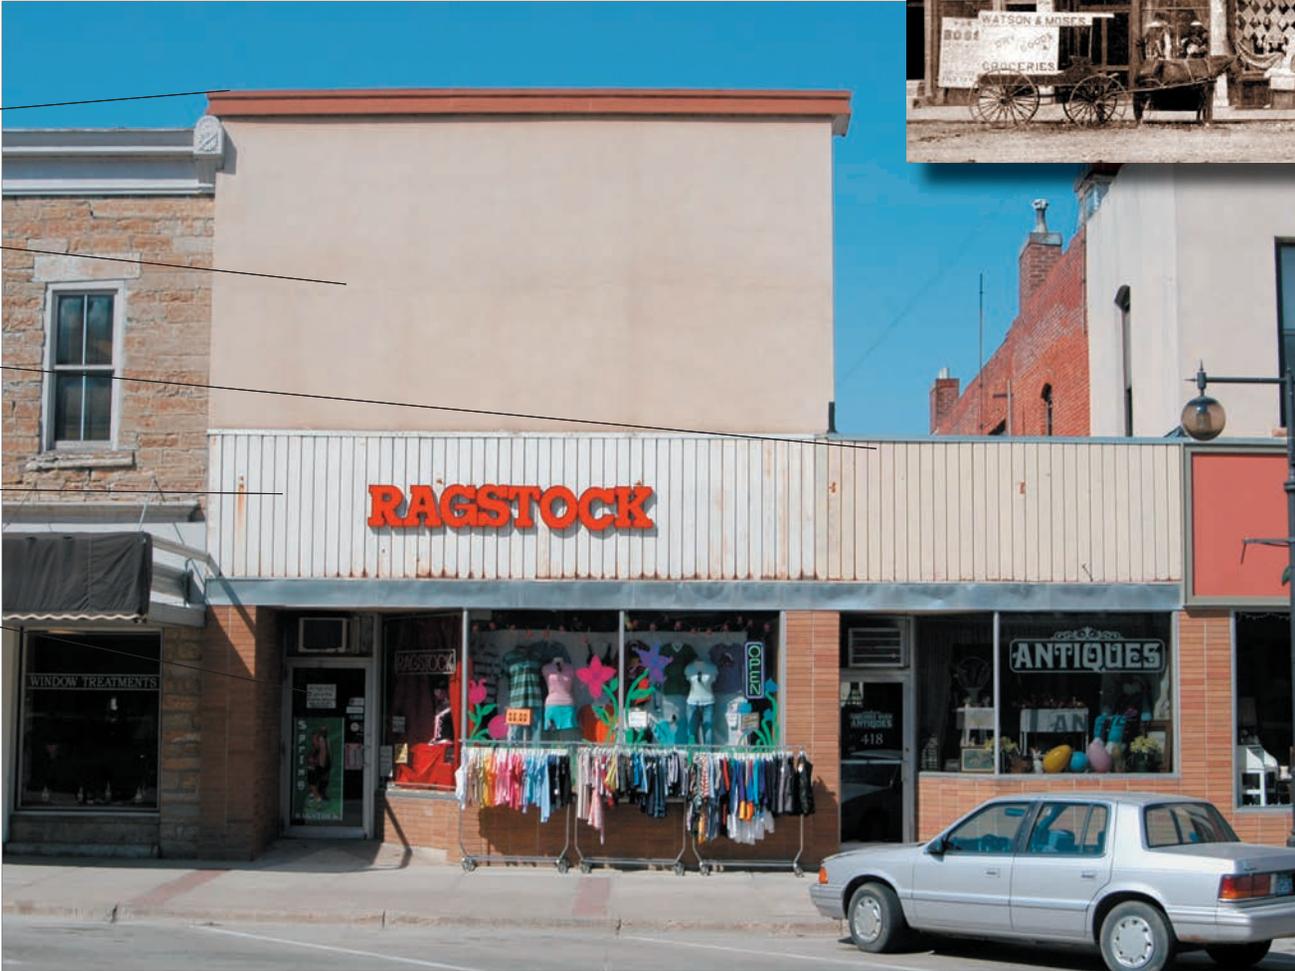
The decorative cornice has been removed and upper-story has been covered with stucco.

Air conditioners project out over the entrances.

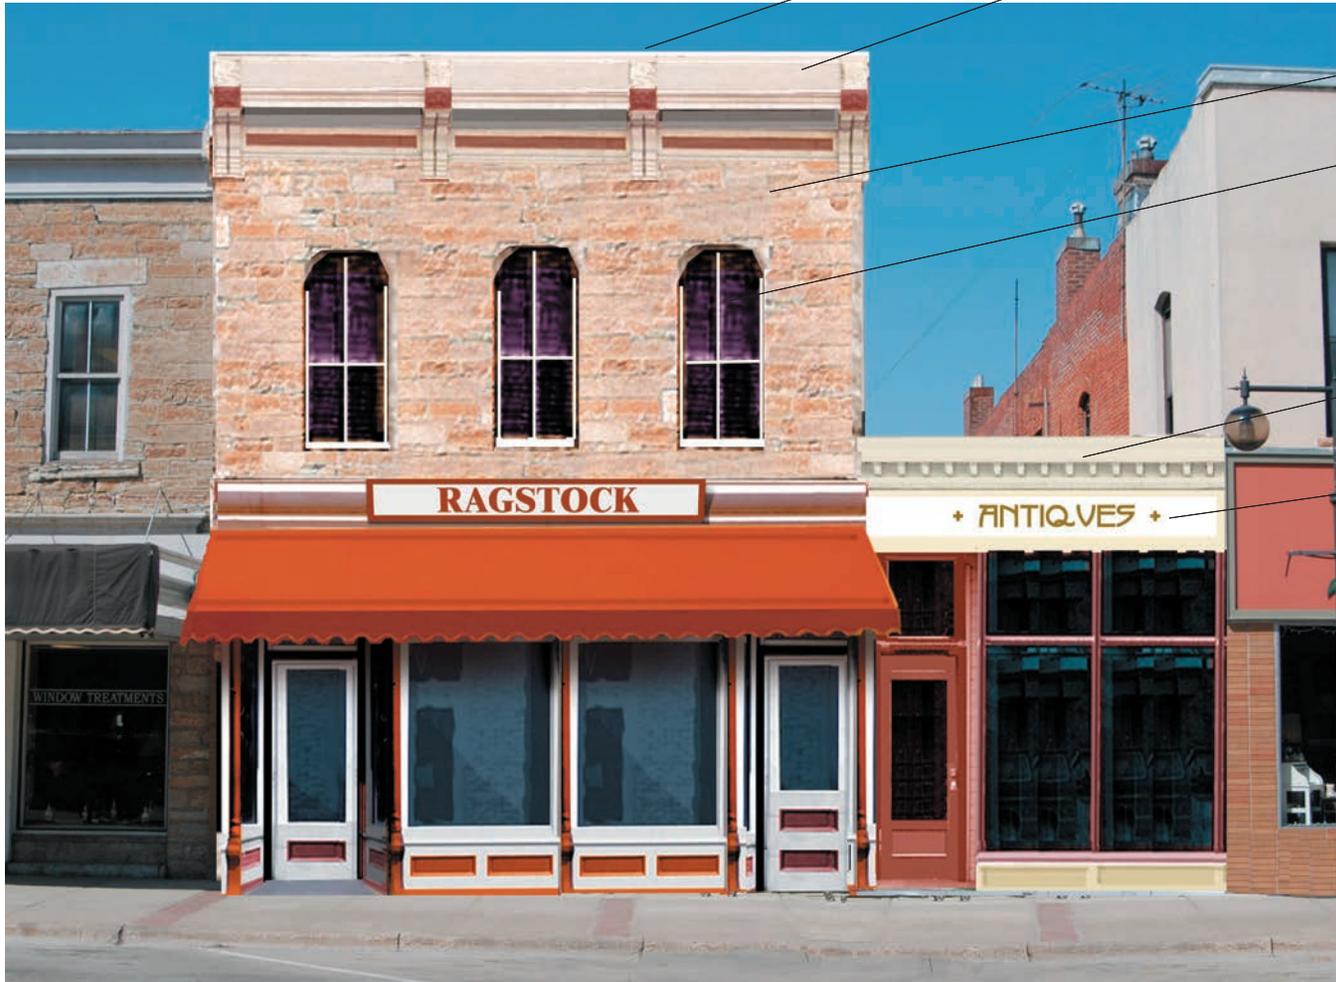
PROPOSED RENOVATION

Inspect roofing and flashing.

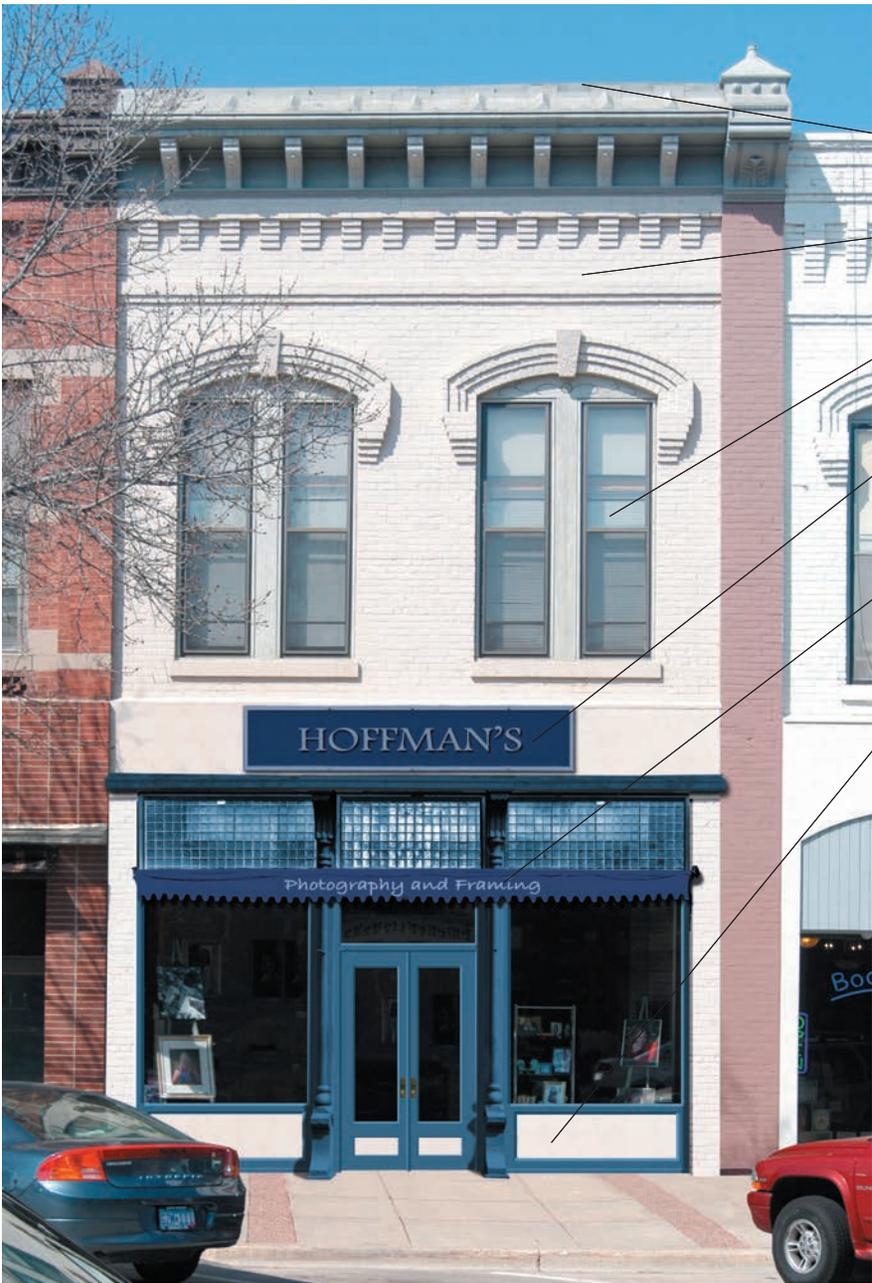
PROPOSED RENOVATION

Inspect roofing and flashing.

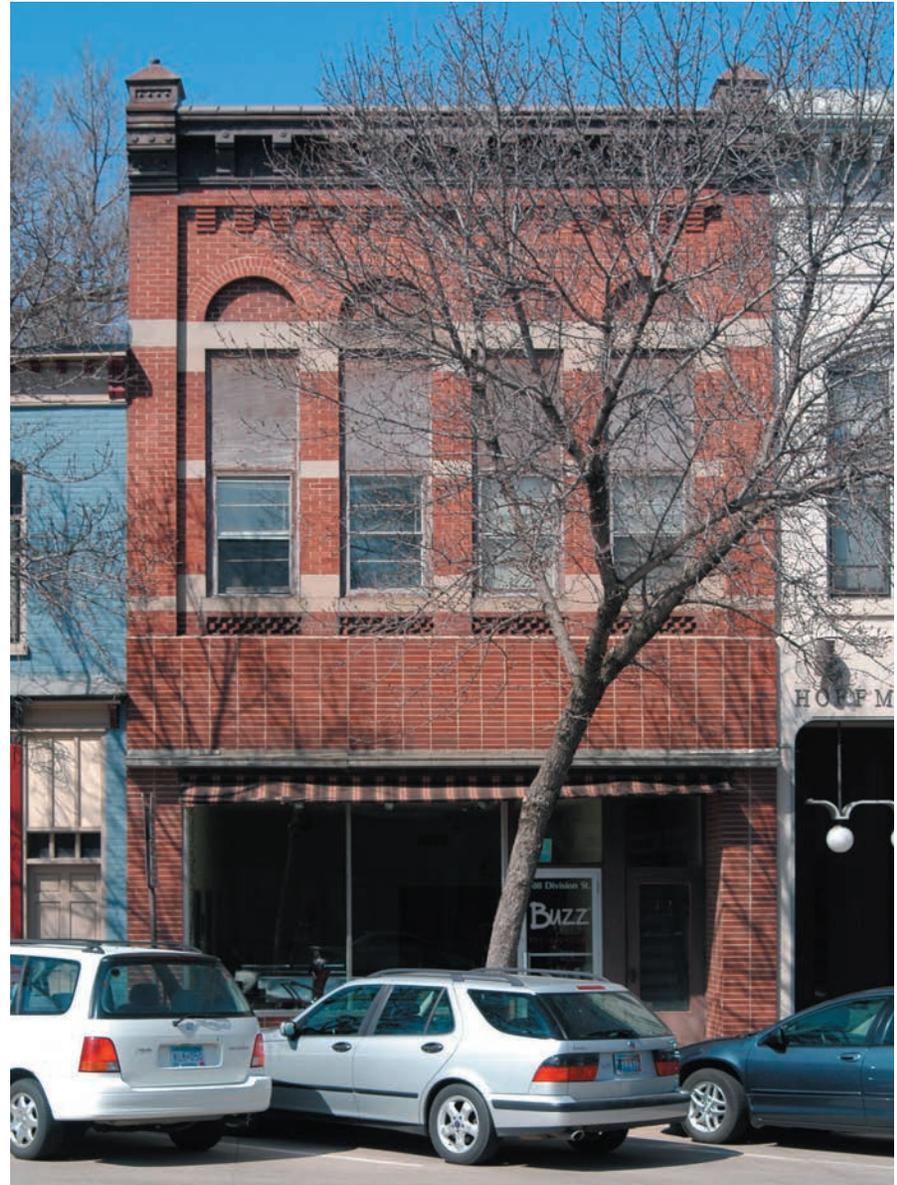
The original storefront has been replaced with a modern, aluminum surround display windows and commercial door.

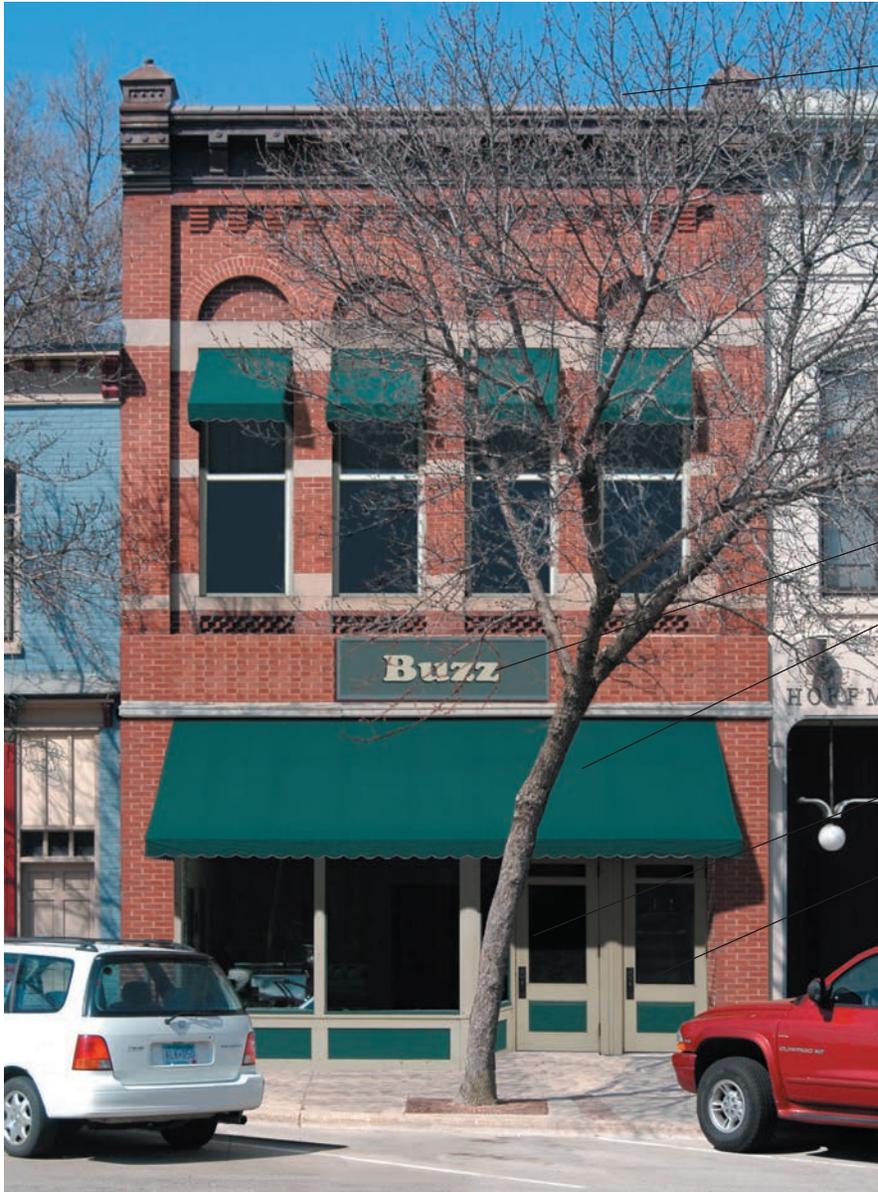
PROPOSED RENOVATION

Inspect roofing and flashing.

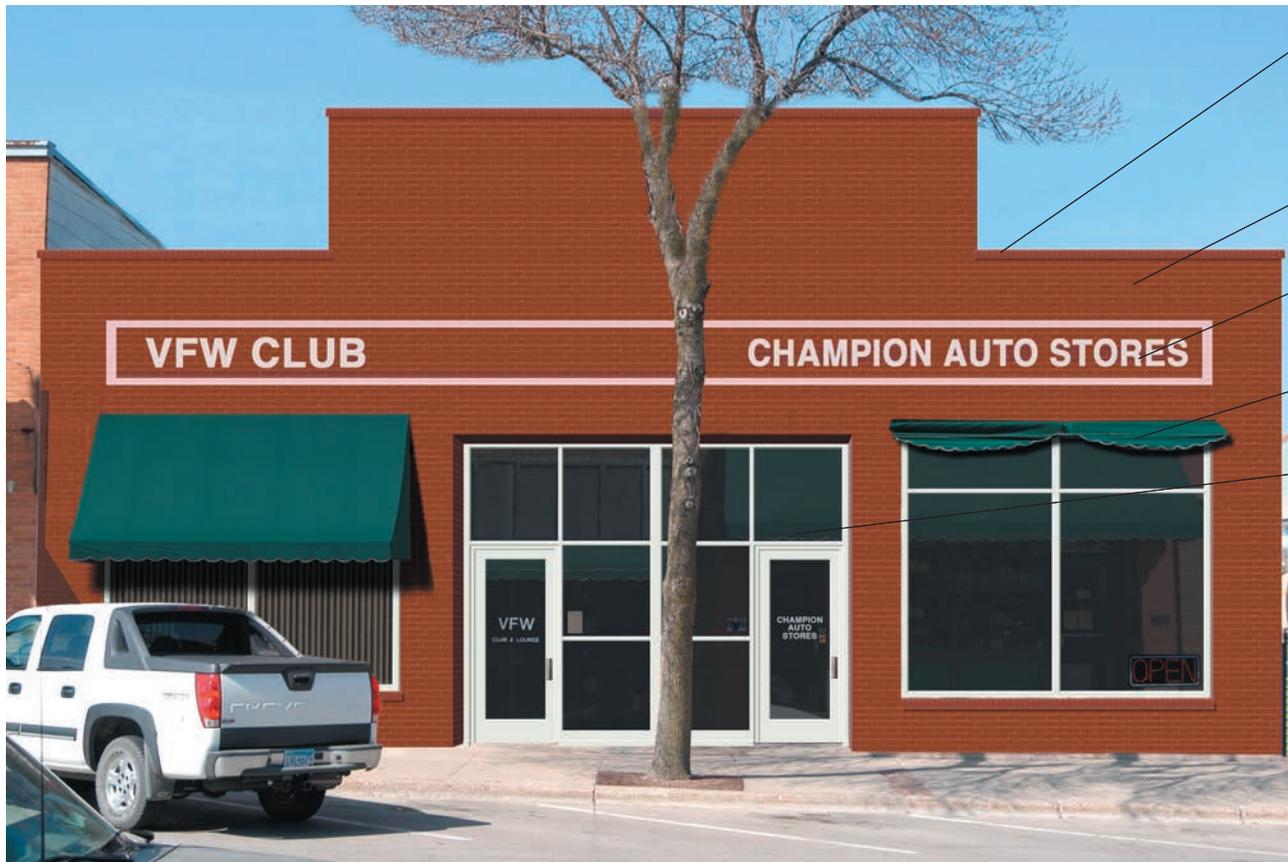
PROPOSED RENOVATION

Inspect roofing and flashing.
