**PARADISE FALLS HOMEOWNERS ASSOCIATION**

## **Level 1 -- Full Reserve Study with Site Visit**

**Date of Site Inspection:      08/02/2019**

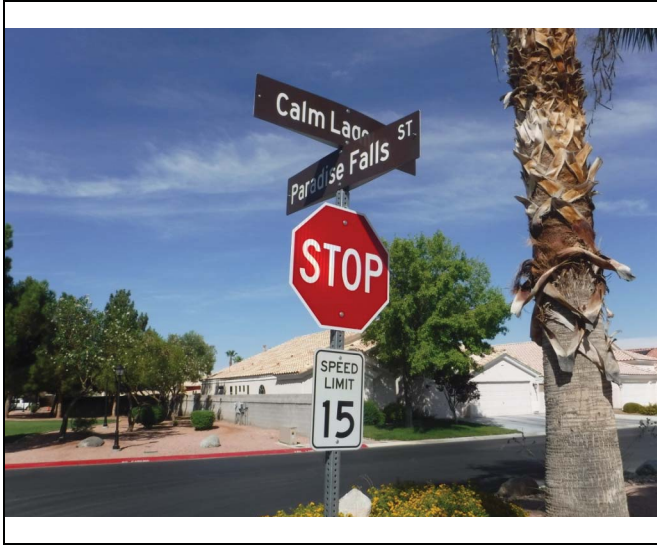
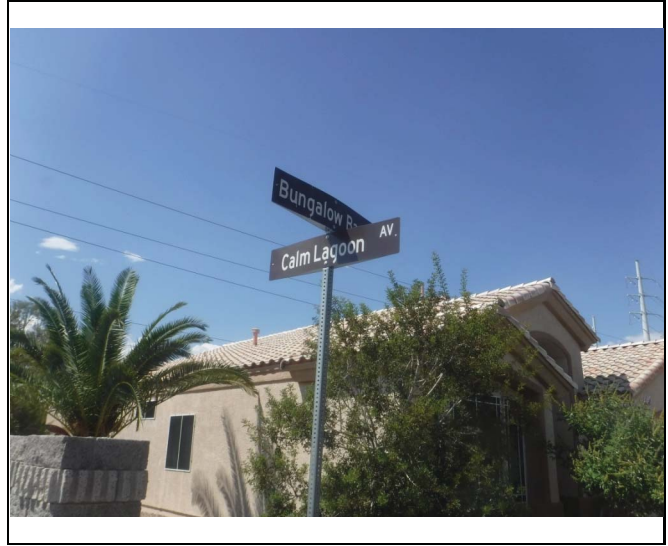
**Comp #: 1.101 Street Signs - Replace**

<b>Evaluation:</b>	No appearance concerns noted. The remaining useful life of this component is based on average age.		
<b>Quantity Notes:</b>	Quantity breakdown: 60 Street Signs (Includes both sides of street signs) 13 Stop Signs

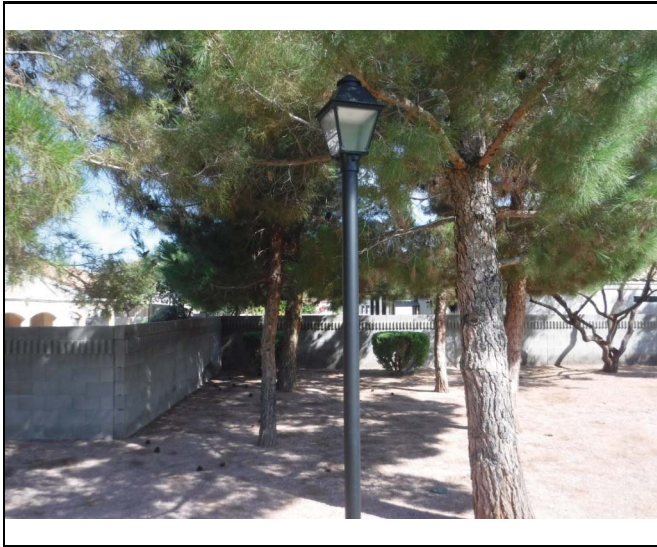
**Comp #: 1.113 Pole Lights - Replace**

<b>Quantity:</b>	19 Pole Lights	<b>Unit Cost:</b>	\$1,250.00
<b>Orig. Service:</b>	2019	<b>% of Unit Cost:</b>	100.0%
<b>Useful Life:</b>	20	<b>Total Current Cost:</b>	\$23,750.00
<b>RUL Adjustment:</b>	0	<b>Cost Explanation:</b>	Estimate to replace
<b>Rem. Useful Life:</b>	19	<b>Cost Source:</b>	Actual Cost History
<b>Vendor:</b>			
<b>Description:</b>	This component includes replacing the pole lights and any othe small light fixtures located at the entrance area or other common area. These lights should be updated and replaced every 20 to 25 years to maintain appearance and functionality.		
<b>Evaluation:</b>	These lights are new and in good condition.		
<b>Quantity Notes:</b>

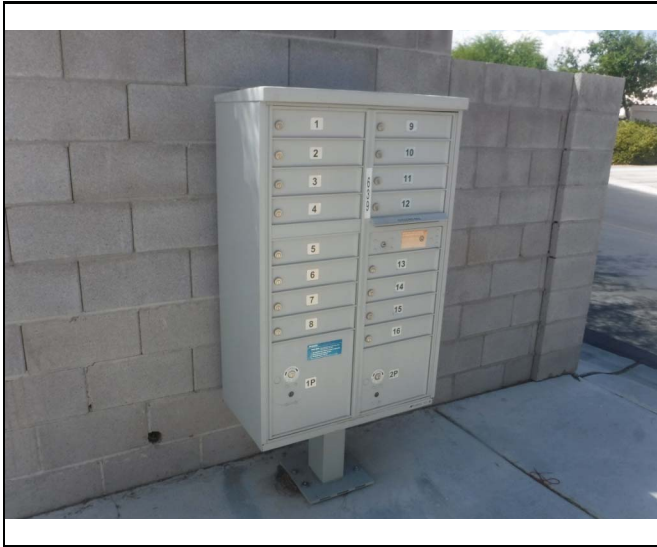
**Comp #: 1.117 Mailbox Cluster Box Units (CBUs) - Replace**

<b>Evaluation:</b>	These CBUs are in the process of being replaced now.		
<b>Quantity Notes:</b>

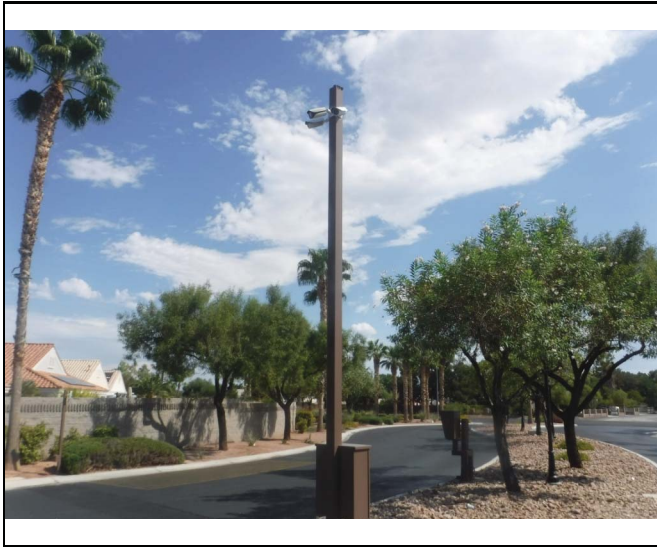
**Comp #: 1.121 Camera System - Replace**

<b>Quantity:</b>	1 Camera System	<b>Unit Cost:</b>	\$5,000.00
<b>Orig. Service:</b>	2015	<b>% of Unit Cost:</b>	100.0%
<b>Useful Life:</b>	10	<b>Total Current Cost:</b>	\$5,000.00
<b>RUL Adjustment:</b>	0	<b>Cost Explanation:</b>	Estimate to replace
<b>Rem. Useful Life:</b>	5	<b>Cost Source:</b>	GeoReserves Database
<b>Vendor:</b>			
<b>Description:</b>	This component includes replacing the camera system and all related parts and items such as the DVR and monitor. This system should be updated every 10 years or when necessary to keep up with current technology.		
<b>Evaluation:</b>	No problems noted.		
<b>Quantity Notes:</b>

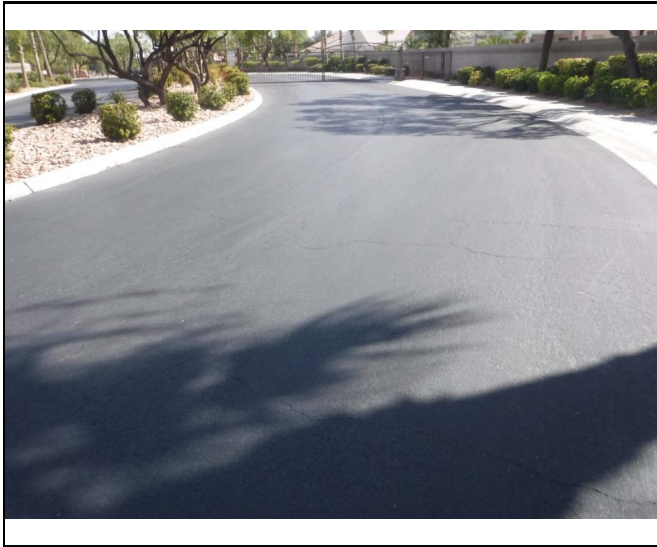
**Comp #: 1.204 Asphalt - Major Rehab**

<b>Evaluation:</b>	No problems noted.		
<b>Quantity Notes:</b>

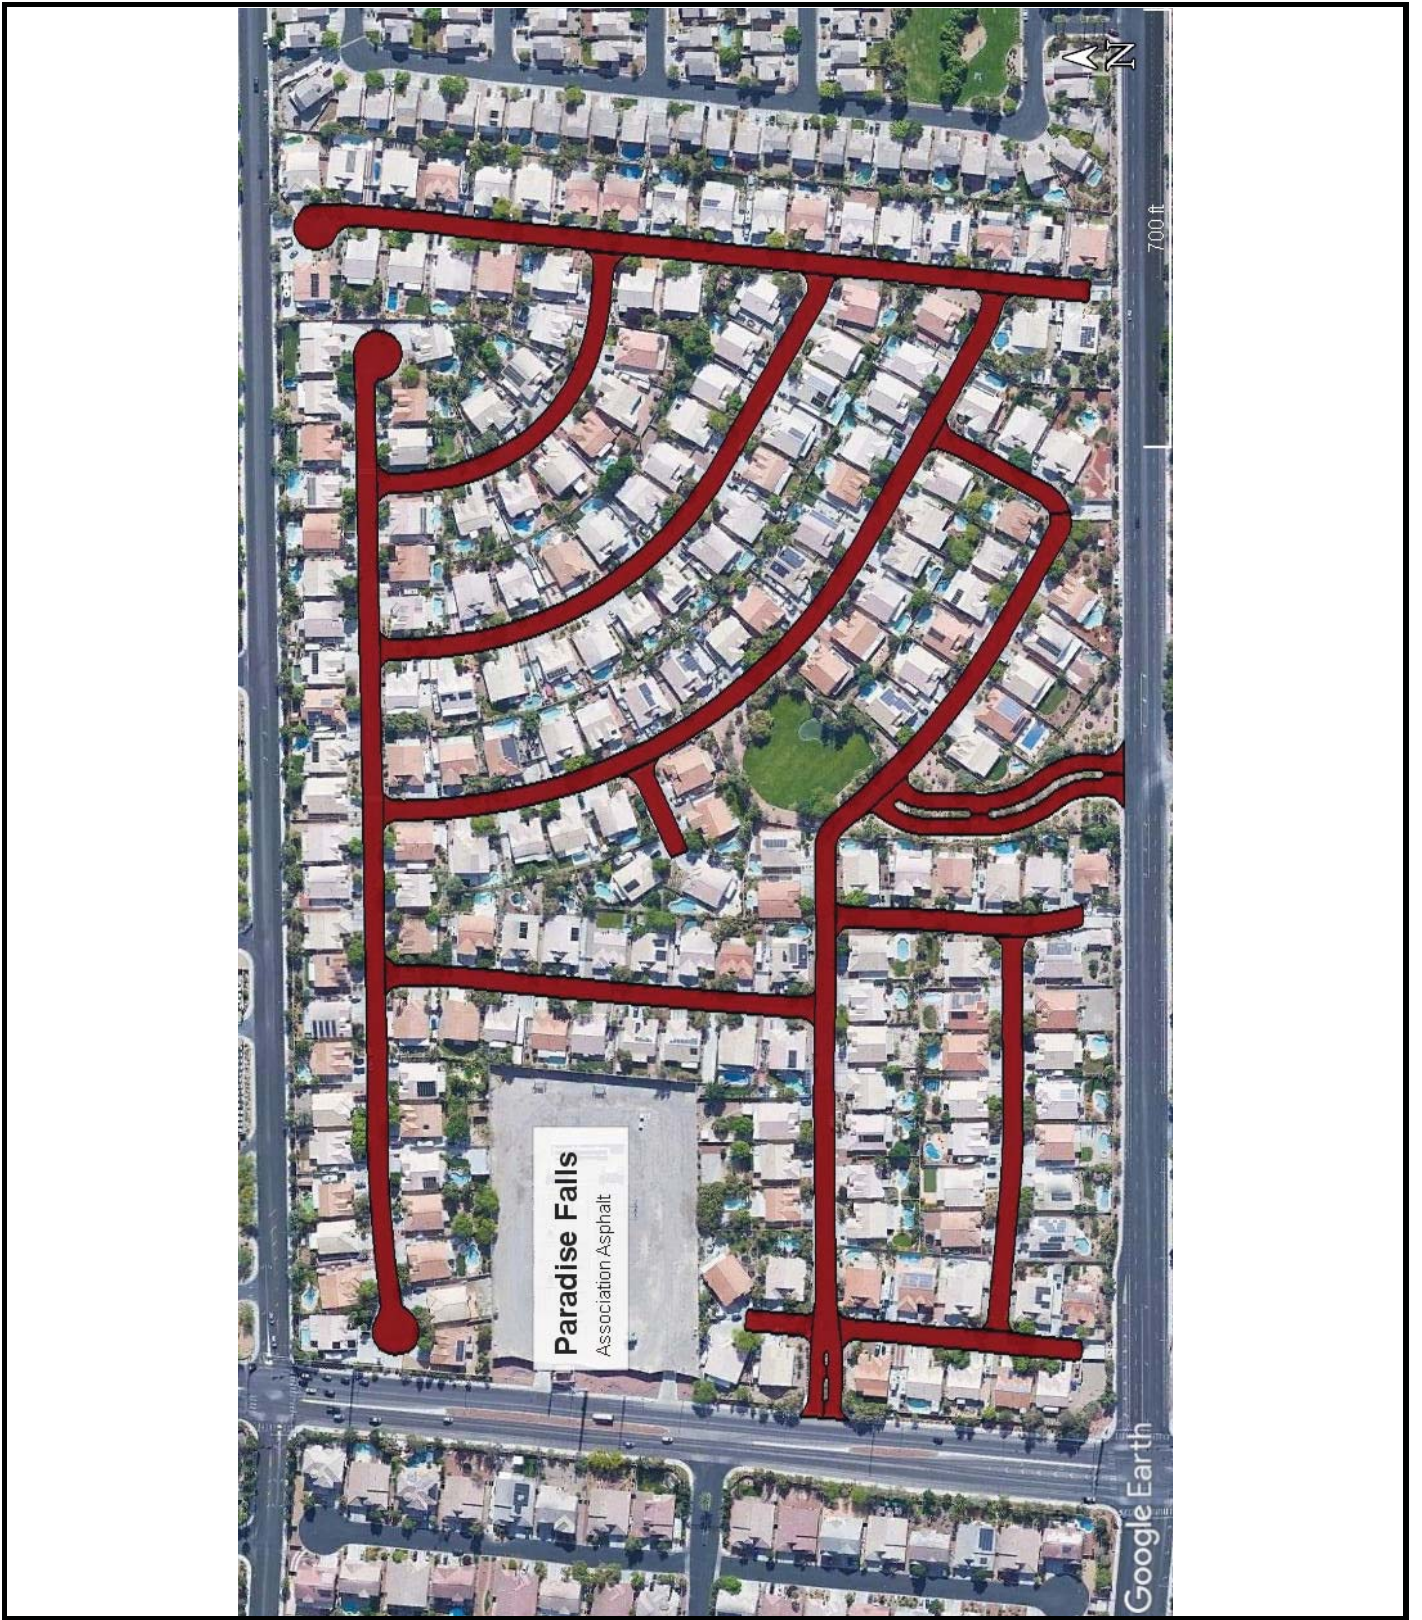
Association maintained asphalt.

<b>Quantity:</b>	350200 Sq.ft.	<b>Unit Cost:</b>	\$2.00
<b>Orig. Service:</b>	2000	<b>% of Unit Cost:</b>	100.0%
<b>Useful Life:</b>	40	<b>Total Current Cost:</b>	\$700,400.00
<b>RUL Adjustment:</b>	0	<b>Cost Explanation:</b>	Estimate for a major repair project
<b>Rem. Useful Life:</b>	20	<b>Cost Source:</b>	GeoReserves Database
<b>Vendor:</b>			
<b>Description:</b>	<p>As the asphalt ages certain signs of damage may appear. These signs can include alligator cracking, block cracking, thermal cracking, potholes, raveling, and other issues. It is imperative that proper asphalt preservation and maintenance is performed to prevent these problems from developing prematurely. However, over time, the asphalt will begin to fail and more significant work will be needed. Major asphalt repair work can include a thin overlay, mill and overlay, or more significant reconstruction. It can be difficult to predict when this major repair work will occur, or the appropriate scope of work. It is therefore necessary for the community to continually consult the advice of an expert and develop a suitable maintenance plan. This component budgets for a major repair project to occur every 40 years.</p>

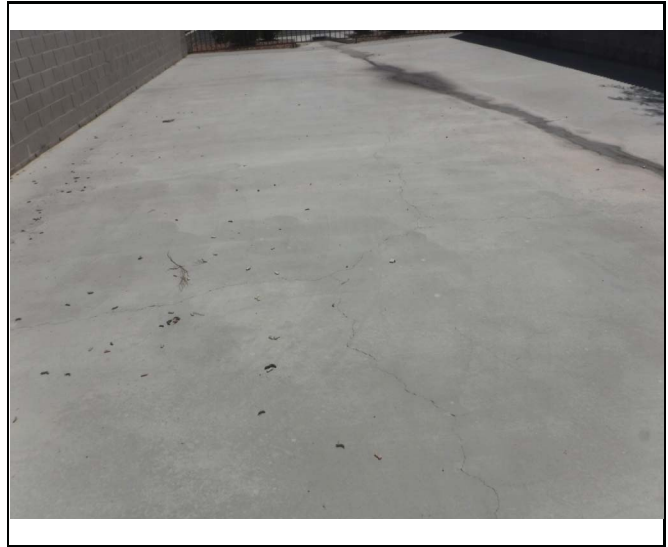
**Comp #: 1.206 Concrete - Repair**

<b>Evaluation:</b>	<p>No major spalling or delamination noted. We recommend inspecting and repairing any minor cracks or issues annually.</p>		
<b>Quantity Notes:</b>

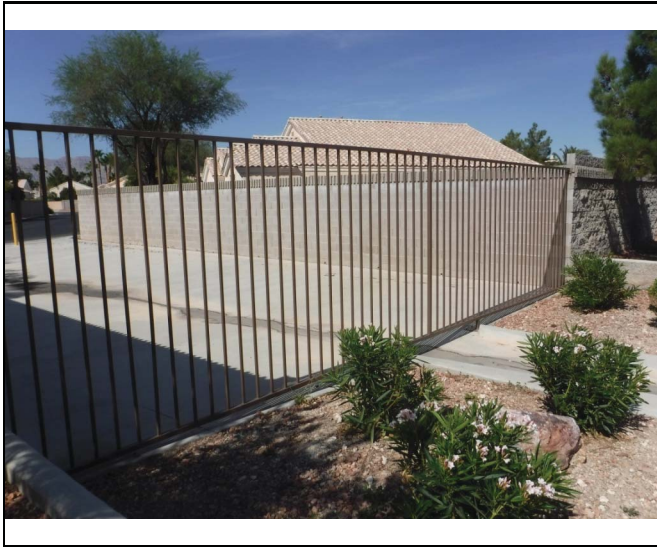
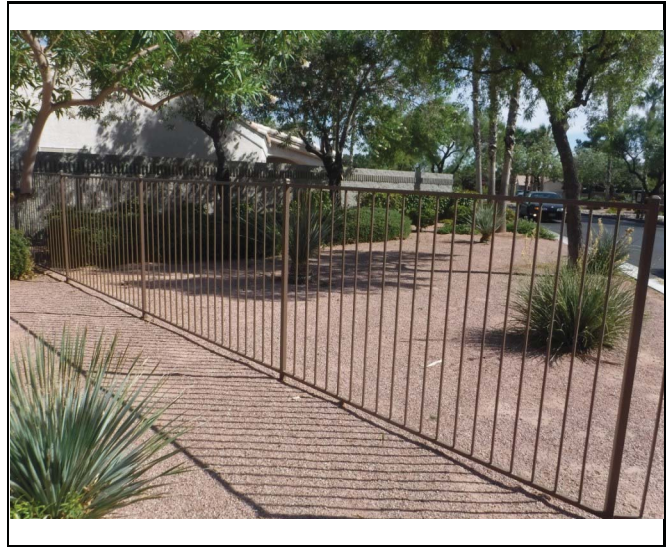
**Comp #: 1.306 Wrought Iron Fencing - Repair/Repaint**

<b>Quantity:</b>	200 Linear ft.	<b>Unit Cost:</b>	\$10.00
<b>Orig. Service:</b>	2017	<b>% of Unit Cost:</b>	100.0%
<b>Useful Life:</b>	5	<b>Total Current Cost:</b>	\$2,000.00
<b>RUL Adjustment:</b>	0	<b>Cost Explanation:</b>	Estimate to repair and repaint
<b>Rem. Useful Life:</b>	2	<b>Cost Source:</b>	GeoReserves Database
<b>Vendor:</b>			
<b>Description:</b>	This component includes painting the metal fencing, along with making any repairs to bent or rusted areas. This project should be performed every 5 years or when necessary to maintain appearance and ensure the fence realizes a full useful life. Different paint materials and techniques will determine the actual useful life and may result in adjusting this schedule.		
<b>Evaluation:</b>	No significant rusting or faded paint noted.		
<b>Quantity Notes:</b>

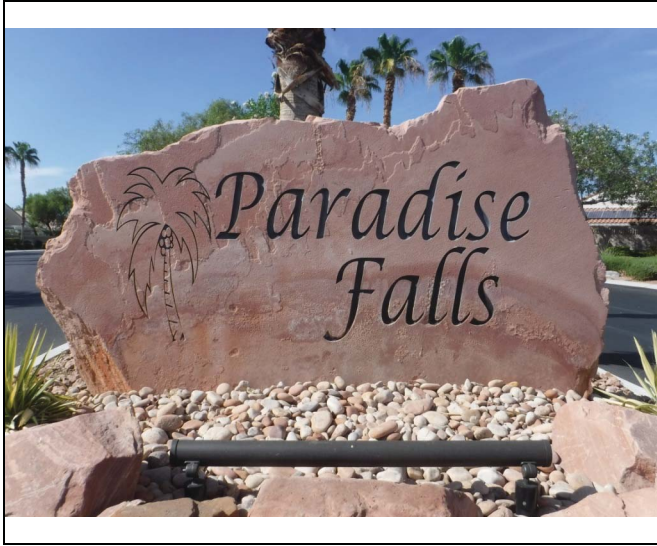
**Comp #: 2.104 Monument - Refurbish**

<b>Quantity:</b>	1 Monument	<b>Unit Cost:</b>	\$1,000.00
<b>Orig. Service:</b>	2015	<b>% of Unit Cost:</b>	100.0%
<b>Useful Life:</b>	10	<b>Total Current Cost:</b>	\$1,000.00
<b>RUL Adjustment:</b>	0	<b>Cost Explanation:</b>	Estimate to refurbish
<b>Rem. Useful Life:</b>	5	<b>Cost Source:</b>	GeoReserves Database
<b>Vendor:</b>			
<b>Description:</b>	Monuments can come in a wide range of sizes, materials, and designs. However, over time they will eventually need to be updated to maintain appearance and to keep a current look. This component can include a general refurbishment or a complete replacement. The cost and useful life of this project can vary depending on what type of monument the association has installed. Any minor repairs should be done regularly as an operating expense.		
<b>Evaluation:</b>	No major appearance concerns noted. The Remaining Useful Life is based on both age and overall condition.

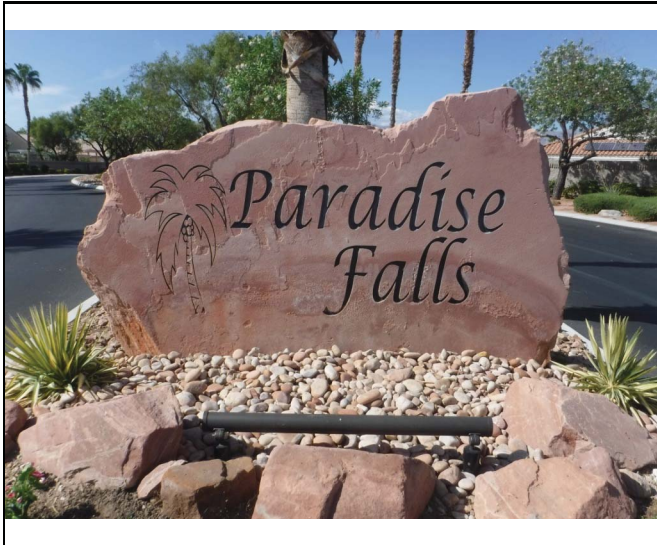
**Comp #: 2.104 Monument - Replace**

<b>Quantity:</b>	1 Monument	<b>Unit Cost:</b>	\$5,000.00
<b>Orig. Service:</b>	2000	<b>% of Unit Cost:</b>	100.0%
<b>Useful Life:</b>	25	<b>Total Current Cost:</b>	\$5,000.00
<b>RUL Adjustment:</b>	0	<b>Cost Explanation:</b>	Estimate to refurbish
<b>Rem. Useful Life:</b>	5	<b>Cost Source:</b>	GeoReserves Database
<b>Vendor:</b>			
<b>Description:</b>	Monuments can come in a wide range of sizes, materials, and designs. However, over time they will eventually need to be updated to maintain appearance and to keep a current look. This component can include a general refurbishment or a complete replacement. The cost and useful life of this project can vary depending on what type of monument the association has installed. Any minor repairs should be done regularly as an operating expense.		
<b>Evaluation:</b>	No major appearance concerns noted. The Remaining Useful Life is based on both age and overall condition.

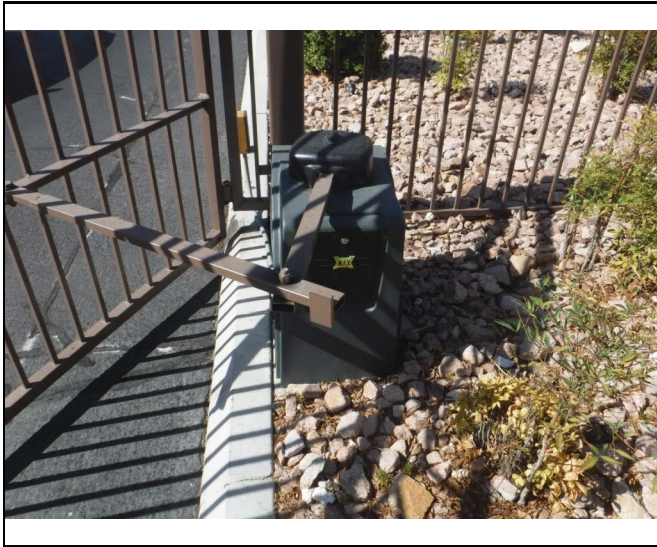
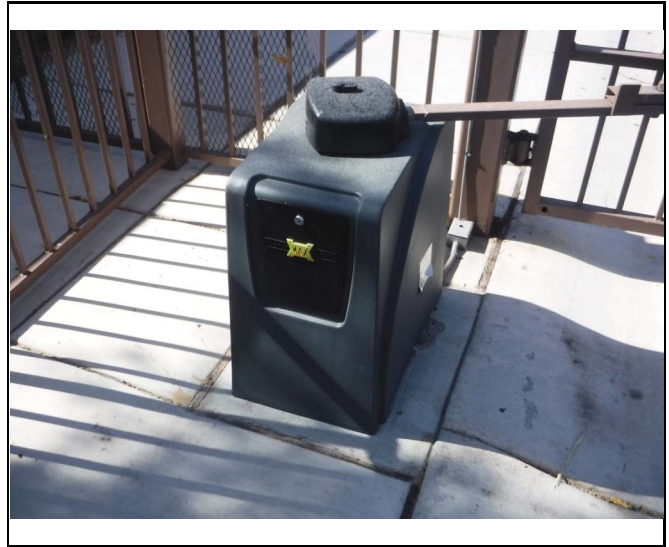
**Comp #: 2.505 Vehicle Gate Operators - Replace**

<b>Quantity:</b>	4 Gate Operators	<b>Unit Cost:</b>	\$5,500.00
<b>Orig. Service:</b>	2018	<b>% of Unit Cost:</b>	100.0%
<b>Useful Life:</b>	12	<b>Total Current Cost:</b>	\$22,000.00
<b>RUL Adjustment:</b>	0	<b>Cost Explanation:</b>	Estimate to replace
<b>Rem. Useful Life:</b>	10	<b>Cost Source:</b>	GeoReserves Database
<b>Vendor:</b>			
<b>Description:</b>	This component includes replacing the entire gate operator unit. During the normal life of these gate operators certain parts, such as battery backups, circuit boards and motors may need to be repaired or replaced. For most associations, these minor costs should be considered an operating expense. Gate operators should last between 10 to 12 years however the actual life could be longer if individual parts are routinely replaced. Additional information can be found at <a href="http://www.dasma.com">www.dasma.com</a> .		
<b>Evaluation:</b>	These gate operators were functioning normally at time of site visit with no problems noted.

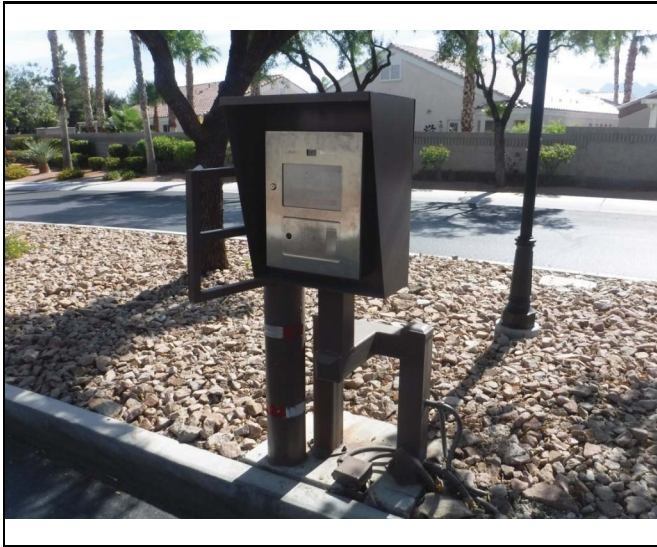
**Comp #: 2.507 Vehicle Gate Entrance System - Replace**

<b>Evaluation:</b>	<p>This component is functional with no major problems noted.</p>		
<b>Quantity Notes:</b>

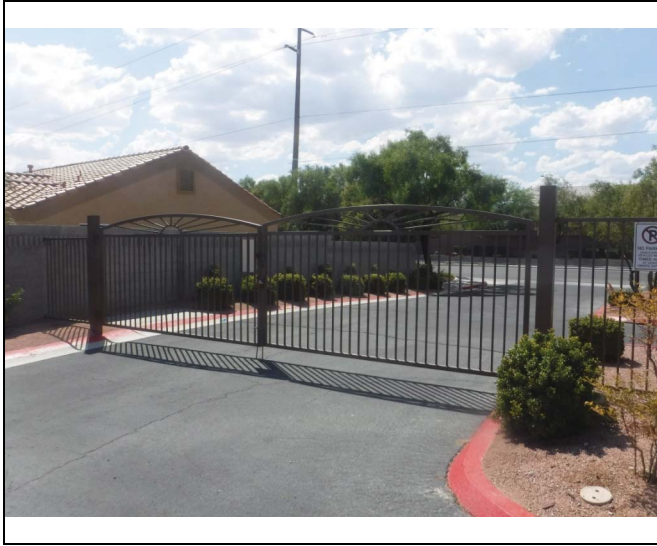
**Comp #: 3.501 Vehicle Gates - Replace**

<b>Quantity:</b>	4 Vehicle Gates	<b>Unit Cost:</b>	\$3,000.00
<b>Orig. Service:</b>	2000	<b>% of Unit Cost:</b>	100.0%
<b>Useful Life:</b>	30	<b>Total Current Cost:</b>	\$12,000.00
<b>RUL Adjustment:</b>	0	<b>Cost Explanation:</b>	Estimate to replace
<b>Rem. Useful Life:</b>	10	<b>Cost Source:</b>	GeoReserves Database
<b>Vendor:</b>			
<b>Description:</b>	This component includes replacing the vehicle gates. These gates should last approximately 25 to 30 years before they should be replaced to improve the appearance of the entrance area. Any accidents from cars hitting these gates should be considered an insurance issue and not a normal reserve expense. Additional information can be found at <a href="http://iframe.americanfenceassociation.com">iframe.americanfenceassociation.com</a> .		
<b>Evaluation:</b>	No problems with these gates noted. This community has plans to update this entrance area within the next few years.

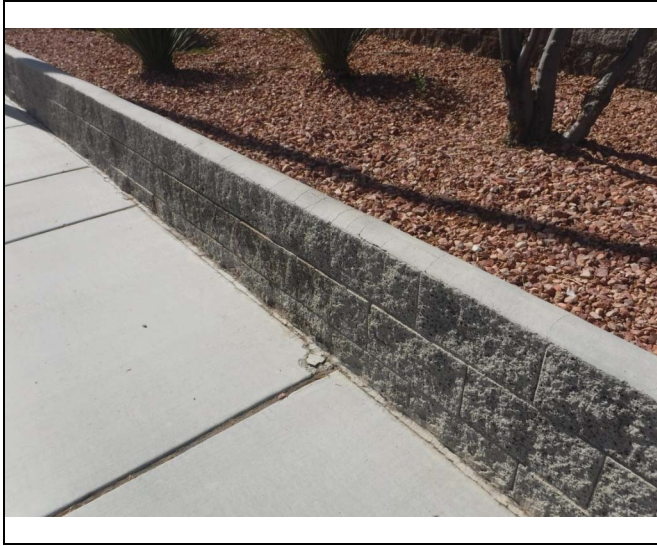
**Comp #: 4.301 Landscaping Retaining Wall - Repair**

<b>Quantity:</b>	3650 Linear ft.	<b>Unit Cost:</b>	\$25.00
<b>Orig. Service:</b>	2010	<b>% of Unit Cost:</b>	10.0%
<b>Useful Life:</b>	10	<b>Total Current Cost:</b>	\$9,125.00
<b>RUL Adjustment:</b>	0	<b>Cost Explanation:</b>	Estimate to repair 10% of wall
<b>Rem. Useful Life:</b>	0	<b>Cost Source:</b>	GeoReserves Database
<b>Vendor:</b>			
<b>Description:</b>	This component includes the portions of the block wall that the association is obligated to maintain. These walls are designed to last a very long time and funding for a complete replacement is not necessary. However, repairs are usually necessary due to water damage, tree roots and other ground movement, and vandalism or other damages. A feasible reserve study plan is to make repairs every 10 years. However, this schedule and cost estimate may be adjusted as the community ages and a cost history is developed.		
<b>Evaluation:</b>	No major issues such as water damage, cracking or other issues noted.

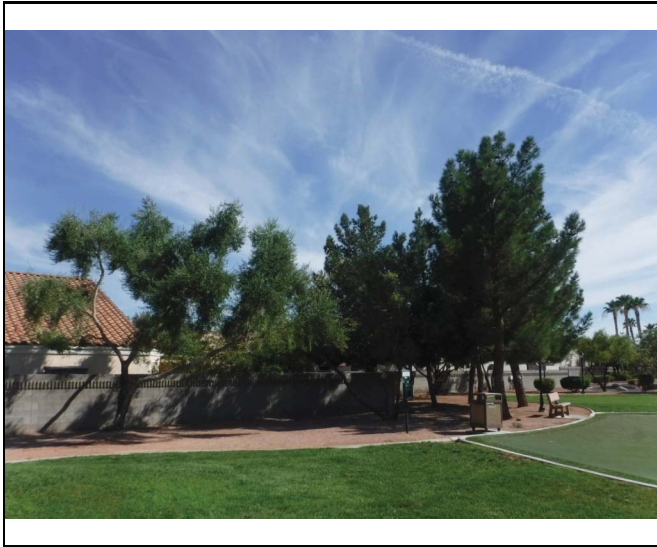
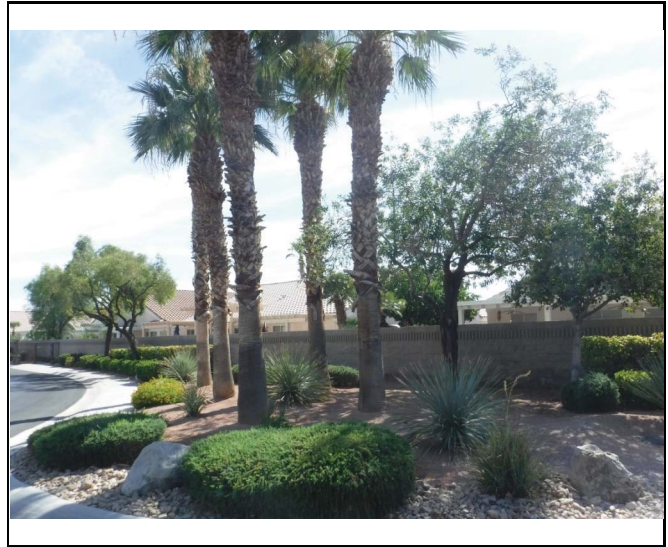
**Comp #: 4.401 Landscaping - Renovate**

<b>Evaluation:</b>	<p>No major appearance concerns noted. This landscaping should be maintained on a regular basis and the association should work with the landscaper to determine any specific areas of improvement that go beyond the normal maintenance contract.</p>		
<b>Quantity Notes:</b>

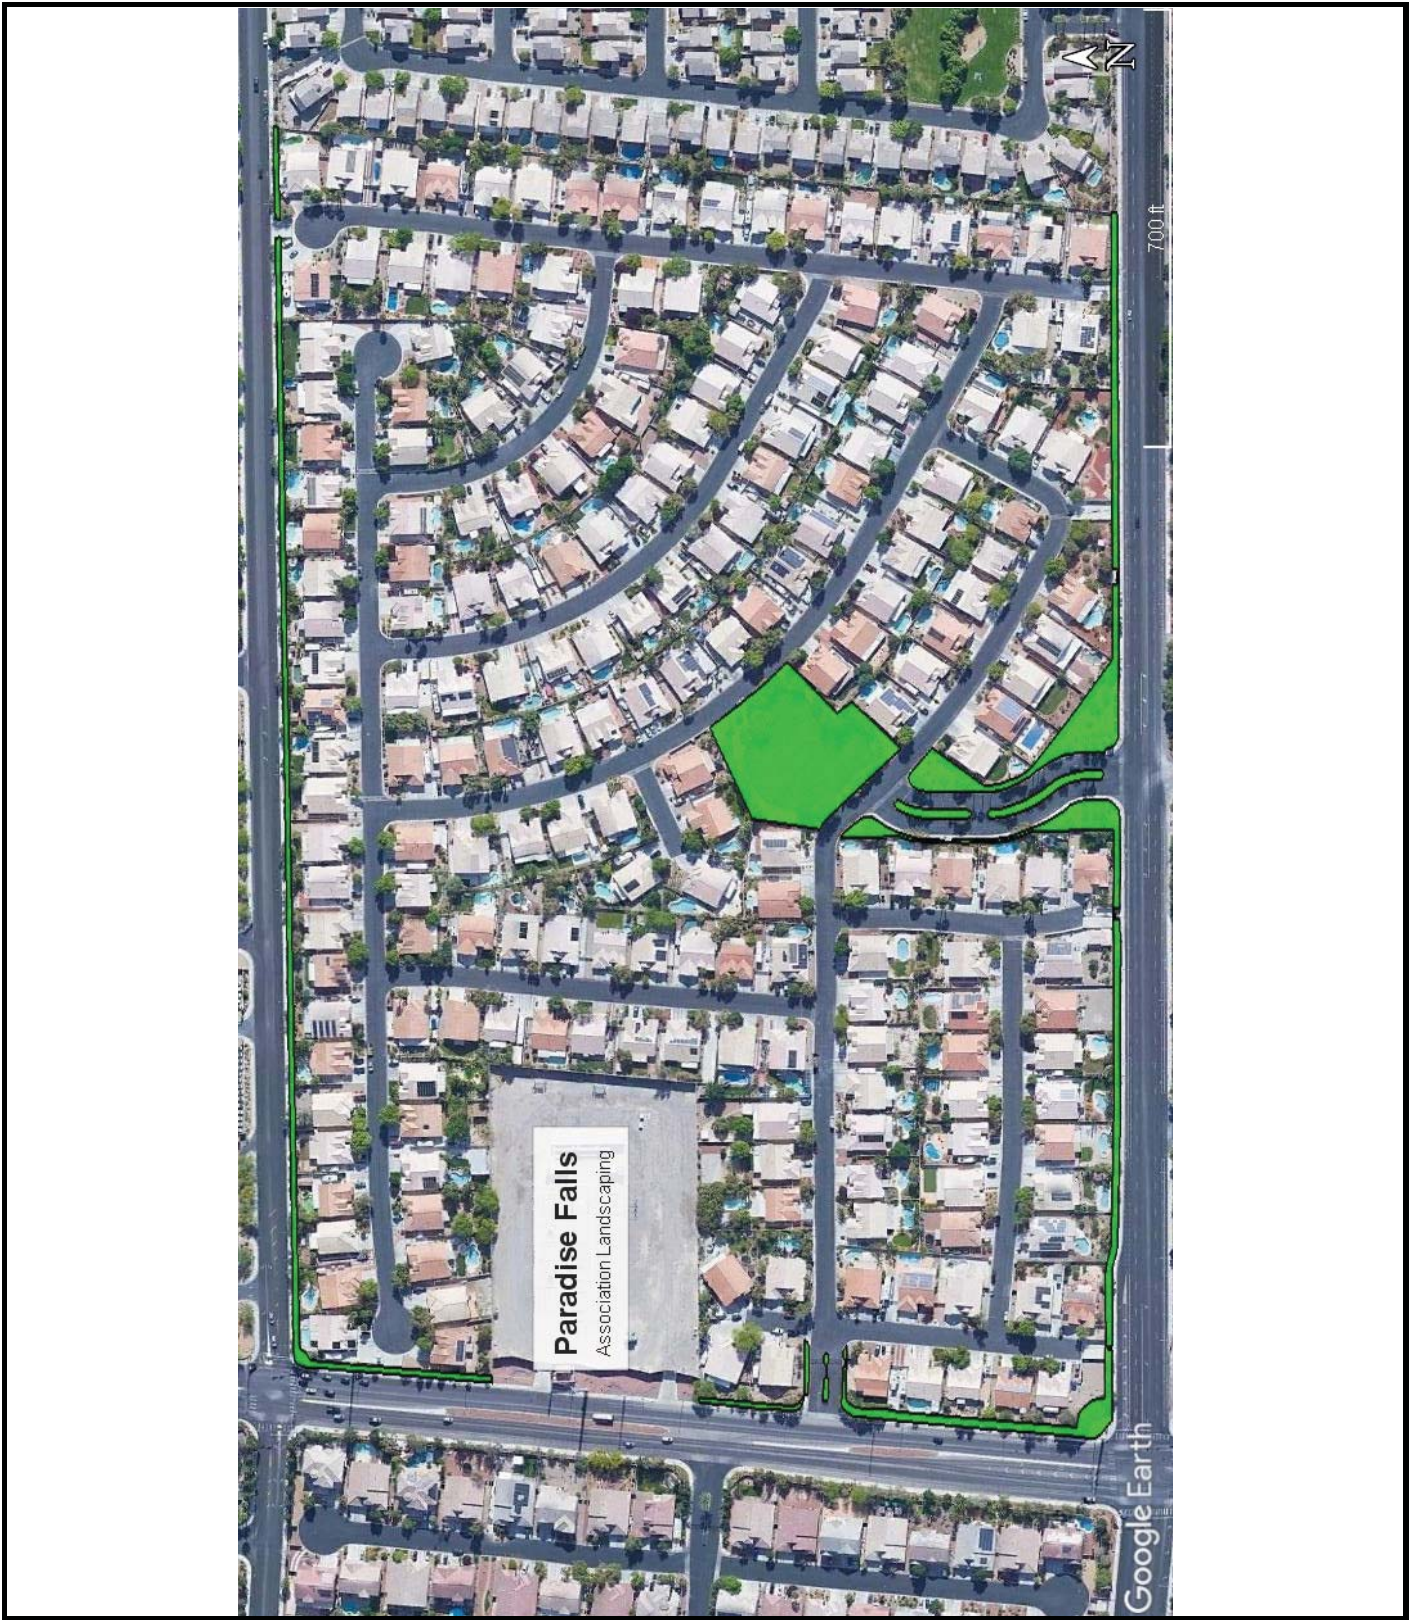
Association maintained landscaping

<b>Quantity:</b>	120000 Sq.ft.	<b>Unit Cost:</b>	\$0.50
<b>Orig. Service:</b>	2000	<b>% of Unit Cost:</b>	100.0%
<b>Useful Life:</b>	5	<b>Total Current Cost:</b>	\$60,000.00
<b>RUL Adjustment:</b>	0	<b>Cost Explanation:</b>	Estimate to renovate
<b>Rem. Useful Life:</b>	0	<b>Cost Source:</b>	GeoReserves Database
<b>Vendor:</b>			
<b>Description:</b>	<p>Landscaping should be maintained on a regular basis primarily as an operating expense. As small plants, portions of rocks, or parts of the irrigation system need to be replaced it is usually included in the standard maintenance contract with the landscaper. However, over time larger portions of landscaping and irrigation should be upgraded or replaced to maintain appearance standards. These types of projects are very much subjective and up to the board and residents to determine the scope and cost. This reserve study funds for a general cost that should be looked at closely by the association to determine their specific landscaping needs. Visit local water district website for water conservation ideas and additional information.</p>

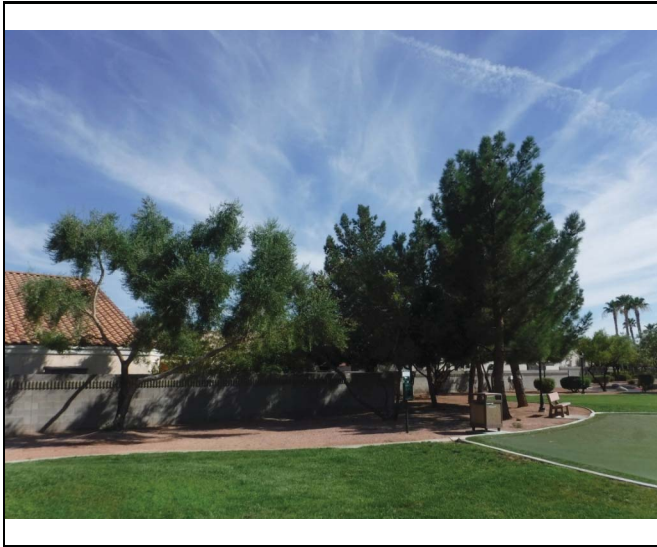
**Comp #: 4.409 Tree Trimming - Perform**

<b>Quantity:</b>	1 Project	<b>Unit Cost:</b>	\$6,600.00
<b>Orig. Service:</b>	2019	<b>% of Unit Cost:</b>	100.0%
<b>Useful Life:</b>	4	<b>Total Current Cost:</b>	\$6,600.00
<b>RUL Adjustment:</b>	0	<b>Cost Explanation:</b>	Estimate to trim trees
<b>Rem. Useful Life:</b>	3	<b>Cost Source:</b>	Actual Cost History
<b>Vendor:</b>			
<b>Description:</b>	This component includes trimming all of the trees. This project should be done every three to five years as needed.		
<b>Evaluation:</b>	No problems noted.		
<b>Quantity Notes:</b>

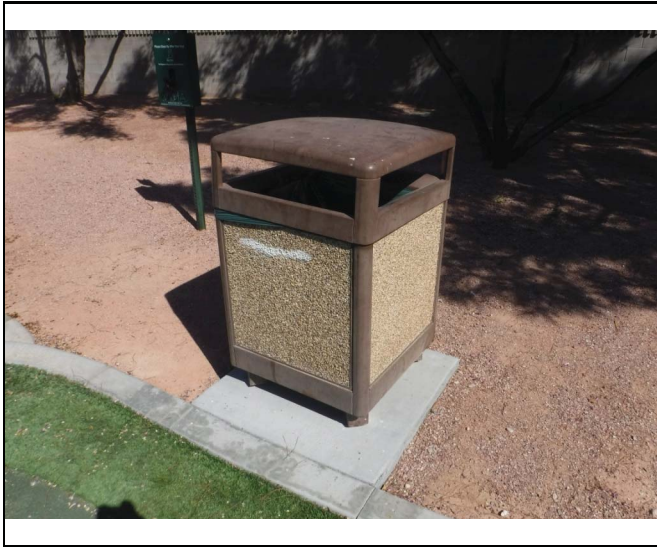
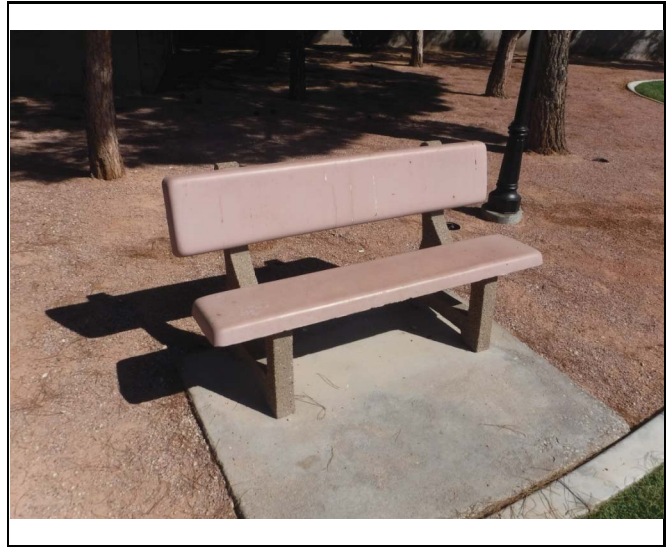
**Comp #: 4.601 Park Furniture - Replace**

<b>Quantity:</b>	1 See Detail	<b>Unit Cost:</b>	\$10,000.00
<b>Orig. Service:</b>	2000	<b>% of Unit Cost:</b>	100.0%
<b>Useful Life:</b>	20	<b>Total Current Cost:</b>	\$10,000.00
<b>RUL Adjustment:</b>	5	<b>Cost Explanation:</b>	Estimate to replace
<b>Rem. Useful Life:</b>	5	<b>Cost Source:</b>	GeoReserves Database
<b>Vendor:</b>			
<b>Description:</b>	This component includes replacing all of the outdoor furniture items commonly referred to as park furniture. This includes any tables, benches, trash receptacles, and other related items. Each individual item may have its own useful life. However, unless an item breaks prematurely, they should should all be replaced at the same time to maintain a common appearance. This study funds to replace these items every 20 years but this can be adjusted depending on the amount of use.		
<b>Evaluation:</b>	No problems with these items noted.		
<b>Quantity Notes:</b>	Quantity breakdown: 3 Benches 2 Pet Waste Stations 2 Trash Cans
