Pueblo at Santa Fe Condominium Association

Level 1 Reserve Study

Report Period - 1/1/2024 to 12/31/2024

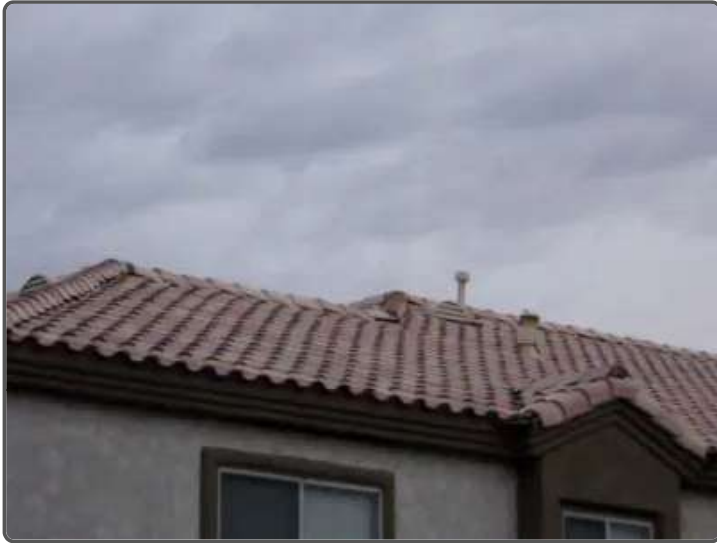
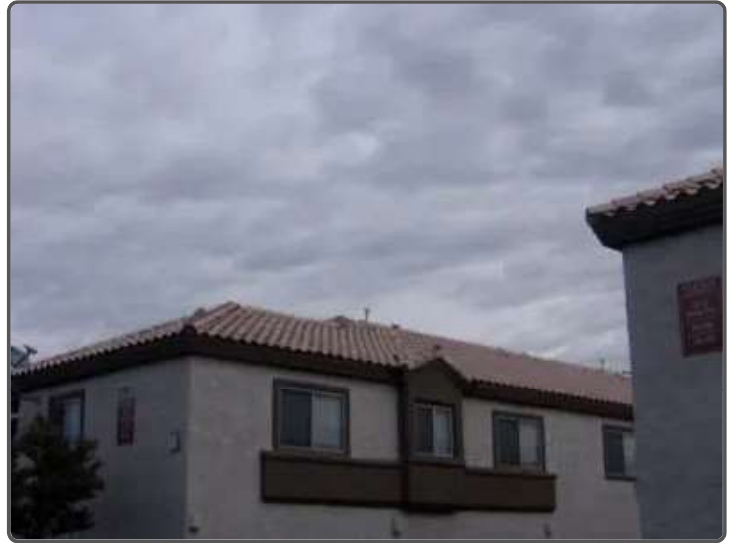
Comp # 102 Roof Inspection & Repair/Maintenance (2025)

Client has informed inspections and repairs are performed annually until roofs are replaced.

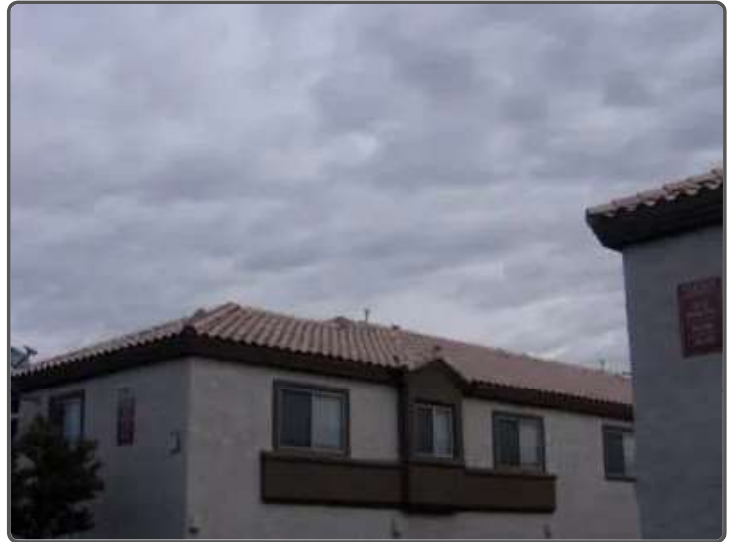
Comp # 106 Pitched Roof - Tile - Replace

Tile roofs have a typical life expectancy of approximately 25 to 30 years before underlayment deterioration causes significant leaks. Inspect roofs regularly and make repairs as necessary as an operating expense to ensure full life.

\$3.00/Sq.ft.; Estimate to replace underlayment

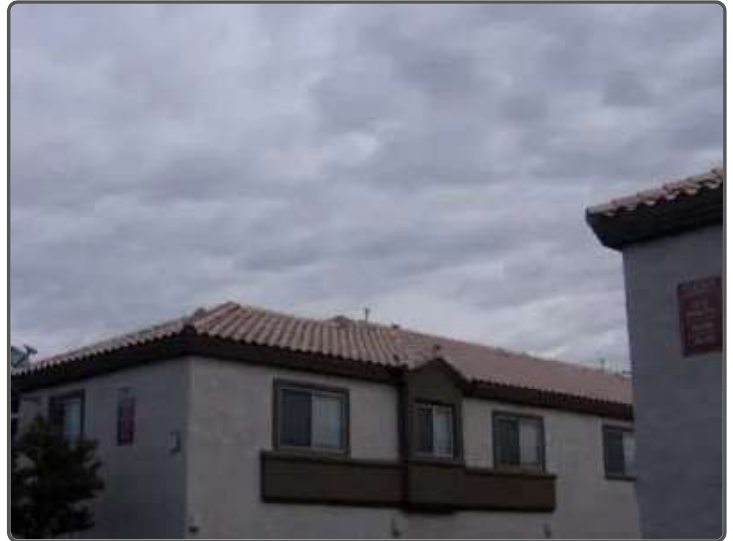
Comp # 201 Building Exterior Surfaces - Repaint

Painted stucco surfaces are generally in fair condition. Stucco surfaces should typically be repainted approximately every 10 to 12 years to protect stucco surface and maintain appearance. Remaining life based on current condition.

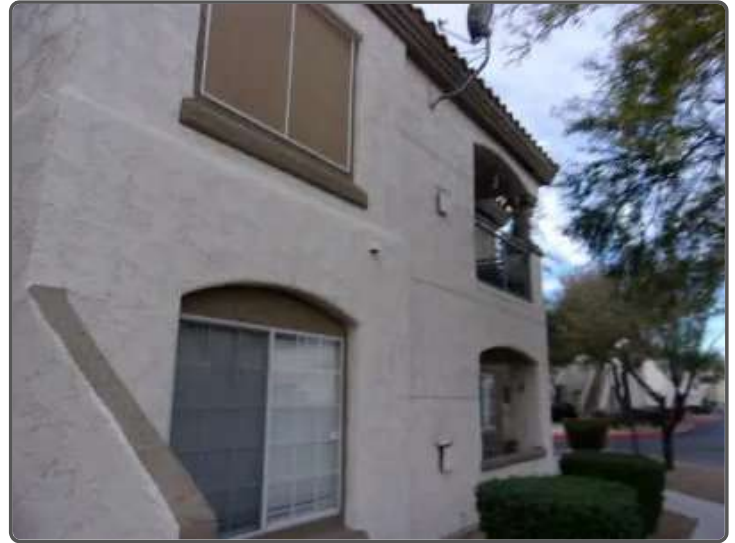
We recommend funding for an allowance to repaint the building trim surfaces as needed every 4 to 6 years to maintain appearance. Remaining life based on current condition.

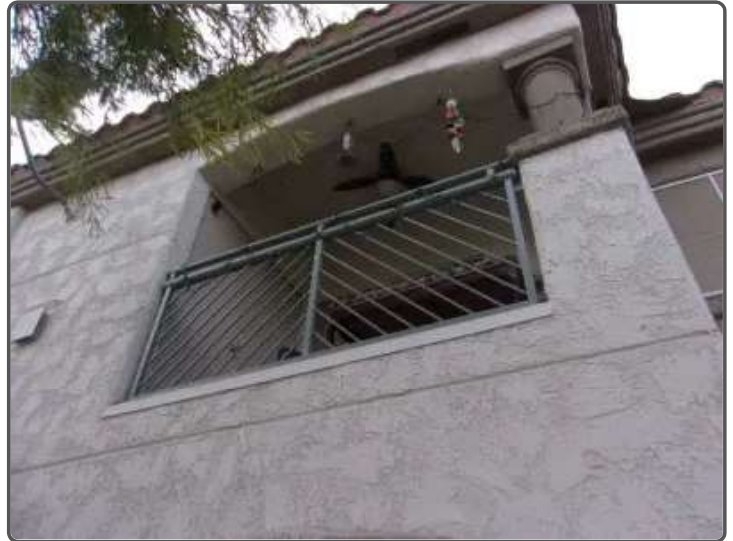
Painted wrought iron surfaces are generally in good condition, no rusting or broken welds noted. Repaint this component approximately every 5 years to maintain appearance and protect metal surfaces. Remaining life based on current age.

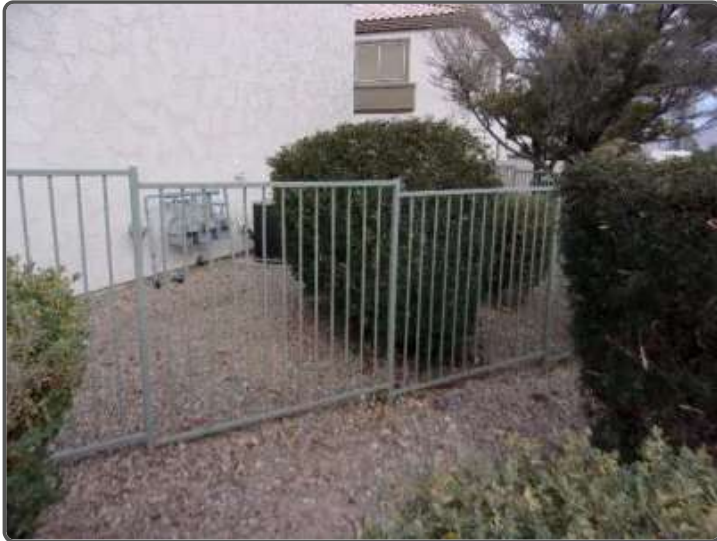
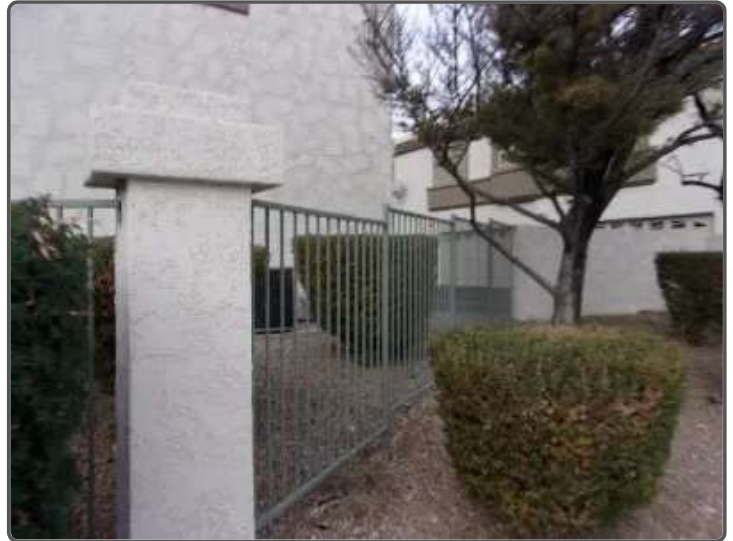
50 Linear ft. - Crash Gate
200 Linear ft. - Front Fencing
250 Linear ft. - Pool Fencing

500 Linear ft. - Total

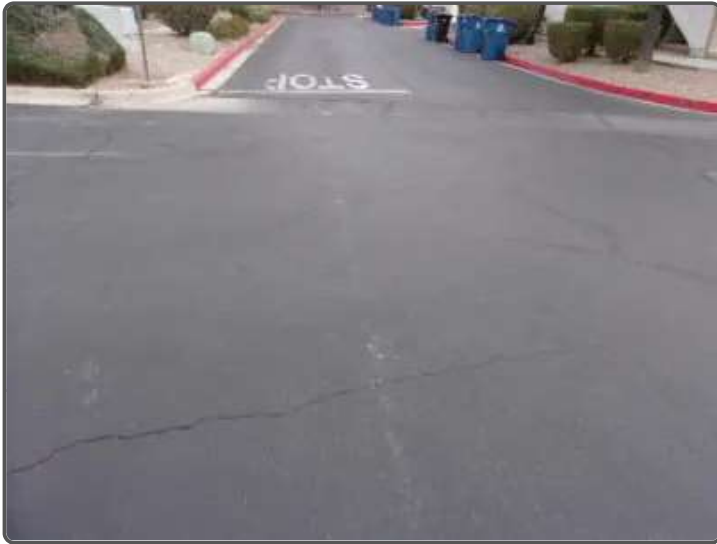
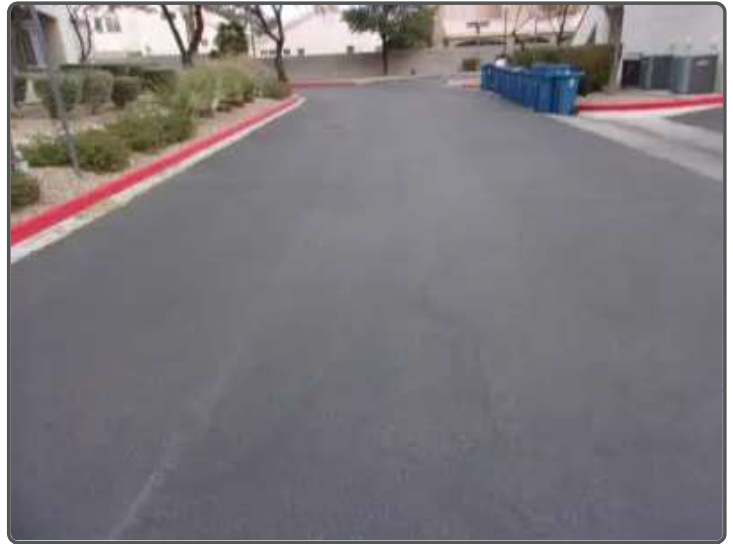
There are two main types of asphalt sealing products, those with aggregate (slurry seals) and those without (seal coats). Seal coats provide protection from water intrusion and in general are adequate for newer asphalt surfaces or those surfaces that are in good condition. As a surface ages a more heavy duty slurry seal application may provide better protection as well as some restorative qualities. Slurry seals cost more but last significantly longer than a seal so the increased cost is more or less offset by the lower frequency of required application. We recommend having the asphalt inspected regularly by a licensed engineer or asphalt expert. Ultimately our goal is to provide adequate funding so that the board can choose the best application for their asphalt based on its current condition and recommendations from those experts that have inspected the asphalt. For the purposes of this report we have funded for a seal coat.

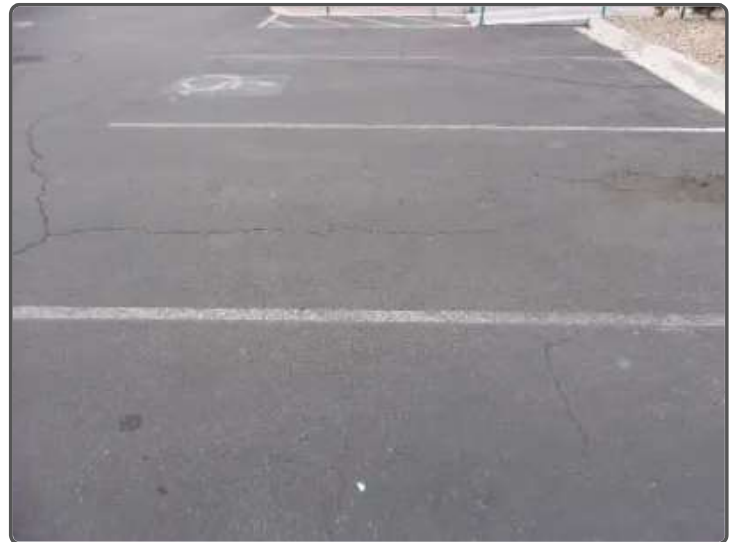
Per client community is funding for concrete repairs this fiscal year (2024). We recommend making local repairs as necessary as an operating expense and funding to make more significant repairs approximately every 10 years.

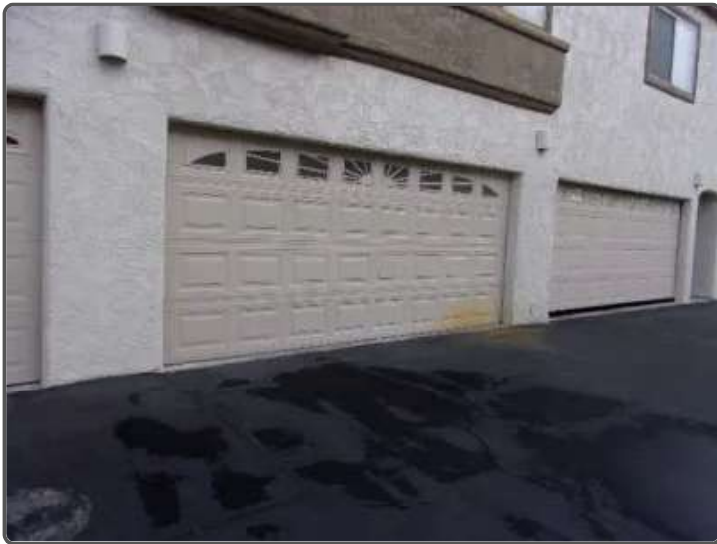
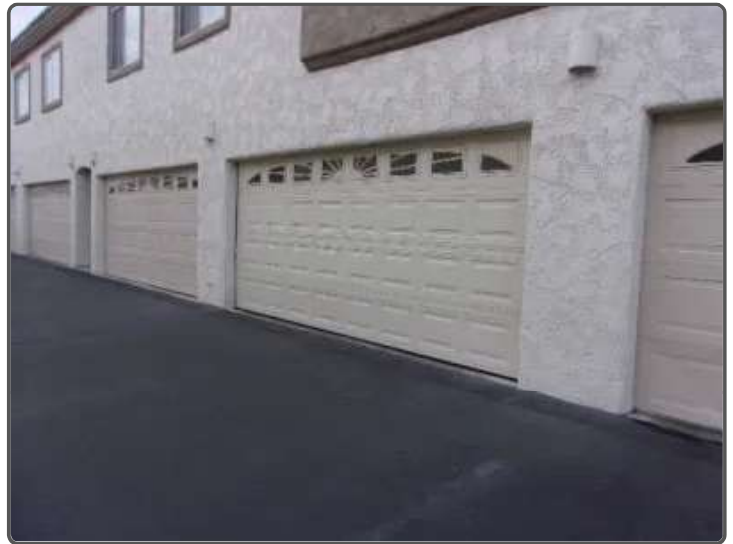
Comp # 502 Garage Doors - Replace (Homeowner Responsibility)

No problems noted at the time of inspection. Replacement of these doors is the responsibility of the individual owner. No reserve funding necessary.

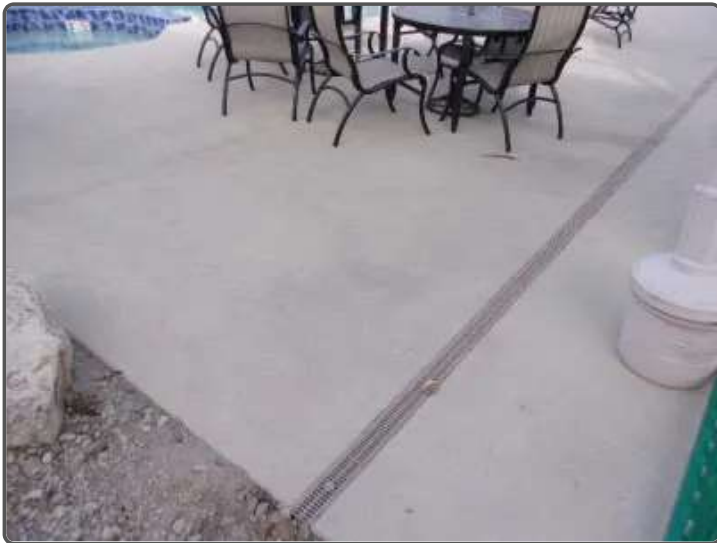
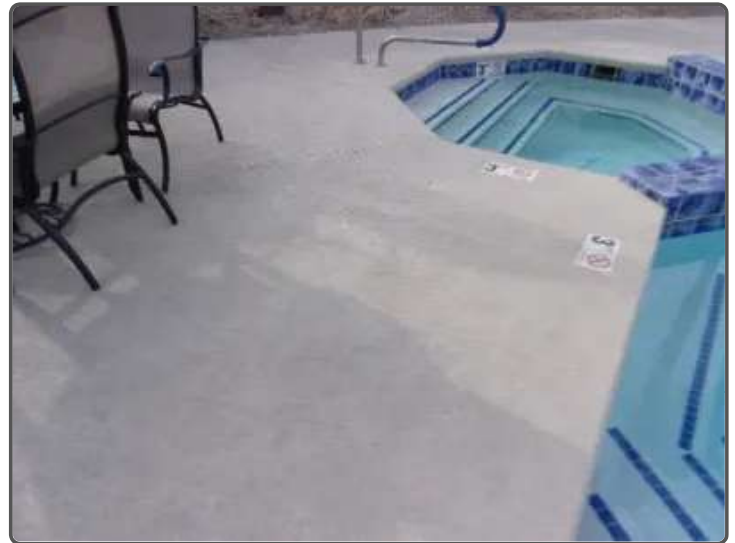
Pool deck is in fair condition. No surface loss noted. Expect to seal this component approximately every 5 years (see Comp# 603 Elastomeric Deck - Reseal) and to completely resurface approximately every 20 years.

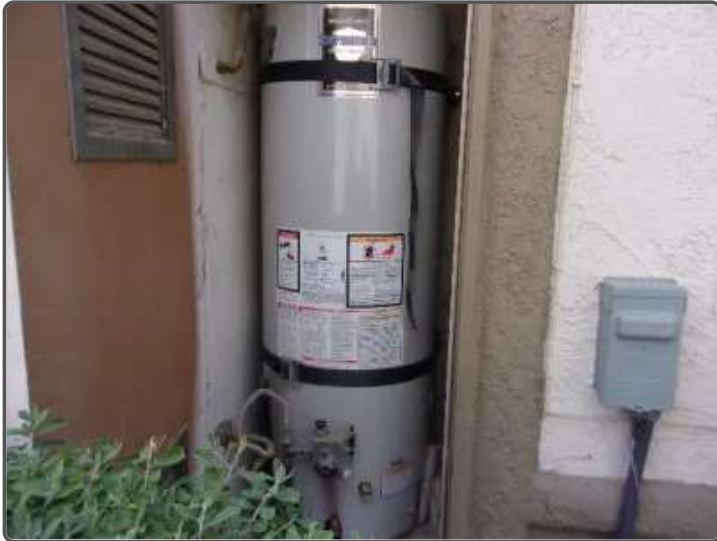
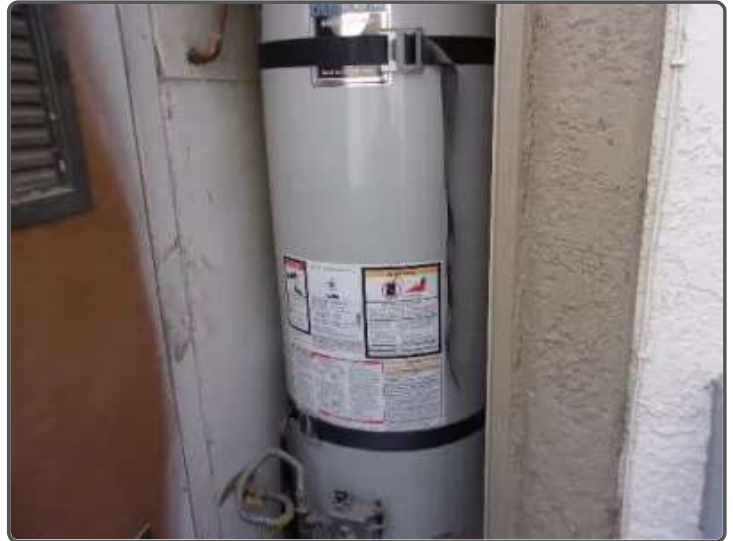
Comp # 703 Water Heater - Replace

Bradford White
Mod# RG240T6N
40 Gallon

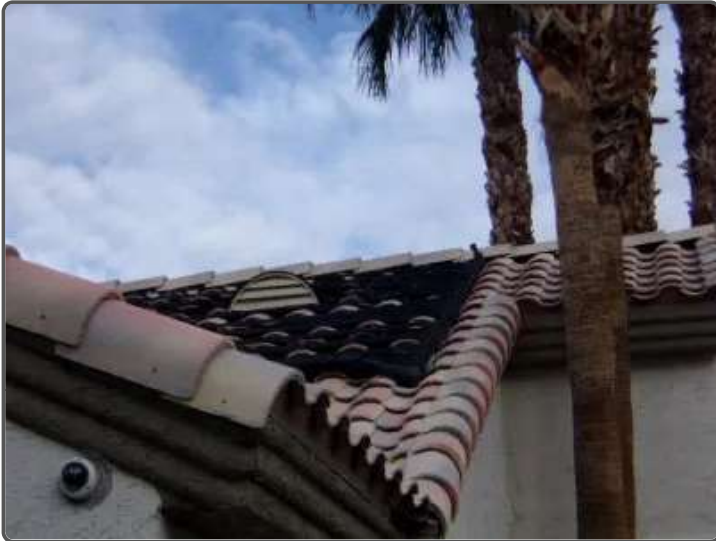
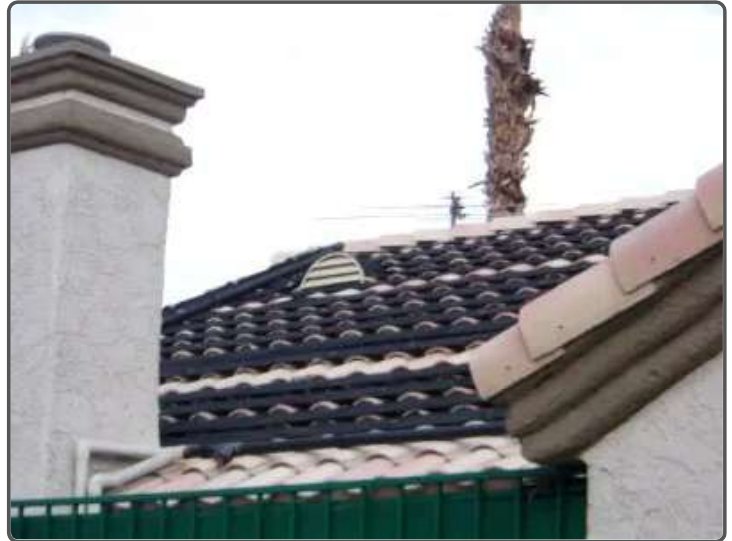
Comp # 704 Solar Water Heater System - Replace

No problems with solar heating system at time of site visit. We recommend funding to replace this system every 13 to 15 years to ensure proper function.

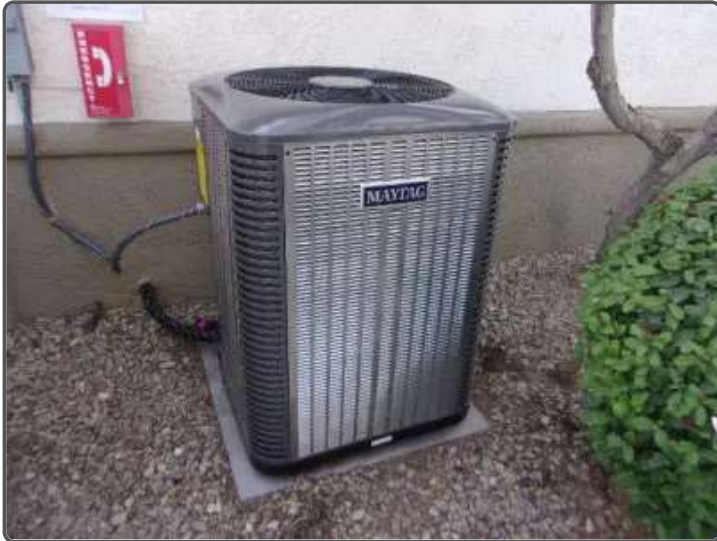
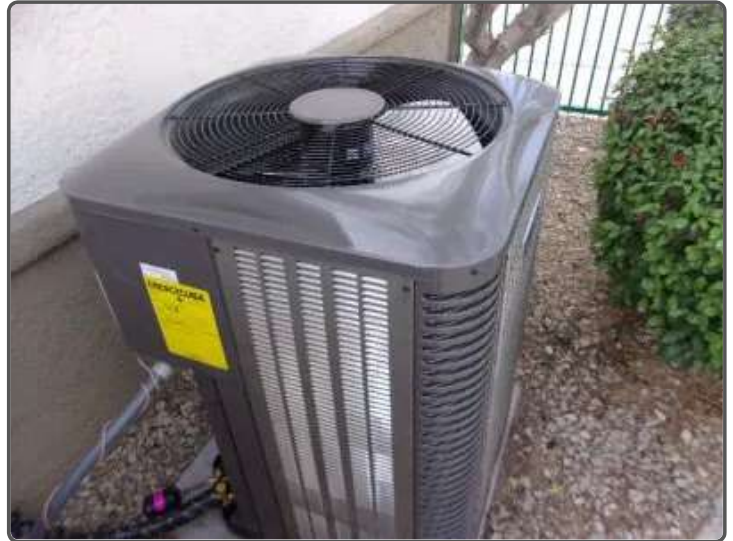
Comp # 705 HVAC Condenser - Replace

Maytag
Mod# PSA3BE4MISW48K

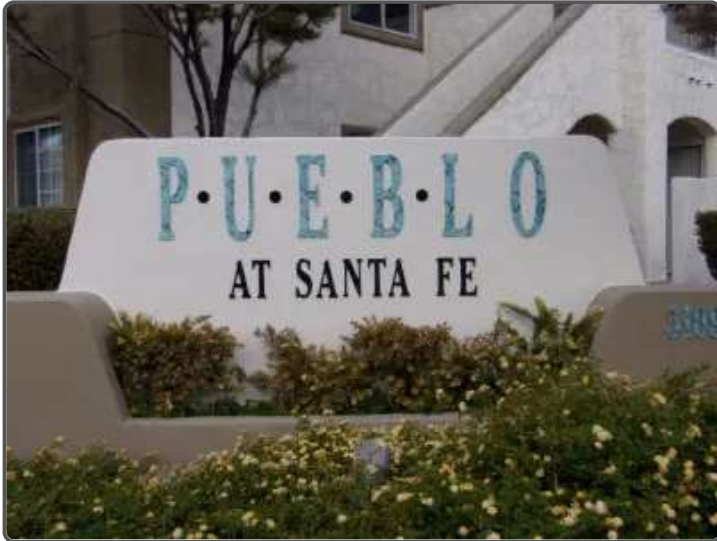
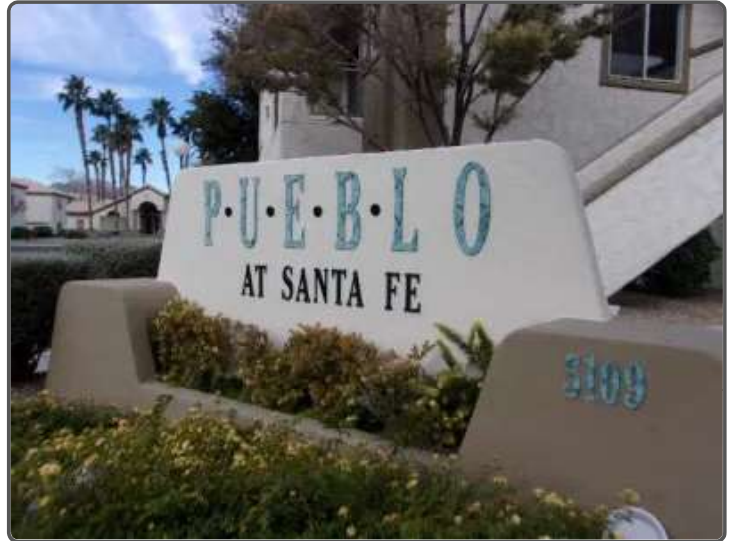
Comp # 801 Monuments - Refurbish / Replace

No problems at time of site visit. We recommend funding to replace these monuments every 18 to 20 years to maintain appearance and keep up with modern taste. Remaining life based on current condition.

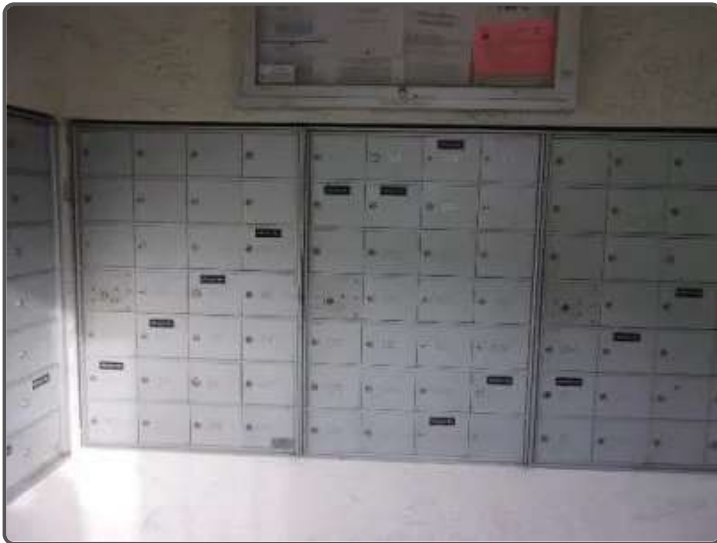
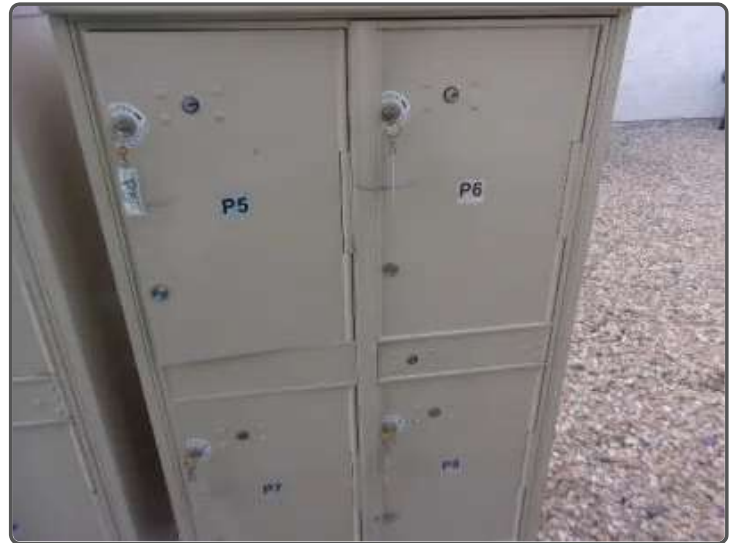
Comp # 803 Mailboxes - Replace

No problems noted at time of site visit. We recommend funding to replace these mailboxes every 18 to 20 years to ensure proper function. Remaining life based on current age.

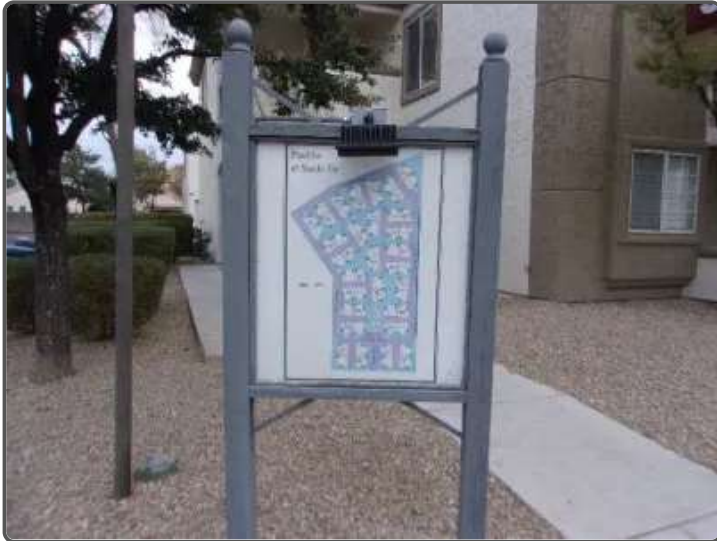
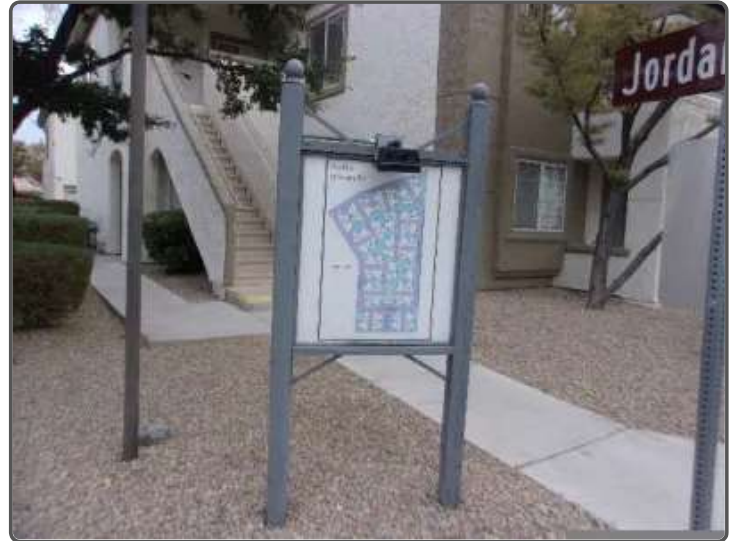
Comp # 805 Directory Sign - Replace

Directory sign is in fair condition. Expect to replace this sign approximately every 18 to 20 years to update map and keep up with modern taste. Remaining life based on current age.

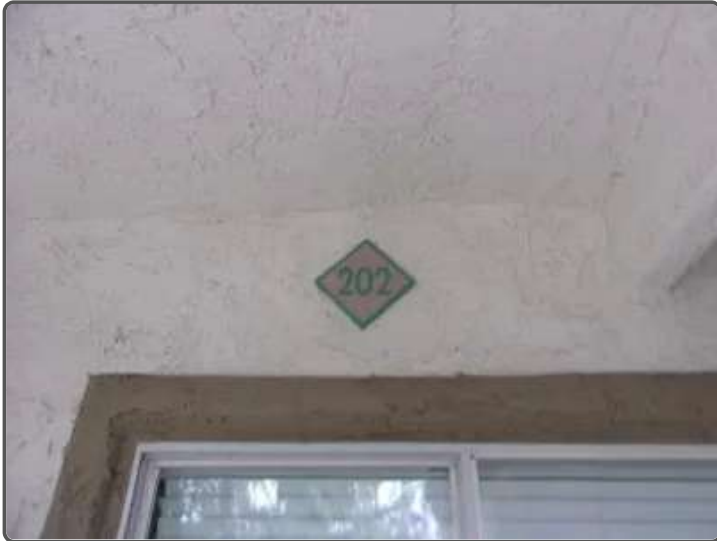
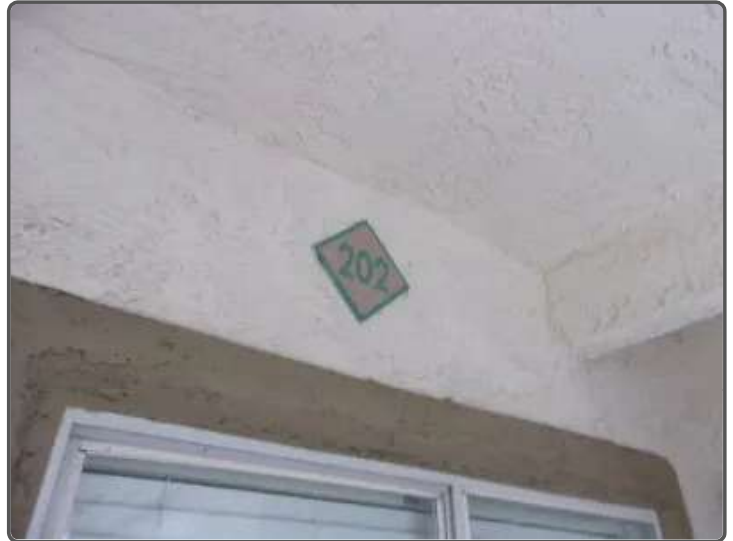
Comp # 805 Unit Signs - Replace

No problems noted or reported at the time of the site visit. We recommend replacing these fixtures approximately every 20 years to maintain appearance throughout the community. Remaining life based on current age.

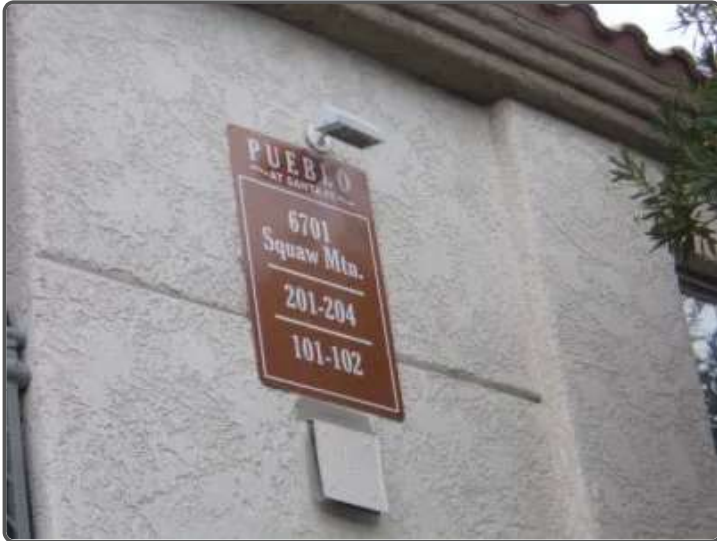
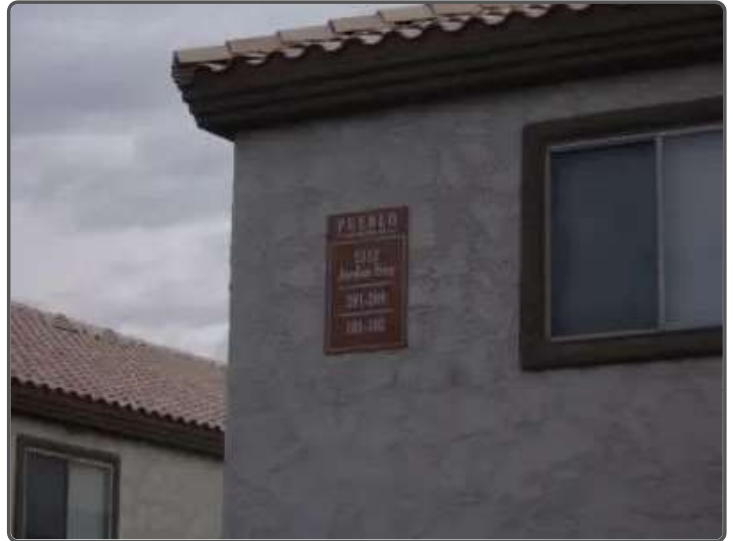
Comp # 806 Address Signs - Replace

We recommend funding to replace these signs approximately every 15 to 20 years to maintain appearance and to keep up with current decorative tastes. Remaining life based on current age.

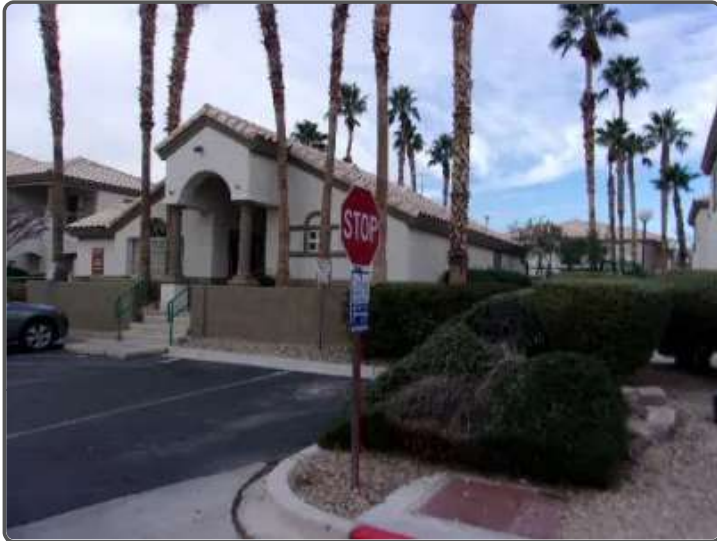
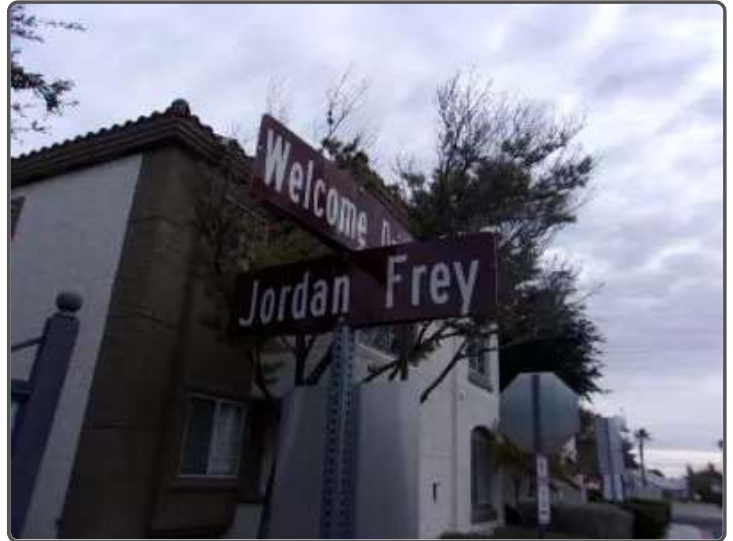
Comp # 808 Street Signs - Replace

- (2) Signs - Indian Chief Dr. (2 Street)
- (2) Signs - Harvest Time Dr. (2 Street)
- (2) Signs - Squaw Mountain Dr. (2 Street)
- (2) Signs - Jordan Fryer St. (2 Street)
- (3) Signs - Welcome Ln (2 Street, 1 Stop)

(11) Street Signs - Total

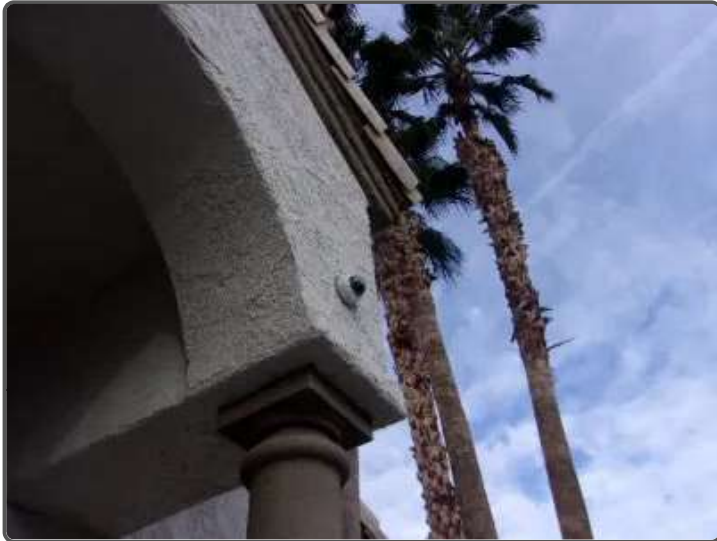
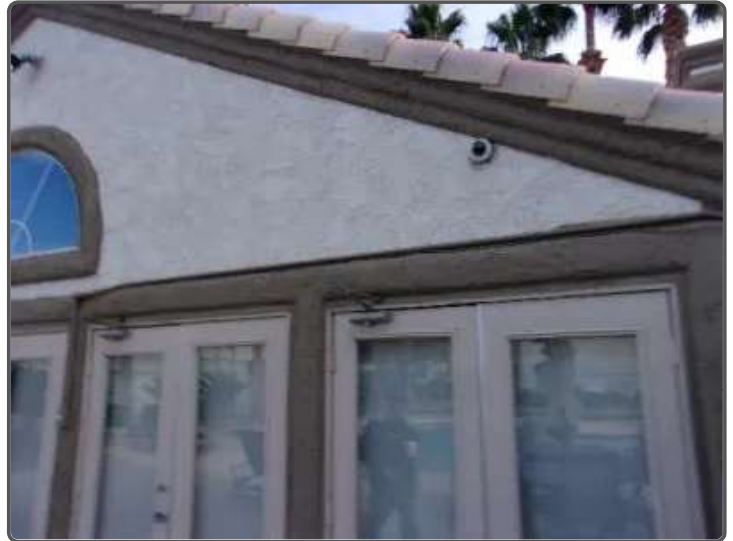
Comp # 903 Camera System - Replace

No problems noted or reported. We recommend funding to replace this camera system approximately every 8 to 10 years to ensure proper function and keep up with current technology.

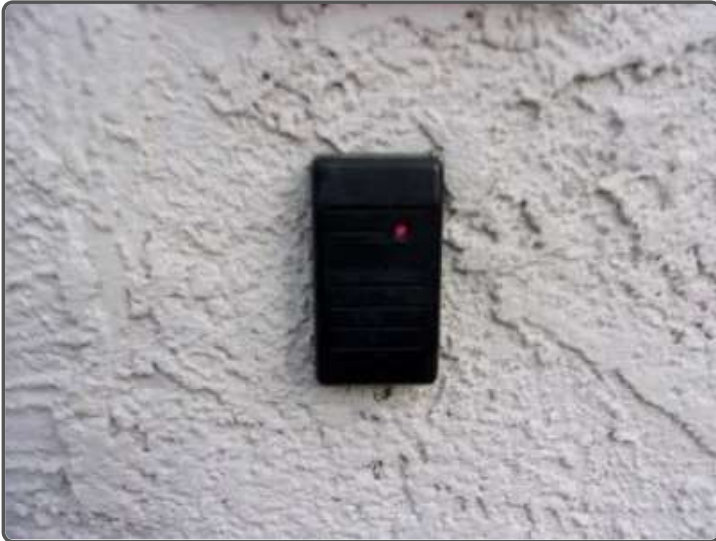
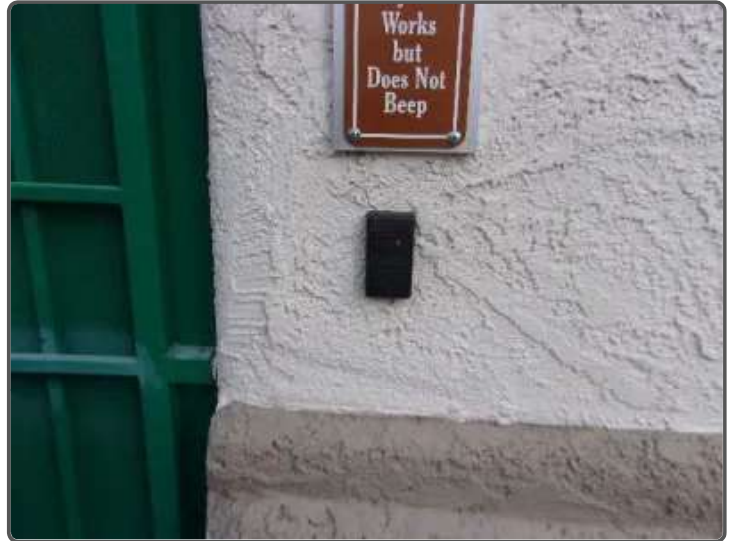
Comp # 904 Fob System - Replace

Fob system is in working condition. We recommend funding to replace this system approximately every 10 to 12 years to ensure proper function and to keep up with current technology.

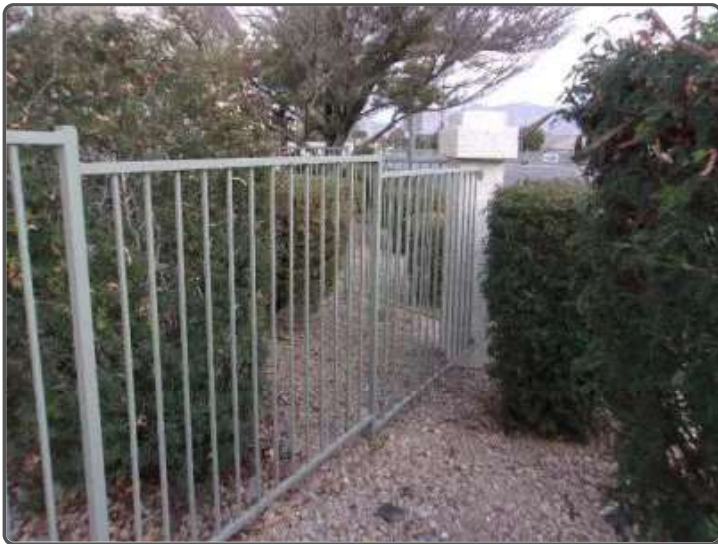
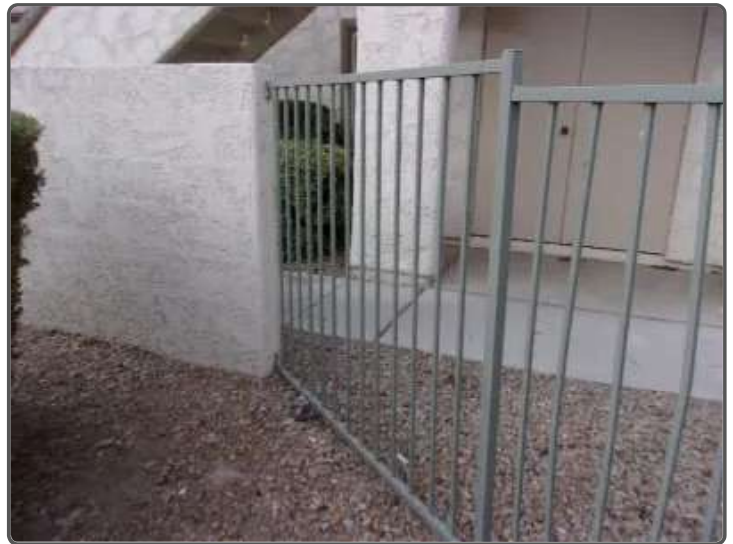
Comp # 1002 Wrought Iron Fencing - Replace

Wrought iron fencing is in fair condition. No significant rusting or structural problems noted at the time of site visit. With regular painting and maintenance, expect a useful life of 25 to 30 years from this component. Remaining life based on current condition.

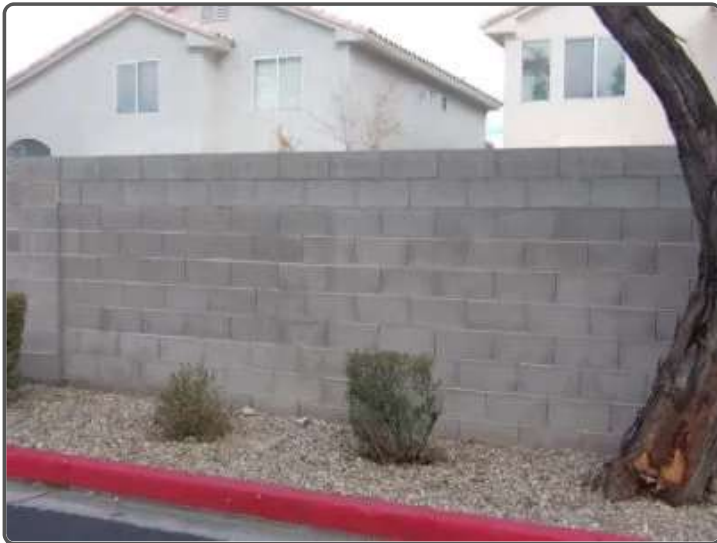
Comp # 1005 Block Wall - Repair/Repaint

Expect to make local repairs as necessary as an operating expense and funding for an allowance to make more significant repairs and repaint the block wall approximately every 20 years.

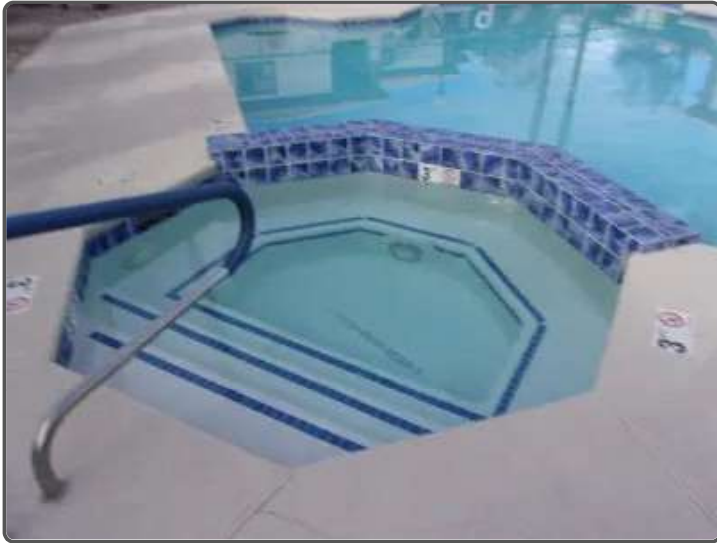
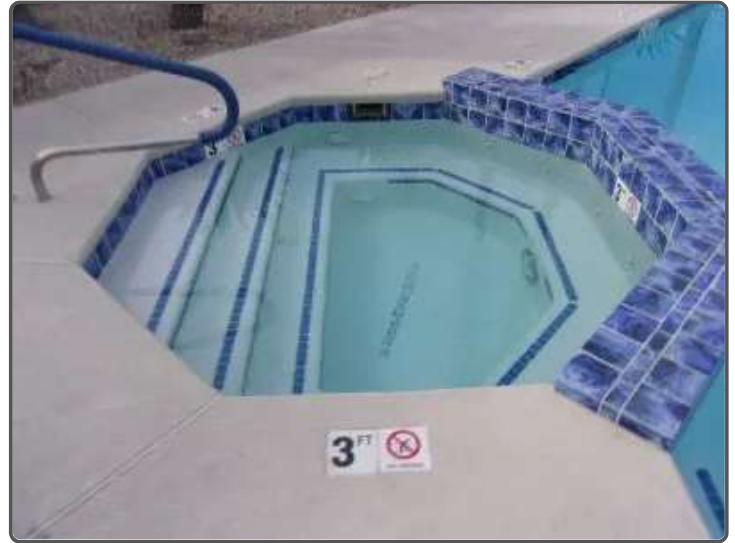
Spa is in fair condition. Because entire spa surface experiences traffic wear expect to replaster spa approximately every 6 years. Remaining life based on current condition.

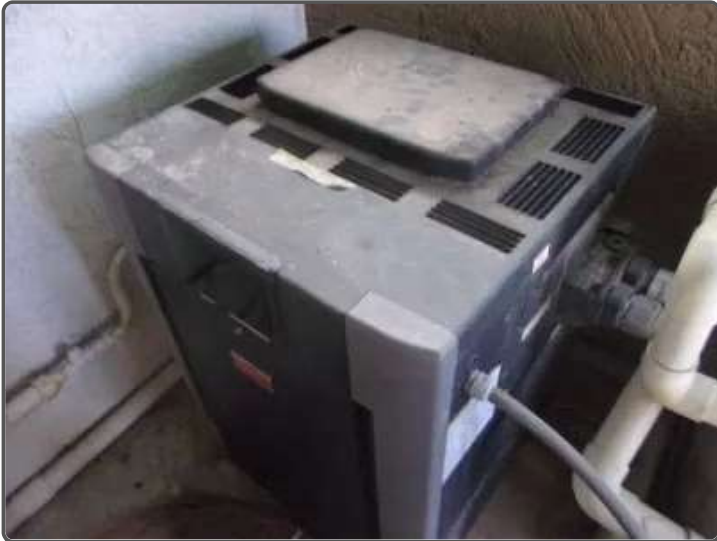
Comp # 1105 Spa Heater - Replace

Spa heater is in fair condition. No reports of problems at time of site visit. Expect a typical useful life of approximately 8 years from this component. Remaining life based on current condition.

Mod# C-R406A-EN-C-ASME
Ser# 1508405779

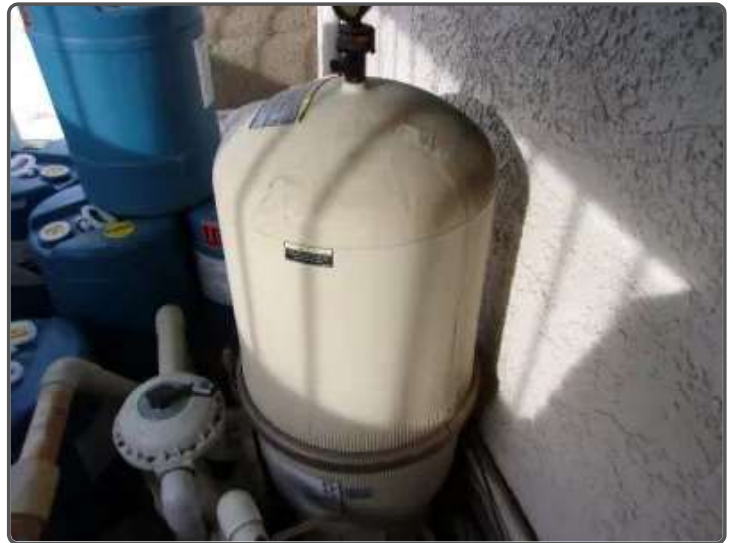
Spa filter is in good condition. No evidence of significant leaks noted at the time of site visit. With regular maintenance expect a useful life of approximately 10 to 12 years from this component.

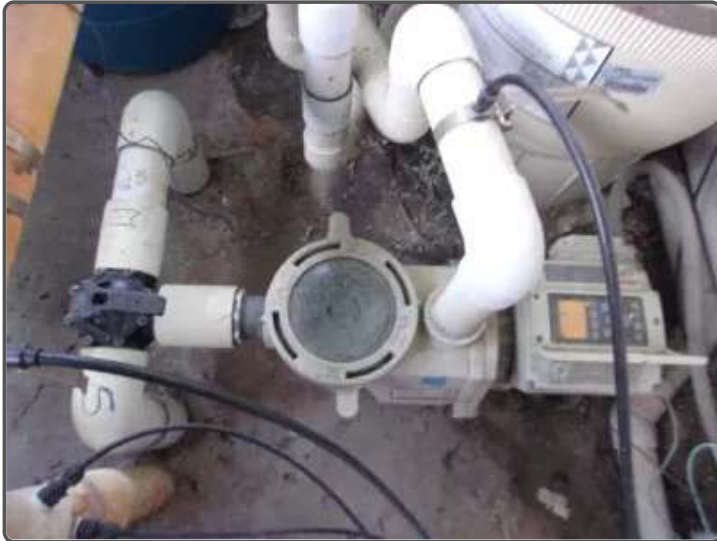
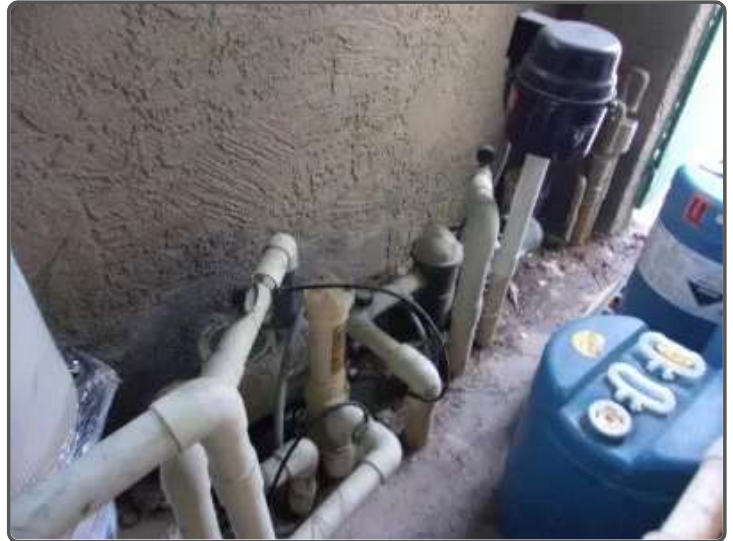
Comp # 1110 Pool/Spa Pumps - Replace

Pumps are in fair condition. We recommend funding to replace one pump approximately every three years. Replace motors as necessary as an operating expense.

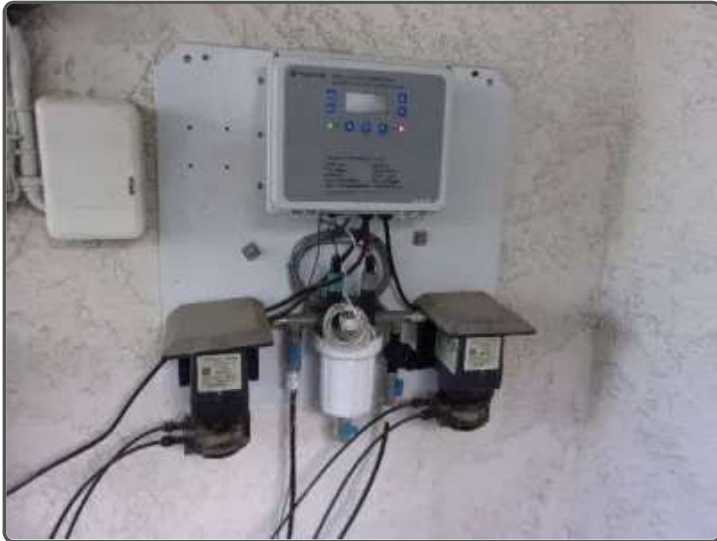
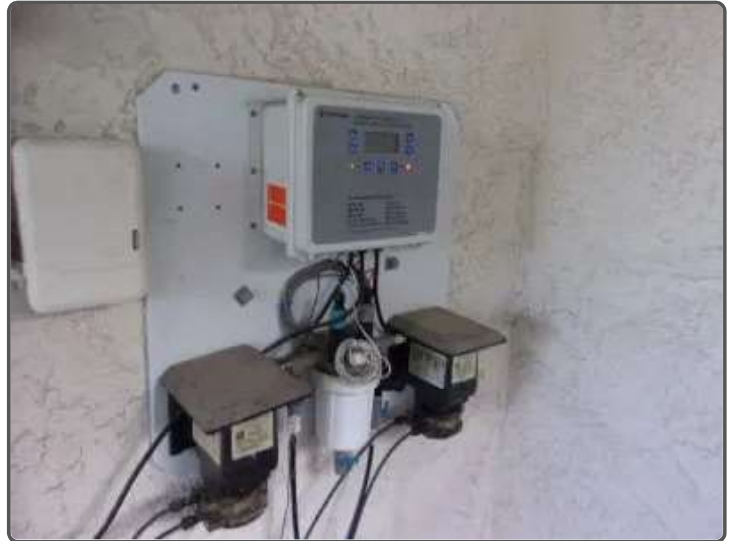
Comp # 1111 Pool/Spa Chlorinators - Replace

We recommend funding to replace this system approximately every 8 to 10 years to ensure proper function and to keep up with current technology.

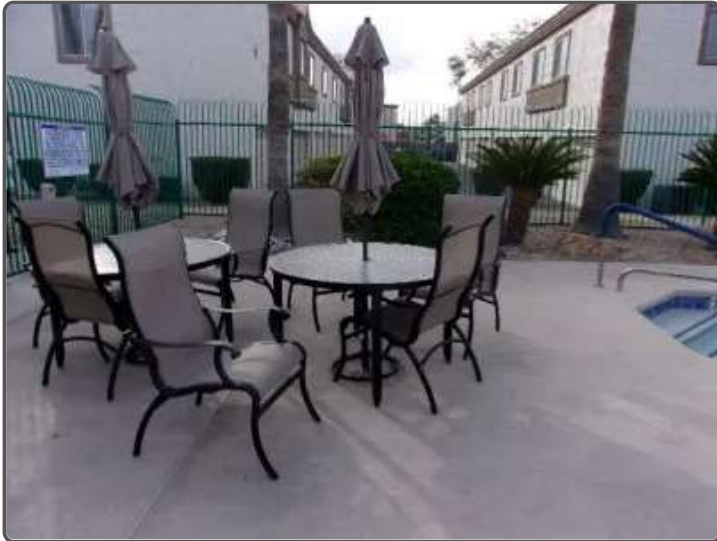
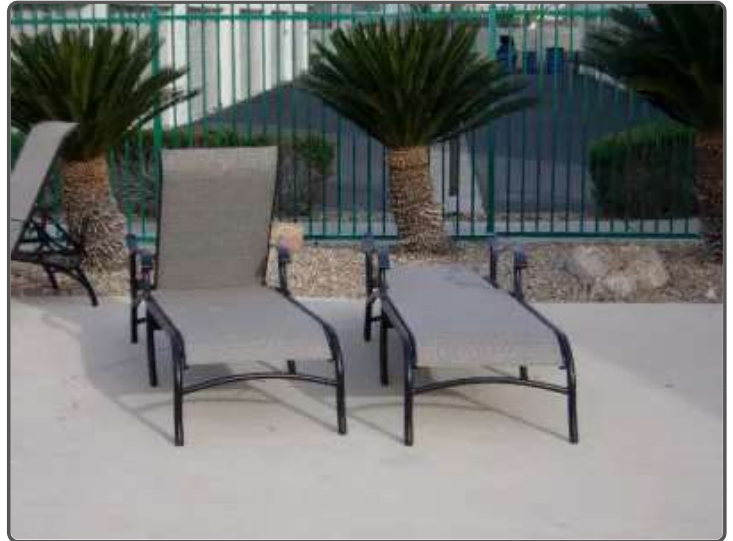
Comp # 1121 Pool Furniture - Replace

Pool furniture is in good condition. No broken straps or significant sun damage noted at the time of our site visit. Expect a useful life of approximately 6 years from this component. Remaining life based on current age and condition.

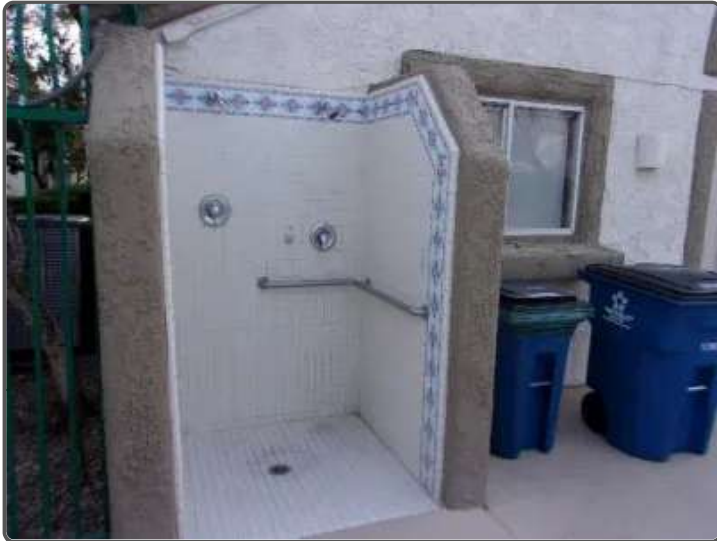
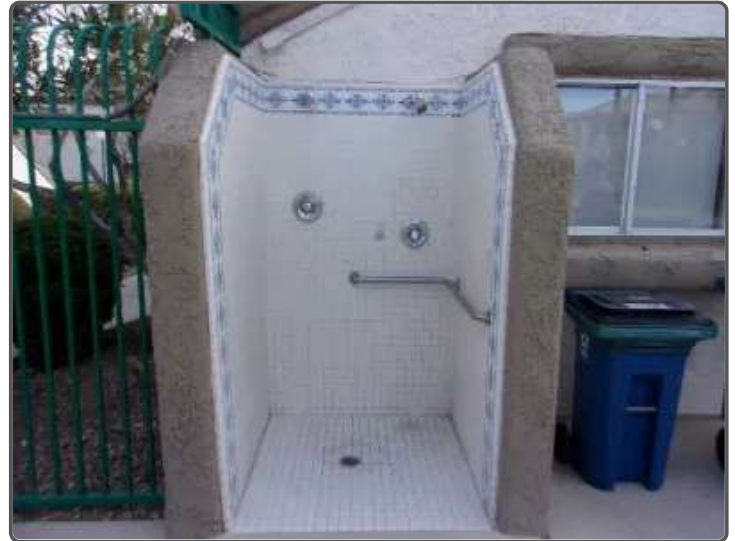
Comp # 1311 Outdoor Shower - Re-Tile

No problems with shower at time of site visit. We recommend funding to retile this shower approximately every 12 to 15 years to maintain appearance and keep up with current decorative tastes.
