Pueblo at Santa Fe Condominium Association

Level 1 Reserve Study

Report Period - 1/1/2024 to 12/31/2024

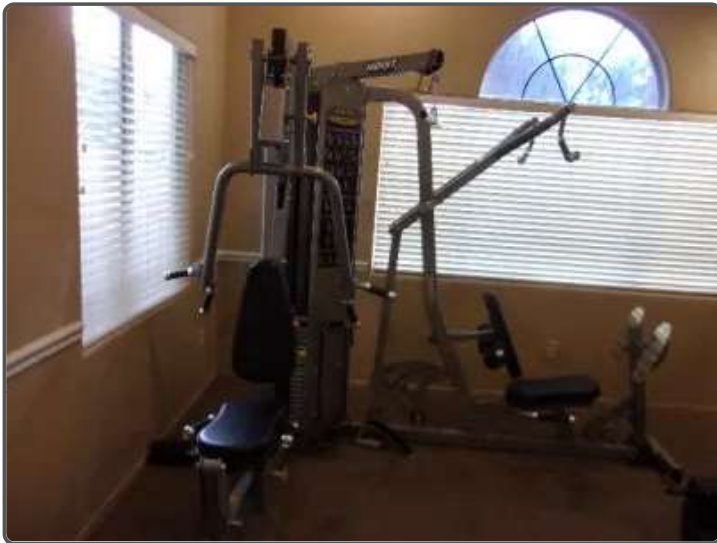
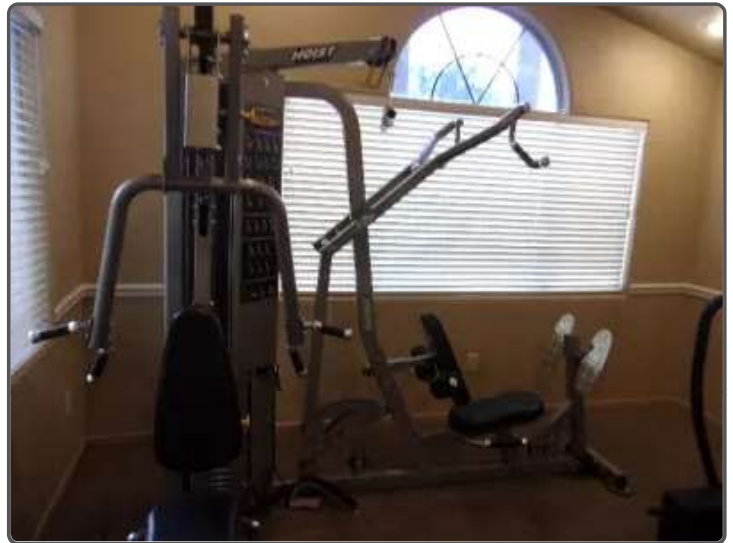
Comp # 1406 Fitness Equipment - Replace

Fitness equipment is in fair condition. No signs of damage or premature wear on this component. We recommend making necessary repairs as an operating expense and funding for a complete replacement approximately every 15 years.

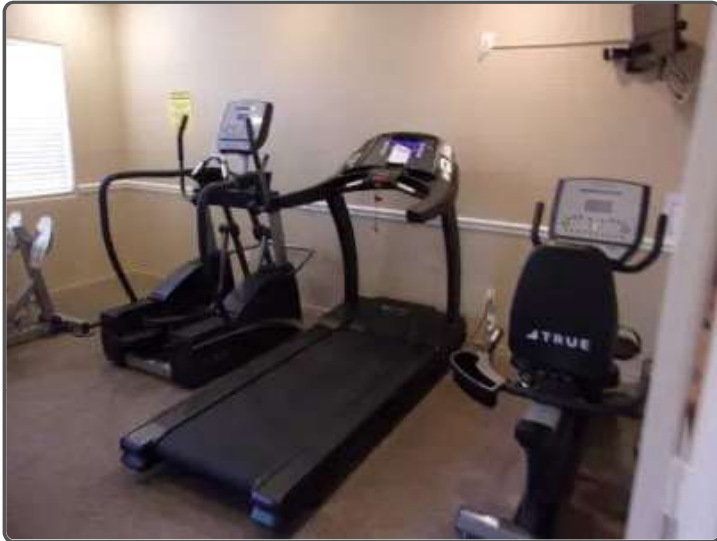
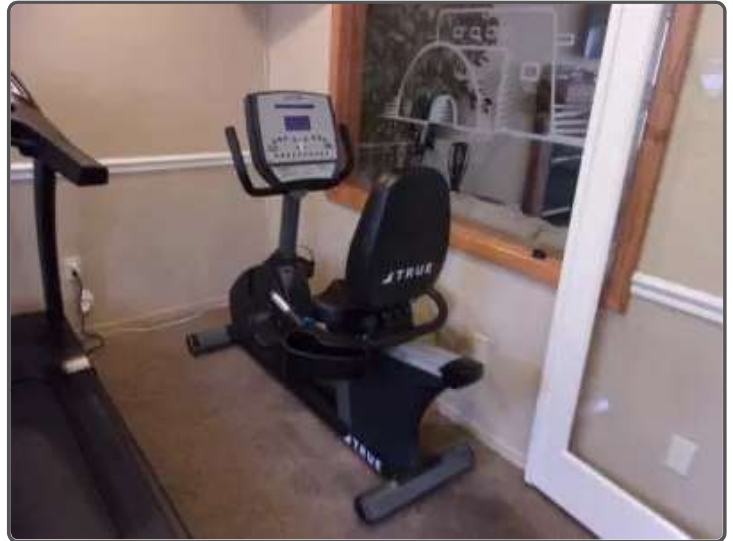
Comp # 1407 Cardio Equipment - Replace

Cardio fitness equipment is in good condition. No signs of damage or premature wear on this component. We recommend making necessary repairs as an operating expense and funding for a complete replacement approximately every 7 years.

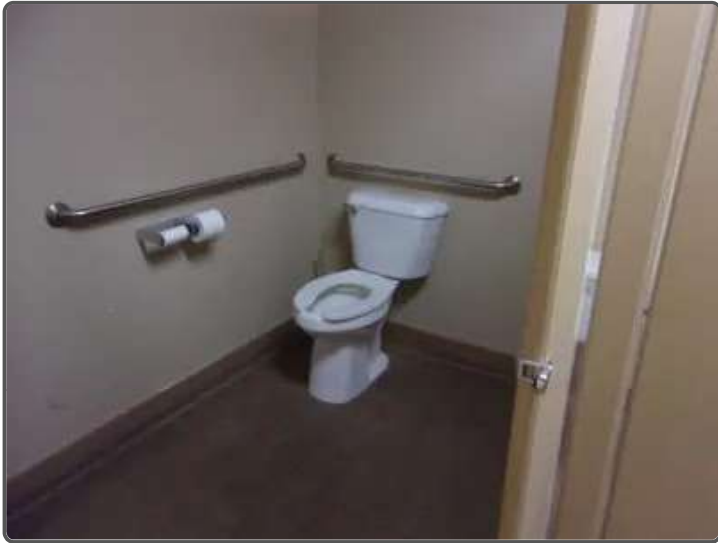
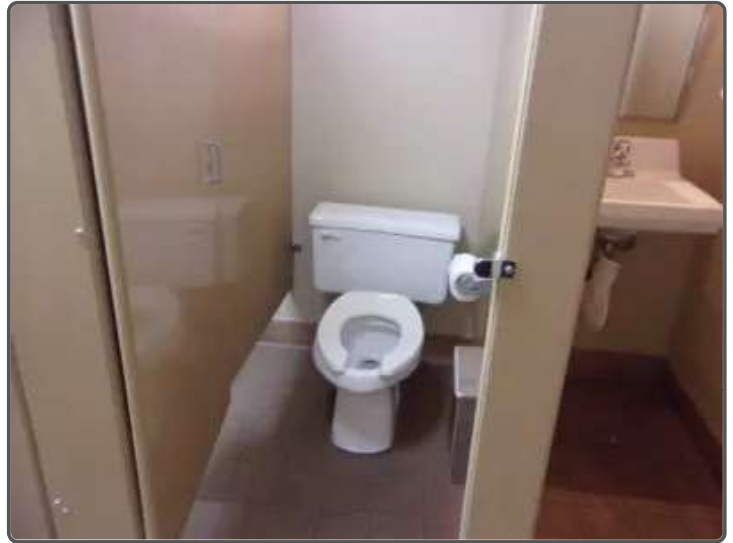
Comp # 1413 Restroom - Remodel

Restrooms are in fair condition. We recommend funding to generally remodel and refurbish these restrooms approximately every 15 to 20 years to maintain appearance and keep up with current decorative tastes.

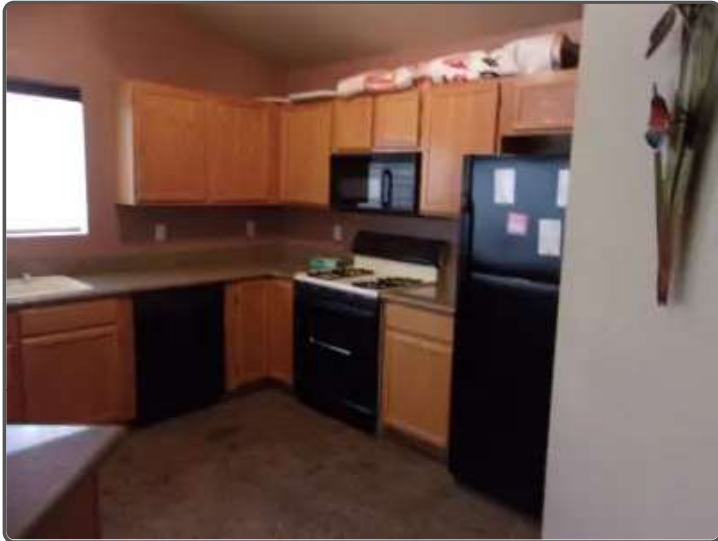
Comp # 1417 Kitchen - Remodel

We recommend funding to remodel this kitchen approximately every 18 to 20 years to keep up with current decorative tastes and ensure proper function of appliances.

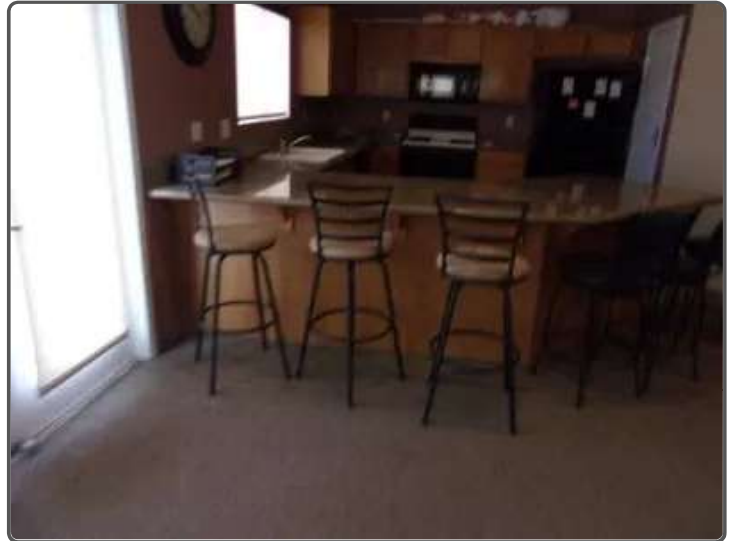
Carpet is in fair condition. Some evidence of wear noted but no rips or curling seams observed at the time of site visit. Expect to replace this component approximately every 10 years assuming normal use and wear. Remaining life based on current condition.

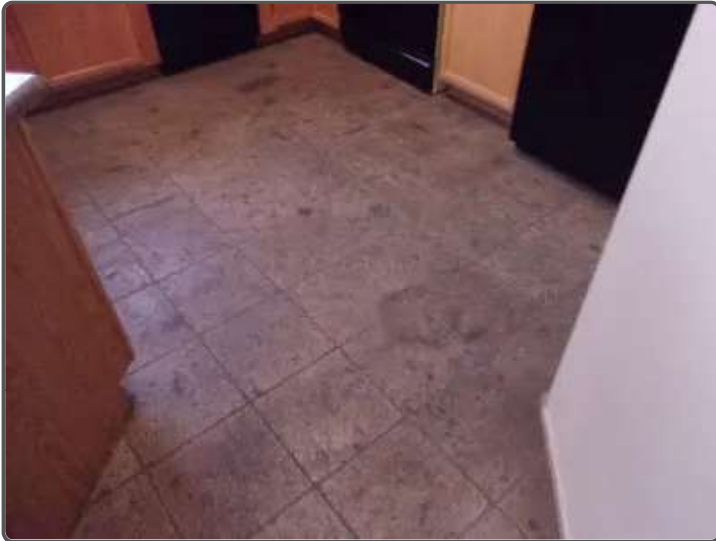
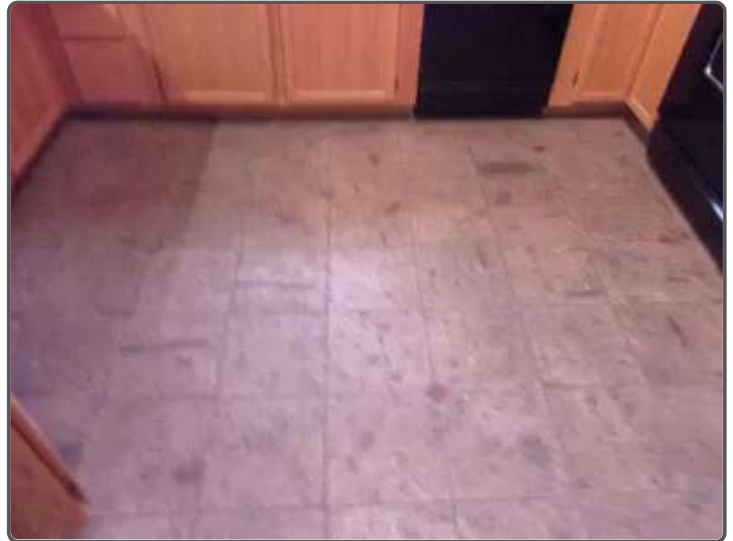
Comp # 1503 Tile Flooring - Replace

No problems noted at the time of site visit. We recommend funding to replace the tile approximately every 30 years to ensure appearance and keep up with current decorative tastes.

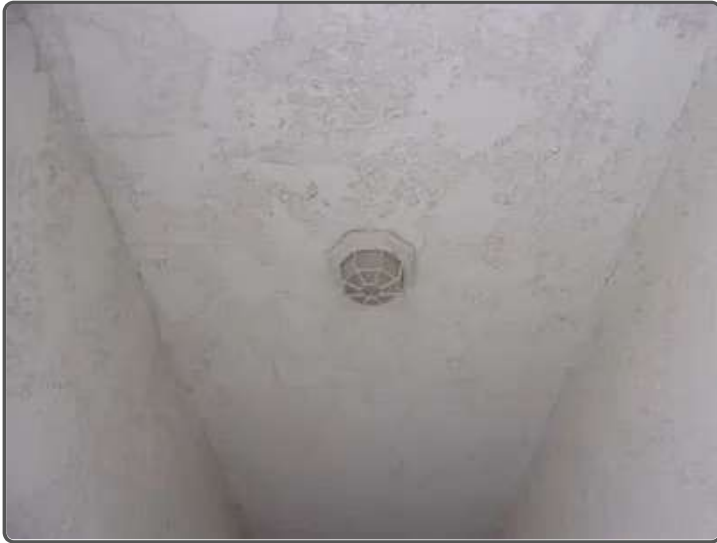
Comp # 1601 Area Lights - Replace

Lights are in fair condition. Expect to replace these lights approximately every 15 to 20 years to maintain appearance and keep up with current decorative tastes. Remaining life based on current age.

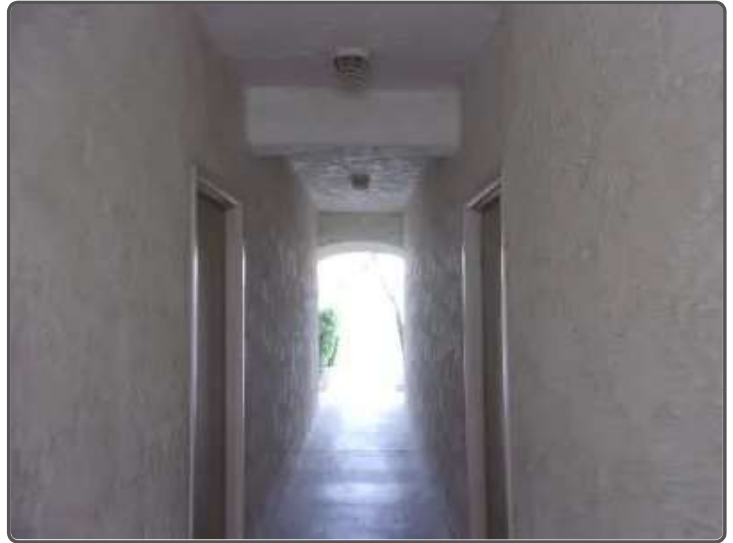
Lights are generally in fair condition. No significant pitting or discoloration noted. Expect to replace these lights approximately every 18 to 20 years to maintain appearance. Remaining life based on current condition.

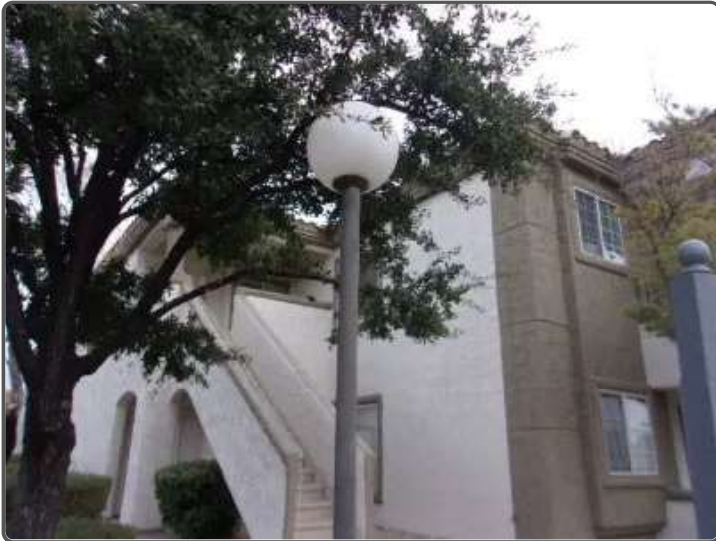
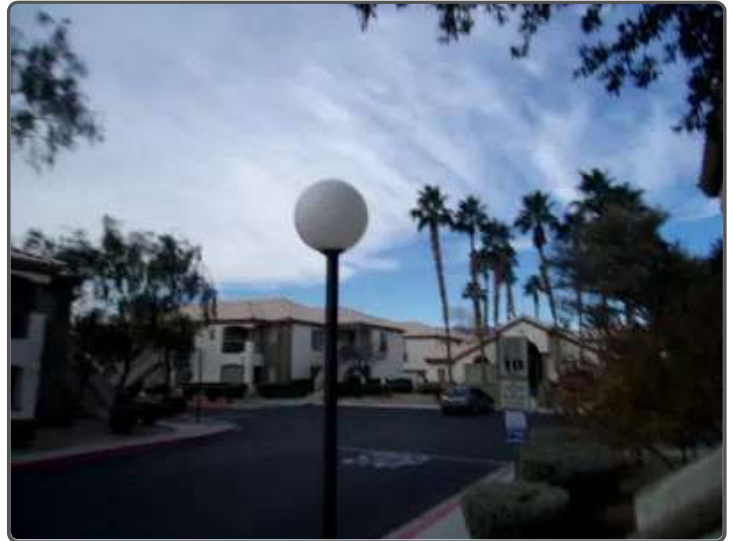
Comp # 1604 Pole Light Fixtures - Replace

No problems noted or reported. We recommend funding to replace the fixtures, make local pole replacements, and to generally refurbish the electrical approximately every 20 to 25 years.

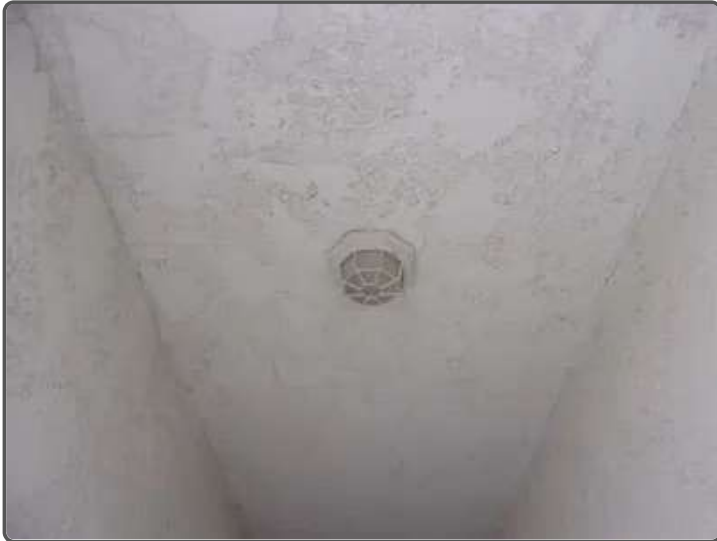
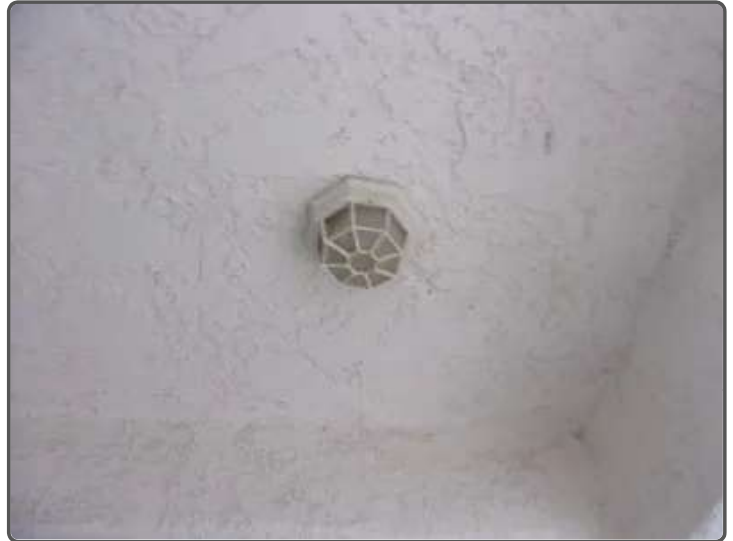
Comp # 1608 Can Lights - Replace

No problems noted or reported at time of site visit. We recommend funding to replace these fixtures approximately every 20 years to ensure proper function. Remaining life based on current age.

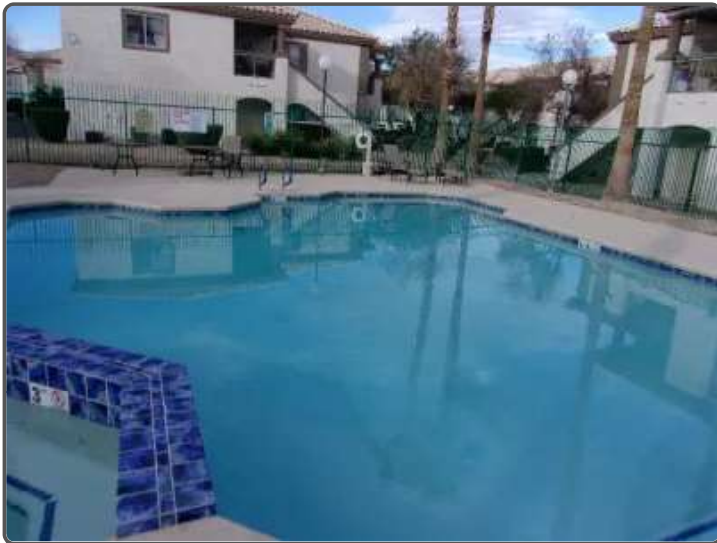
Comp # 1690 Pool Light Fixture - Replace

We recommend funding to replace pool lighting every 8 to 10 years to ensure proper function. Remaining life based on current age.

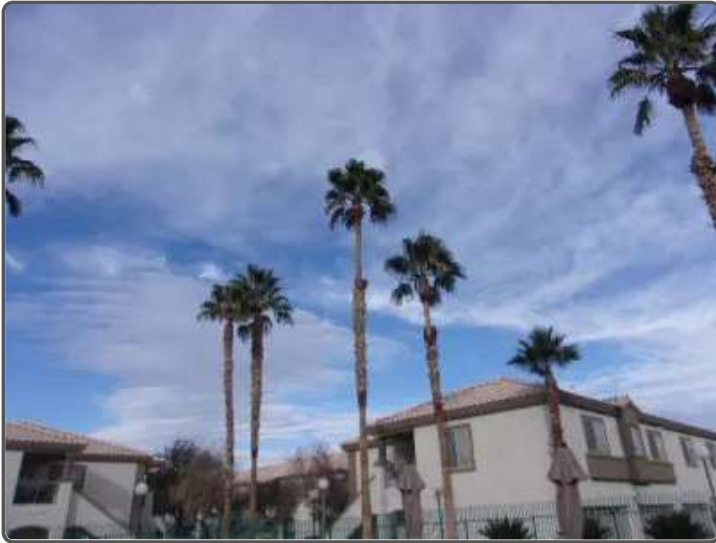
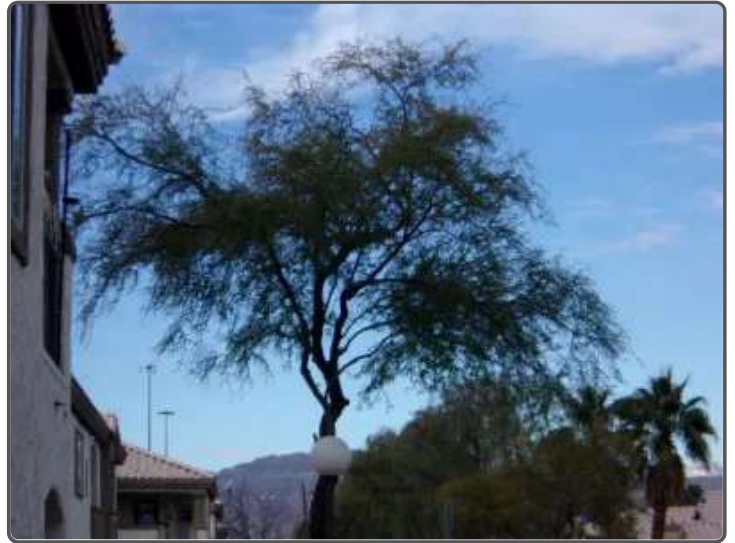
Comp # 1802 Trees - Maintain (Remove / Replace)

We recommend funding to perform tree maintenance including tree trimming and local replacements approximately every 5 to 10 years.

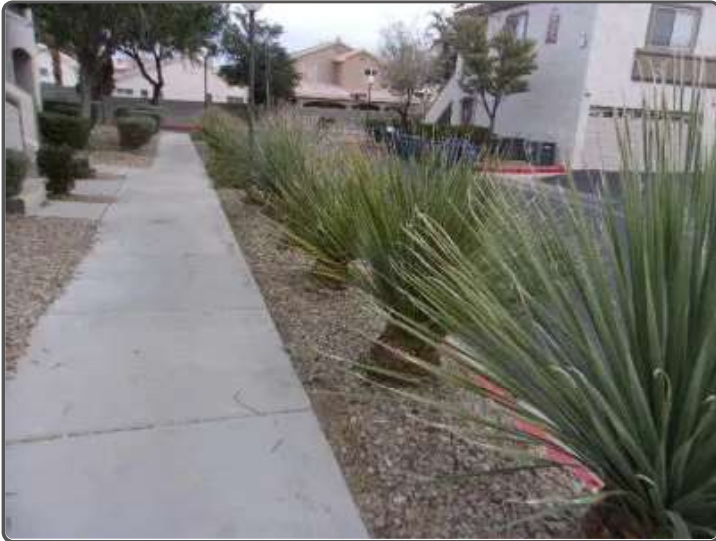
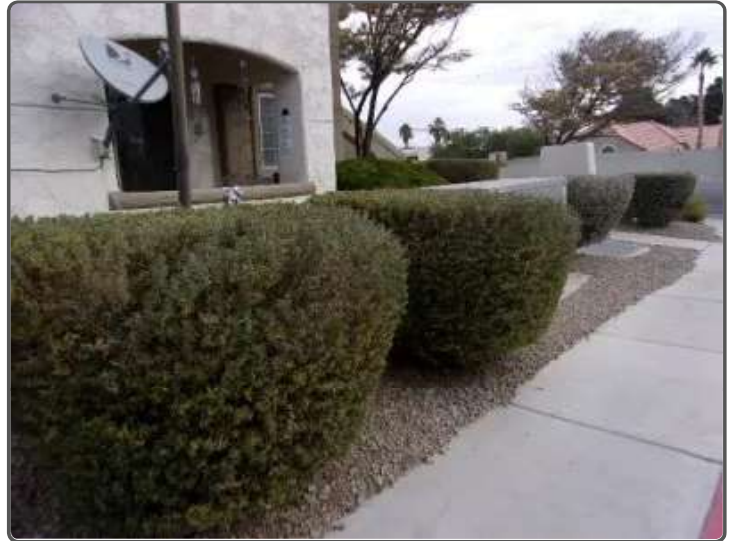
Comp # 1812 Landscaping / Irrigation - Renovate

We recommend funding for an allowance to generally refurbish the landscaping and make upgrades to the irrigation system and landscape lighting approximately every 10 years. Replace irrigation clocks, valves, etc. as necessary as an operating expense.
