Emerald Crest HOA

Level 1 Reserve Study

Report Period - 1/1/2021 to 12/31/2021

Report prepared on - Oct 28, 2020

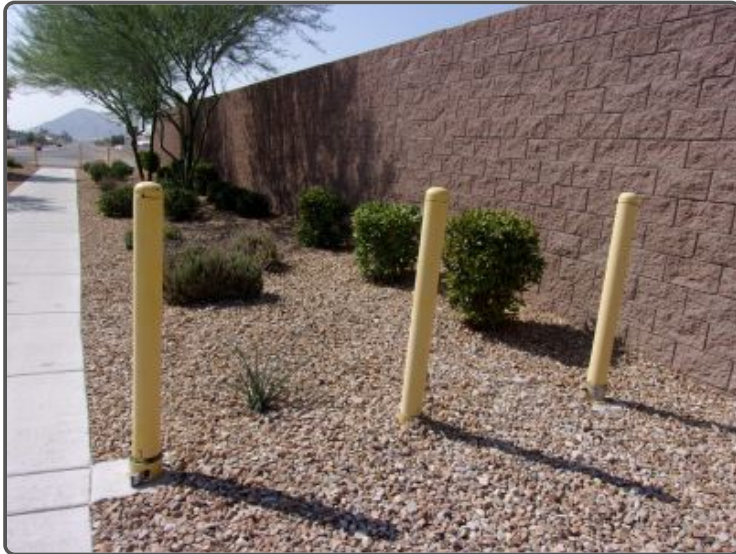
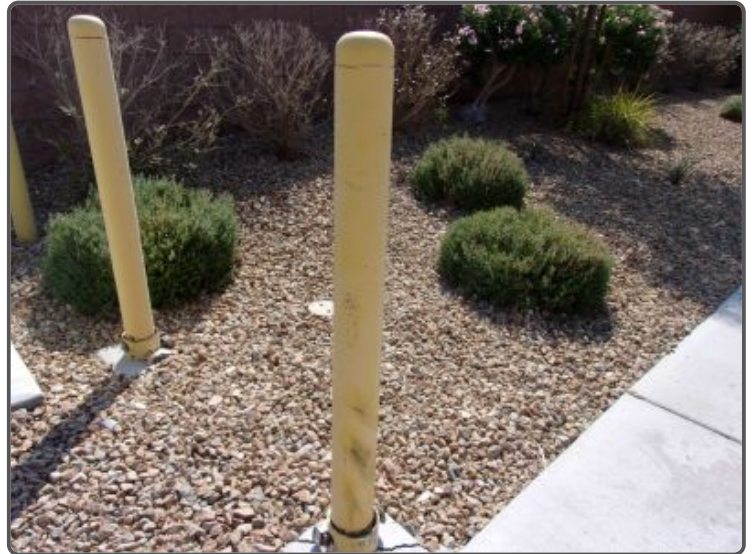
Bollard poles are in fair condition. Due to the minimal cost we recommend repainting the bollard poles as an operating expense.

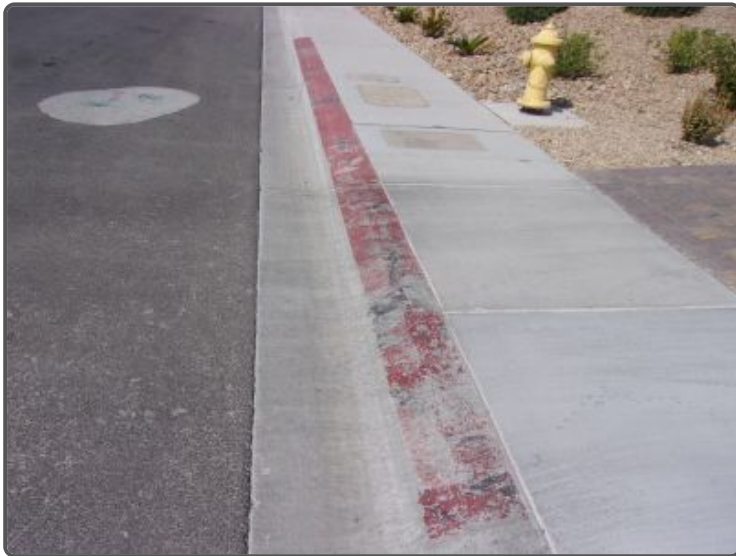
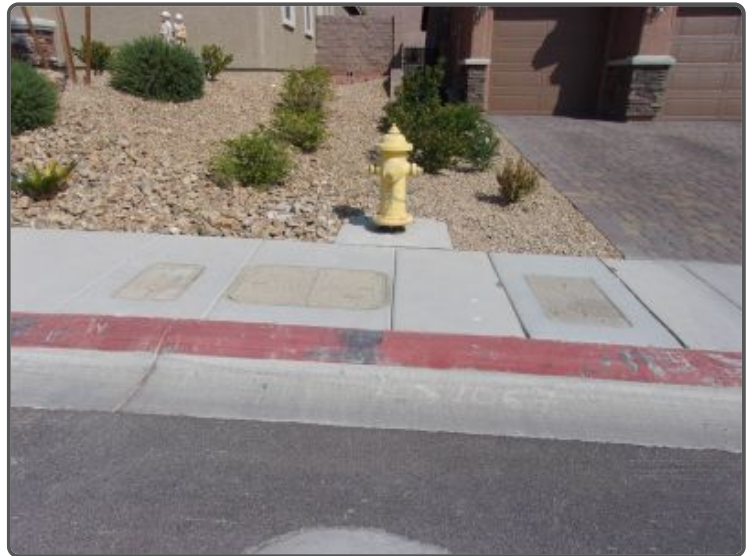
Comp # 214 Red Curbing - Repaint

Red curbs and hydrants are in fair condition. Minor fading and discoloration noted. Expect to repaint these surfaces approximately every 3 years to maintain appearance and visibility. Remaining life based on current condition.

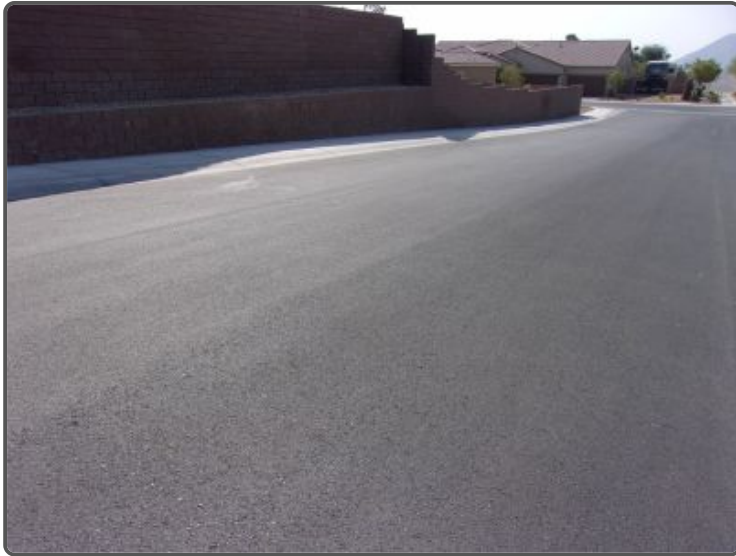
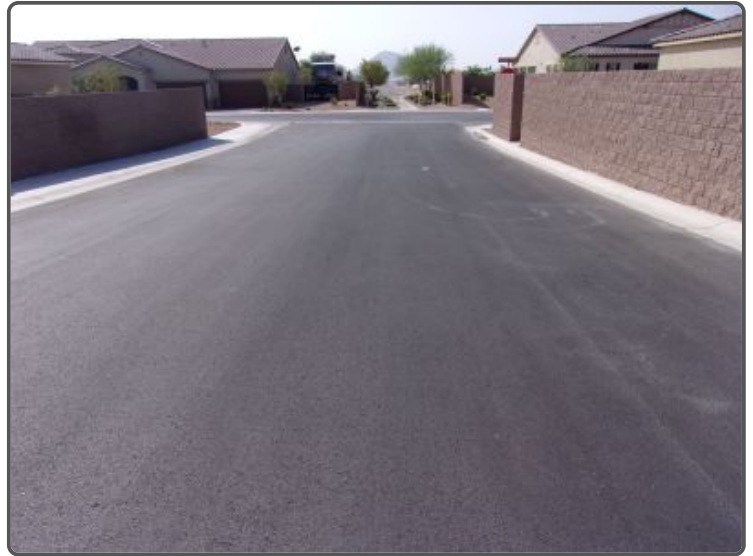
Comp # 401 **Asphalt - Major Rehab.**

No problems noted at the time of site visit. With regular sealing and repairs (see Comp# 402 Asphalt - Preventive Maintenance) asphalt surface should reach a typical useful life of approximately 30 years before a major rehabilitation (overlay, R & R, etc.) is necessary.

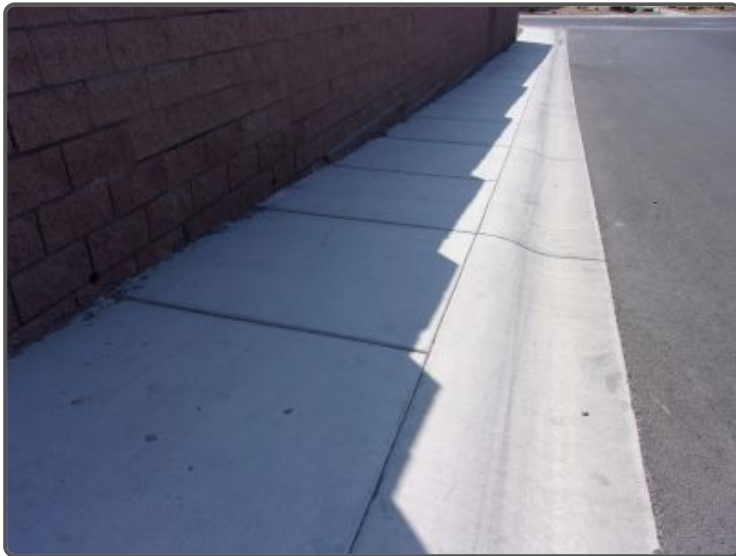
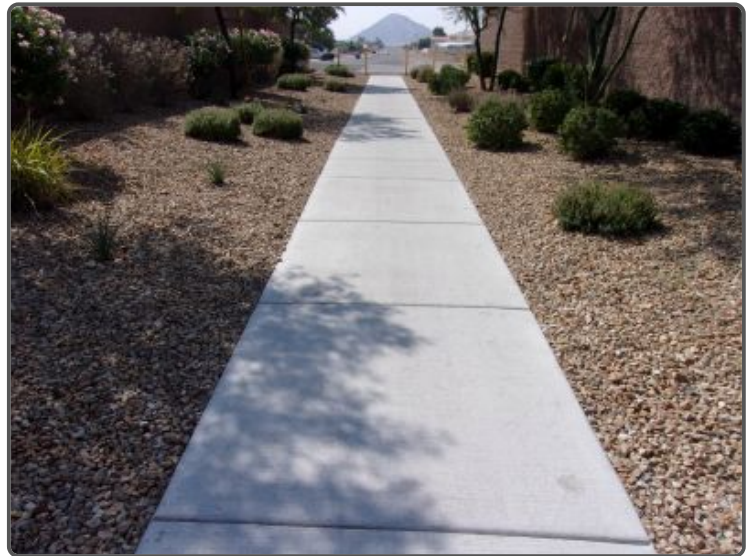
Comp # 403 Concrete - Repair/Replace

No expectation to completely replace the concrete surfaces. We recommend making local repairs as necessary as an operating expense and funding to make more significant repairs approximately every 10 years.

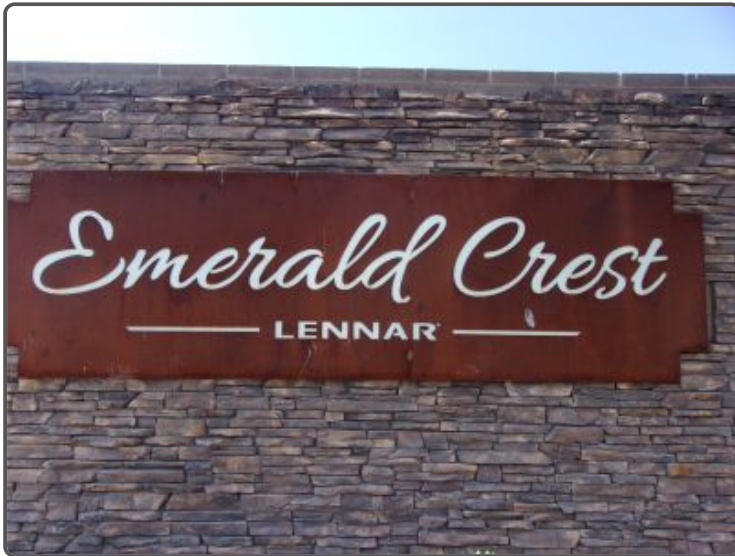
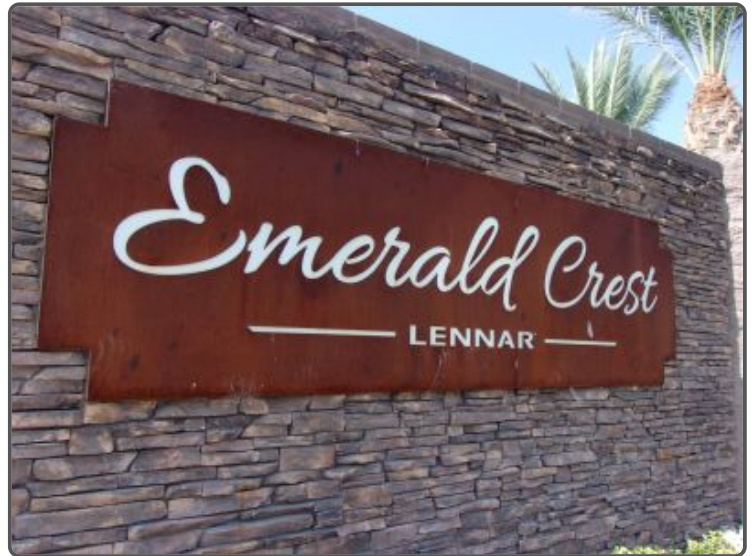
Comp # 801 Monument - Replace

Monument signs are in good condition. No expectation to completely rebuild the monuments. We recommend funding to generally refurbish and repair the monuments approximately every 15 to 20 years.

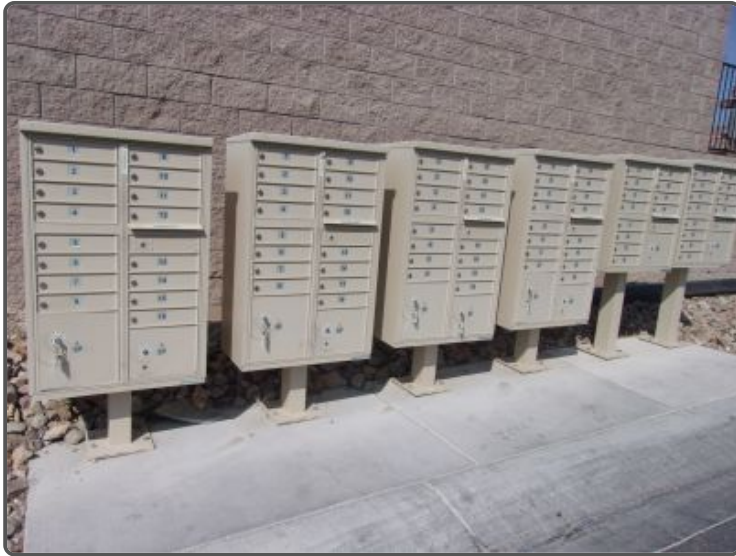
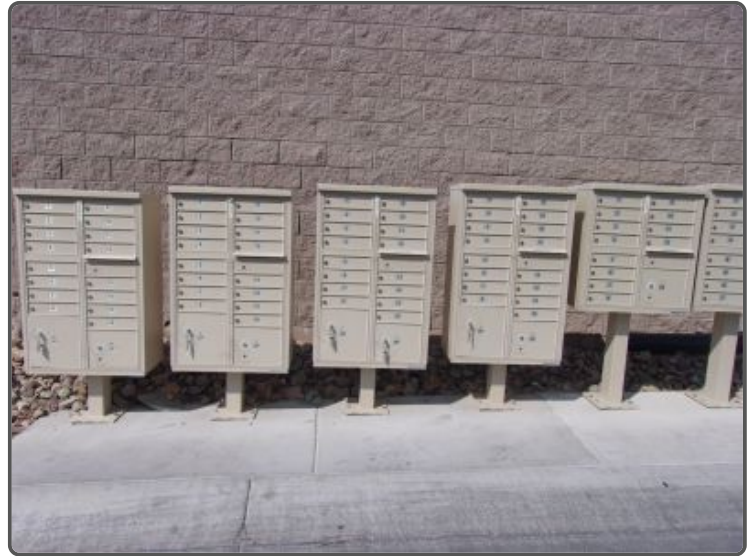
Comp # 803 Mailboxes - Replace

Boxes are generally in fair condition. Some marking and discoloration noted but no broken boxes observed. Expect to replace this component approximately every 15 to 20 years to maintain appearance and function. Remaining life based on current age and condition.

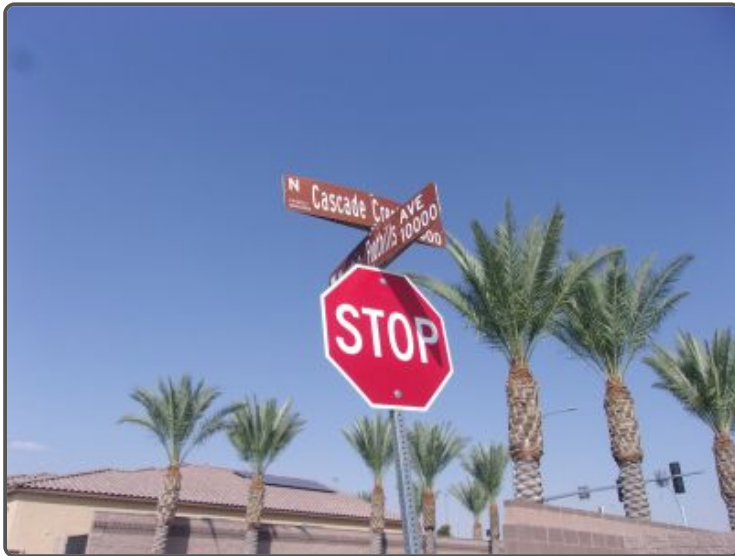
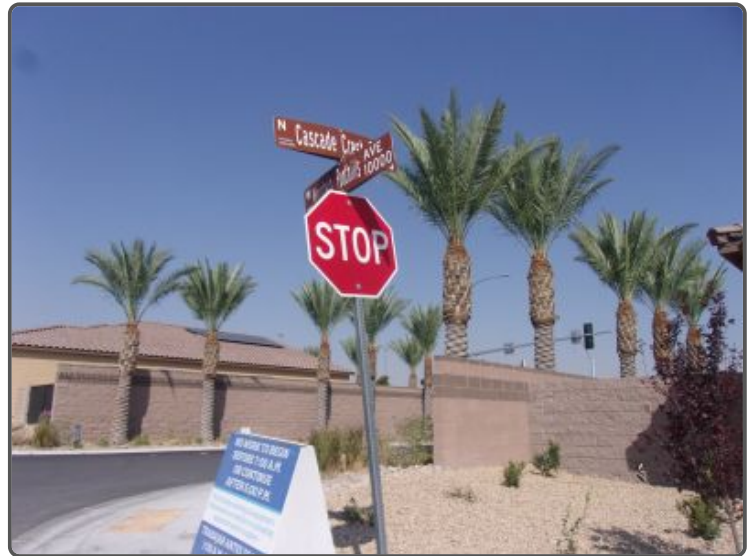
Comp # 808 Street Signs - Replace

Signs are in good condition. Although these signs may reach an extended life we recommend funding to replace them approximately every 20 years.

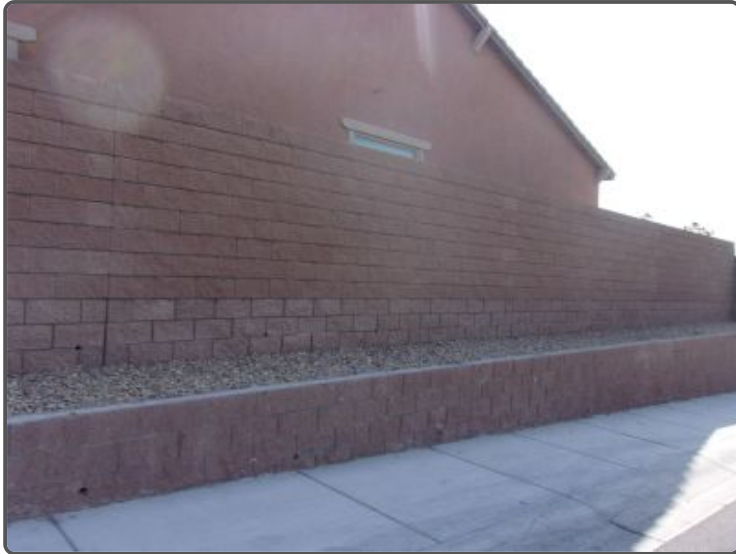
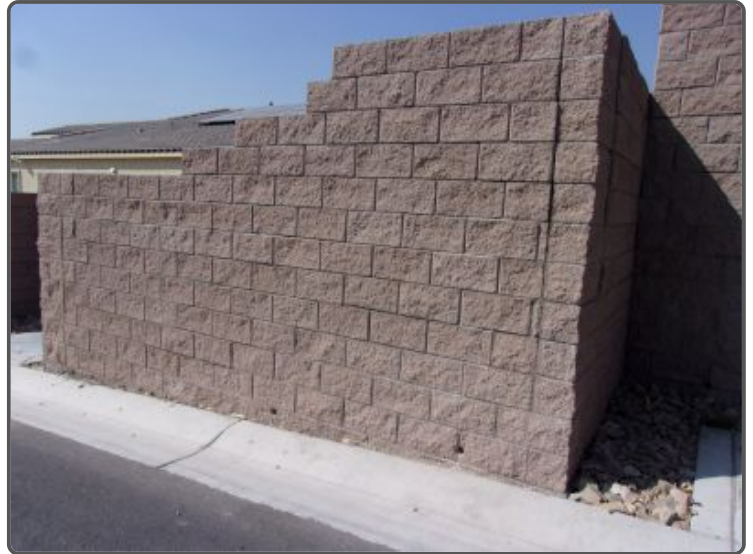
Comp # 1005 Block Wall - Repair (Homeowner Responsibility)

Perimeter walls are the responsibility of the individual owner. No reserve funding necessary.

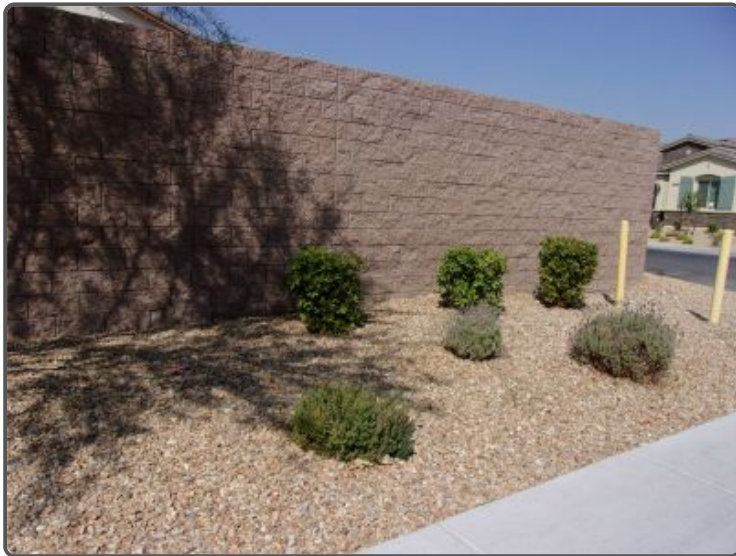
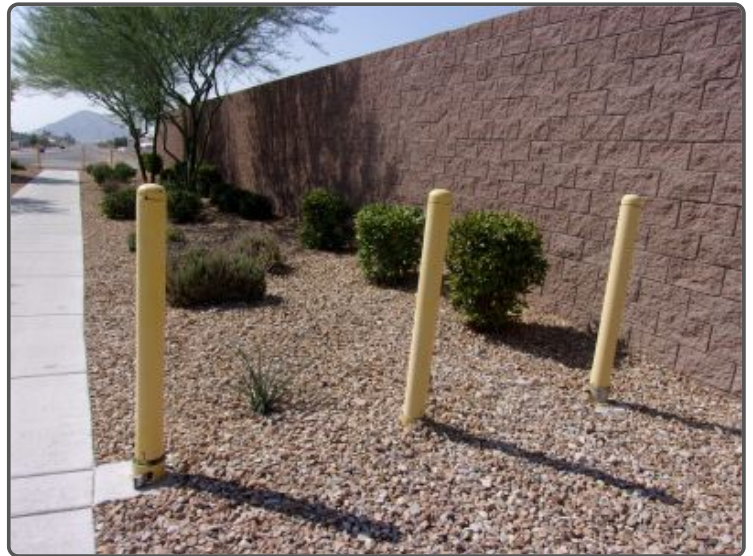
Comp # 1801 Groundcover - Replenish

Rock is in good condition. No expectation to completely replace rock. We are funding to generally top fill and dress the rock throughout the community approximately every 3 years.

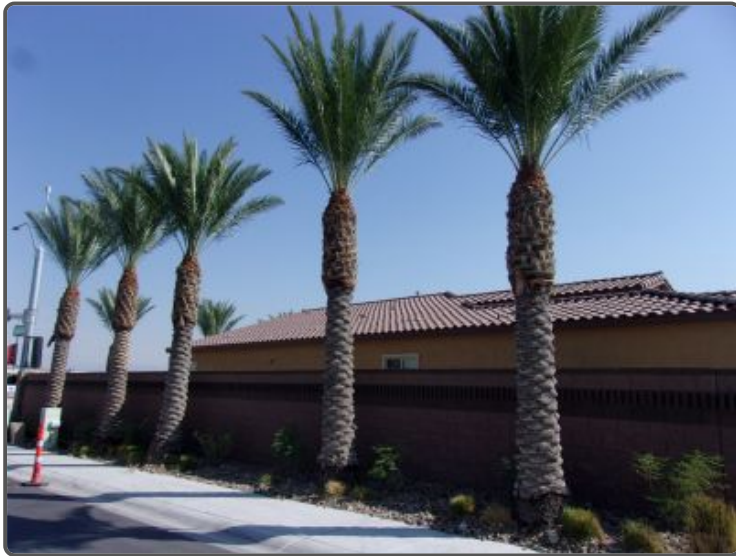
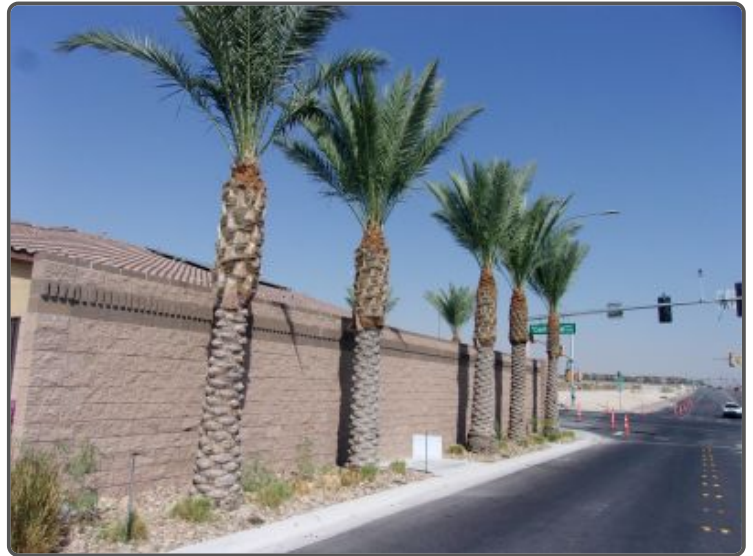
Comp # 1804 Tree - Replacement

In general palm trees have an extended life. However due to the relatively high number of palm trees at the community we recommend funding to replace a tree periodically due to vehicle damage, disease, high winds, etc. Although it is hard to predict when a tree will die we recommend funding to replace one tree approximately every 5 years. Note: This allowance can be increased in future reserve studies as the trees age.

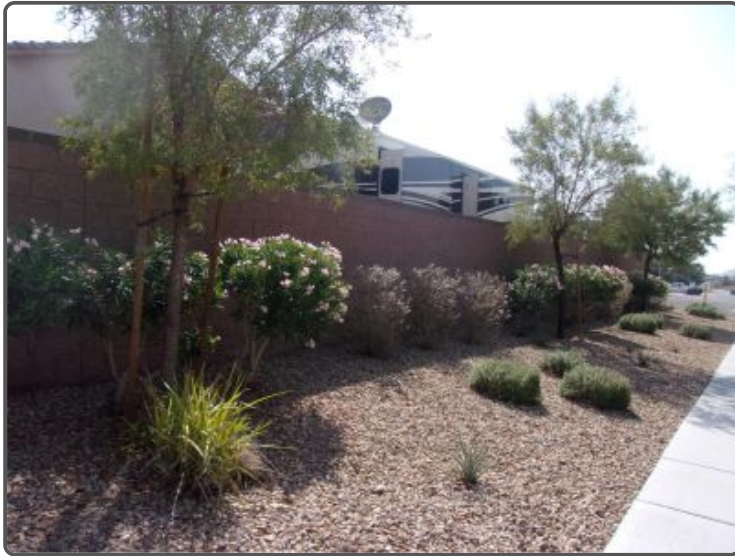
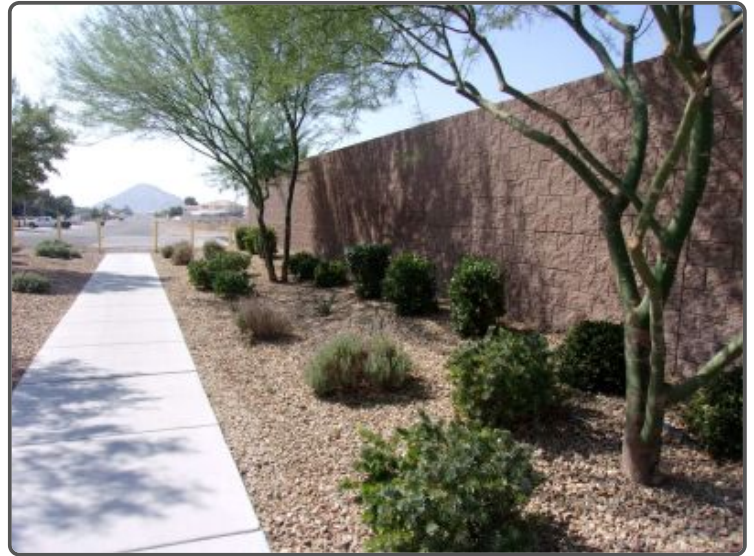
Comp # 1812 Landscaping / Irrigation - Renovate

No expectation to completely replace the landscaping. We recommend funding for an allowance to generally refurbish the landscaping, make local tree replacements, and make upgrades to the irrigation system and landscape lighting approximately every 10 years. Replace irrigation clocks, valves, etc. as necessary as an operating expense.
