UNDERGROUND STORAGE TANK FACILITY

Site work included partial system replacement. Gasoline product piping and dispensers were closed by removal and replaced with new. One kerosene pump and the associated product line were closed by removal. The kerosene UST was converted to auto diesel and piping was installed between the diesel UST and the diesel pumps. New tank top equipment was installed on the gasoline and diesel USTs.

11.	Briefly describe the storage tank facility and the nature of the operations which were conducted at the facility (both historical and present) <b>including use of tanks</b> :
	The facility has been operated as a retail petroleum distribution facility and convenience store from
	2001 through present. Two USTs containing regular gasoline and one UST containing premium
	gasoline are currently in service. Site work included partial system replacement. Gasoline product
	piping and dispensers associated with USTs 002, 003 and 004 were closed by removal and replaced
	with new. The kerosene product line and dispenser associated with UST 001 were closed by removal.
	The kerosene UST was converted to auto diesel and piping was installed between the diesel UST and
	the

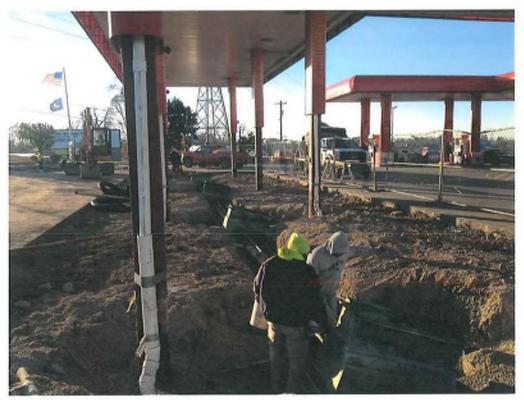
View of pumps 1 through 10 facing south/southeast

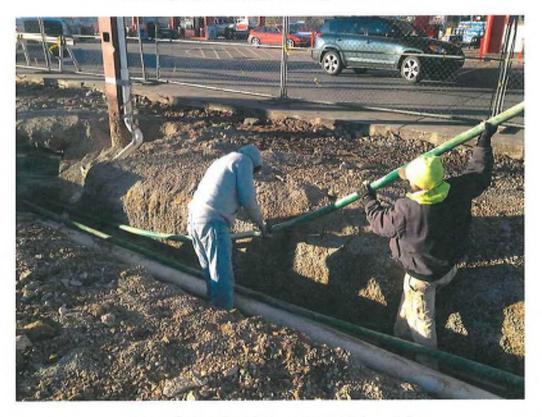
Removal of product piping at pumps 1 through 8

All gasoline product lines (approximately 290 linear feet) and kerosene product lines (approximately 125 linear feet) were closed by removal. Product lines were in good condition.

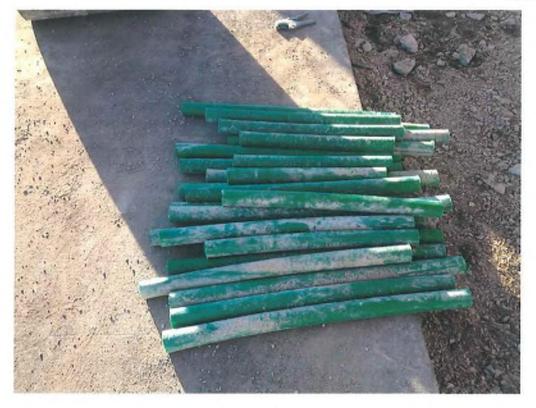
# Removed piping

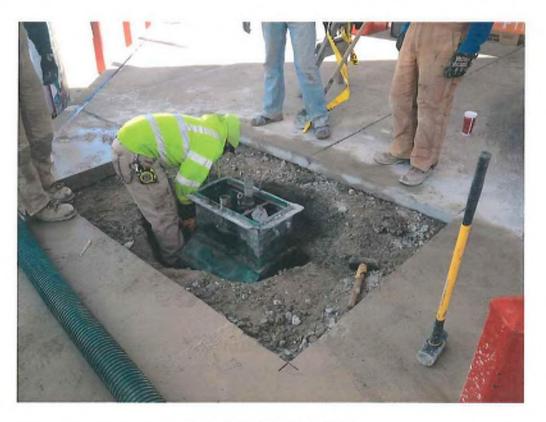
Excavation of kerosene sump

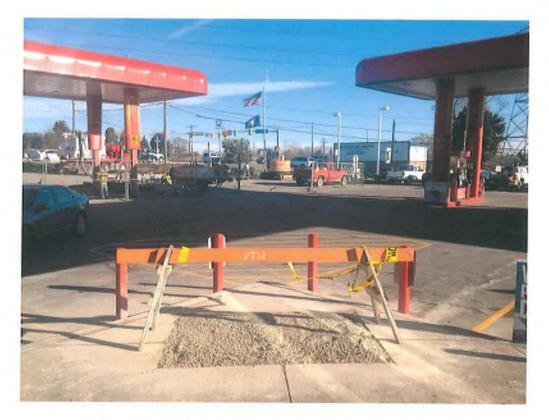
After removal of kerosene dispenser and sump, facing southeast

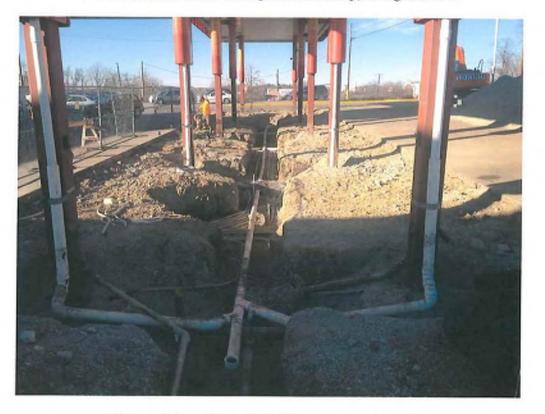
Pumps 1 through 10 after piping and sump removal

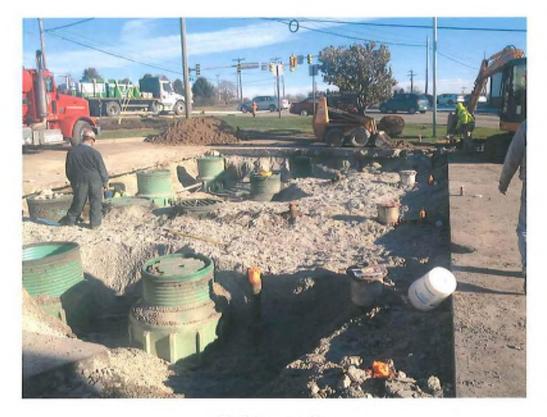
# Tank top upgrades

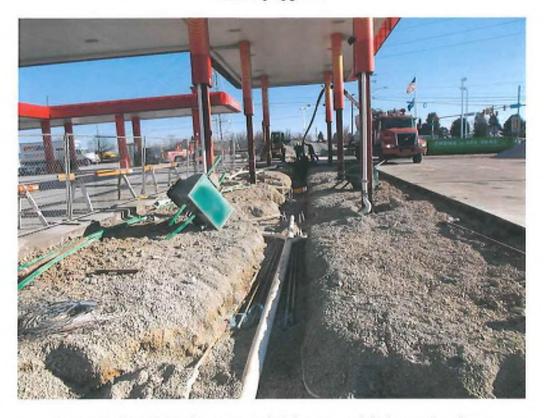
Pumps 11 through 18 after sump and piping removal, facing east/northeast

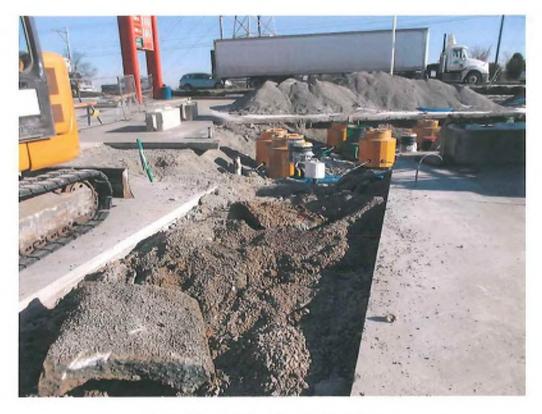
Product line trench and tank top equipment

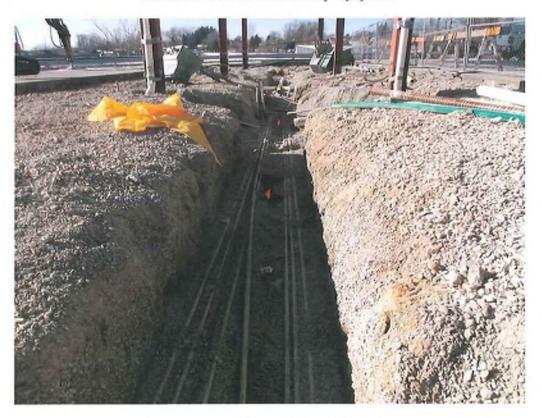
Product line trench with electrical conduits

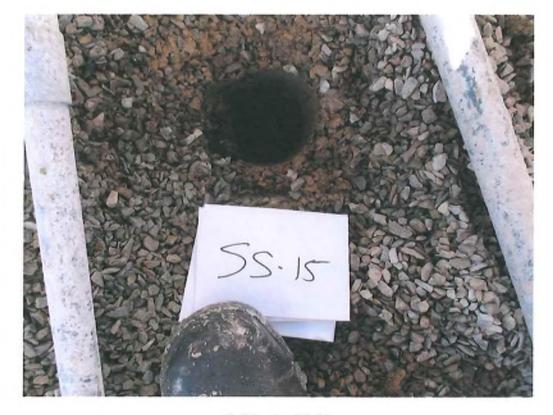
# Soil boring SS-15

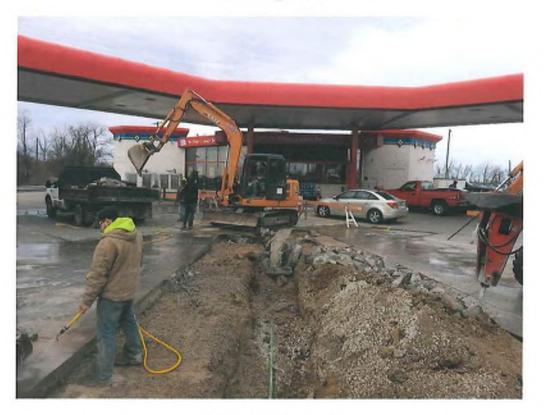
Kerosene line removal

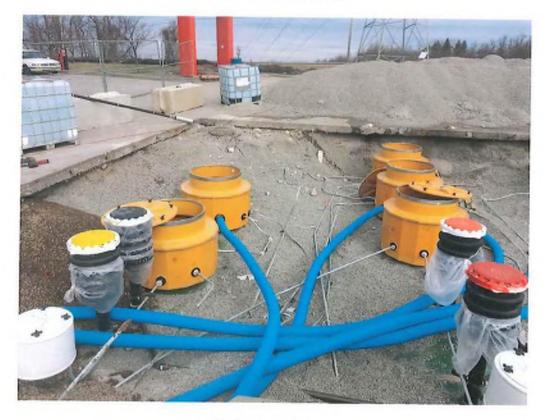
Tank top equipment

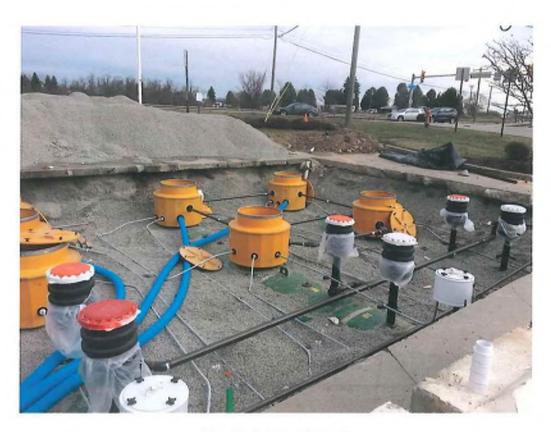
New tank top equipment
