Radiators and Reservoirs in Li'l Reds

John C. Roberts (Lil Red Dad)
Co-Founder, President & Senior Concours Judge,
NALRETO (National Association of Li'l Red Express
Truck Owners)

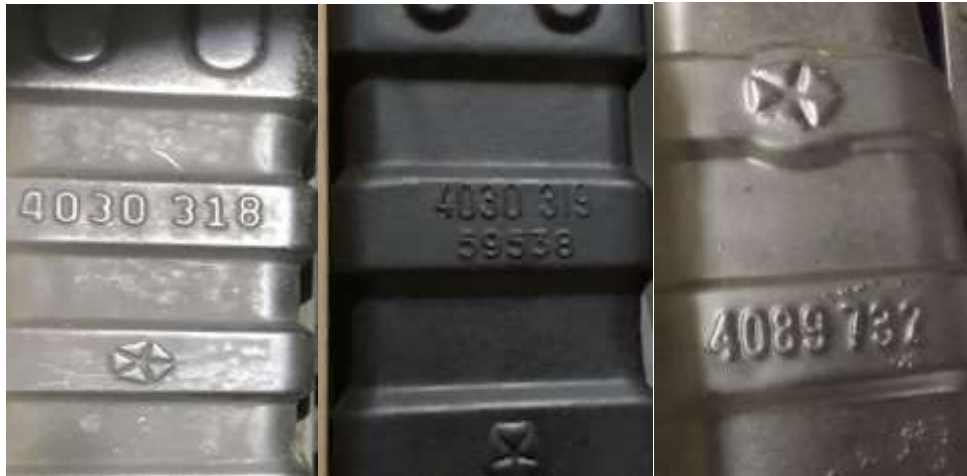
1978 & 1979 Mopar radiator, part numbers with and without A/C
#4030318 #4030319 #4089732

1978 without A/C

1978 with A/C

1979 with/without A/C

During this investigation, I found that the '78 had 2 different radiator part numbers, one for a non-air conditioned truck and one for an air conditioned truck. When checking the '79, I found that there was only one part number radiator used, whether the truck had air conditioning or not.

As far as why the 1978 had 1 reservoir and 2 different radiators was obvious, the A/C trucks had an extra 3rd core in the radiator, for cooling, as opposed to 2 cores on non – A/C trucks.

The 1979 models were not that easy to figure out. Apparently, all '79 radiators came with 3 cores, thereby negating the need for 2 separate radiators for A/C and non – A/C trucks.

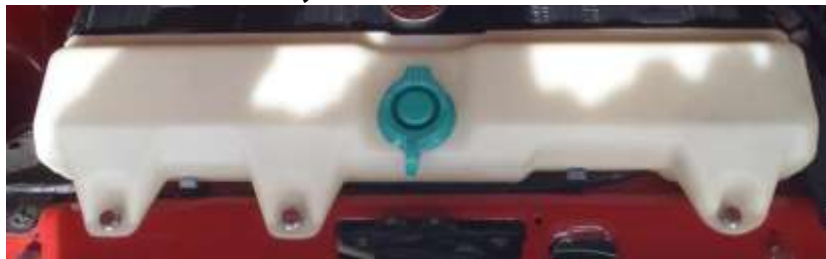
'78 radiator reservoir tank, drivers side overflow hose, green cap with indentation, vent in neck. # 4086800

On the '78 reservoir, there is a vent "hole", at the back of the tank neck, where the pressure could be released. One of the '79 tanks has the exact same neck vent hole, but the other tank with the vent in the cap did not have the hole in the neck. While examining these tanks, I noticed that the '78 had the overflow hose coming off the bottom of the tank, on the "*driver*" side and going to the recovery port on the "*driver*" side of the radiator filler neck.

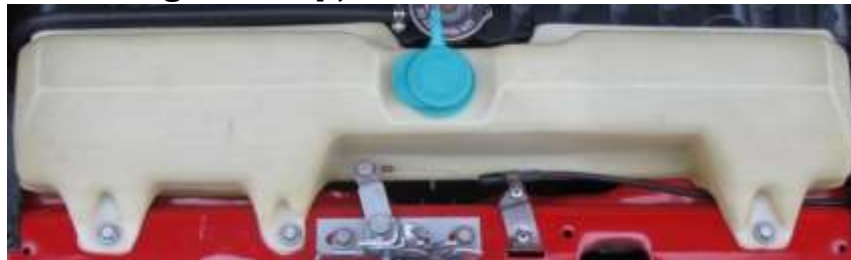
'79 radiator reservoir tank, passenger side overflow hose, flat green cap, vent in neck. # 4089624

The '79 tanks had the overflow hose coming off the bottom of the tank on the "*passenger*" side, and then going to the recovery port on the "*passenger*" side of the radiator filler neck.

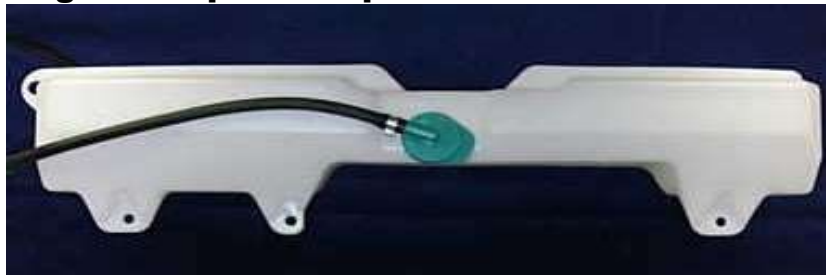
'79 radiator reservoir tank, passenger side overflow hose, green cap with top vent hose. #40089623

I have not been able to correlate when or why they switched the overflow tanks from being vented out the hole in the neck on some trucks and out the cap on others. The overflow coming off the cap, just vents to the atmosphere, down the passenger side of the radiator. The only answer I can come up with is, if the tank vented coolant out the neck hole, there would be residue on the top of the radiator and on the radiator shroud. By venting down the side of the radiator, the residue would be expelled to the ground, instead of the engine compartment. Since at this point, we do not know at what VIN range they changed the overflow tanks, either type will be accepted on a 1979, in the Concours Judging Class.
