# VETIVER PHYTOREMEDIATION TECHNOLOGY FOR TREATMENT OF POLLUTED WATER AND CONTAMINATED LAND

Dr. Paul Truong

TVNI Technical Director

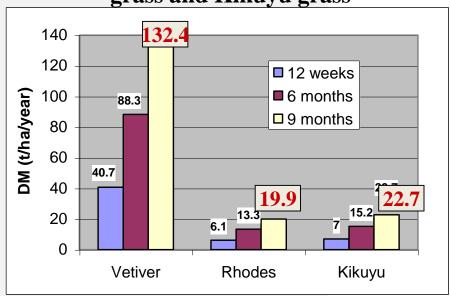
Comparative yield between vetiver, Rhodes grass and Kikuyu grass

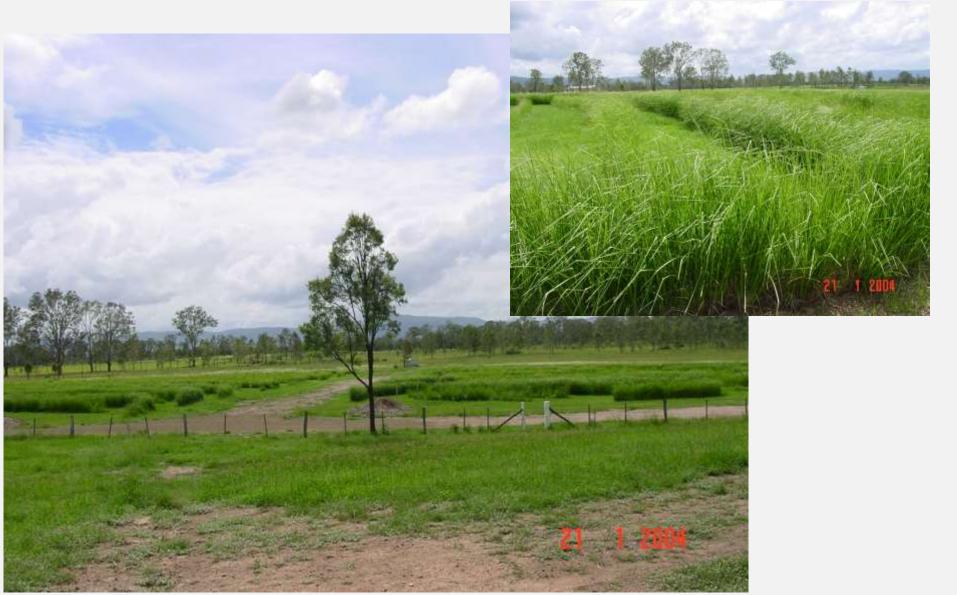
**SEWAGE EFFLUENT:** Disposal of municipal domestic sewage effluent by Ephemeral Wetland treatment in Australia

#### **Effluent quality before and after the vetiver treatment**

Tests * (license requirements)	Effluent Input	Effluent Output
PH (6.5 to 8.5)8*	7.3 to 8.0	7.6 to 9.2
Dissolved Oxygen (2.0 minimum) *	0 to 2 mg/l	8.1 to 9.2 mg/l
5 Day BOD (20 - 40 mg/l max) *	130 to 300 mg/l	7 to 11 mg/l
Suspended Solids (30 - 60 mg/l max) *	200 to 500 mg/l	11 to 16 mg/l
Total Nitrogen (6.0 mg/l max) *	30 to 80 mg/l	4.1 to 5.7 mg/l
Total Phosphorous (3.0 mg/l max) *	10 to 20 mg/l	1.4 to 3.3 mg/l

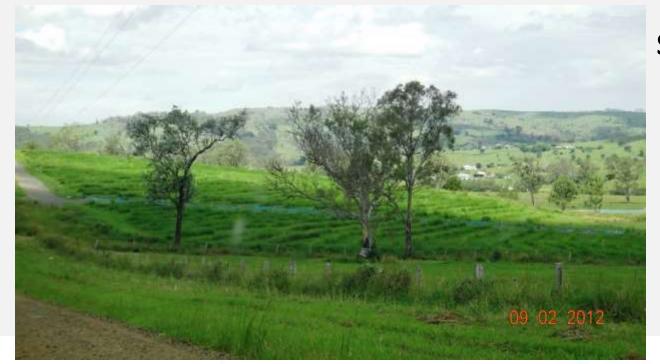
Six month old

This planting has totally disposed 500-600KL/day

12 month old

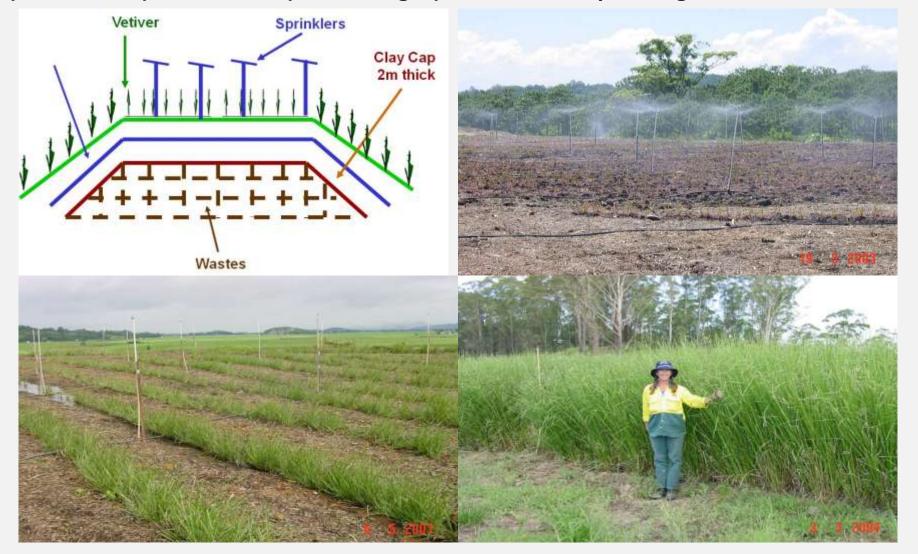
Spray irrigation on landfill mound: the diagrammatic cross section of the mound (top left), vetiver irrigated every day with leachate after planting (top right), two (bottom left) and twelve (bottom right) months after planting.

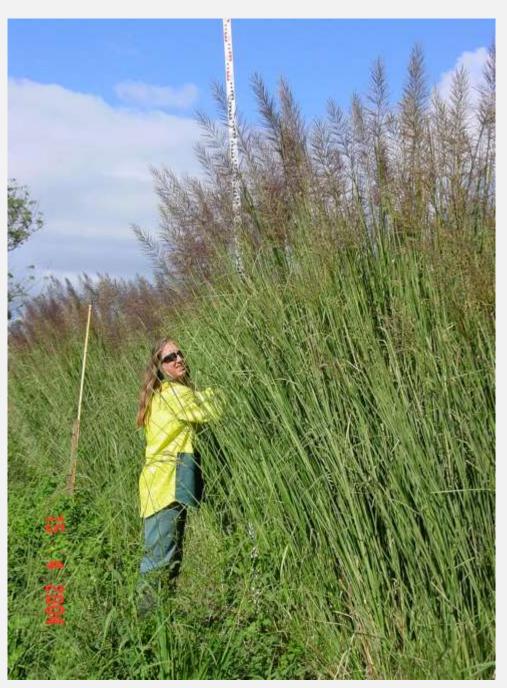
### Vetiver growth was over 3m in the second summer

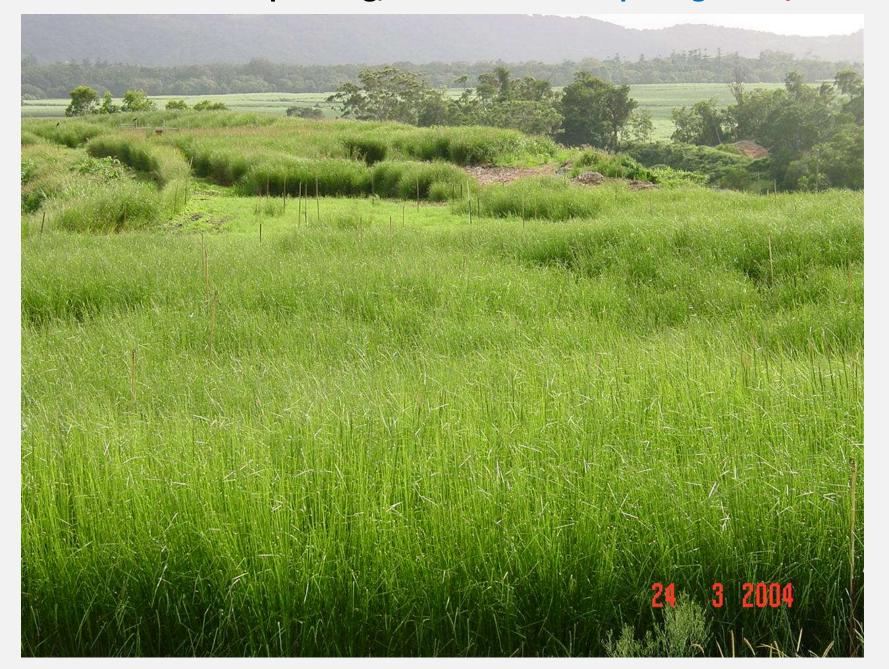
Fresh leachate pool

Twelve months after planting, the 3.5ha site disposing 4 ML/month

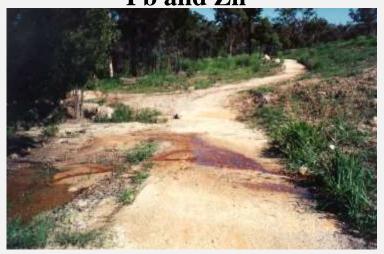
This leachate runoff is highly contaminated with Cr, Cd, Cu, Pb and Zn

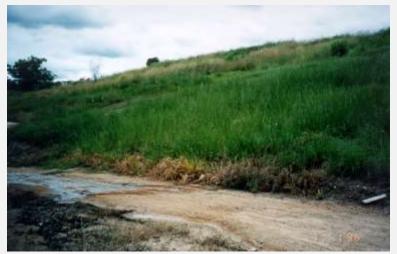
Three months after planting, good growth, no adverse effects

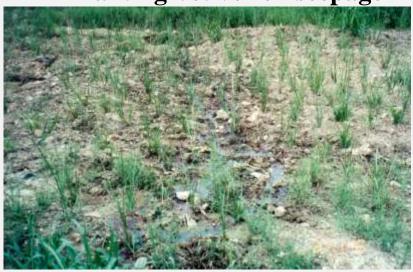
**Planting Vetiver on seepage**

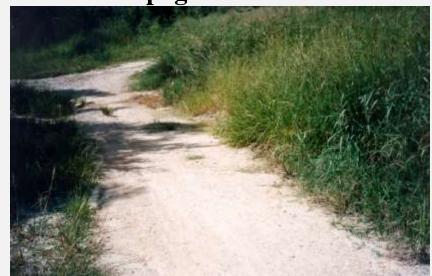
Within a year vetiver has completely stopped the leachate seepage

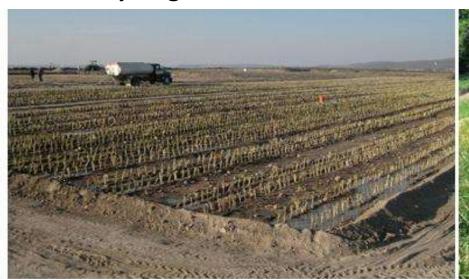
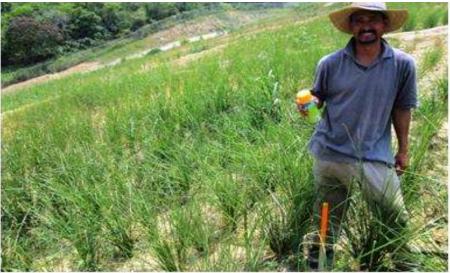
Early stage of vetiver establishment at Leon (left) and Poza Rica (right).

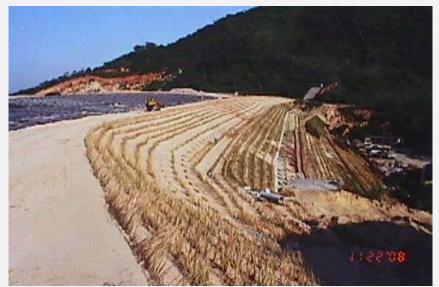
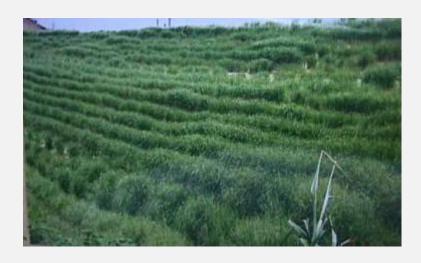
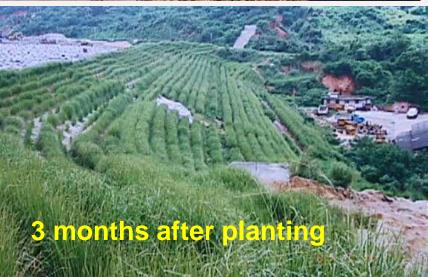
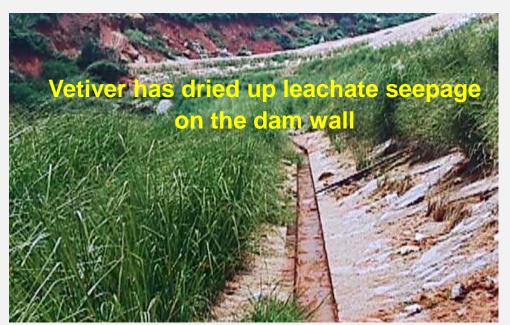
The dam 75m high and 100m long was built to retain garbage, vetiver was planted to stabilize the wall and to reduce seeping leachate. Previous attempts with other plant species have failed because of the toxic nature of the leachate.

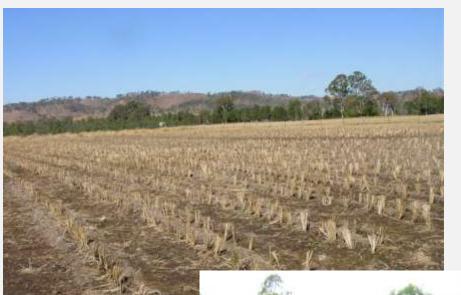
Food processing factory effluent disposal by land irrigation. The 22.5 ha site disposing 48ML/month

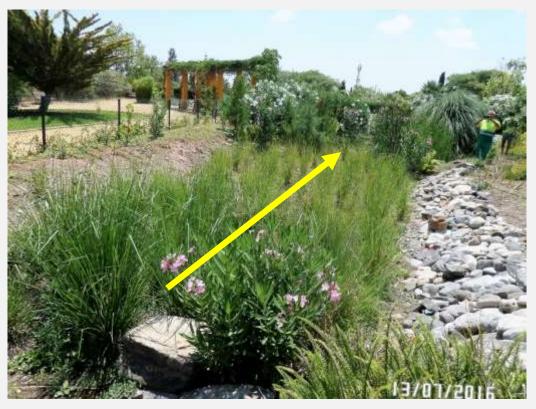
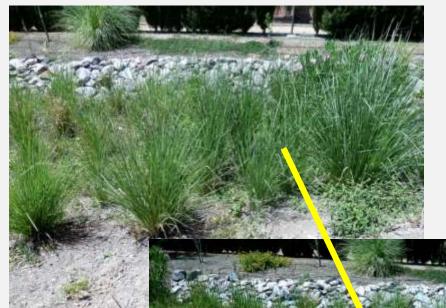
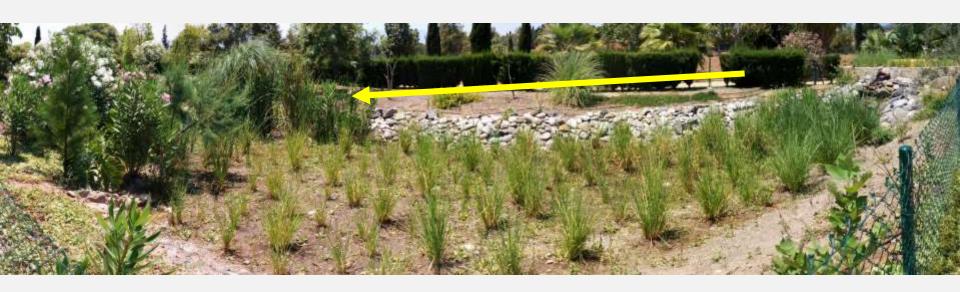
## Effectiveness of Vetiver in removing nutrient in polluted water at parque cementario de malaga

**Top section (Input)**

**Middle section**

**End section**

#### **Flow direction**

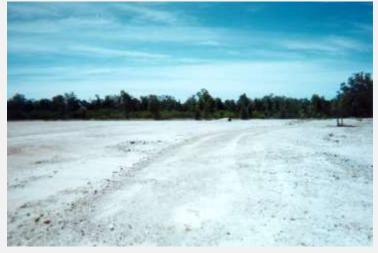
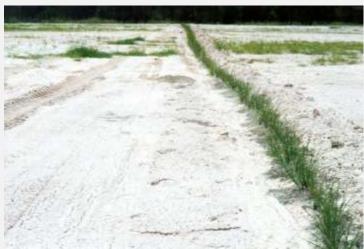
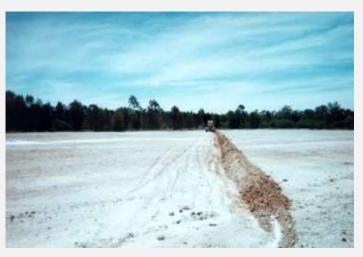
This Bentonite mine tailings dump is barren with an extremely erodible surface which has low water infiltration and high runoff rates.

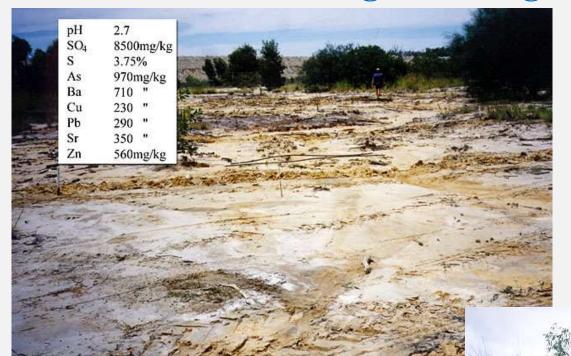
Kidston mine old gold tailings: An extremely acidic (pH 2.7, sulfate 8 500mg/kg) gold mine tailings in north Queensland

Good establishment and growth with lime and fertiliser application on this site
