ENGLEWOOD

SENIOR WALKABILITY WORKSHOP

MAY 2018

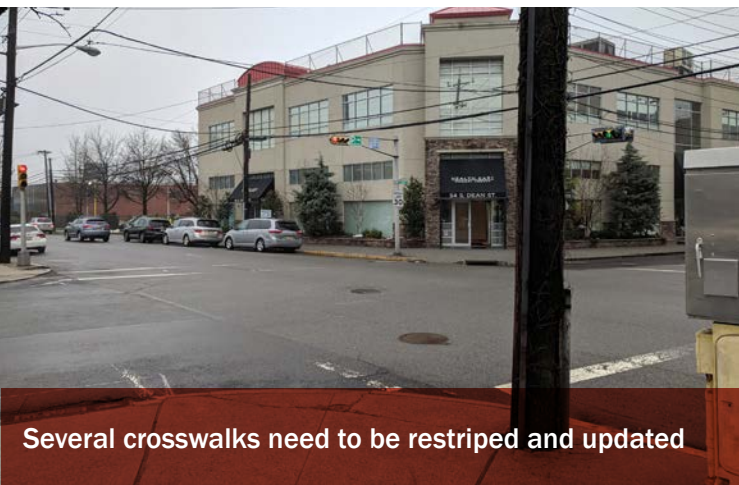
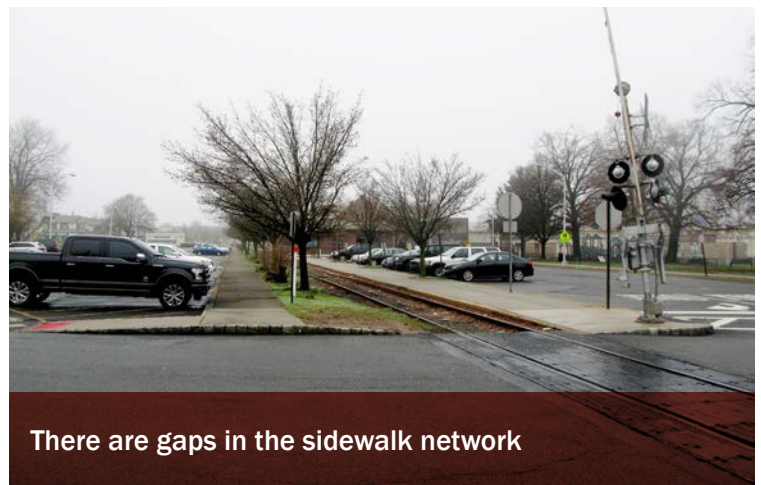
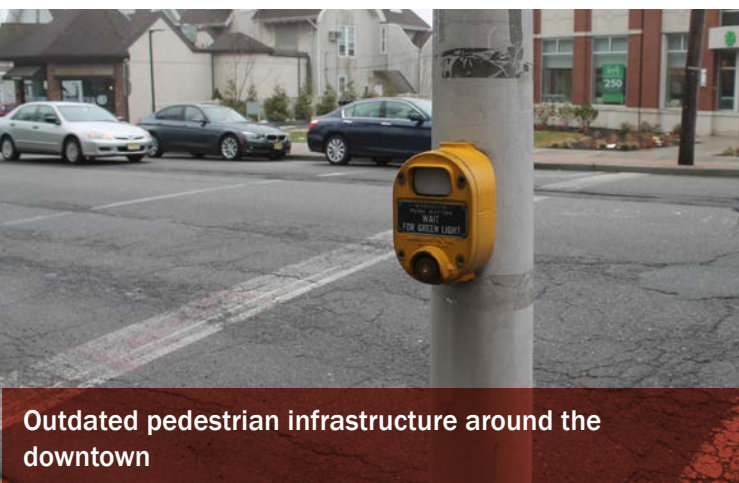
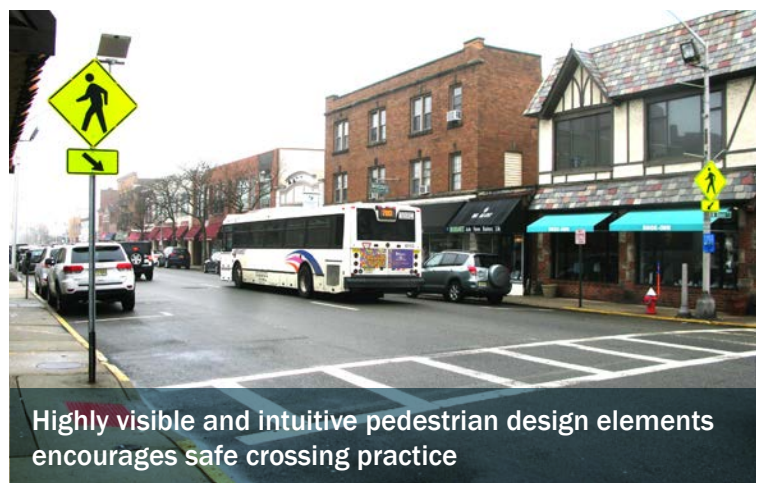
Strengths and deficiencies were identified by the group during the course of the walk. Strengths included a mostly complete sidewalk network, numerous pedestrian destinations and an active downtown core. Deficiencies discussed among the group included sidewalk maintenance and lack of comfortable crossings.

Although a complete sidewalk network can be found in most parts of the City, some segments are cracked or uneven. A number of pedestrian crossings are difficult due to high traffic volumes and lack of high visibility crosswalks. Many positive examples of crossing infrastructure were observed and these should be replicated throughout the City.

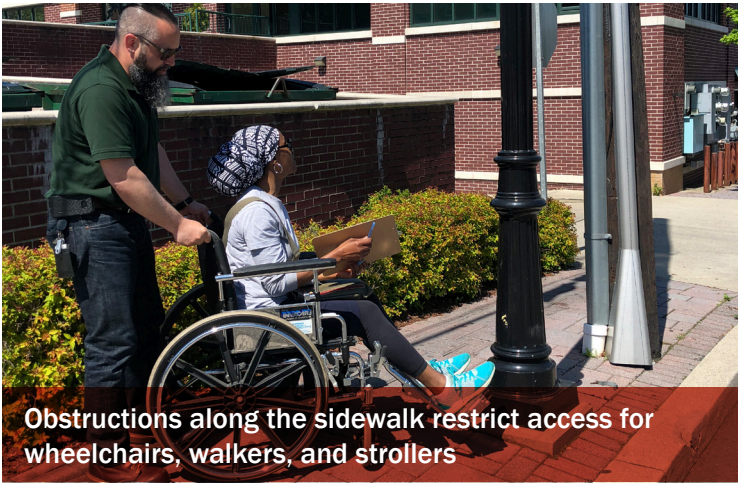
Obstructions along the sidewalk restrict access for wheelchairs, walkers, and strollers

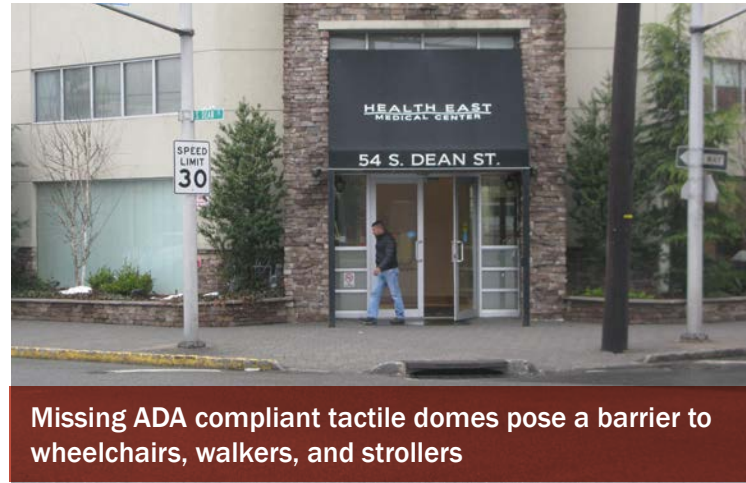
Missing ADA compliant tactile domes pose a barrier to wheelchairs, walkers, and strollers

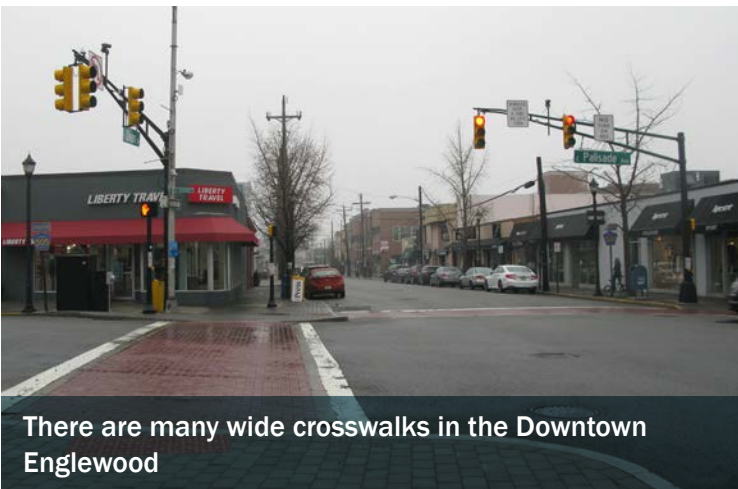
There are many wide crosswalks in the Downtown Englewood

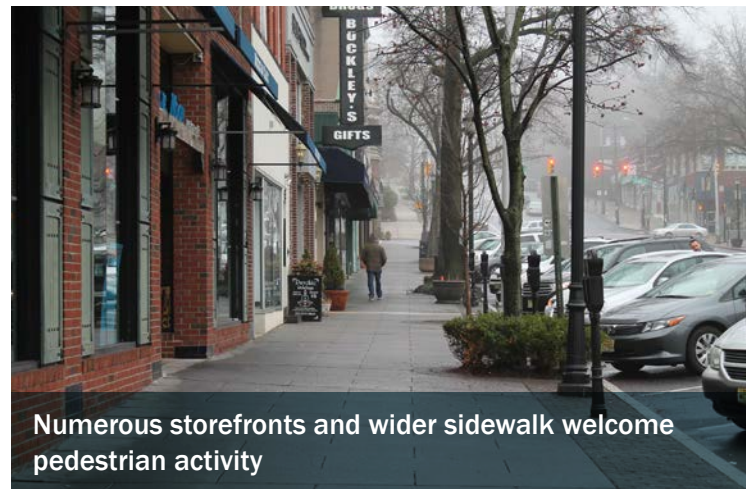
Numerous storefronts and wider sidewalk welcome pedestrian activity

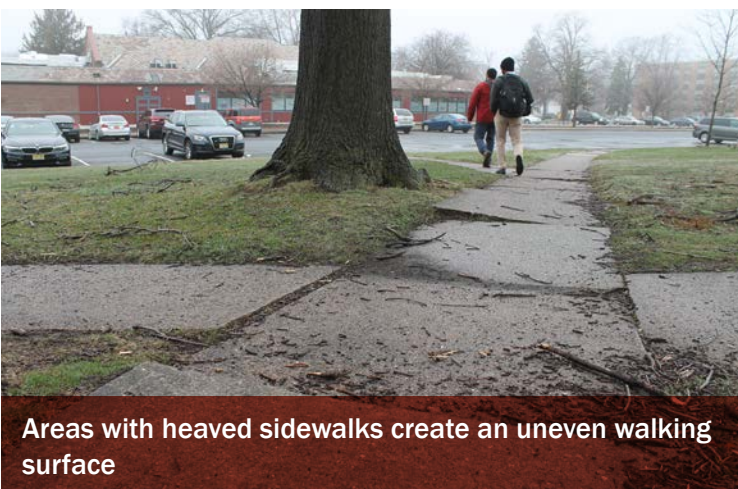
Areas with heaved sidewalks create an uneven walking surface

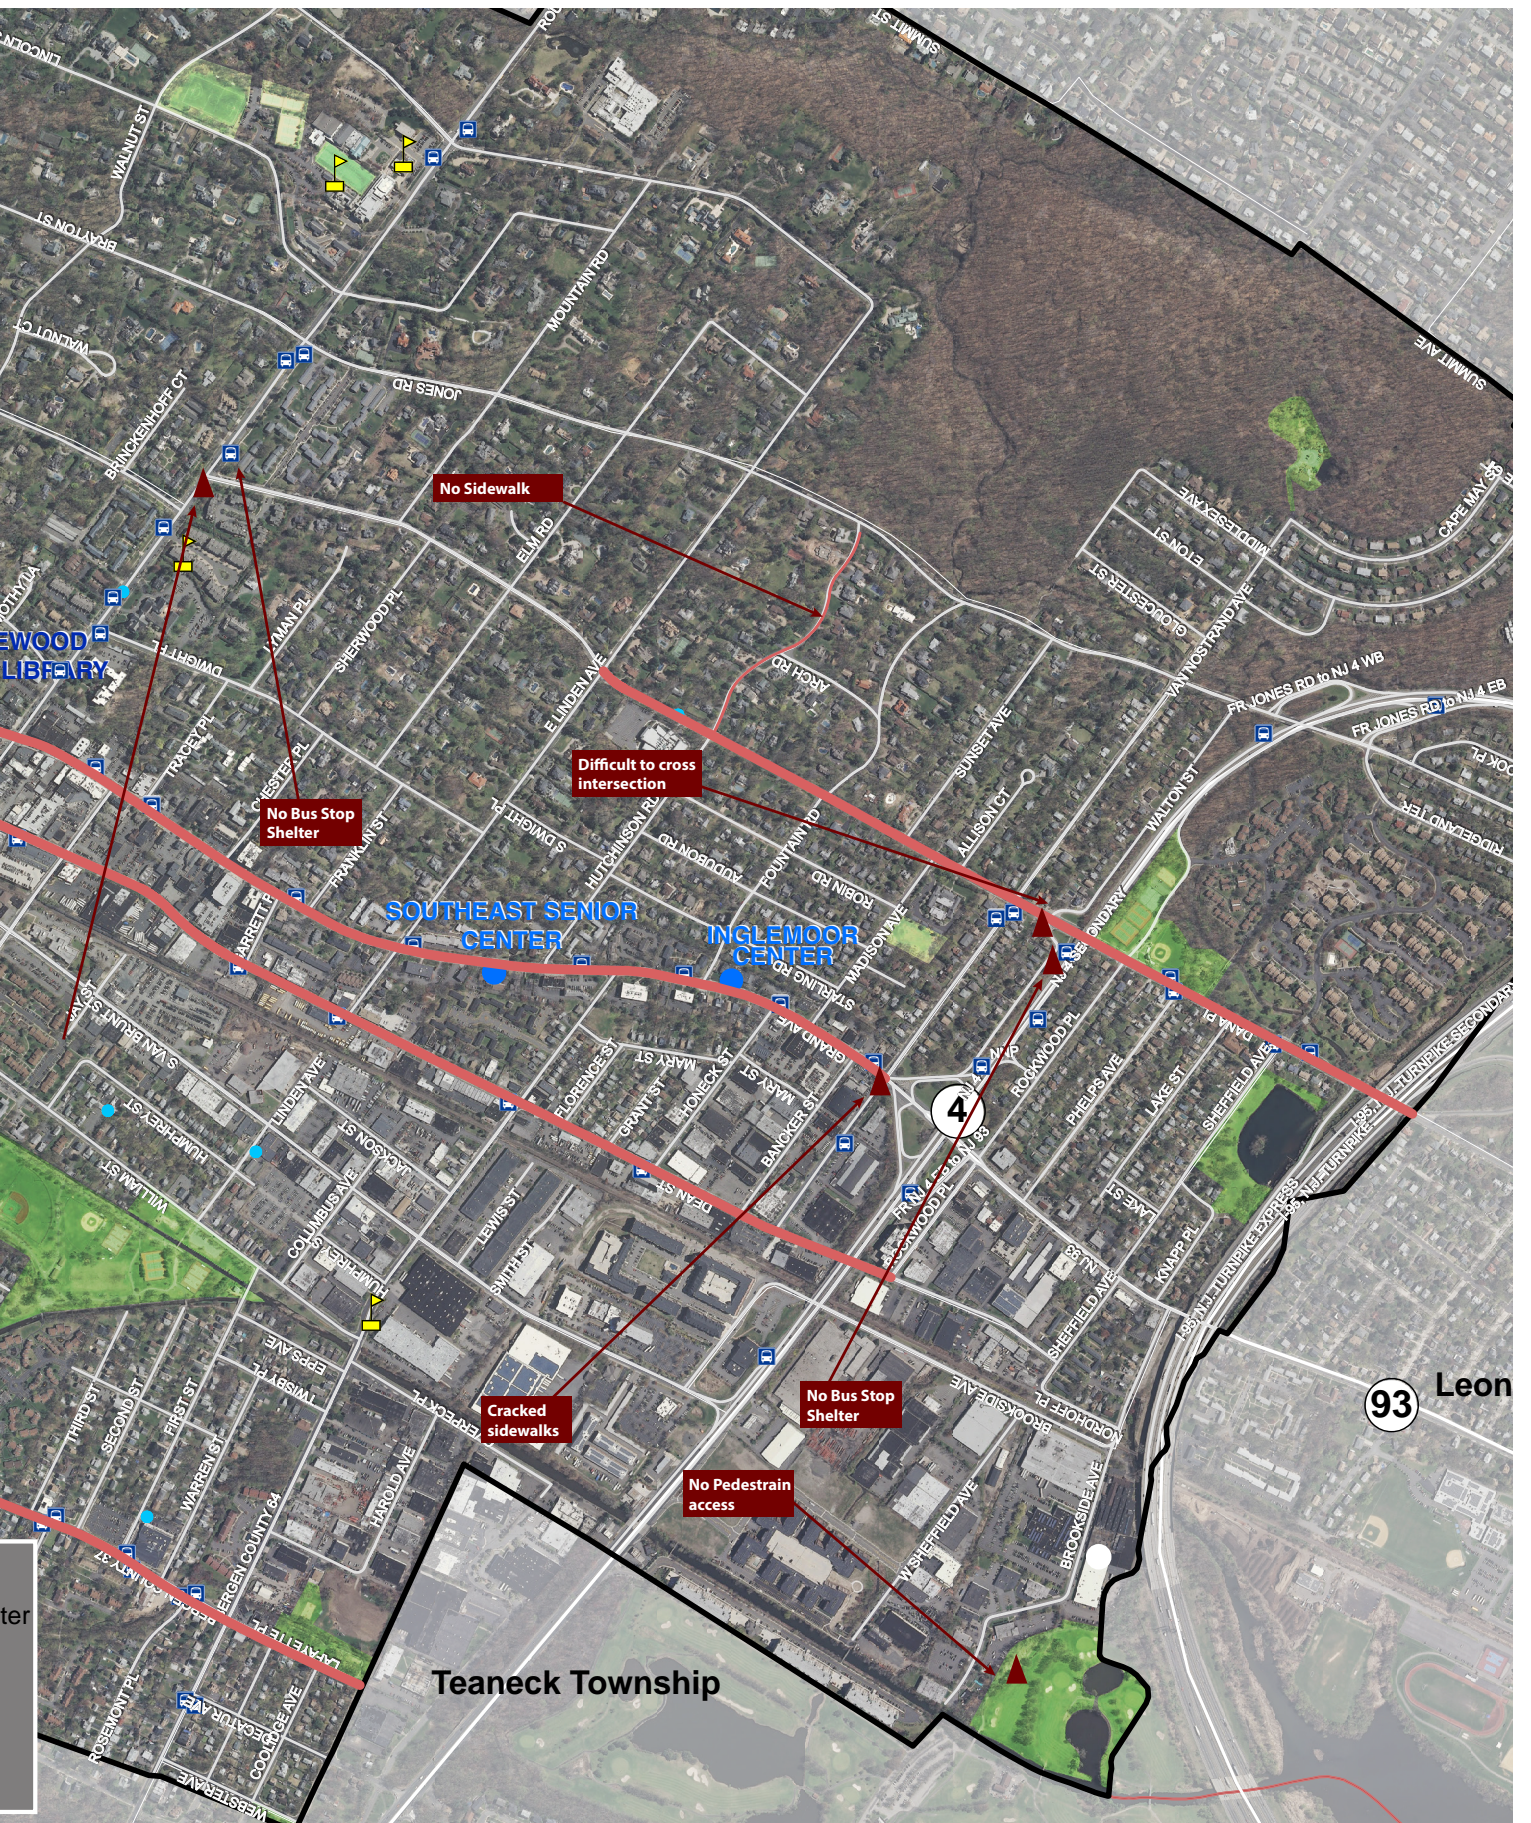
COMMUNITY-IDENTIFIED AREAS OF CONCERN

Comments from workshop participants during brainstorming exercise

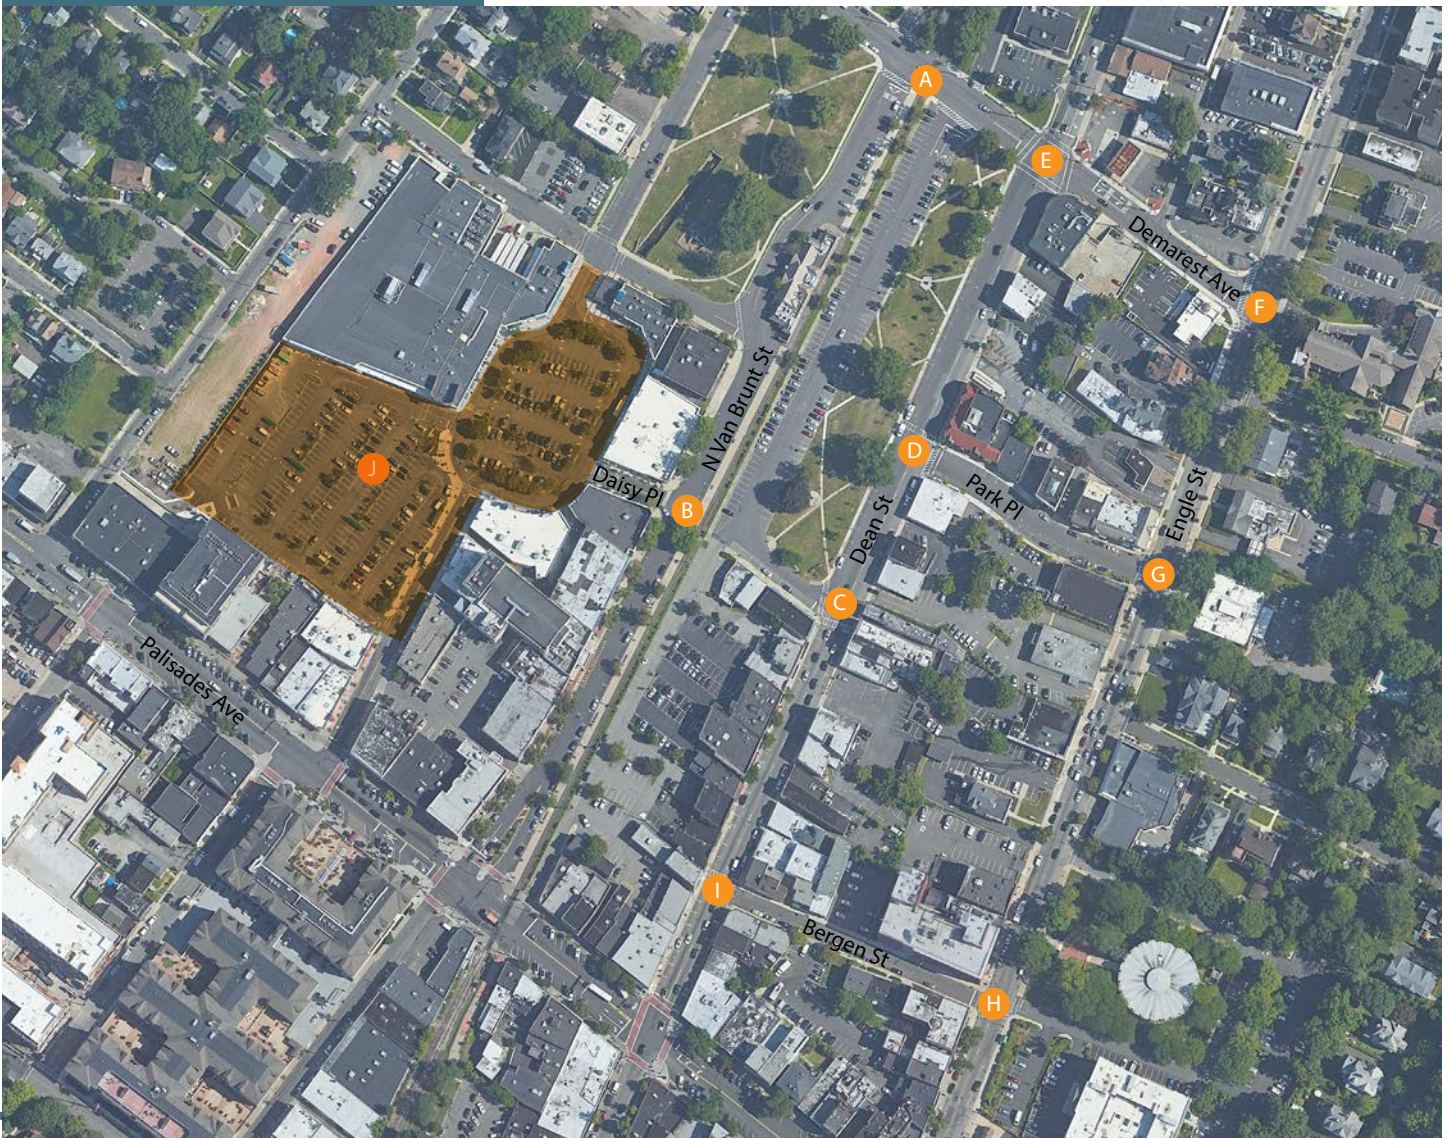
Englewood Downtown Area Recommendations

High travel speeds, low visibility due to on-street parking near intersections, long crossings, and an CSX railroad track splitting the city in two halves characterize the area surrounding the downtown. This creates a very challenging environment for both pedestrians and motor vehicles. While Englewood has taken measures to address the matter, such as upgrading crosswalks, installing curb extensions and pedestrian signage, workshop participants commented that there is still a regular occurrence of traffic incidents. Below are several strategies that can be implemented to improve the environment not just for pedestrians and seniors, but for all users (locations shown in the map on page 14 and detailed illustrations of recommendations are shown on pages 18 - 20):

A Install sidewalk and railroad gates for pedestrian crossing over CSX railroad tracks along Demarest Avenue east of the intersection with N Van Brunt Street. This would create a safer crossing for pedestrians over the railroad tracks instead of going on the pavement along with vehicles. The next accessible crossing for pedestrians over the railroad tracks is approximately 1400' (feet) south at the intersection of N Van Brunt Street and Palisades Avenue.

B Collaborate with NJT to install a pedestrian crossing at the intersection of N Van Brunt Street and Daisy Place and continue it across the existing railroad tracks along N Van Brunt Street (approximately 750' south of Demarest Ave) to create a safe pedestrian connection between the shopping complex on the west and the residents on the east railroad tracks. Crossing should include curb extensions on both sides of the street with ADA-compliant curb ramps, high-visibility continental crosswalk striping, advanced warning signage, railroad gates, and a Rectangular Rapid Flashing Beacon (RRFB). This would discourage at-risk mid-block crossings, and provide a suitable alternative.

C Upgrade the existing mid-block pedestrian crossing by installing curb extensions, high visibility continental crosswalk striping, and a Rectangular Rapid Flashing Beacon (RRFB) on N Dean Street approximately 434' north of Bergen Street. This would discourage at-risk mid-block crossings, improve yielding behavior by drivers, and provide a suitable alternative.

D Upgrade the existing pedestrian crossing at the unsignalized intersection of N Dean Street with Park Place by installing curb extensions, high visibility continental crosswalk striping, and a Rectangular Rapid Flashing Beacon (RRFB). This would discourage at-risk mid-block crossings, improve yielding behavior by drivers, and provide a suitable crossing alternative. Also, reposition the Stop signs higher at a height of 7' or higher on either sidewalk at the intersection on Park Place to avoid people getting hit on the head.

E Install pedestrian signal heads with push buttons and countdown timers at the intersection of Demarest Avenue and N Dean Street to provide a safer crossing opportunity. Install curb extensions at south-east and south-west corner of the intersection to reduce pedestrian crossing distance and time. This

F Install curb extensions and restripe the existing crosswalk with high-visibility continental striping at the intersection of Engle Street with Demarest Avenue. Reposition pedestrian signal heads in the correct orientation so that they are visible along the crosswalks and upgrade the pedestrian signal heads along with the push buttons to improve accessibility.

G Install curb extensions with ADA-compliant curb ramps, and restripe the existing crosswalk with high-visibility continental striping at the intersection of Engle Street with Park Place. Upgrade the pedestrian signal heads along with the push buttons to improve accessibility.

H Install curb extensions with ADA-compliant curb ramps, and restripe the existing crosswalk with high-visibility continental striping at the intersection of Engle Street with Bergen Street. Replace the pedestrian signal heads along with the push buttons with up-to-date ones that improves accessibility.

I Restripe faded crosswalk with high-visibility continental striping across N Dean Street by the Bergen Street intersection, install curb extensions with ADA-compliant curb ramps.

J Install speed humps with striped pedestrian crosswalks on top and post advance warning signs around the peripheral circulation roads of the parking lots of the shopping complex of ShopRite providing mid-block type crossing opportunities, safer vehicular travel speeds, and improved visibility.

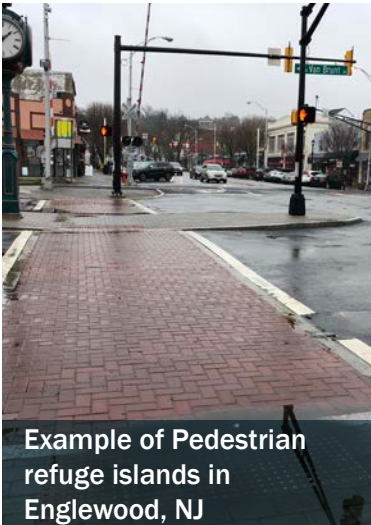
Example of Pedestrian refuge islands in Englewood, NJ

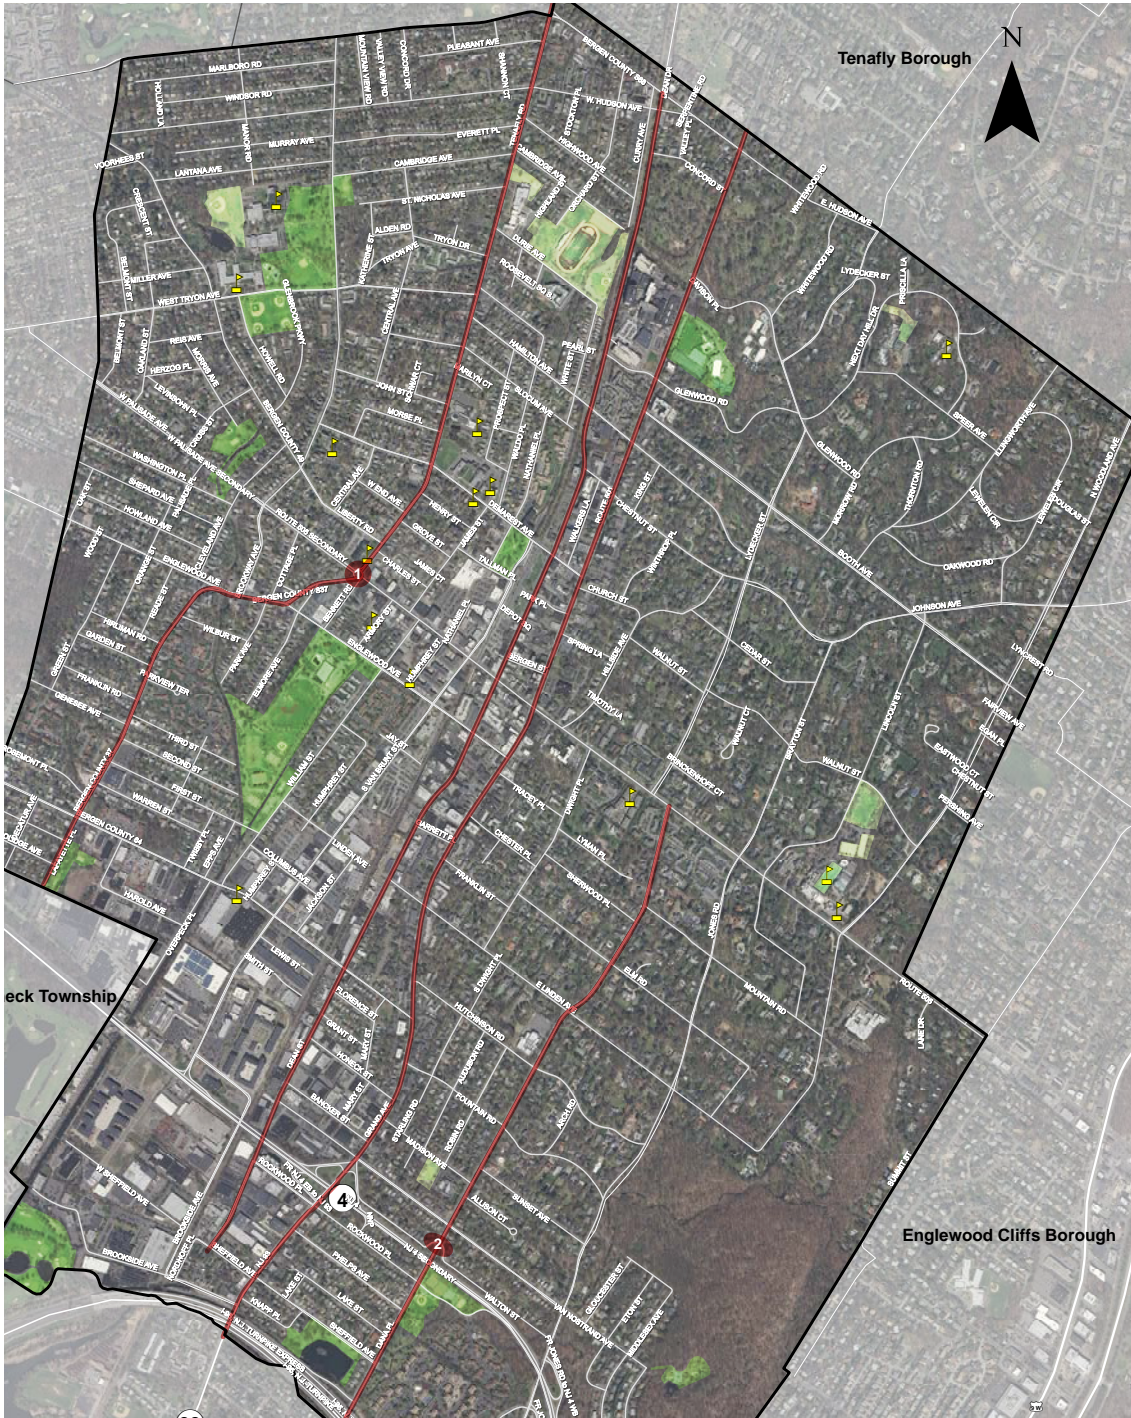
Englewood Corridor locator map

Corridor-wide Recommendations

Study corridor-wide traffic calming opportunities to understand economic feasibilities and traffic impacts. Install missing pedestrian facilities like continental crosswalks and coordinate with lead public agencies to install new traffic calming and pedestrian facilities.

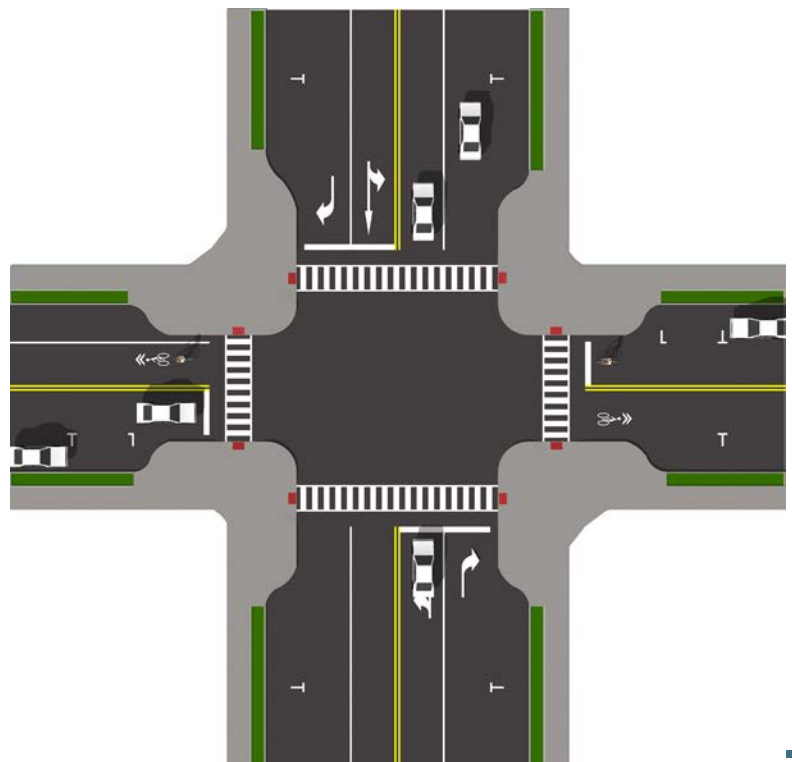
Curb Extensions

Curb extensions, or bulb-outs, extend the sidewalk or curbface into the parking lane at an intersection. Curb extensions narrow the roadway at intersections, contributing to lower motor vehicle speeds, as well as reducing the crossing distance for pedestrians and increasing the amount of space available for street furniture and green stormwater management features.

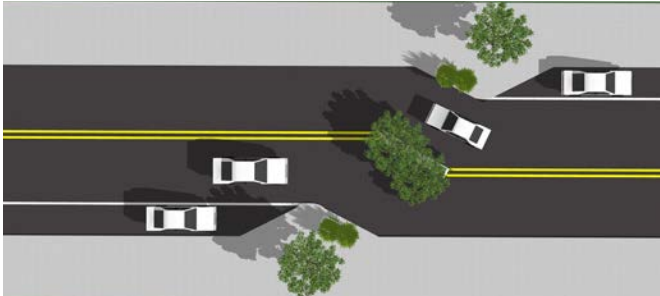
Chicanes are a series of raised or delineated curb extensions, edge islands, or parking bays, that are placed on alternating sides of a street to form an S-shaped bend in the roadway. Chicanes reduce vehicle speeds by requiring drivers to shift laterally through narrow travel lanes.

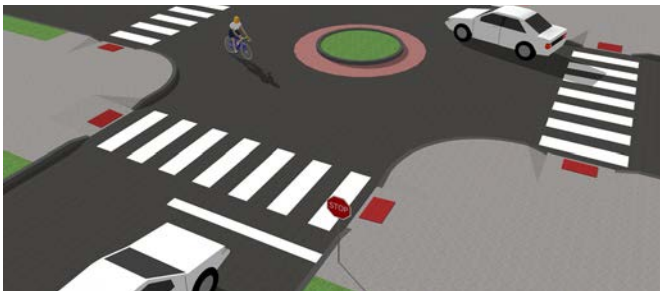
Neighborhood Traffic Circles

Neighborhood traffic circles are raised or delineated islands used at minor street crossings to reduce vehicle travel speeds by reducing turning radii, narrowing the travel lanes, and, if planted, obscuring the visual corridor along the roadway.

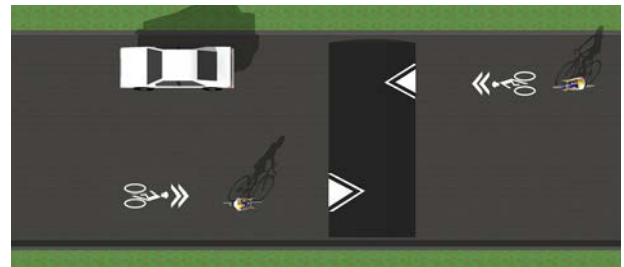
Speed Humps

Speed humps are 3 to 4 inches high and 12 to 14 feet long, with an intended vehicle speed of 15 to 20 mph. Humps are often referred to as “bumps” on signage and by the general public.

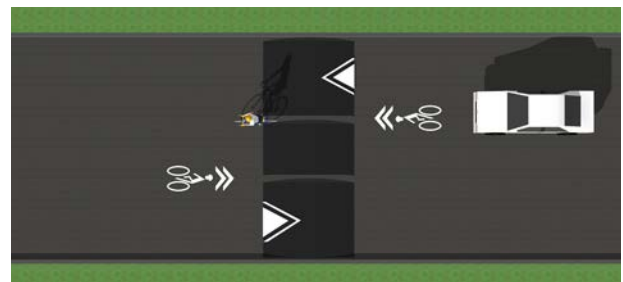
Speed Cushions

Speed cushions are speed humps or speed tables that include wheel cutouts that allow larger vehicles to pass unaffected, but reduce passenger vehicle speeds. They are often used on key emergency response routes to allow emergency vehicles to pass unimpeded. Speed cushions should be used with caution, however, as drivers will often seek out the space in between the humps.

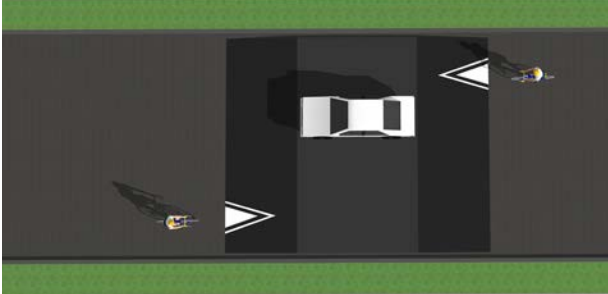
Speed Tables

Speed tables are longer than speed humps and have a flat

top, with a height of 3 to 3.5 inches and a length of 22 feet. Intended vehicle operating speeds range from 25 to 35 mph, depending on the spacing. Speed tables may be used on collector streets, transit, and/or emergency responder routes.

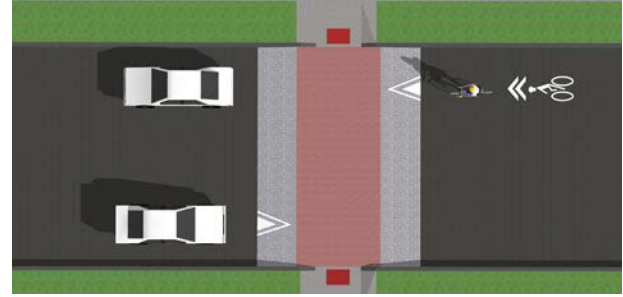
Raised Crosswalk

A raised crosswalk is a speed table that is signed

and marked as a pedestrian crossing. It extends the full width of the street and is typically 3 inches high. At minor intersections the entire intersection can be raised to reduce motor vehicle speeds in all directions.
