THE MODEL T FORD

ITS REPAIR,
SERVICE, AND
RESTORATION

Radiator Efficiency Check

APCO Outside Oil line for the Improved Car, 1926-1927

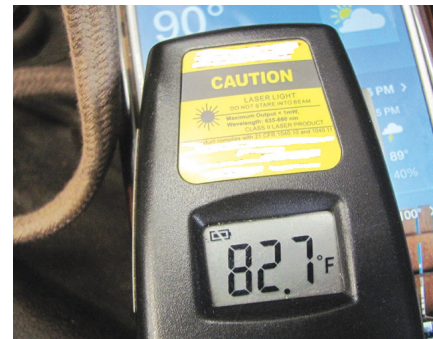
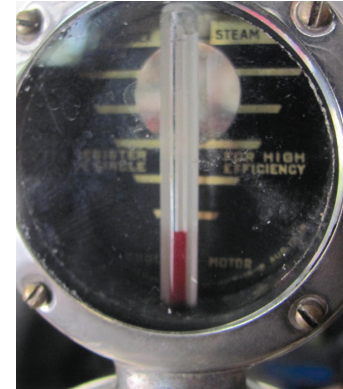
For this test, on a hot summer day, I warmed up the T with a drive of approximately five miles. I took various readings with the laser tool, including the cold engine. All readings were made at the radiator upper tank, inside the engine compartment, and at the lower inlet metal pipe which returns the coolant to the engine.

The outside temperature was 90° and cold engine was at 82.7° for the start of the test run. I also recorded the temperature reading on a Motometer to take similar readings of coolant temperature.

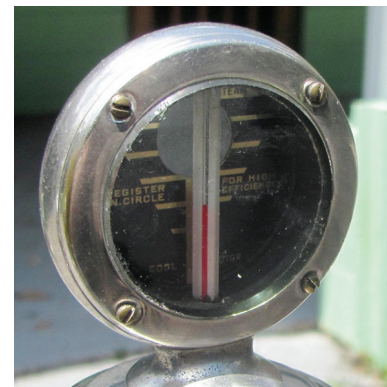
After the test run I measured the temperature of the upper tank with the engine still running at idle speed; the reading was 183.5°. The normal ideal for an internal combustion engine is in the 180° range. The Motometer matched the efficiency reading, too.

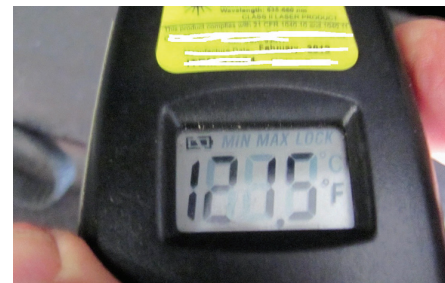
The lower pipe reading was 121.5° and felt rather cool to the touch, compared to the upper tank which was way too hot to touch.

Subtracting the difference gives a 62° drop, showing the radiator, fan, and cooling system operating well within efficiency parameters. Without a significant temperature drop when the coolant returns to the engine, overheating causes should be investigated. Of course, after shutting off the engine, I heard some gurgle from the radiator upper tank. That is normal, as the air is no longer flowing through the radiator and the residual engine heat will cause a temporary rise in the coolant temperature as the engine cools down on its own.

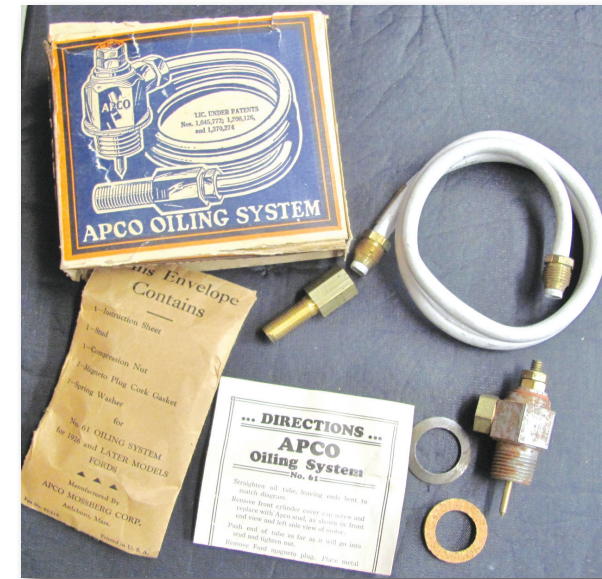
... DIRECTIONS ...
APCO
Oiling System
No. 61

Straighten oil tube, leaving ends bent to match diagram.
Remove front cylinder cover cap screw and replace with Apco stud, as shown in front end view and left side view of motor.
Push end of tube as far as it will go into stud and tighten nut.
Remove Ford magneto plug. Place metal washer and cork gasket on Apco magneto plug so that cork gasket will be against transmission case and screw plug, by hand, down tight.
If side outlet does not line up with tube end, use wrench to turn plug to proper position.
Push tube into side outlet as far as it will go and tighten nut.
Connect magneto wire in regular way.

The instructions show the proper way of fitting the outlet at the hogshead: be sure to have the outlet tube to the left side, as the oil thrown inside the hogshead cover is directed to the fitting to flow out and down to the crankcase hollow stud.
