Radiators and Reservoirs in Li'l Reds

During my continual search for differences in the 1978 & 1979 Dodge Li'l Red Express Trucks, I recently found some unique information about the radiators and reservoirs used on these two-year trucks.

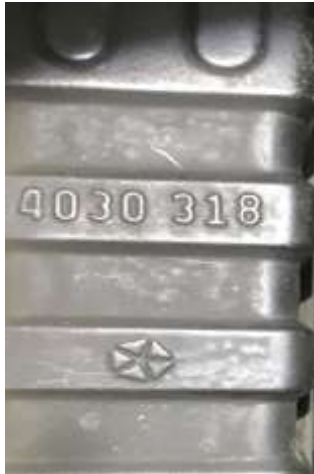
1978 without A/C

1978 & 1979 Mopar radiator, part numbers with and without A/C
#4030318 #4030319 #4089732

As far as why the 1978 had 1 reservoir and 2 different radiators was obvious, the A/C trucks had an extra 3rd core in the radiator, for cooling, as opposed to 2 cores on non – A/C trucks.

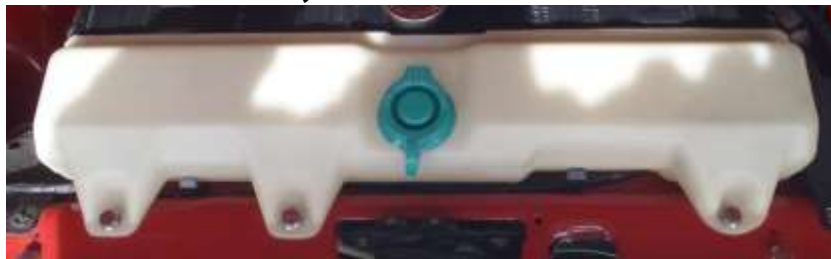
'78 radiator reservoir tank, drivers side overflow hose, green cap with indentation, vent in neck. # 4086800

On the '78 reservoir, there is a vent "hole", at the back of the tank neck, where the pressure could be released. One of the '79 tanks has the exact same neck vent hole, but the other tank with the vent in the cap did not have the hole in the neck. While examining these tanks, I noticed that the '78 had the overflow hose coming off the bottom of the tank, on the "*driver*" side and going to the recovery port on the "*driver*" side of the radiator filler neck.

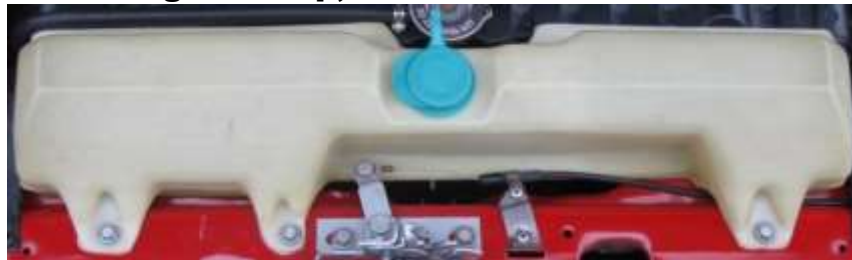
'79 radiator reservoir tank, passenger side overflow hose, flat green cap, vent in neck. # 4089624

The '79 tanks had the overflow hose coming off the bottom of the tank on the "*passenger*" side, and then going to the recovery port on the "*passenger*" side of the radiator filler neck.

I have not been able to correlate when or why they switched the overflow tanks from being vented out the hole in the neck on some trucks and out the cap on others. The overflow coming off the cap, just vents to the atmosphere, down the passenger side of the radiator. The only answer I can come up with is, if the tank vented coolant out the neck hole, there would be residue on the top of the radiator and on the radiator shroud. By venting down the side of the radiator, the residue would be expelled to the ground, instead of the engine compartment. Since at this point, we do not know at what VIN range they changed the overflow tanks, either type will be accepted on a 1979, in the Concours Judging Class.

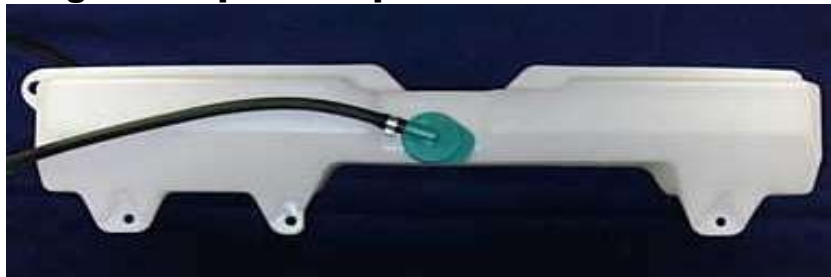
'79 radiator reservoir tank, passenger side overflow hose, green cap with top vent hose. #4089623
