## New York Roof Coating Giants Take the Field

By Stephanie Marie Chizik on 4/1/2016 10:58 AM

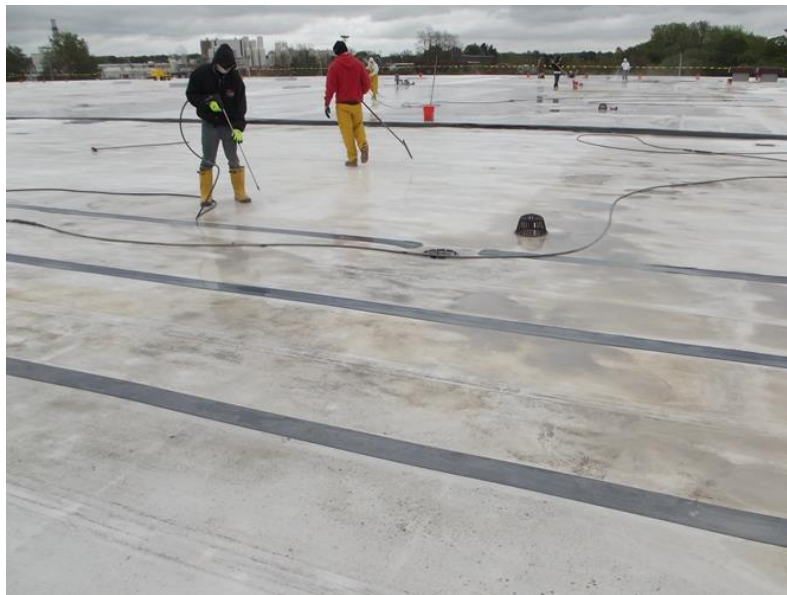
The next step was a wash down. The team sprayed the roof with a trisodium phosphate substitute detergent, scrubbed it with brushes, pressure washed, irrigated, and then squeegeed it dry. On this rooftop job, there were many steps within a step!

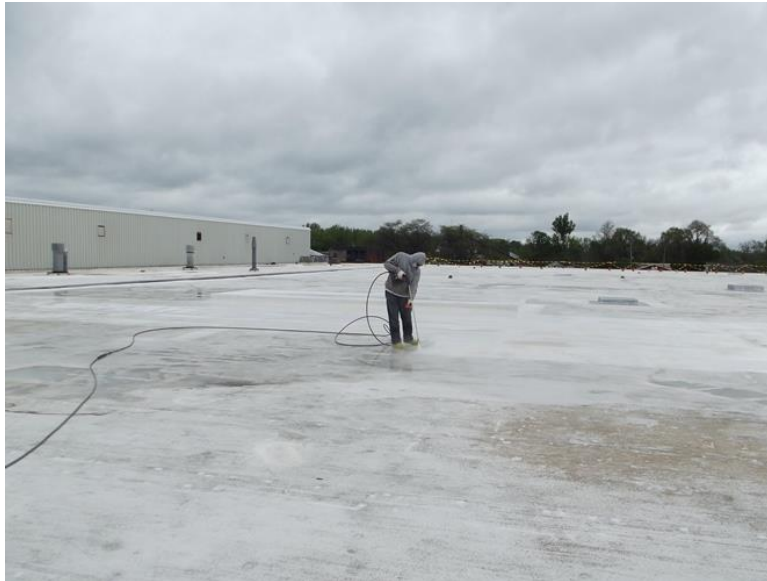
To continue the prep, N.Y. State Industrial worked on the seams and penetrations next. They used the same Urethane 520 material in the system, but they reinforced these areas with a polyester mesh. After all of that “extensive” prep, as DeFranco called it, they were finally ready to move onto the coating system. On all roofs, the crew applied a full coat of the Urethane 520. They used spray guns when possible but squeegeed it on areas where overspray was a concern. That was applied at 1.5 gallons (5.7 L) per 100 square feet (9.3 m<sup>2</sup>), and it was followed by a layer of Silicone 410 at the same thickness, giving the roof ultraviolet resistance and a high reflectivity factor. The roofs that were made of asphalt and had extensive alligatoring received one more layer: an additional pass of American WeatherStar's Asphalt

Emulsion 90, which was applied at 4 gallons (15.1 L) per 100 square feet (9.3 m<sup>2</sup>) to fill any voids.
