THE MODEL T FORD Its repair, Service, and Restoration

DAN TREACE MTFCI Technical Editor

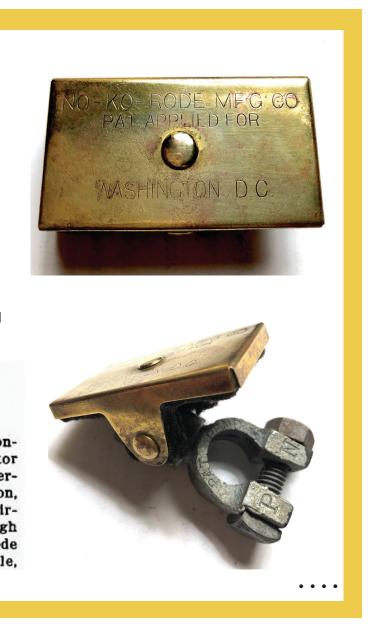
No-Krode Battery Terminal

One of the objectionable features concerning a storage battery on a motor car is the corrosion of the battery terminals necessitating frequent attention, and often causing trouble from open circuits and depletion of the battery through leakage of the current. The No-Krode Mfg. Co., 514 East Pike street, Seattle,
