# Chimney Inspection Report

Client Name: Your House  
 Street: 123 Any Street  
 City, State, Zip: Penfield, NY 14580  
 Inspector: Mike Reed  
 Weather: Cloudy

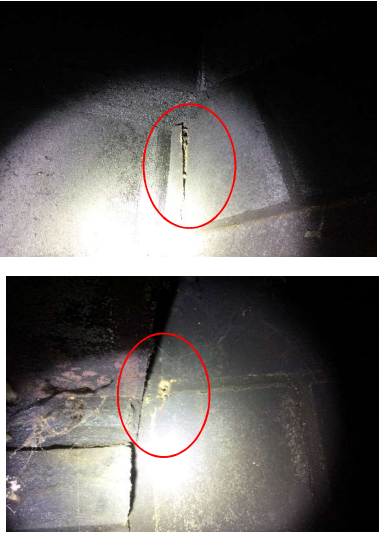
The inspector noted hearths, hearth extensions, smoke chambers or firebox that had joint separation, damage or deterioration.	Yes

<p>Cracking and material loss can allow superheated gasses escape the fireplace/chimney leading to CO2 or fire entering the living space.</p>
<i>Single-Wall Metal Chimneys (Initial Inspection)</i>		
The inspector noted single-wall metal chimneys in one- or two-family dwellings. Single-wall metal chimneys should not be used in one- and two-family dwellings.	Not Applicable	
The inspector noted wall protectors (heat shields) with less than 1-inch air gaps.	Not Applicable	
The inspector noted an exposed interior single-wall metal chimney that was not continuously enclosed where it extended through closets, storage areas, or habitable spaces, or where the surface of the chimney could come into contact with combustible materials or people.	Not Applicable	
<i>Single-Wall Metal Chimneys (Interior)</i>

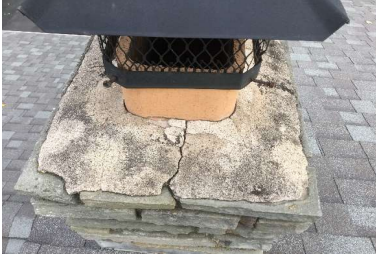
The inspector noted a chimney that terminated less than 2 feet above a portion of a building (ridge, wall or parapet) within 10 feet.	No	
The inspector noted a chimney that terminated less than 3 feet from an adjacent building or building opening.	No	
The inspector noted a chimney that terminated less than 10 feet above grade or a walkway.	No	
The inspector noted a chimney outlet that jeopardized people, overheated combustible structures, or that might cause flue gases to enter nearby building openings.	No	
The inspector noted the damage to crown of a masonry chimney.	Yes

<p>This will allow water to penetrate the chimney/flue compromising the integrity of the unit.</p>
The inspector noted the slope of a crown of a masonry chimney that directed water into the flue.	No	
<i>Flues and Liners</i>		
The inspector noted galvanized flues or connectors. Flues and connectors should not be galvanized.	No

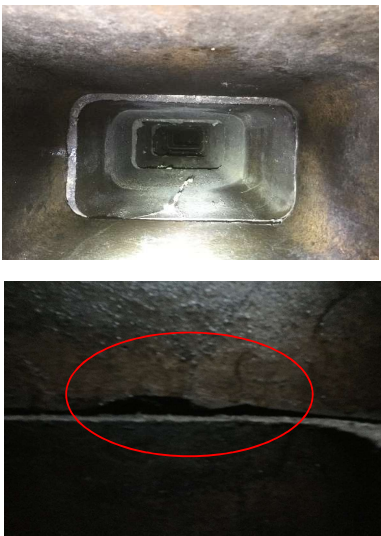
<p>The inspector noted a liner that was visibly softened, cracked, deteriorated or damaged.</p>	<p>Yes</p>

<p>All damage and material loss should be repaired or chimney re-lined prior to first use.</p>
<p>The inspector noted a liner that had excessive accumulation of creosote, soot, or other combustible material.</p>	<p>Yes</p>	<p>This unit should be swept/cleaned prior to its first use and no less than annually thereafter.</p>
<p>The inspector noted a flue that had two or more openings at the same level.</p>	<p>No</p>	
<p>The inspector noted an appliance venting into the space around and between liners. The remaining space surrounding a chimney liner should not be used as a vent.</p>	<p>No</p>	
<i>Flue Size</i>		
<p>The inspector noted that the size of the flue was too small relative to the size of the fireplace opening. This relationship is the most important factor in achieving sufficient draft. A flue that is too small relative to the fireplace opening will be unable to lift and remove hazardous flue gases to the outside.</p>	<p>No</p>
