SEDONA ELITE 3200 FRONT BEARING REPLACEMENT

2015- 2017 SEDONA ELITE 3200 FRONT BEARING REPLACEMENT

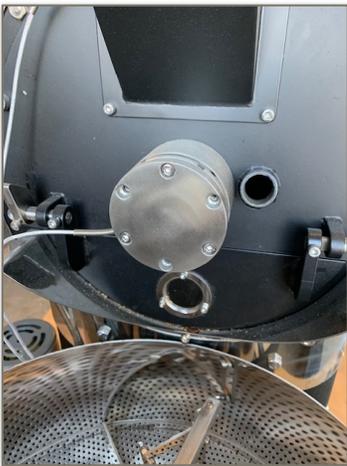
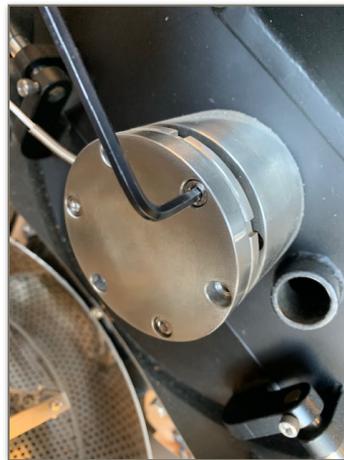
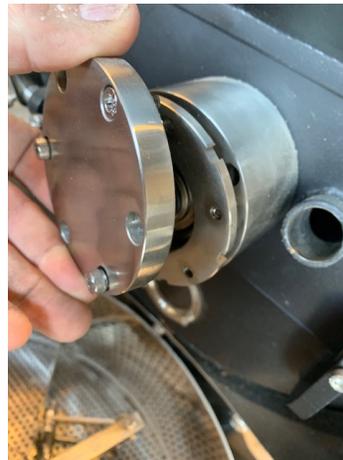
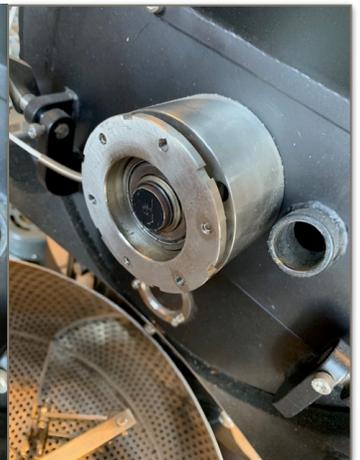
1. Using a Metric Hex Key remove outer bearing cover. 2. Next Remove and store 3 set screws

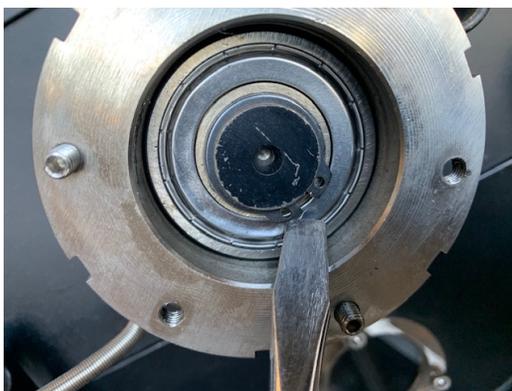
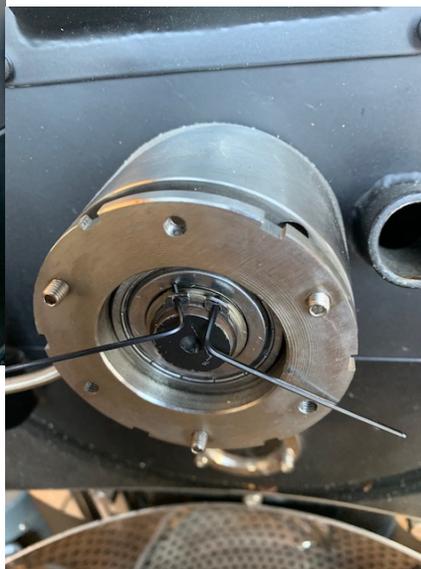
3. Once removed you may find the shaft has a **Retaining Clip Ring** on it. If so you will need to remove this. You may be able to revoke this with a flathead screwdriver or small needle nose pliers. We found it easy to remove with two 1mm hex keys as shown in image (7) **(If your unit does not have the RING CLIP you may proceed to step 5)**

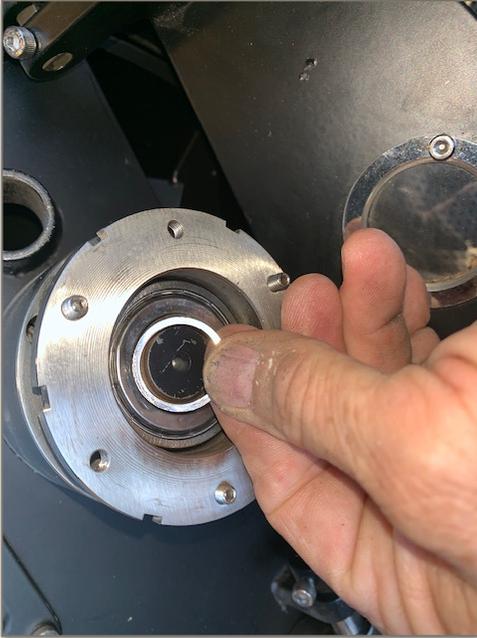
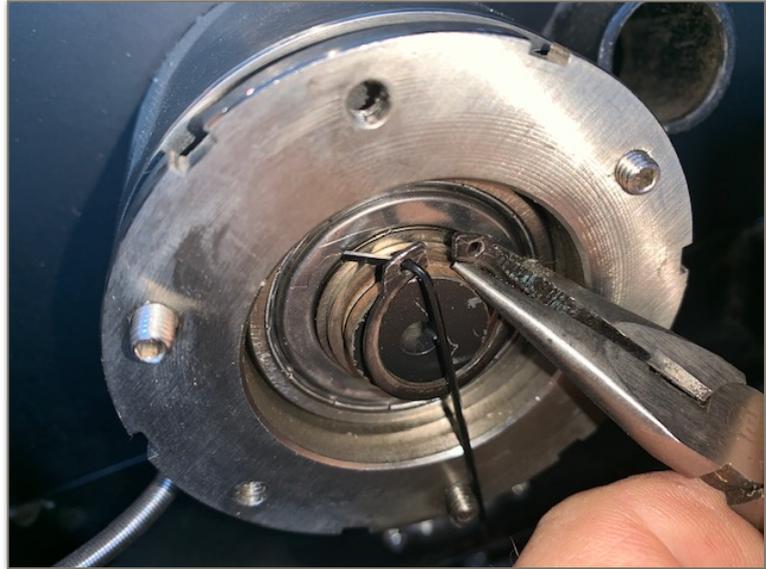
4. Once Retaining Clip Ring is removed (If your unit has this- many models 2015 and older do not have this ring) You may need to also remove a washer

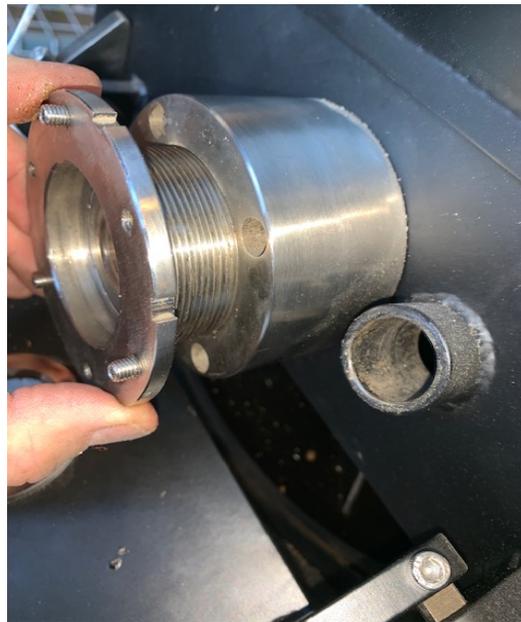
5. Next Unscrew bearing holder. If tight you may need gloves or a tool to get it started. If needed lubricate threads.

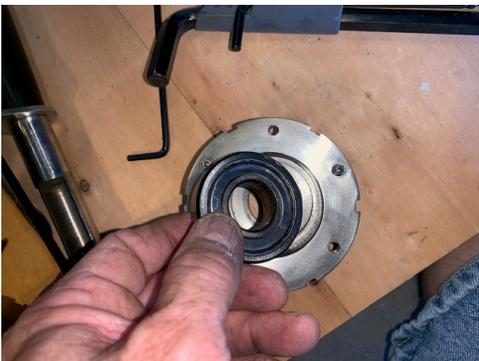
6. Once Bearing holder is removed you may need to use a Rod or wood dowel to tap bearing out of holder

7. Then clean and lubricate holder before putting new bearing back into it.

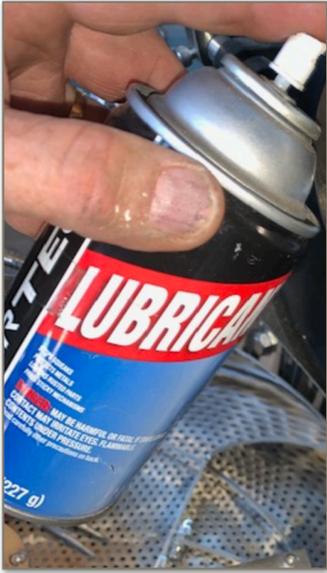
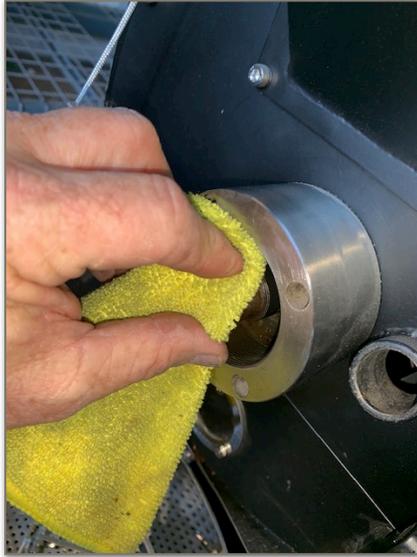
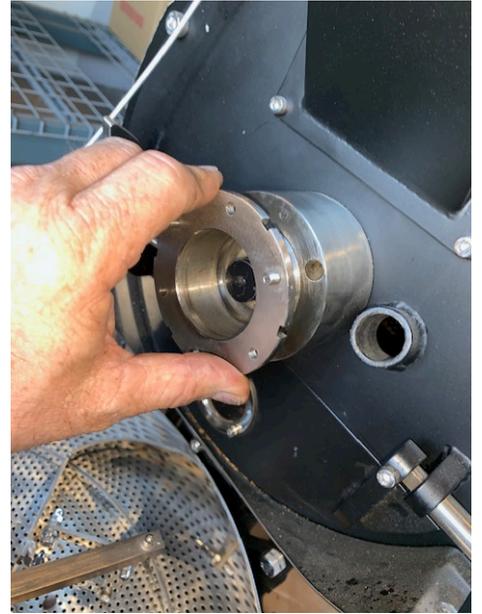
8. Next put bearing into holder. You may need to heat holder to expand so bearing will easily slide into place.
9. Replace washer and ring if applicable
