August 5, 2015

**Subject: Wetland Evaluation Report
Homestead, Murphy, and Marsh Farms
Waterford Borough, Erie County, Pennsylvania**

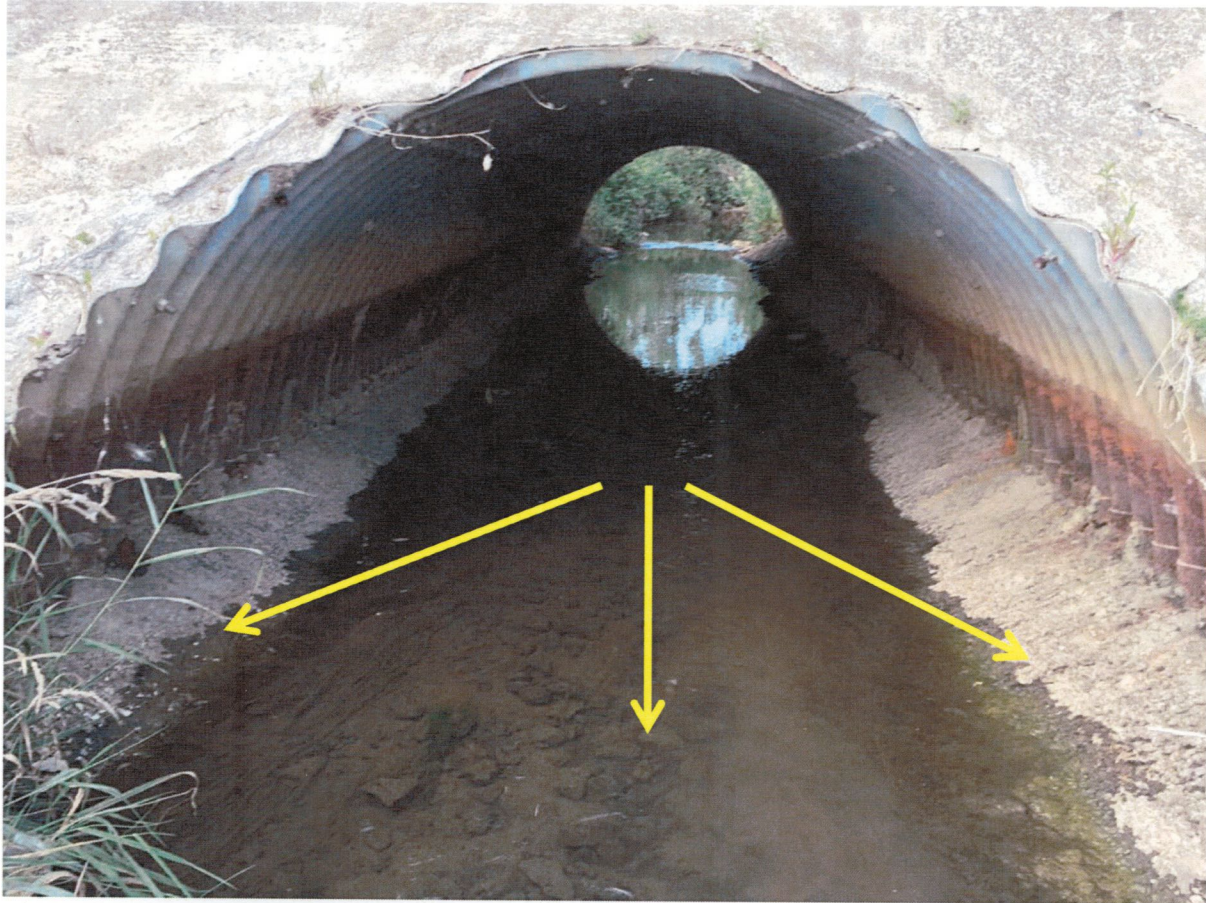
PHOTO 1. Sharp Rd culvert with over 2 feet of concrete and stone base along the bottom, which acts like a dam causing water to backup on Brace Property.

Another important piece of evidence regarding the change to the onsite hydrology is the installation of the Sharp Road culvert (see Figure 5). This culvert on Sharp Road is the location where the drainage leaves the property. The Owner claims that in the mid-late 1980s the Pennsylvania Department of Transportation (PennDOT) installed a new culvert at this location and added concrete along the bottom of the culvert, which backed up the flow and raised the water table in the Lane Road culvert and other parts of the property. As a result, some of the drainage tile outlets on all three farm areas became submerged due to the higher water table. These claims were initially verified in the field by Mr. Bruce Coffin (Supervisor for Waterford Township) and other Town employees (Mr. Gary Taylor and Mr. Jerry Hanas) using a laser level. A copy of the April 22, 2014 journal entry by Mr. Coffin documenting these observations is included under Appendix B.

EcoStrategies conducted a hydrologic elevation survey of these culverts using a total station on July 31, 2015. The results indicated that the top of the concrete at the invert of the Sharp Road Culvert (inlet side or east side) is 1.75-feet higher than the invert on the Lane Road culvert (outlet side or north side) which is located upgradient. In other words, the concrete fill in the Sharp road culvert created a dam that backed water up resulting in 1.75-feet of standing water for more than 1,800 feet up to the Lane Road Culvert and beyond. Based on additional elevation points taken upgradient and downgradient of the Sharp Road culvert, we estimate that at least 2 feet of concrete (and riprap base material beneath the concrete) was added above the natural channel bottom. Photos of Sharp Road and Lane Road Culverts are included under Appendix C. In general, most culverts are installed so that the bottom of the culvert is set approximately 6-inches below the natural channel bottom (not 2+ feet above the bottom) for ecological and other reasons; and also downstream culverts should always be set lower than upstream culverts feeding into it unless there is a specific reason not to follow this standard practice. This culvert is why some of the drain tiles previously installed by the Owner are now either partly or completely submerged under water even under low flow conditions and also why certain areas have evolved more quickly into potential wetland areas. Additional survey details and notes are available upon request.

- The Sharp Road culvert created a dam that was at least 2 feet above the channel bottom that backed water up resulting in 1.75 feet of standing water over 1,800+ feet of property. This caused an increase in the water table, submerged some of the drain tiles, and accelerated the potential for wetland establishment.
