**Mitre House  
124 Kings Road  
London  
SW3 4TP**

**REFURBISHMENT  
OF THE COMMON PARTS**

**FIRE SAFETY REPORT**

# Health & Safety and Fire Risk Assessment

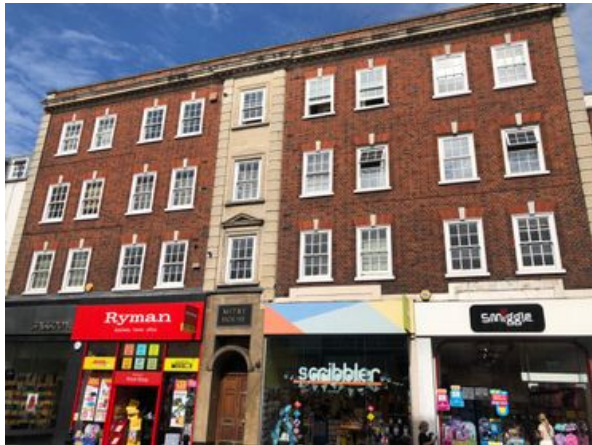
Photo 1

General Health & Safety Risk Assessment Inspection / Security Provisions / CCTV / Intercom Access

Is there a maintenance regime in place for the intercom?	Unknown
--	---------

Is there an intercom system in place?	Yes
Is there a maintenance regime in place for the intercom?	Unknown
Action - Place a maintenance contract with a competent contractor for the intercom / entry system to ensure equipment is suitably maintained. Keep all test certificates on file and make available on request.	
Is there CCTV installed at the premises?	No
Where are the letterboxes located? (If applicable)	Main Communal Door
Is there a letter cage fitted to the door?	Yes

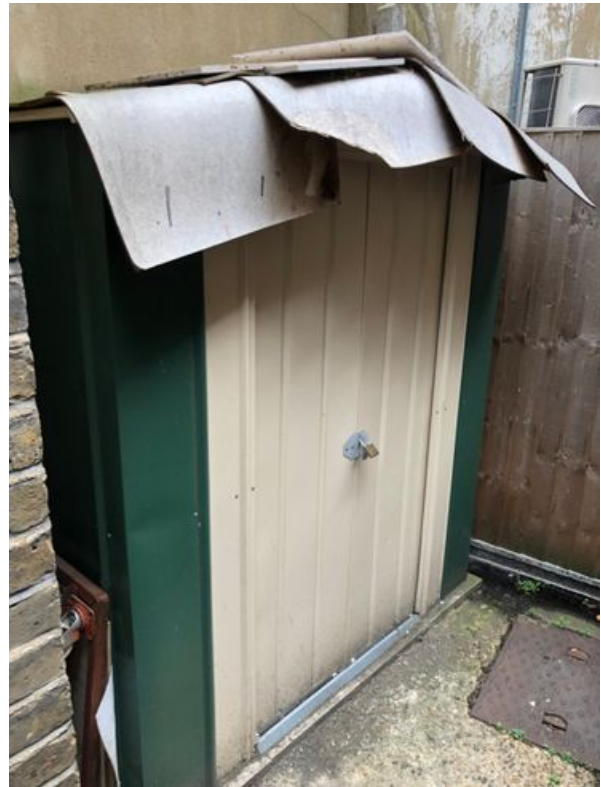
Photo 2

Are they in good condition?	Yes
<p>– Notes</p> <p>Kept locked shut</p> <p>– Photos</p>

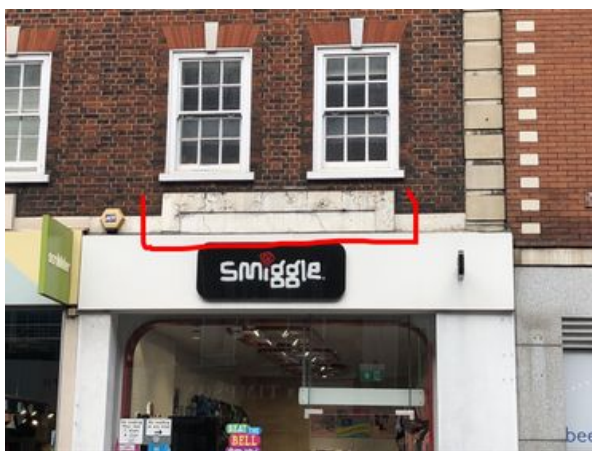
Photo 3

Does the building look to be in good / satisfactory repair / decoration?	Fair
<p>– Notes</p> <p>Render on the front elevation has started to deteriorate. These areas would benefit from being made good with an appropriate filler and decorated to prevent water penetration.</p> <p>– Photos</p>

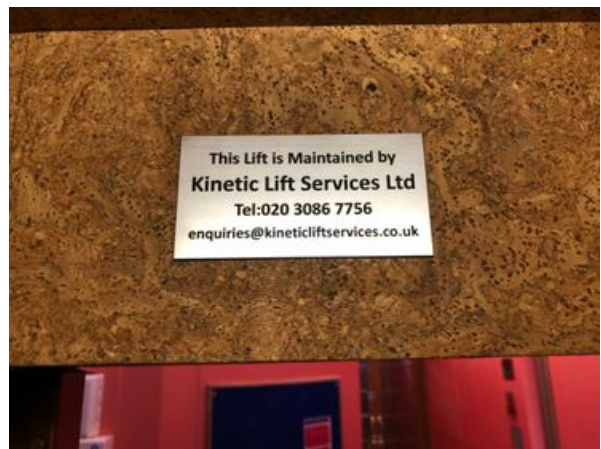
Photo 4

Is there a working lift line / alarm?	Yes
<p>– Notes</p> <p>There is an alarm fitted but this does not connect to a phone line. There is a sign containing the lift maintenance companies details but this is not clearly displayed. It is recommended that it is placed next to the other signage.</p> <p>– Photos</p>

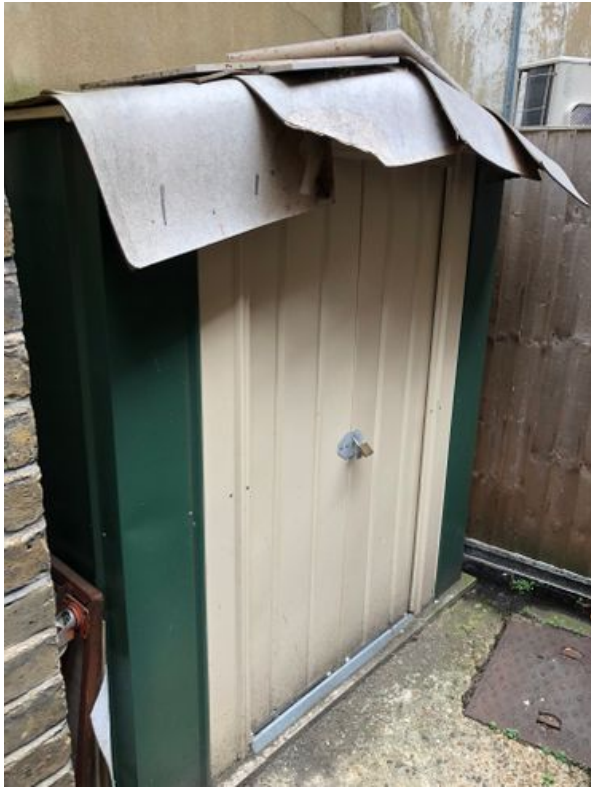
Photo 5

Are there items stored externally?	Yes
<p>– Notes</p> <p>Storage was contained within a locked unit.</p> <p>– Photos</p>

<p>Photo 5</p>	
<p>Action - Occupants to be reminded any items stored externally are to be kept to a minimum and preferably locked away. No flammable substances or sources of ignition are to be stored outside of their demise.</p>

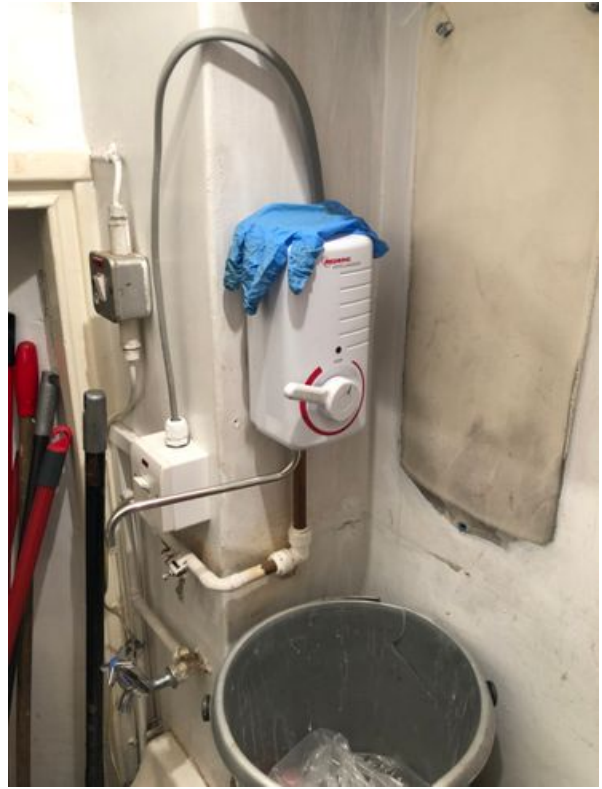
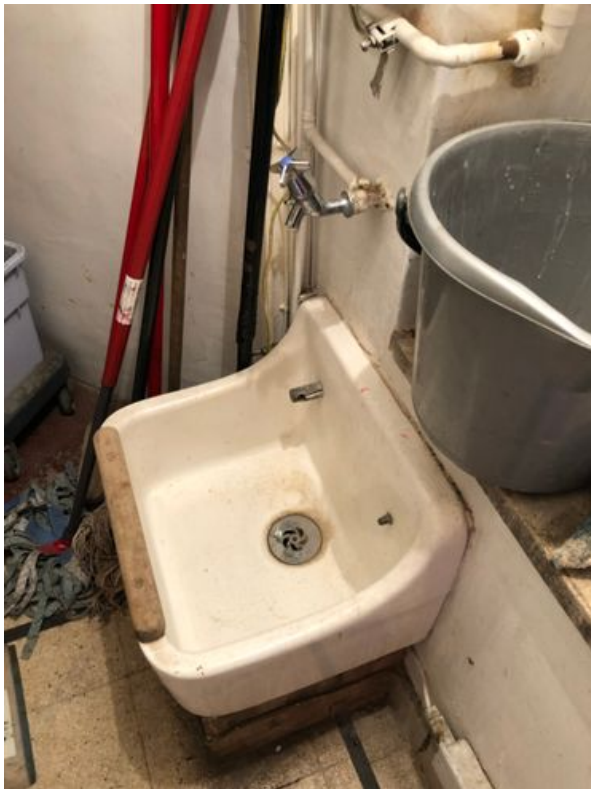
There were no water storage tanks found on site and therefore there is no major legionella risk posed. However, there is a sink with hose unit connected in the ground floor cleaners cabinet. It is recommended this unit is flushed weekly to avoid the build up of contaminants and potentially dangerous bacteria within the system for best practice.

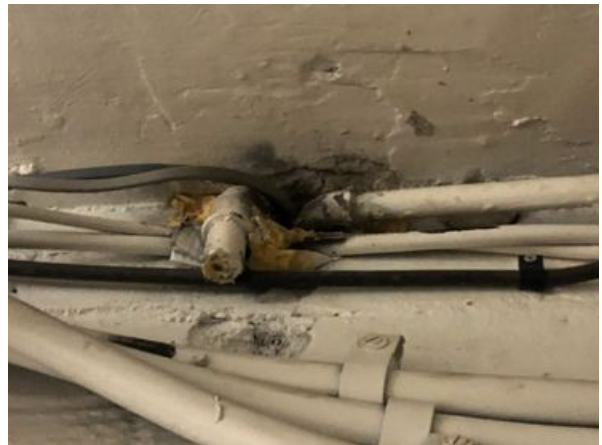
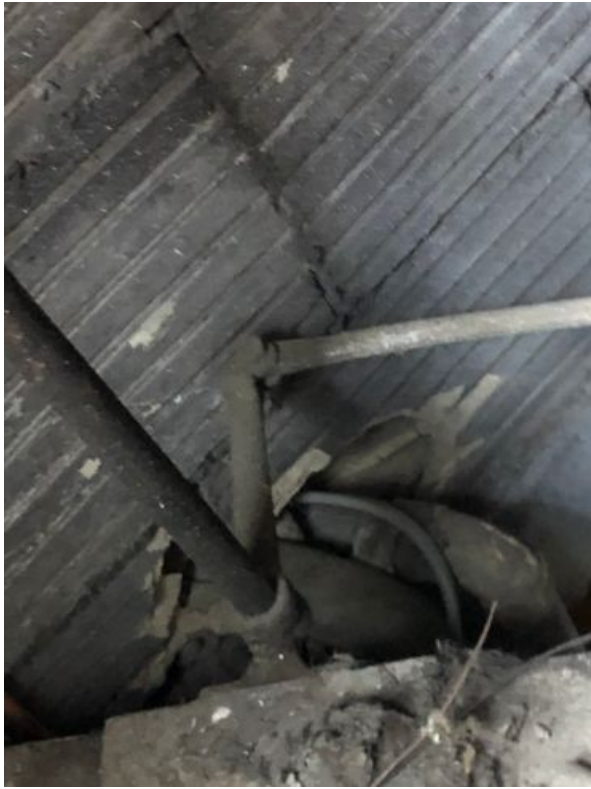
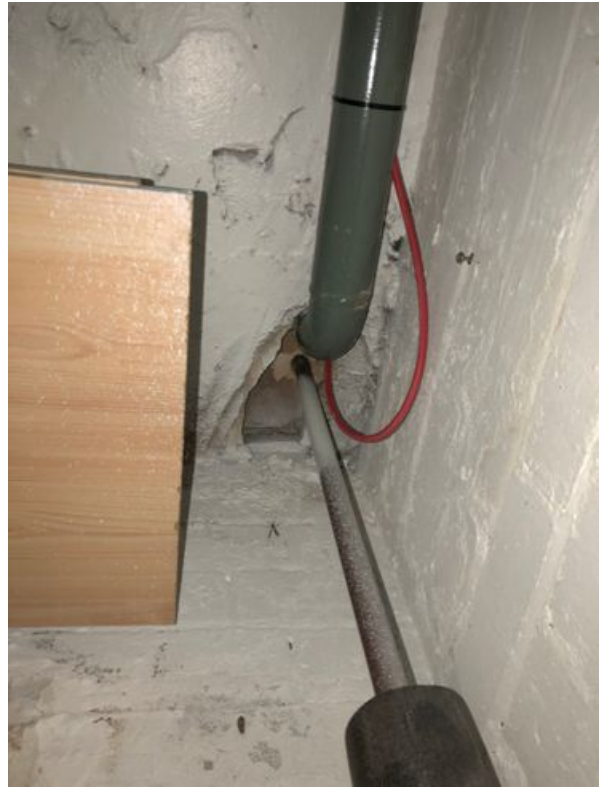
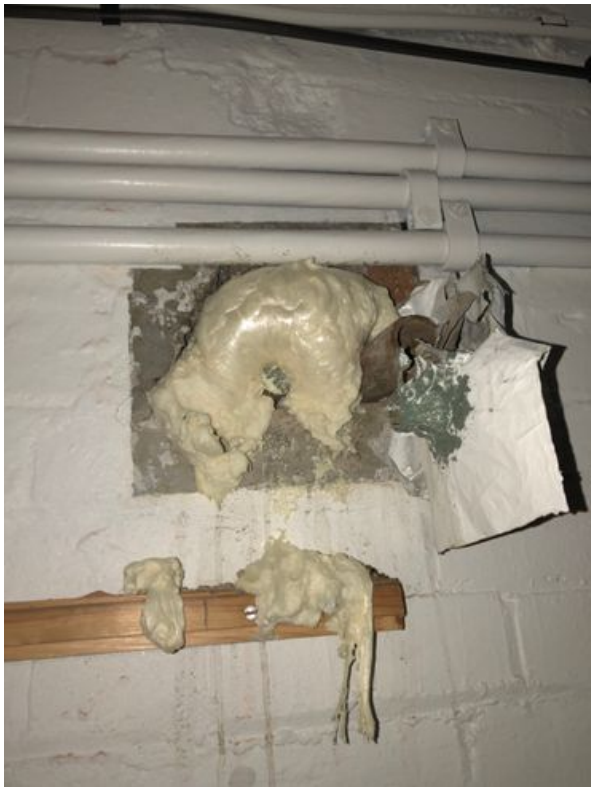
Are any voids suitably fire stopped?	No
<p>– Notes</p> <p>Within the main service room containing the electrical intake services as well as the lift motor, there are three voids around services which have not been fire stopped. One being at high level, adjacent to the ground floor window. Another larger void has been filled with expanding foam but this cannot be confirmed whether this is fire resistant or not.</p> <p>– Photos</p> <div style="display: flex; justify-content: space-around;"> <div style="text-align: center;">

<p>Photo 11</p> </div> </div> <p>Action - Employ a competent contractor to fill any voids with a 30-minute fire rated material such as, fire retardant foam, collars or fire pillows. Check all service cupboards and rectify: where plasterboard joints and abutments, including those to backs of doorframes, have not been fire sealed; and where services exiting have not been fire-stopped.</p>

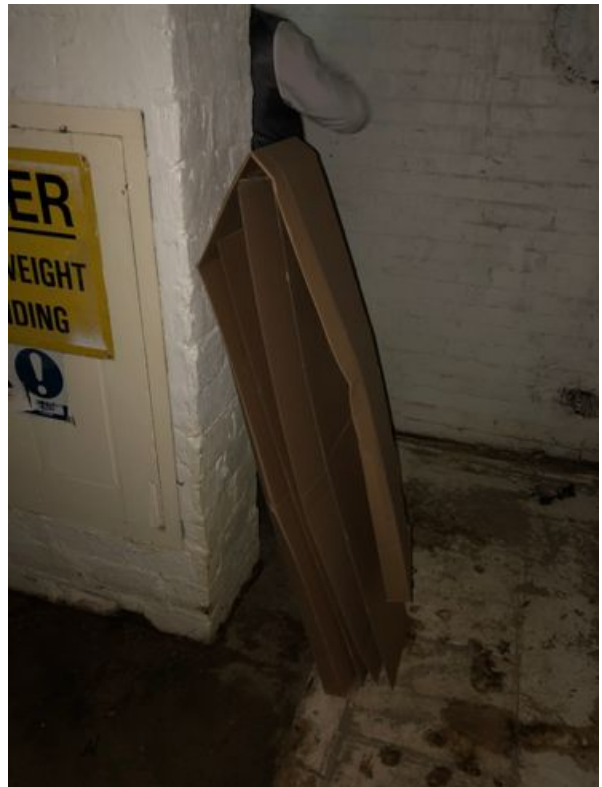
Photo 12

Some pieces of cardboard are being stored within the electrical intake/lift motor room.

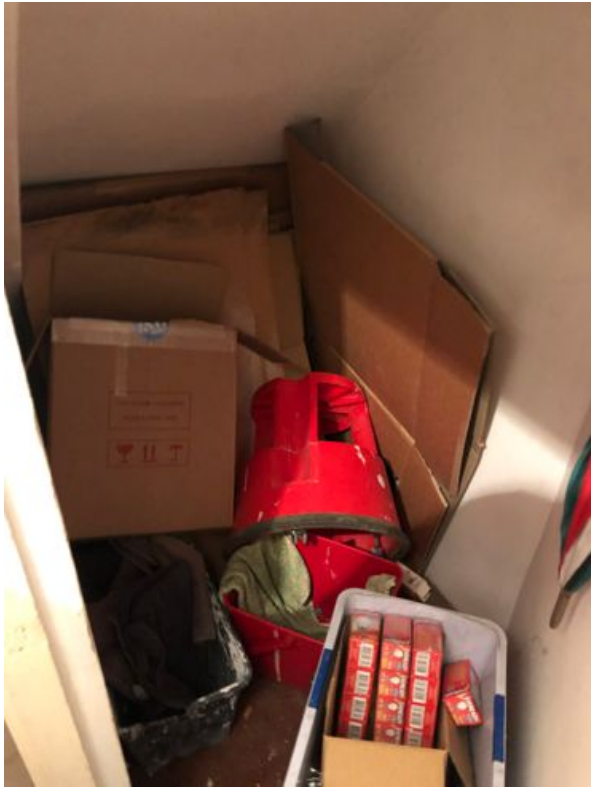
Photo 13

There is a build up of cardboard within the cleaners cupboard on the ground floor.

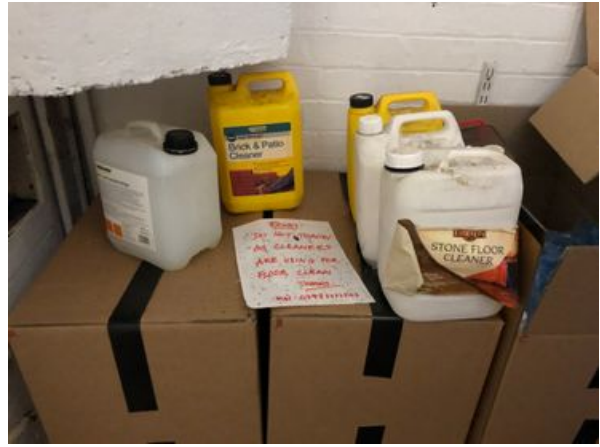
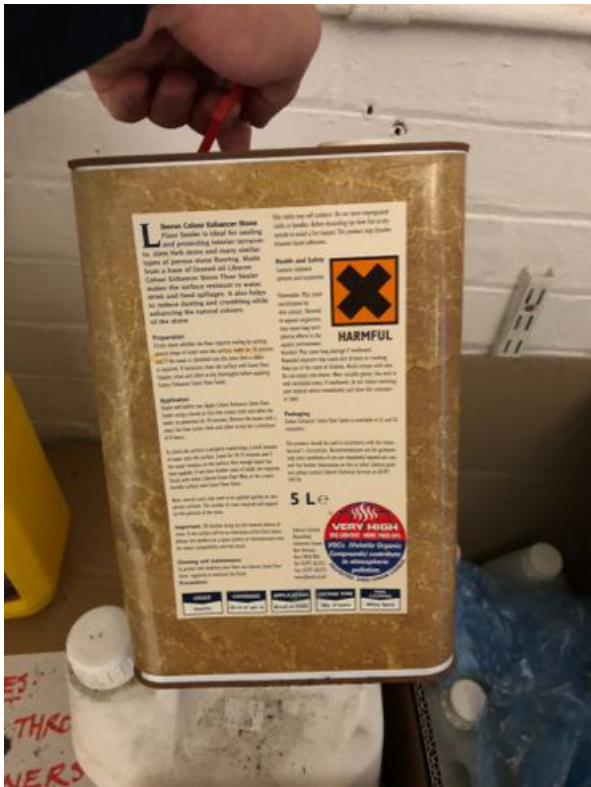
Cleaning chemicals were stored an untidily manner in the basement store cupboard in cardboard boxes. Other supplies were stored under external stair escape on 1st floor. Potentially a contractors materials. See Section "Hazards Introduced by others for further details for more information. See document referenced in action plan for correct storage of cleaning chemicals.

<p>Photo 15</p> </div> </div>	
<p>Action - Remove any hazardous substances from site or alternatively, store locked away in a secure cabinet with signage in accordance with COSHH (Control of Substances Hazardous to Health) Regulations 2002 if required for usage on site.</p>	
<p>Comments / hazards observed</p> <p>None</p>

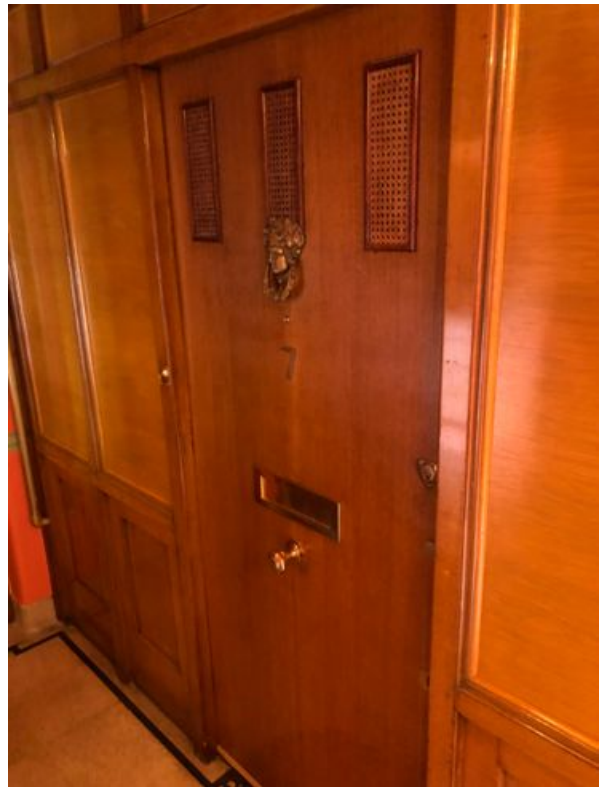
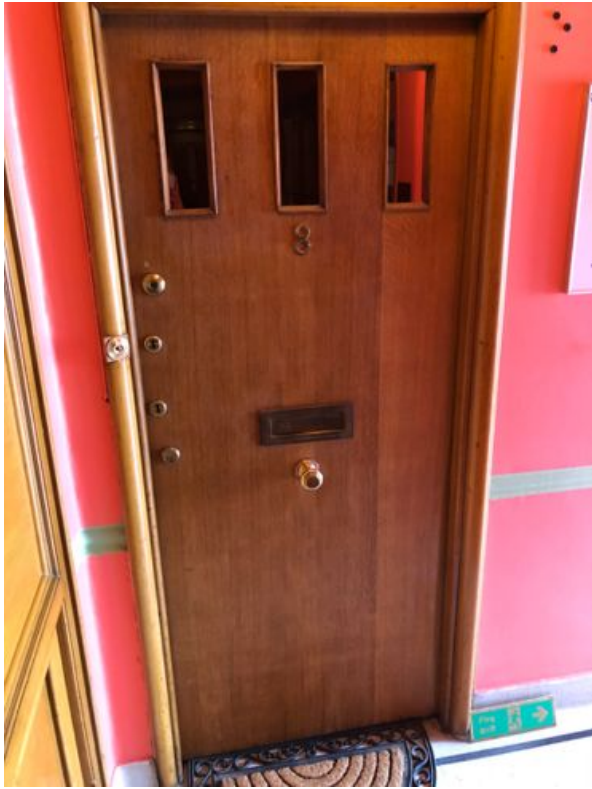
Suitable protection of escape routes?	No
<p>– Notes</p> <p>Flat front doors and the general structure separating some apartments from communal areas do not appear to be fire resisting.</p> <p>– Photos</p> <div style="display: flex; justify-content: space-around;">

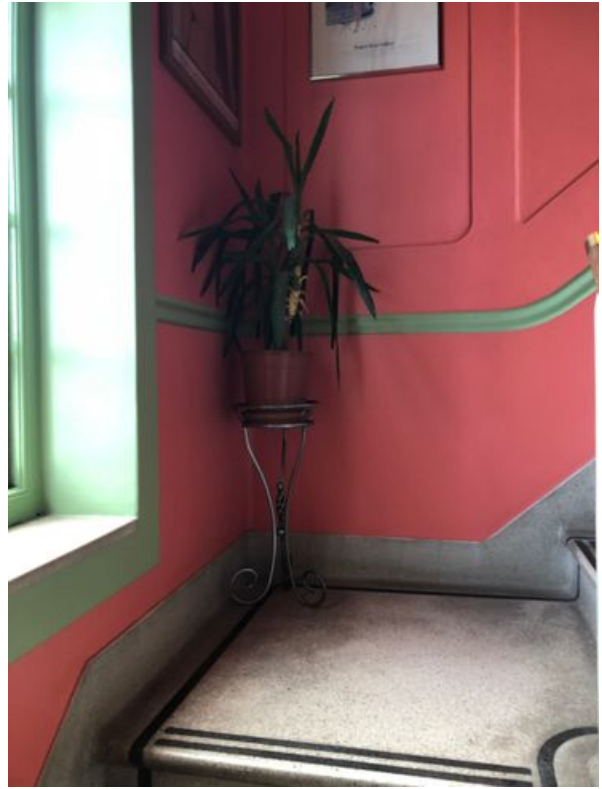
Photo 18

Is it considered that the premises are provided with reasonable means of escape in the event of a fire?	Yes
Adequate design of escape routes?	Yes
Reasonable distance of travel?	Yes
Suitable protection of escape routes?	No
<p>– Notes</p> <p>Flat front doors and the general structure separating some apartments from communal areas do not appear to be fire resisting.</p> <p>– Photos</p> <div style="display: flex; justify-content: space-around;"> <div data-bbox="194 1178 422 1406">   <p>Photo 16</p> </div> <div data-bbox="427 1178 655 1406">   <p>Photo 17</p> </div> </div>	
<p>Action - All designate fire exits should be protected from fire and smoke for a minimum of 30-minutes (dependent on the number of occupants and fire policy) by the use of fire doors and fire resisting construction to allow occupants safe egress from the property should they need to evacuate.</p>	
Adequate provision of Exits?	Yes

<p>Photo 20</p> </div> </div>	
<p>Action - Although all escape routes were clear on day of inspection - Occupants should be reminded regularly that all communal areas are to be kept clear at all times as to not hinder safe egress from, or access into the building. Also, any personal items stored within the communal areas may help promote the spread of fire and therefore they should always be stored within their private demise.</p>	
Is it considered that the premises are provided with additional arrangements for means of escape for disabled people?	N/a

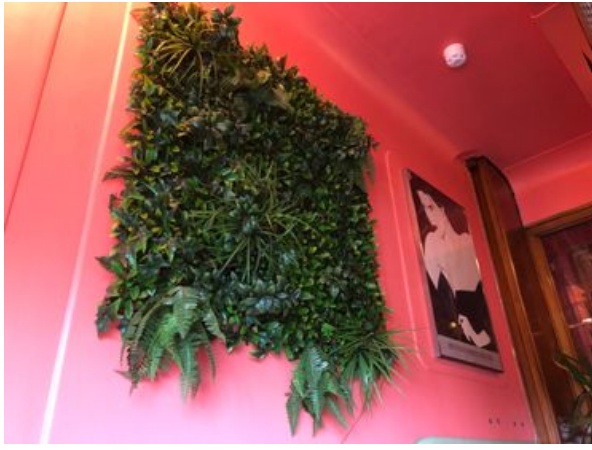
Photo 21

Compartmentation to a reasonable standard?	No
Intumescent strips & smoke seals fitted to escape route fire doors?	No
Reasonable limitation of linings that may promote the spread of fire?	No
<p>– Notes</p> <p>On the fourth floor there are painting and decorative features which look to be combustible.</p> <p>– Photos</p> <div style="display: flex; justify-content: space-around;">

<p>Photo 21</p>	
<p>Action - All materials in communal areas where possible, should be fire resistant, especially those in an escape route. This includes, carpets, paints, decorations and furniture.</p>	
Is there any form of cladding on the exterior of the building?	No
<p>Other comments / hazards</p> <p>None</p>

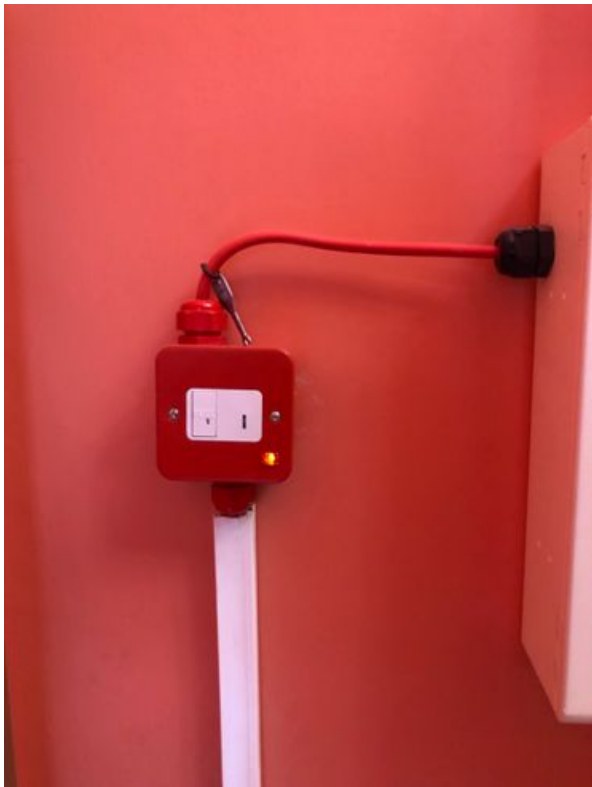
Photo 23

</div> <p>Photo 23      Photo 24</p>	
Is automatic smoke detection provided?	Yes
What type?	Hard wired smoke detectors
Is the current system fit for purpose?	Yes
