REPORT OF TRAVEL

REPORT DATE: 21 APR 10

DESTINATION: 1109th AVCRAD located in Groton, CT

PURPOSE OF TRIP: The purpose of this trip was to provide AMCOM G-4 Technology Integration Branch (TIB) support, at the request of the 1109th Aviation Classification Repair Activity Depot (AVCRAD) located in Groton, CT, for the implementation of the U.S. Technology Type VIII Plastic Media Blast (PMB) into their system.

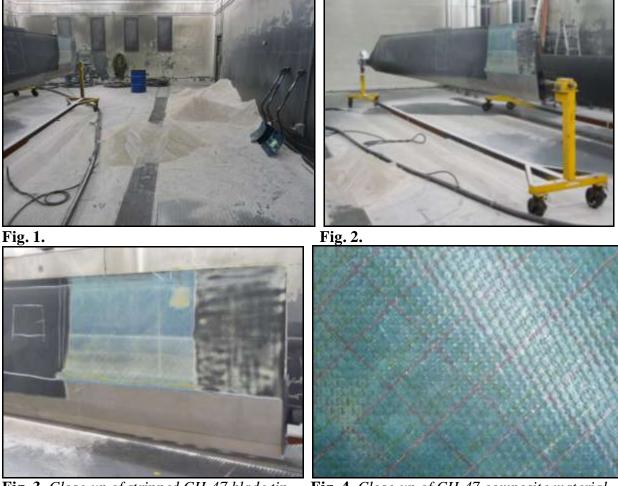
Fig. 3. Close-up of stripped CH-47 blade tip

Fig. 4. Close-up of CH-47 composite material

After all work to get the system up and running and calibrated, Vinny proceeded to blast a portion of one of the CH-47 main rotor blades for the 1109th AVCRAD's top rotor blade Technical Inspector, Staff Sgt. Steve Barrett. (Fig. 2 & 3) Staff Sgt. Barrett stated he had never seen a rotor blade look so good after having the paint completely removed and exposing all of the composite and metallic substrates with absolutely no damage whatsoever anywhere on the stripped portion. (Figs. 4 & 5) After his inspection, Staff Sgt. Barrett gave the "thumbs up" for stripping all of the remaining CH-47 blades that had been provided for the Type VIII transition.

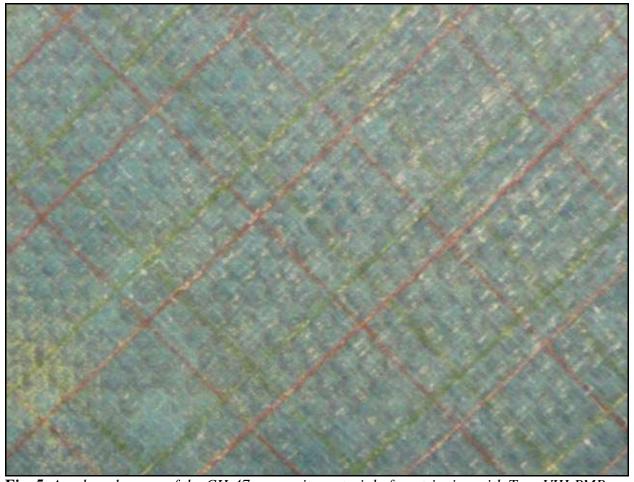
Fig. 5. Another close-up of the CH-47 composite material after stripping with Type VIII PMB

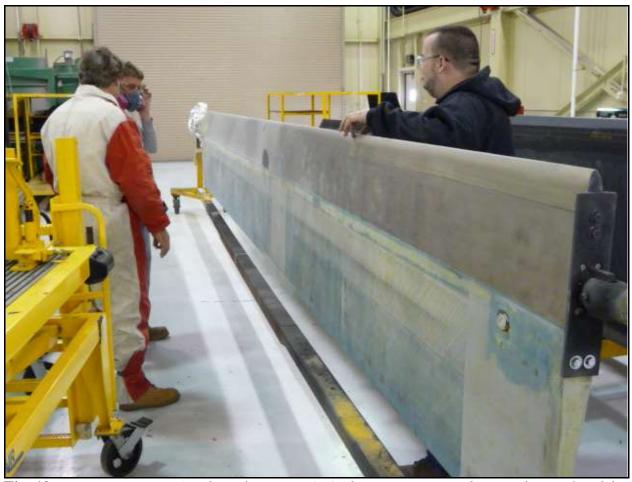
Fig. 10. Vinny, Terry Zurn (Technical Inspector), & Thomas Newman admiring the results of the CH-47 main rotor blade stripped with the Type VIII PMB

After the classroom time and lunch had been completed, it was time to start blasting with the Type VIII PMB. Since there were only four airlines available in the blast room, the actual Type VIII blasting instruction could only take place with four blasters each per session. Each session would yield one completely stripped CH-47 main rotor blade including all four lightning strike panels. As a point of reference, it was learned from experienced blade sanding technicians at the 1109th AVCRAD that the average time to strip an entire rotor blade by hand-sanding was about 14 hours. In the first session involving the Type VIII PMB stripping of a CH-47 rotor blade, including all lightning strike panels, it took approximately 2 hours with only three blasters and Vinny in the booth giving instruction and guidance. (Figs. 6 – 12)

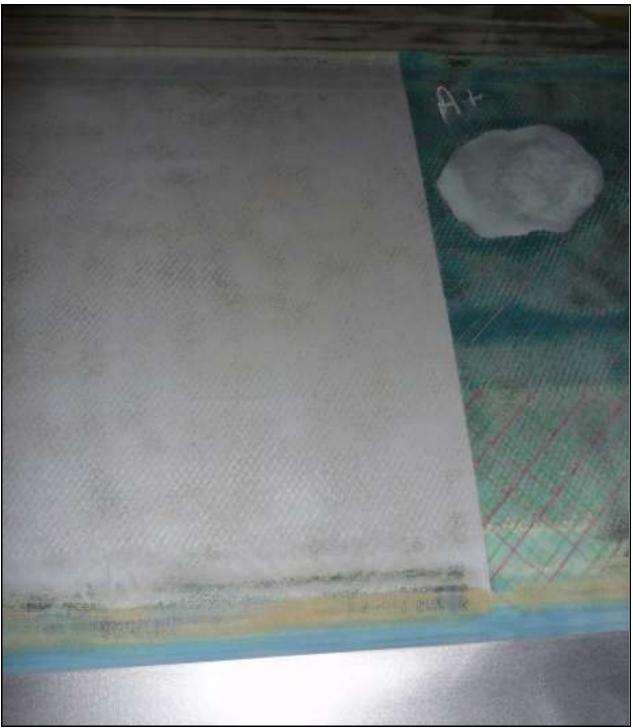
Fig. 13. Here is an excellent example of how good the Type VIII PMB removes coatings from composite substrates on the CH-47 rotor blades. The white square section to the left is one of the lightning strike panels. It is a very delicate area on the blade to remove coating from without damaging it. When using the Type VIII PMB, the topcoat only is first removed on the lightning strike panel at a setting of 15 psi. After the topcoat has been completely removed, the pressure is then turned down to 10 psi and blasting continues down to the white lightning strike substrate seen here. The circle to the right of the lightning strike panel is another example of repair work.

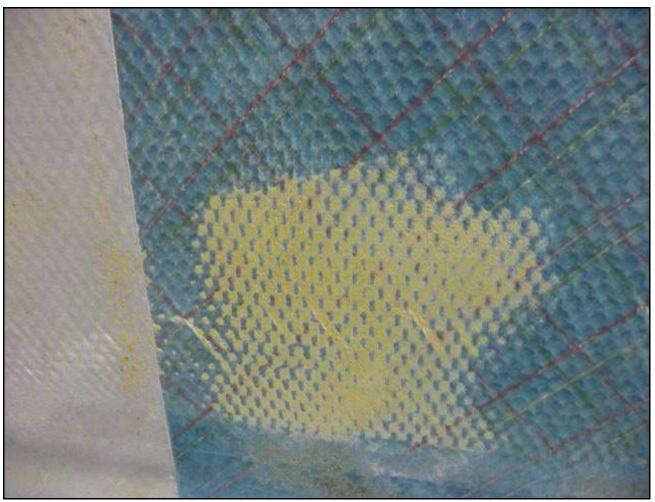
Fig. 14. Another close-up showing the edge of the lightning strike panel on the left and some repair/patch work material in the center (yellowish color). Notice the Type VIII PMB did not disturb the repair material in the dimples of the composite rotor blade substrate, nor did the Type VIII disturb, or roughen, the edges of the very delicate lightning strike panel material.

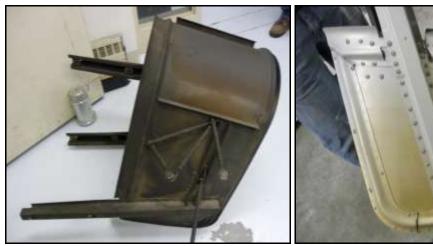
Figures 15 -20 show a Hover Infrared Suppression System (HIRSS) Extender removed from a UH-60 helicopter. This component is located around the aft engine exhaust and is constantly being exposed to high heat exhaust temperatures. The Chemical Agent Resistant Coating (CARC) is essentially baked onto this part around the high temperature areas which makes it very difficult to effectively remove the coatings. This HIRSS extender was not completely stripped using the Type VIII PMB due to time constraints. The areas shown that were stripped with the Type VIII PMB were deemed the most difficult areas to remove the baked on coatings

Fig. 15. HIRSS Extender from UH-60 before **Fig. 16.** HIRSS Extender from UH-60 after blasting with Type VIII PMB (outside) blasting with Type VIII PMB (outside)

per the 1109th AVCRAD maintenance and blaster crew. Notice the browned aluminum after being stripped with the Type VIII PMB (Figs. 16, 18, & 20). These are the areas exposed to the highest amount of heat as is evidenced by the discoloration. The Type VIII PMB completely and efficiently removed all instances of baked-on CARC both inside and outside of the unit at 25 psi.

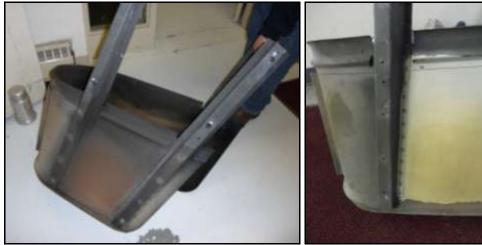
Fig. 17. HIRSS Extender from UH-60 before blasting with Type VIII PMB (outside) blasting with Type VIII PMB (outside)

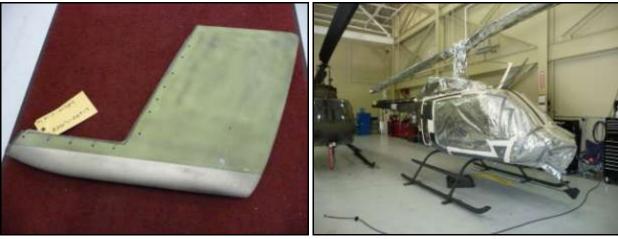
Figure 23 below illustrates a UH-60 main rotor blade tip which had been removed and stripped to substrate using the Type VIII PMB. This was done in approximately 4 minutes at 10 psi. Again, absolutely no damage was done to the part during blasting.

Fig. 23. Composite/Metal UH-60 Blade tip after Fig. 24.

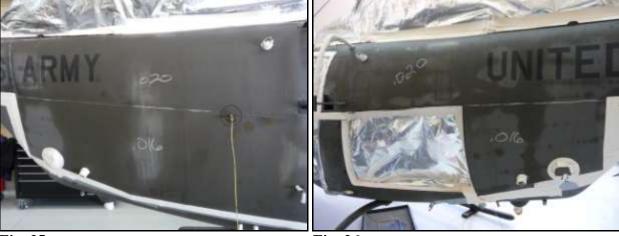
Fig. 25. Fig. 26.

Figures 25 - 28 show the different aluminum thicknesses mapped out on the OH-58 fuselage. The aluminum thicknesses range from 0.016" to 0.040". The reason this is important to map out before going into the blast booth is so the blaster will know what air pressure to strip those parts of the fuselage will be. According to U.S. Technology Type VIII PMB blasting instruction, on aluminum skins between 0.016" to 0.031" thickness; the Type VIII PMB air pressure should be set at 10 psi to 15 psi. On aluminum skins between 0.032" to 0.063" thickness; the Type VIII PMB air pressure can be moved up to settings between 15 psi to 25 psi. Having the proper air pressures matched to the material skin thicknesses prevents damage to the aluminum substrate when using the Type VIII PMB to strip the helicopter.
