Audit Trucks and Paint Markings

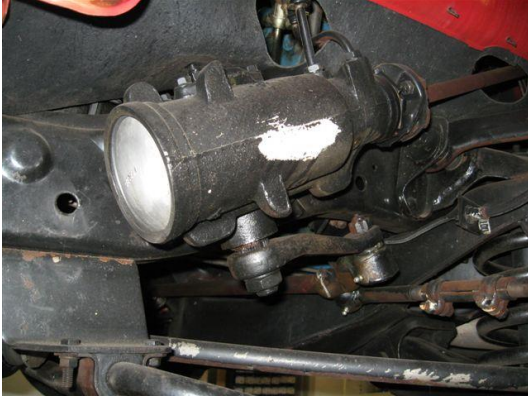
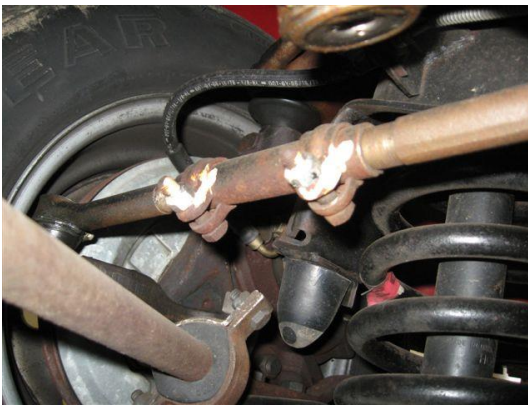
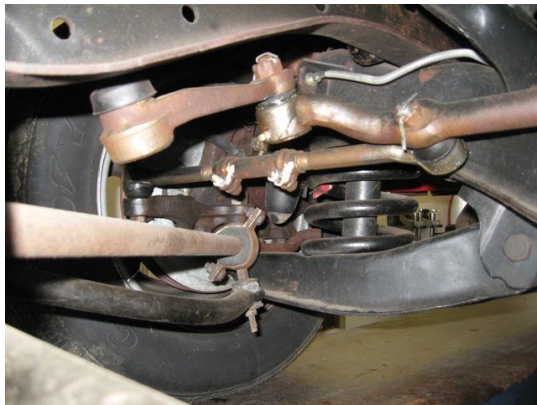
Pics of Audit Truck check marks are below.

Audit Truck paint markings, showing checked

First, I want to address the “Audit Trucks”, what to look for and the reason for them in the first place. I’m including some pics of what identifies the “Audit Truck”. During assembly of the trucks, the assembly plant would randomly pull a truck off the line, lift it in the air and check everything for correct operation and certain torque factors, such as all the steering components. To know that the torque numbers were checked, and the operation was correct, they would put a “dab” of white paint on the bolt holding the item. This procedure was typically done on Class A or safety critical applications, like steering components. So, on a Li’l Red, if you see white paint on every nut on the suspension system, it was an “Audit” truck. Nobody knows how frequently this was done or how they determined which trucks would be checked. They were all picked at random. By doing it that way, line workers had no idea where or when they may check the trucks. I’ve seen trucks that have been restored and they have a bunch of white paint on every nut and bolt, thinking that all the trucks were done this way, not true!!
