U.S. Military M1030 Motorcycle Restoration Story

By Allen Foley

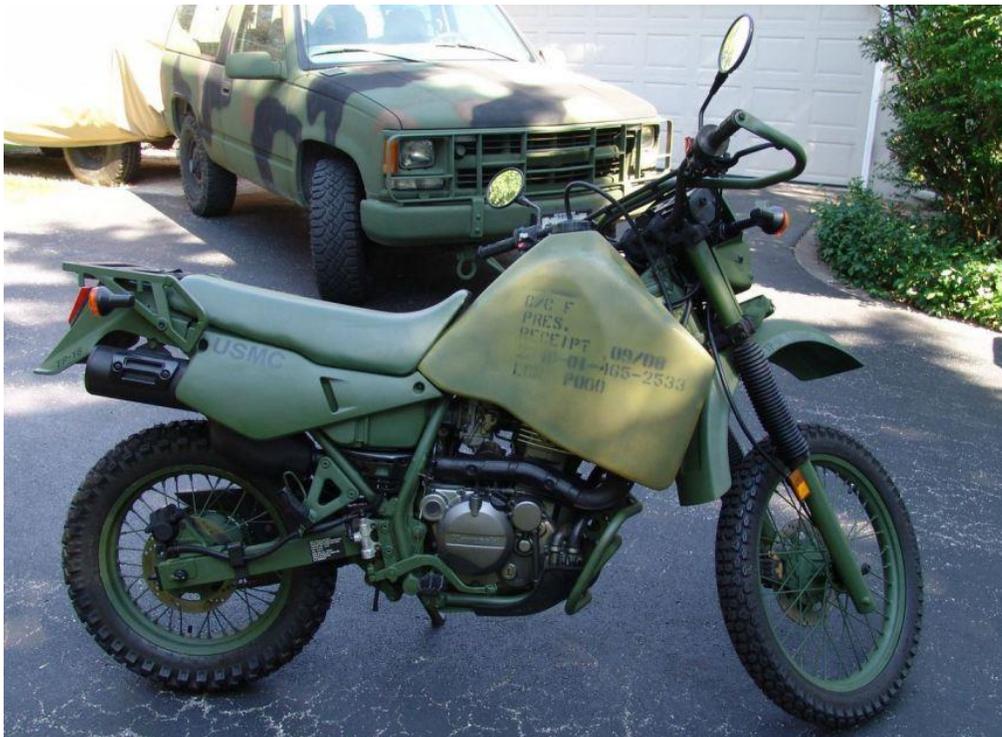
When it arrived it needed a good restoration. After many man hours, replacement of parts, new tires and paint, I now had my modern U.S. military motorcycle. After the restoration was completed it was driven twice for a total of just under two miles. Here is a photograph of the motorcycle after the restoration. It is Registration Number 598880.

It looked great but I did not like it because of the following reasons. It weighed in at around 360 pounds. Not a problem but the large 6.6 fuel gallon gas tank was mounted very high which made the center of gravity too top heavy. This coupled with a seat height of 35 inches made it "tippy toed on one foot" for me when it came to a stop. Remember that a seat height of 35 inches is really more because as you straddle the motorcycle seat, you lose a couple of inseam inches. The civilian KLR650's have a very devoted group of follows called Adventure Riders. That group talks about their members dropping their bike at least once or twice because of the high center of gravity. This was not going to work for me. I looked into the possibility of lowering the

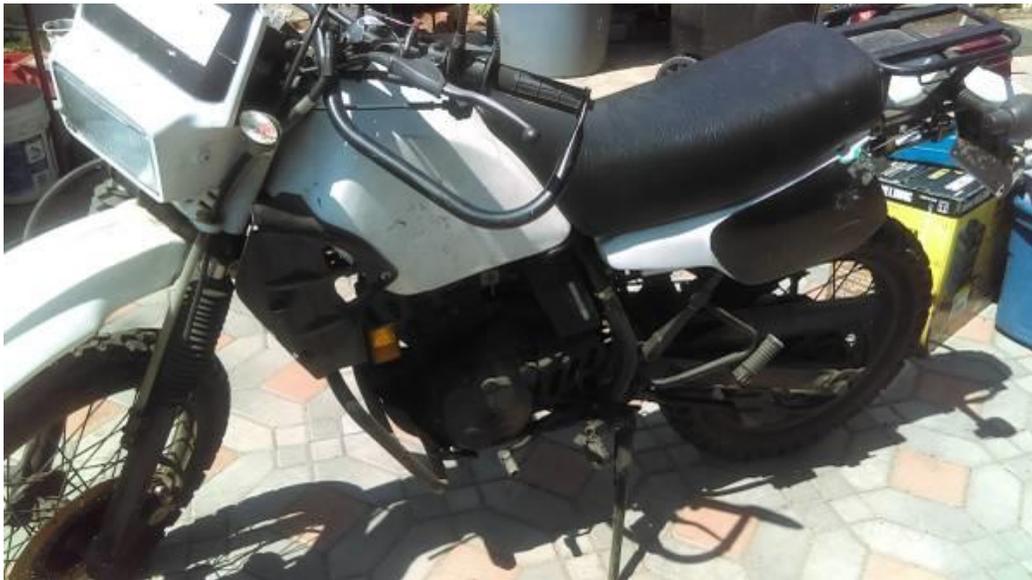
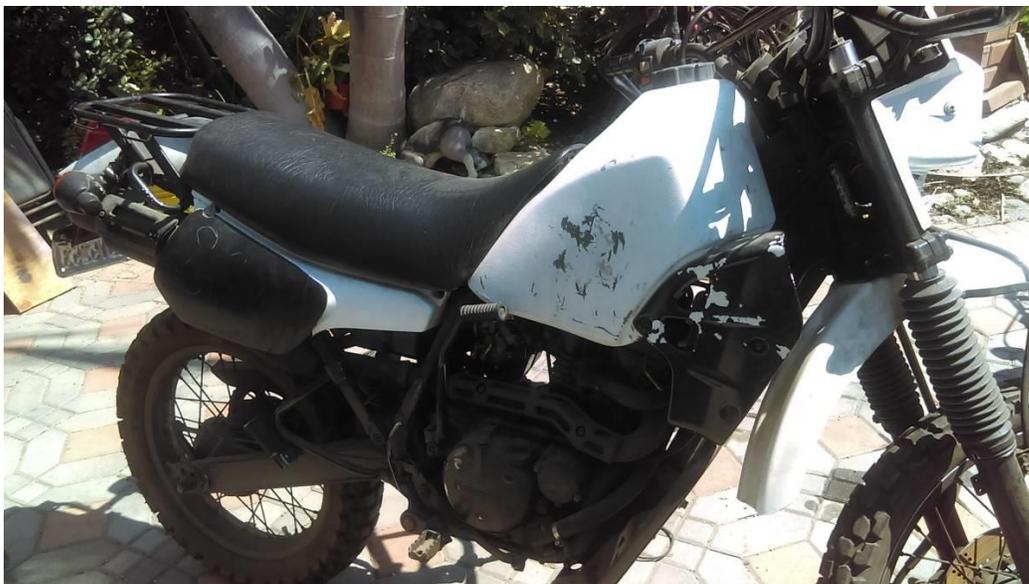
Note the remains of the CHP police star marking on the gas tank.

I closed the deal in late September of 2017 and had it shipped home. It was in early October before I started to really look at the motorcycle. During an inspection I noticed that the police department had done a superb job repainting the bike. They even used epoxy Imron paint because it would barely sand using #40 grit sandpaper. The engine, cables and wiring also had some overspray on them. The use of the imron paint meant that the restoration would take a much longer time than planned. On the plus side the data plate and both Kawasaki identification stickers had been masked prior to the CHP painting. Even though they had been masked, they did have some slight overspray. Using care and spending time I was able to save them. Notice the extra wires attached to the wiring loom from the Hayes conversion. The green circle on the right was not painted black because it had a rubber cap covering that area.

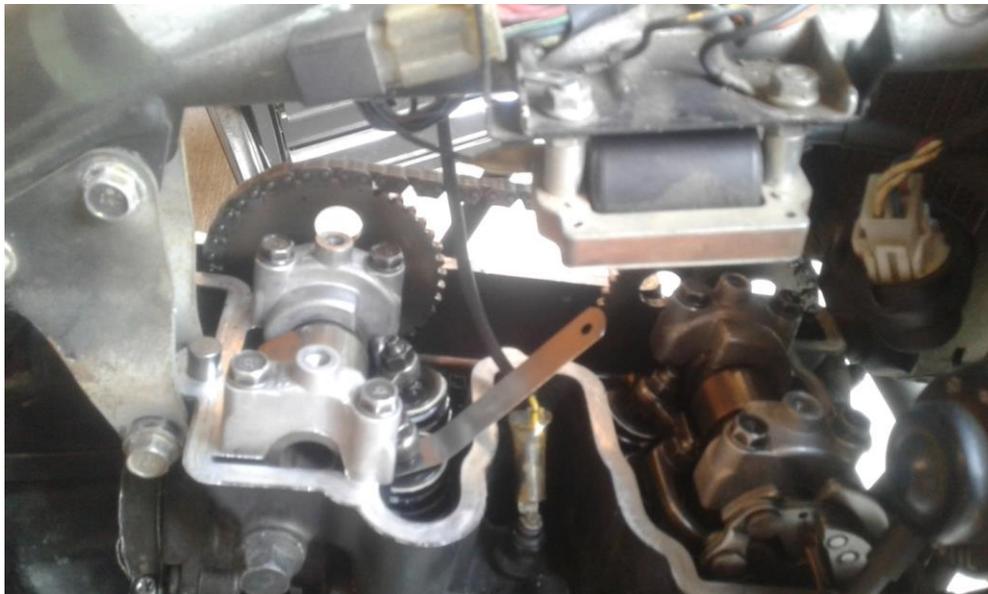
With the engine at TDC the valve clearances were checked with the feeler gauge and all four intake and exhaust valves were still set at 0.009.

Here is a picture of the four valves with the feeler gauge inserted in one of the intake valves.

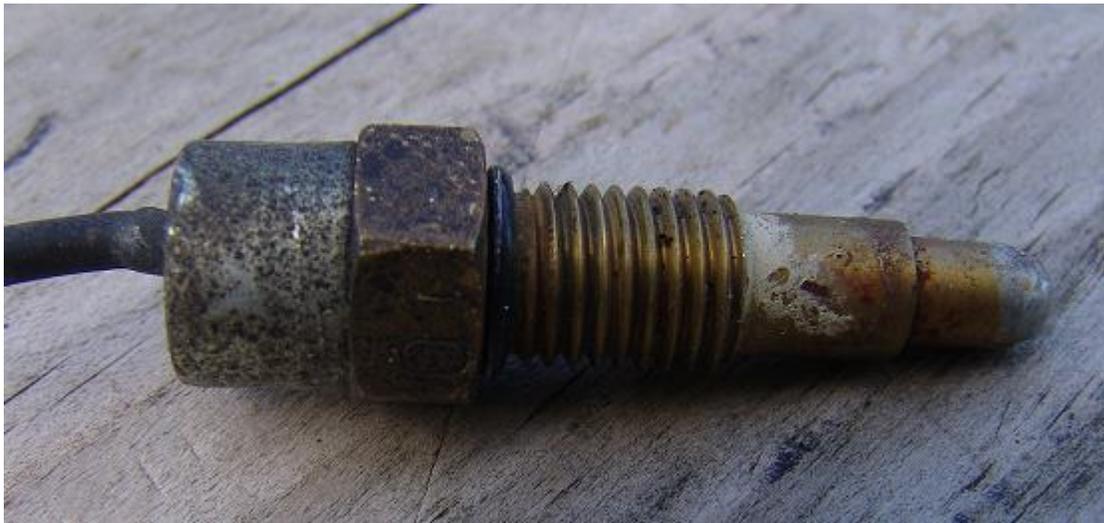
I rode it for about ten minutes but the temperature gauge on the front panel did not move. Checking the cylinder head temperature sensor, the electrical tab on the sensor broke off in my fingers. Replaced it with a new sensor and now after a short ride the temperature gauge needle just touched the red mark. The motorcycle had an overheating problem. I shut it down and a couple of minutes later the needle went into the red and cooling fan turned on. These motorcycles are water cooled and the system consists of two radiators, a water pump, cooling fan, two temperature sensors and a thermostat. The radiator sensor sending unit was removed and it showed some corrosion build up so it was replaced it with a new one.

Here is a photo of the old sensor.

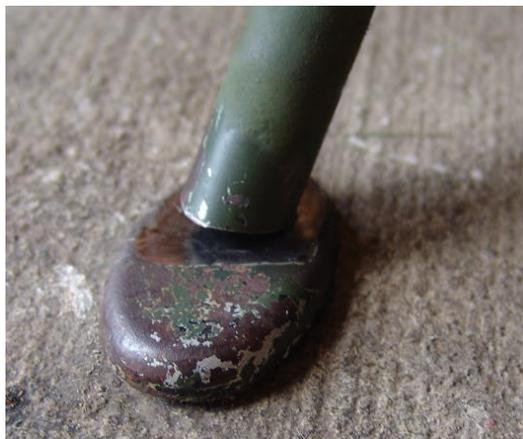
With the motorcycle now lowered, the kick stand was too long. So one and a quarter inches were cut off the bottom of the stand. The base plate piece was then ground flat and was re-welded it to the bottom of the stand leg.

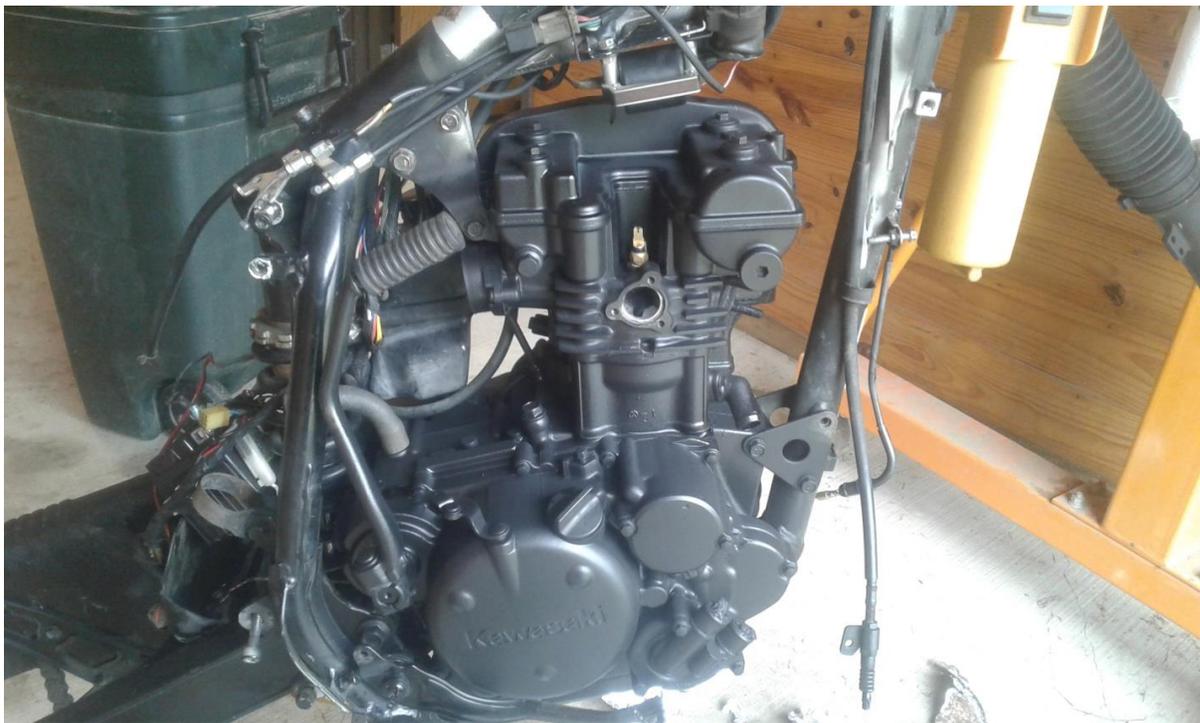
Here is a photograph of the painted engine. Notice the shiny black iron paint to the left of the frame.

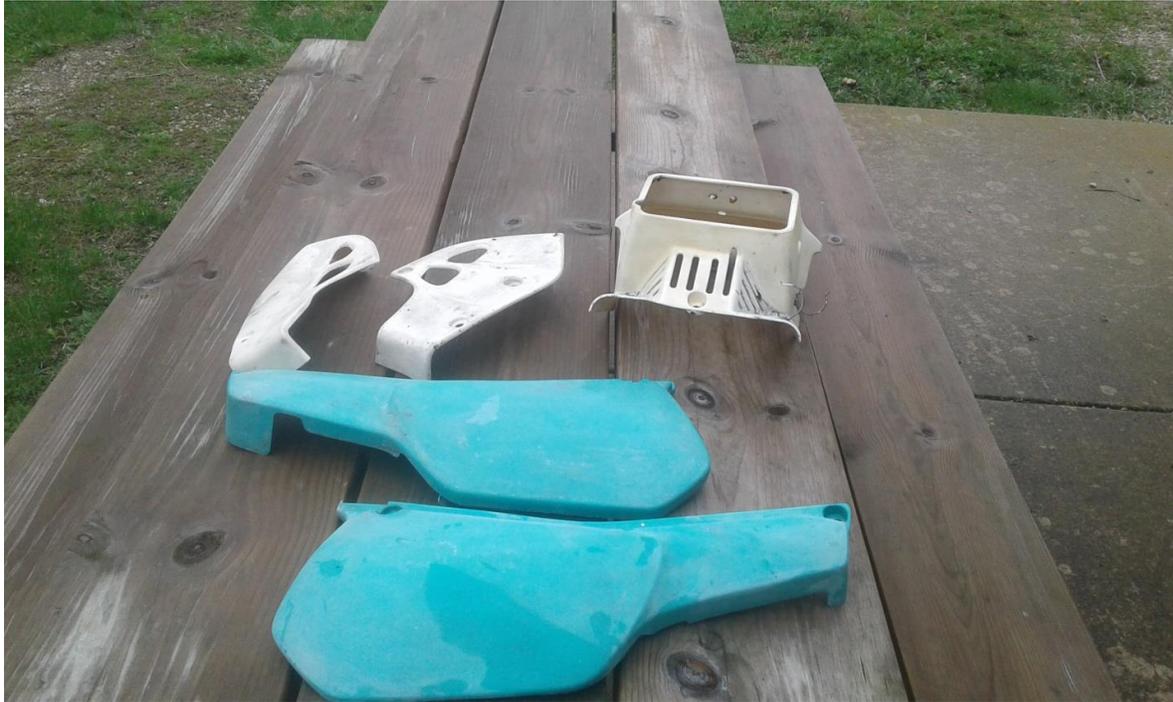
Plastic parts stripped waiting for primer and paint.

With the engine painted the next step was to strip the paint off the frame, swing arm, sub frame, wheels, plastic parts, fenders and gas tank. The stripping of the plastic parts took about 12 hours and a variety of stripping products were used. The plastic parts stripped included the fenders, side covers, radiator panels, front cowlings and the gas tank. The removal of the paint

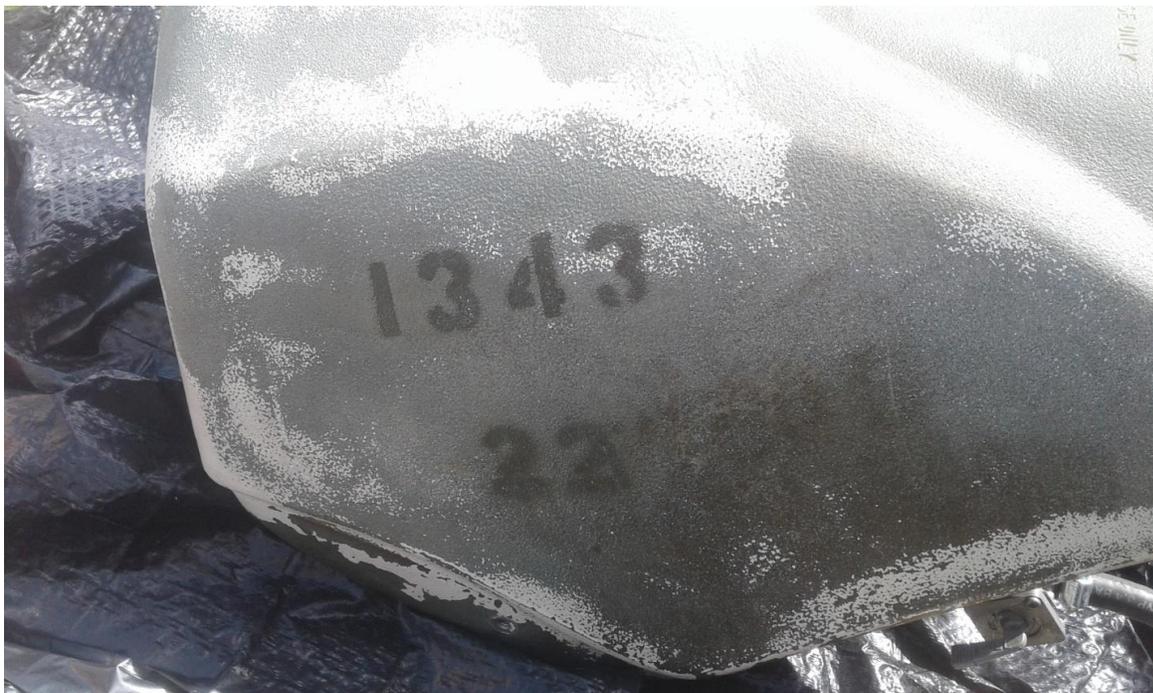
While stripping the white paint off the gas tank the USMC markings were found.

The markings are “1342” and “22nd MEU”. The 22nd MEU stencil indicates the USMC 22nd Marine Expeditionary Unit and I believe the number “1343” is the vehicle number. After stripping the paint from the plastic gas tank it had a dull green finish from UV damage. It was filled with water and a heat gun was used to carefully re-melt the plastic. After the plastic cooled it returned to close of the original shade of green.

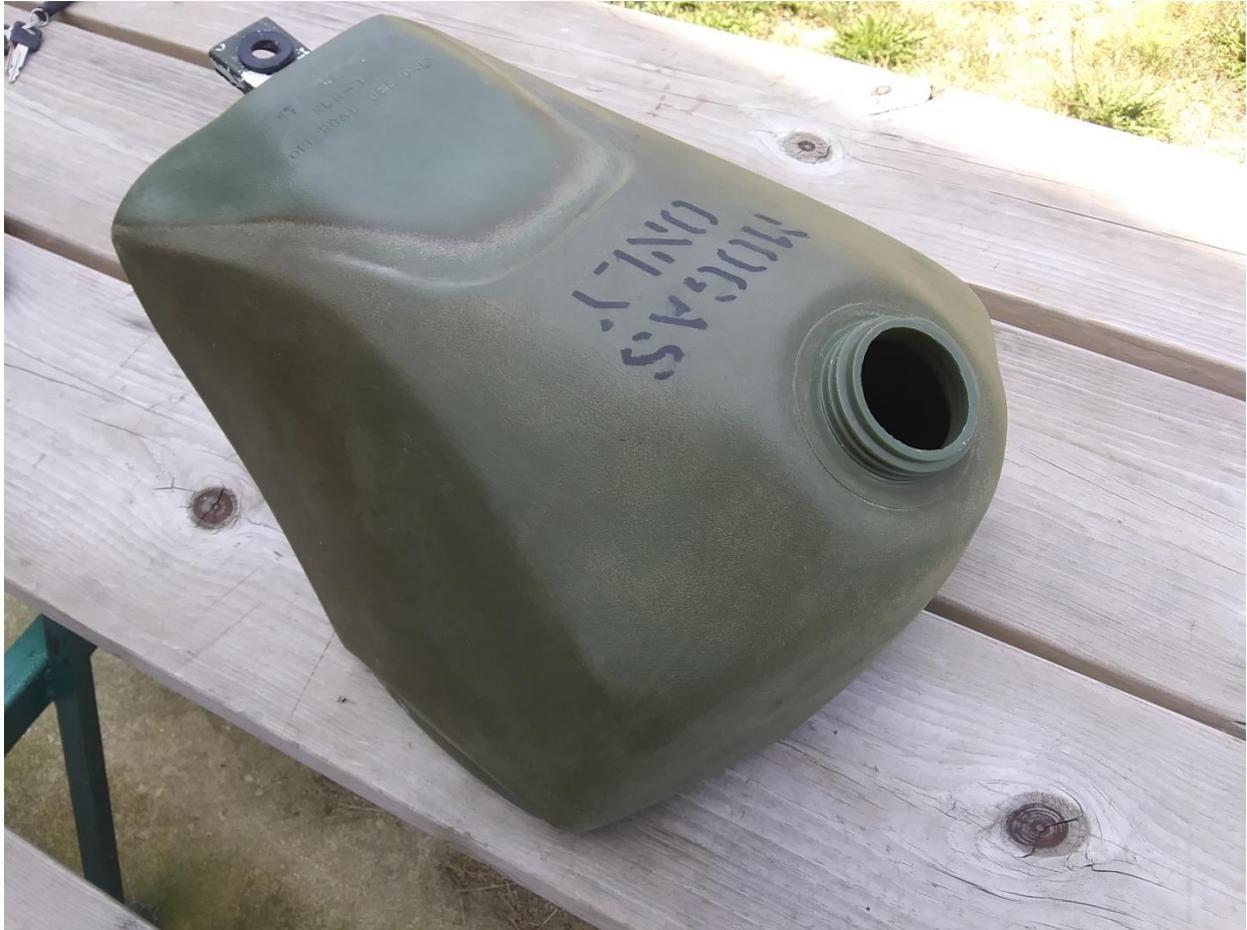
Hayes changed out the fuel tanks on the later M1030's to a larger capacity plastic fuel tank. The Kawasaki stock fuel tank was made of steel and held 2.9 gallons. Hayes purchased their plastic polyethylene fuel tanks from a company who specializes in motorcycle racing plastic fuel tanks. That company is called IMS Products and the replacement fuel tank is rated at 3.2 gallons.

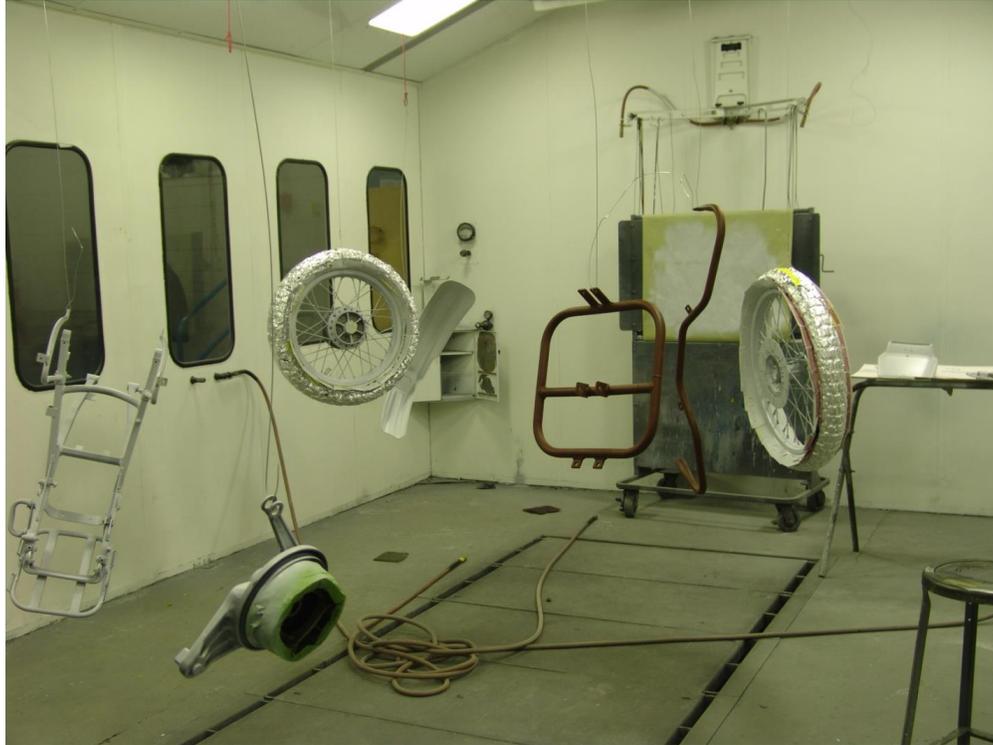
All surfaces were stripped, sanded and now primed.

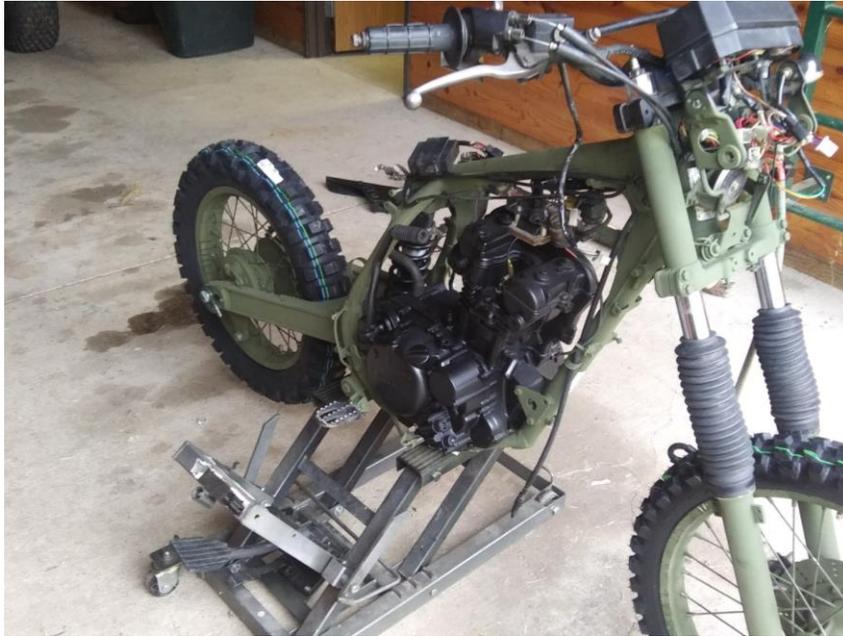
The first items to replace were the dry rotted tires and rusted drive chain. A set of new Dunlop D606 tires were fitted and a new chain installed.

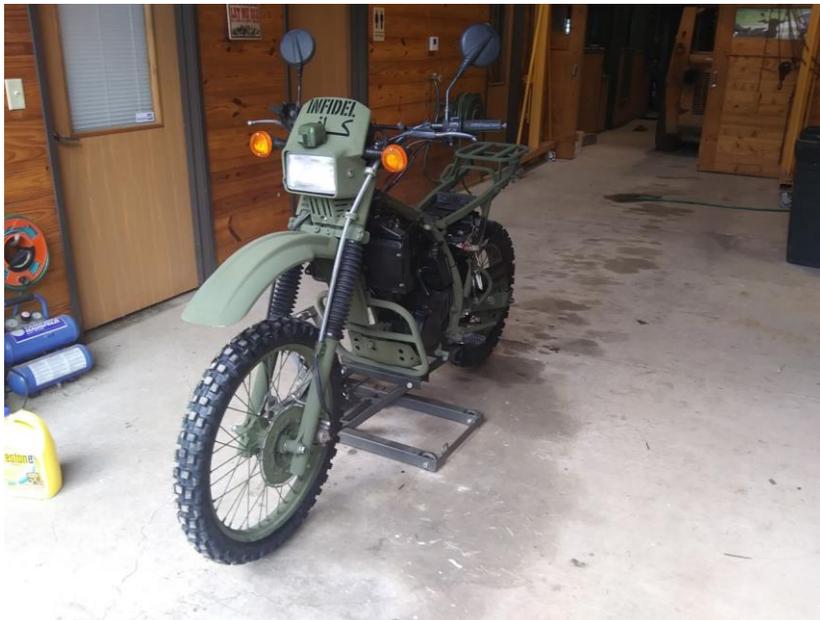
Now the radiators, hoses, carburetor, carburetor cable and choke, air box, clutch cable and engine guards were installed. The front fender, brake caliper and speedometer cable were attached. With that done the front electrical connections were buttoned up, installed front headlight housing, blackout light and front turn signals.

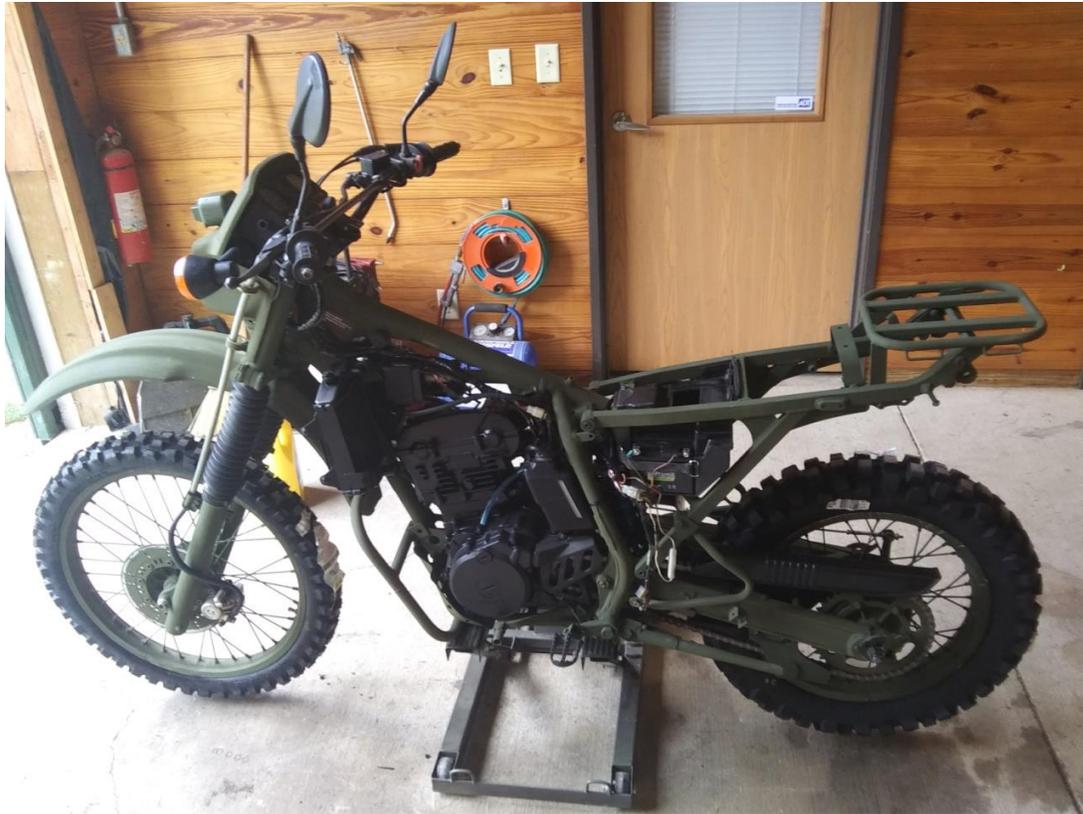
The rear sub assembly installed and work being done on the rear electrical and brake switch.

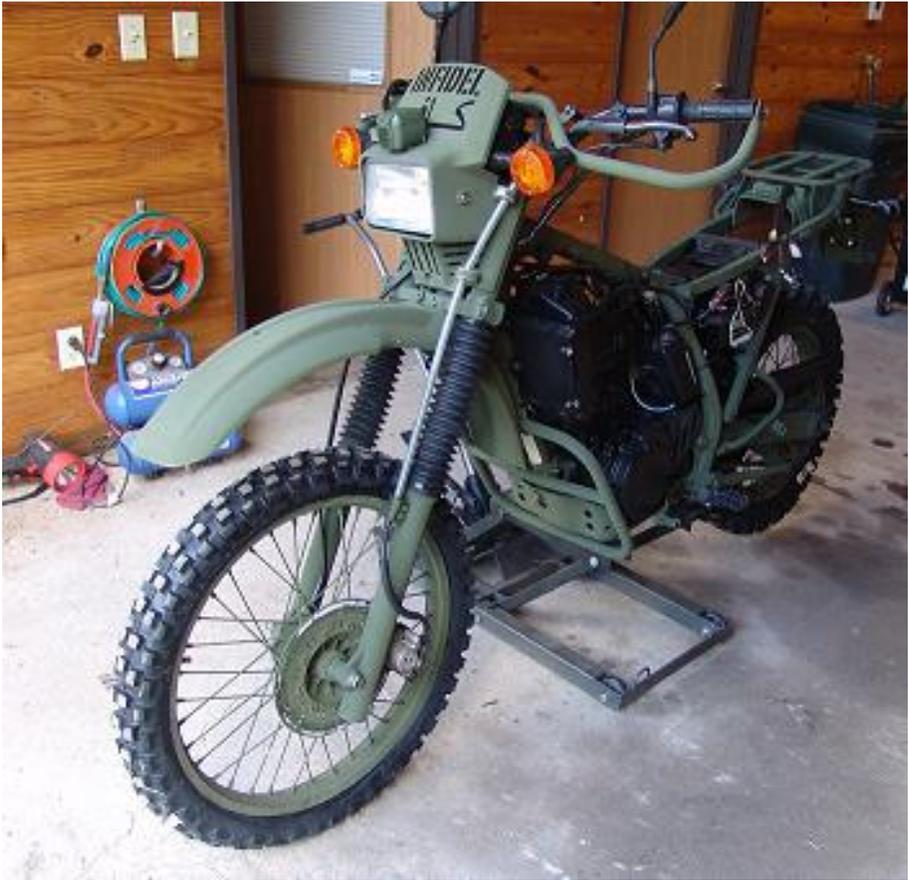
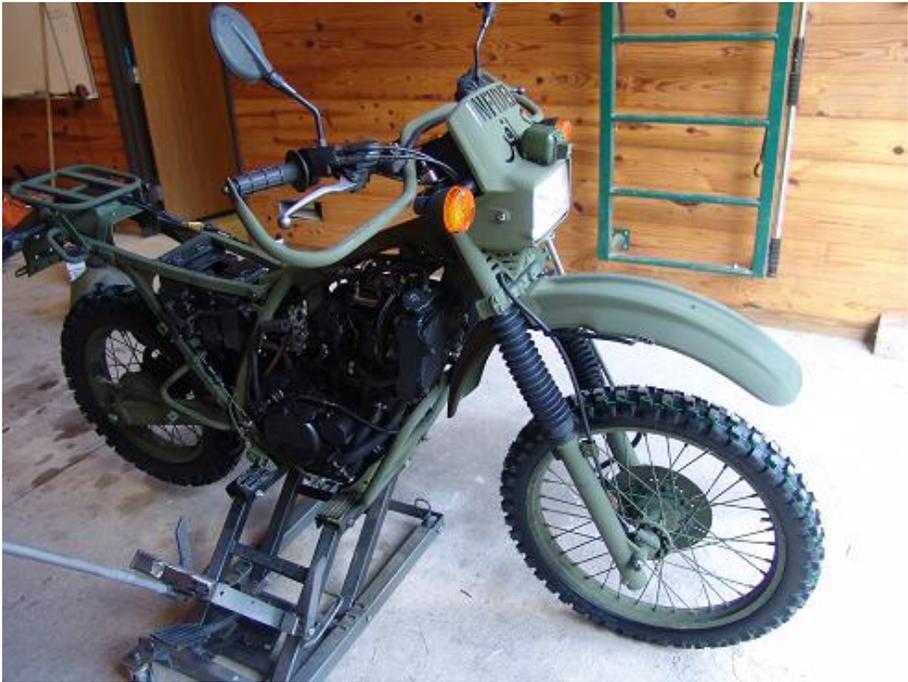
The front buffalo handlebar guard, rear taillight assembly, turn signals and wiring.

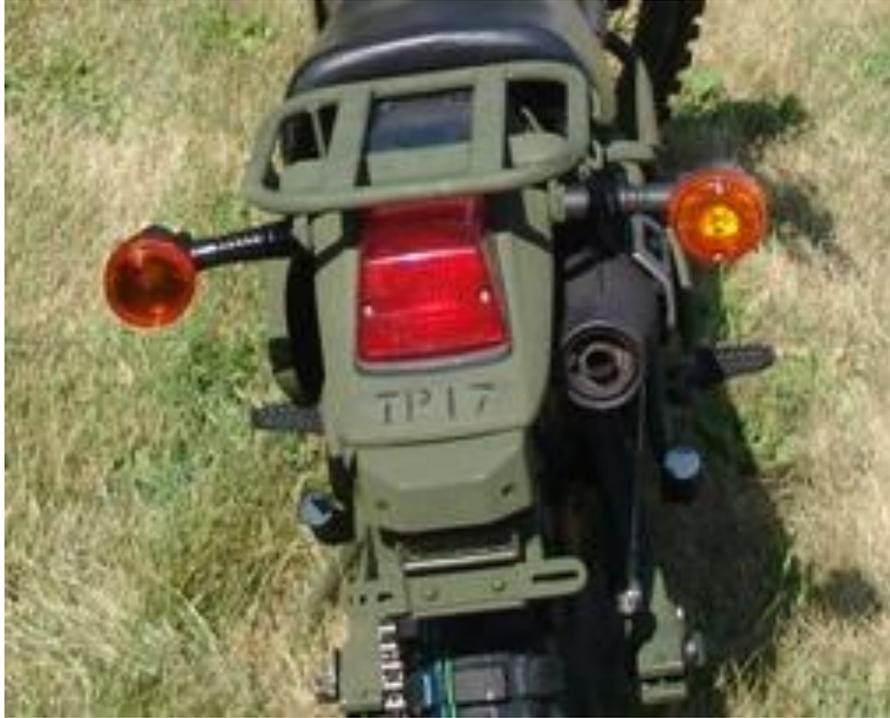
Rear Convoy Rear Light and Brake Light (Above License Plate Mount) and Rear Carrier
