# Hazards of the Consolidated Industries H-Series Horizontal Furnace

By Michael Whedon  
Licensed, Certified, Private Fire Investigator.

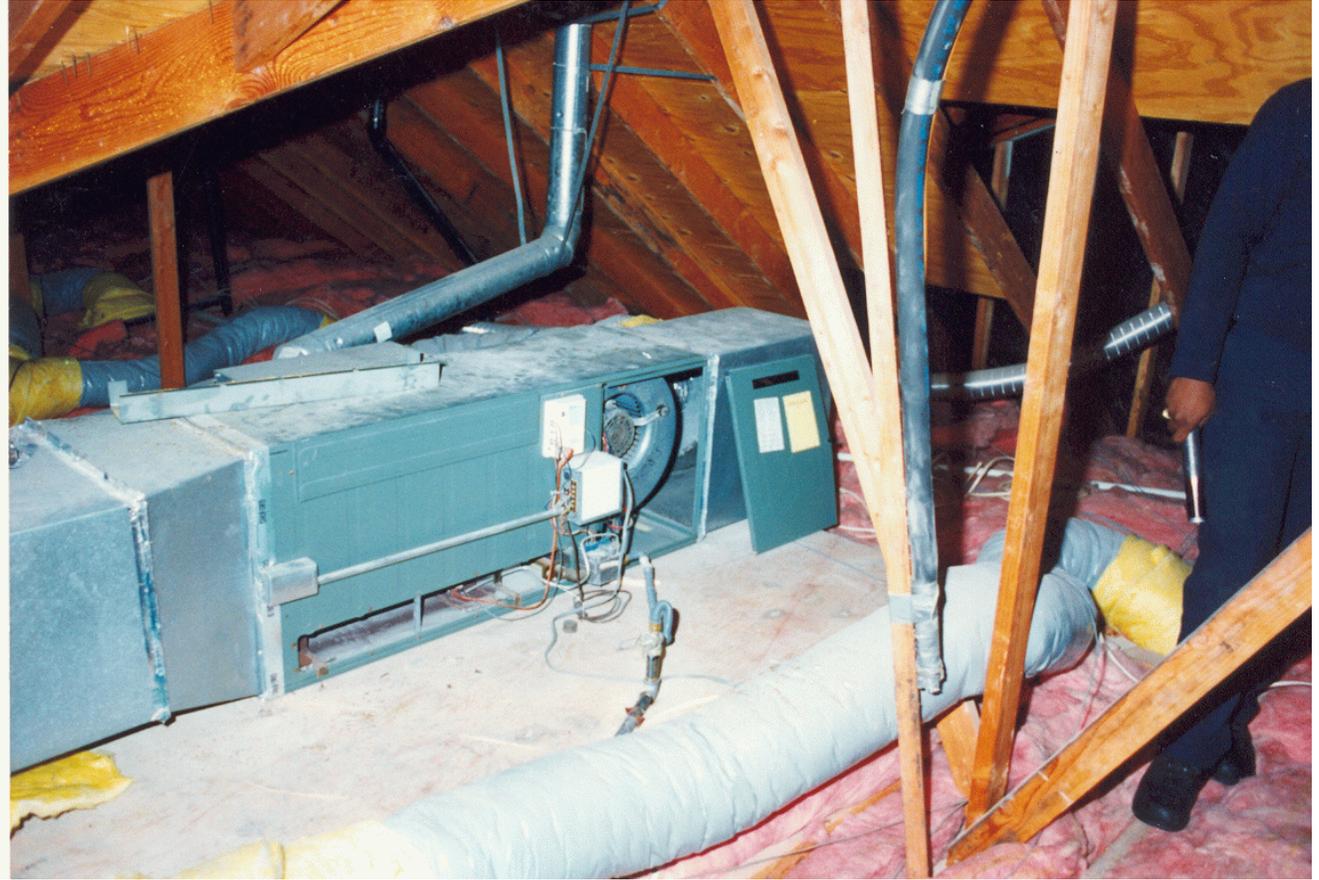
**Photo One: Typical installation method for H-Series furnace.**

During the same time period, fire investigators began to see an increase in fires occurring in homes equipped with the Consolidated H-Series furnaces. These Consolidated furnaces had been installed in attic spaces on plywood decks or set perpendicular across wooden ceiling joists. The initial theorization was that although the furnaces were rated for installation on combustible surfaces, heat was passing from the burner compartment through the bottom panel of the furnace and igniting the

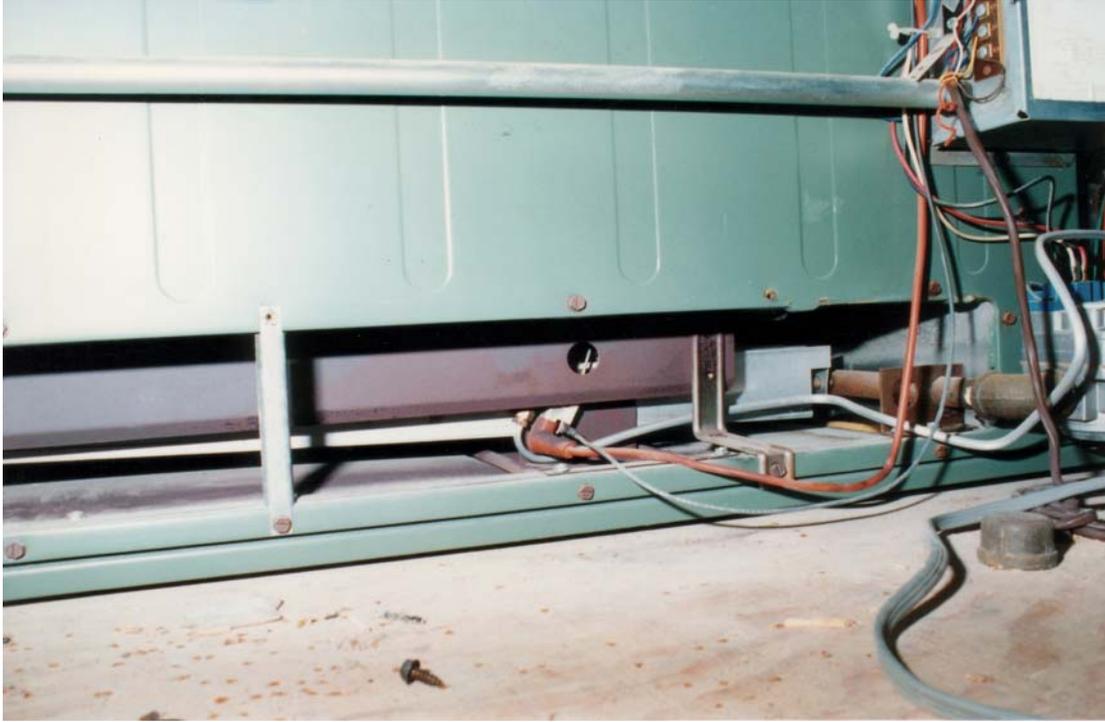
**Photo Two: Combustion air intake port at bottom edge of furnace housing.**

During the operation of a damaged furnace, if sufficient amounts of circulation air enters the combustion chamber, through holes in the heat exchanger, the burner flames can be pushed down against the bottom panel of the furnace housing as well as out the sides of the furnace through the combustion air intake openings. The combustion air intake openings are located along the sides of the furnace just above the bottom edge. This movement of flames and hot combustion gases out of the furnace is called "flame roll out."

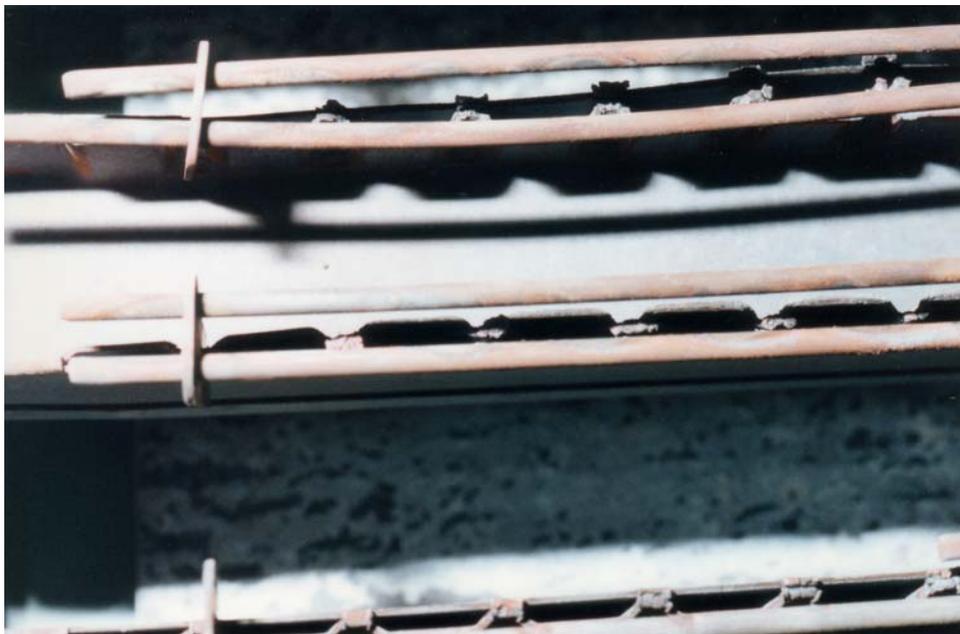
**Photo Three: Close up view of cracks in the web between burner port openings resulting in the enlargement of the port openings.**

It was determined through observation and testing that small cracks were forming in the metal webs between the gas port openings in the individual burner tubes. After the cracks formed, continued use of the furnace caused the cracks to grow. This resulted in the eventual splitting of the metal between the individual ports which enlarged the port openings to many times their original size. In some burner assemblies examined, holes measuring three to four inches in length and 3/4-inch in width were found. It follows that the larger the hole, the more gas/air can pass through the opening and burn above the burner tube. The normally small, controlled gas flames are replaced by large, irregular shaped flames. Depending on the degree of the failure in the burner assembly, the resulting flames can reach nine or more inches in height. These irregular flames impinge directly on the bottom of the heat exchanger cells which are normally offset and two to 2-1/2 inches above the burner assembly.

During the fabrication process, the burner tubes are formed from flat pieces of steel. The port openings are punched into the metal and then the metal is bent to form the tube assembly. Part of the failure problem was due to internal stresses in the metal caused by the bending in the fabrication process. The problem was further exacerbated by the continuous expansion and contraction of the metal due to heating and cooling caused by operation of the furnace.

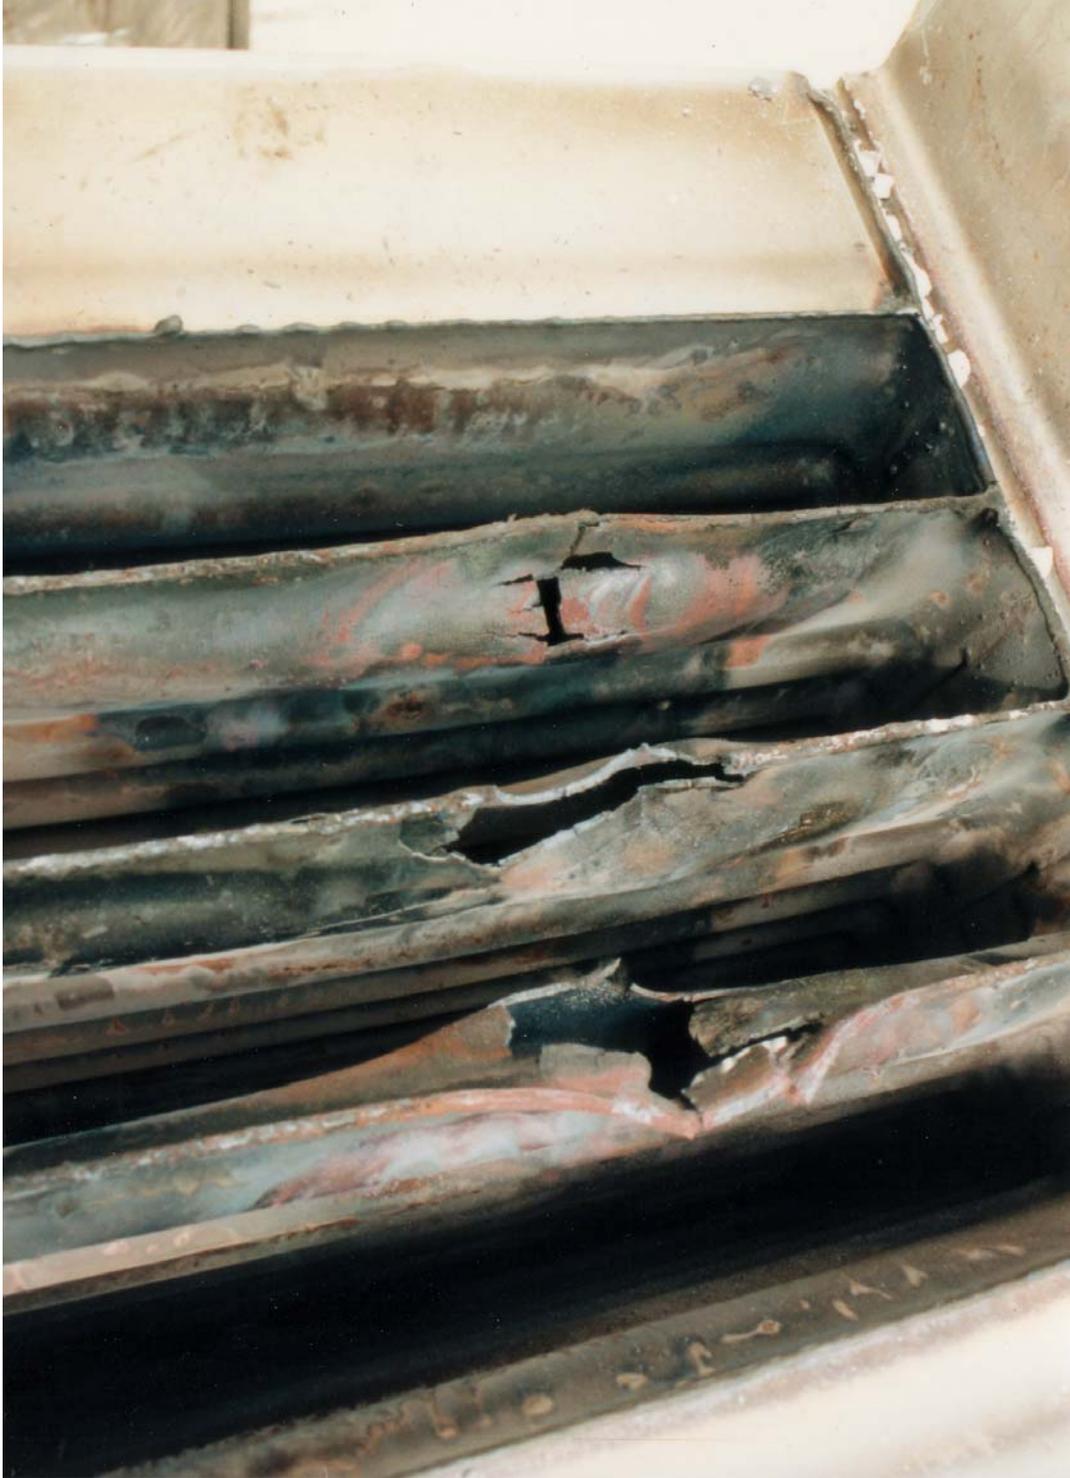
**Photo Six: Failed heat exchanger.**

The heat exchangers are made of 18 gauge steel machine welded together to form cells or tubes. The purpose of the heat exchanger is to warm the air passing through the furnace before it is discharged into the duct system for distribution into the living space of the house. The metal from which the heat exchanger is formed did not have the ability to withstand the direct impingement of the burner flames. Additionally, weld seams at the bottom of the heat exchanger tubes were also being subjected to the direct flame impingement. The welds were of relatively poor quality and would fail quickly when exposed to the direct flame contact. Lateral cracks would begin to form in the weld seams and horizontal cracks would also begin to appear in the walls of the heat exchanger cells. Under continued use, these cracks widen and eventually the metal fails causing holes to form in the bottom of the heat exchanger cells. The holes continue to grow larger in size each time the furnace is used.

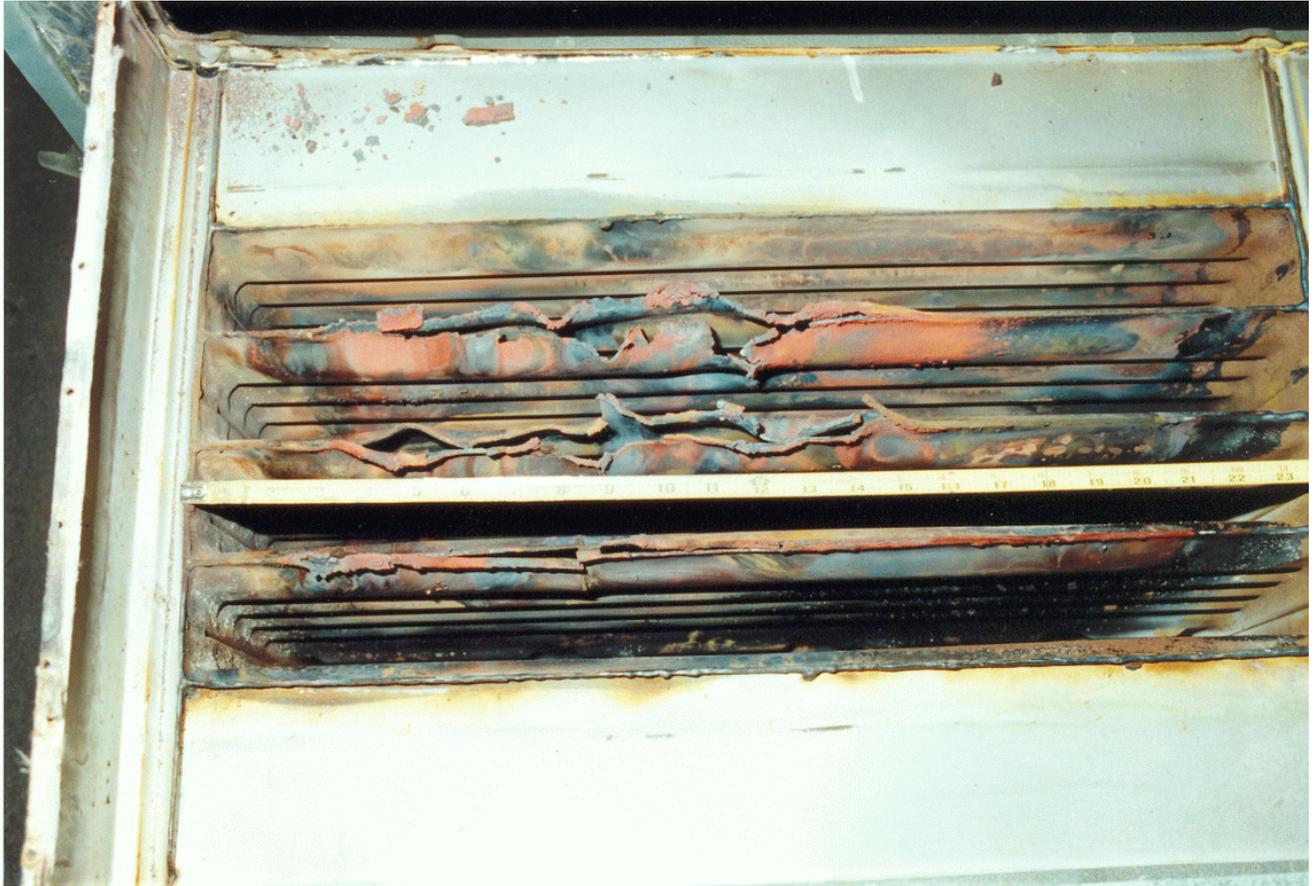
**Photo Seven: Major failure of heat exchanger.**
