## ABOUT OUR REPORT

## ❁ 22 - Heating and Cooling

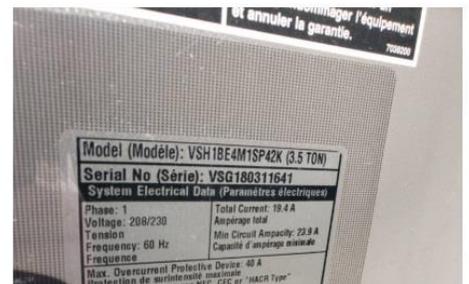
**HVAC System #1 Notes: HVAC Exterior Unit Manufacturer**

Nortek

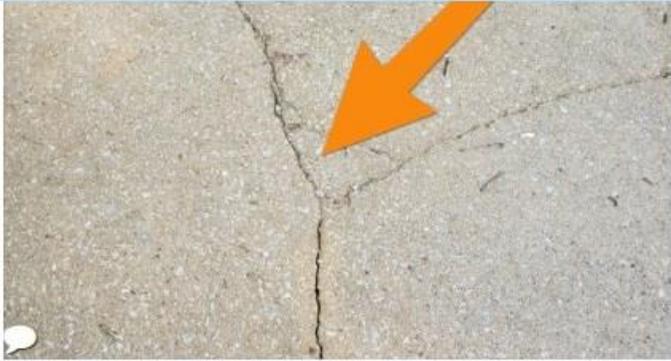
2.1.1 - Driveway Notes

**MINOR (TYPICAL) CRACKS NOTED.**

These are common in driveways, but should be monitored for expansion and development of trip hazards.

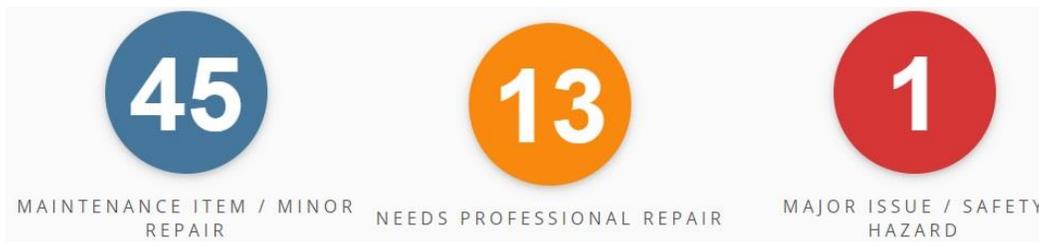
**There are three defect categories.**

1. Blue (Maintenance / Minor repair) Simple, normal maintenance issue. Things many homeowners either don't care about or are easy to repair by the average homeowner.
2. Orange (Professional Repair). These are items we expect most homeowners need to contact a plumber, roofer, electrician or some other professional to repair.
3. Red (Major issue / Safety Hazard). These may be expensive items (new roof or significant foundation issue), safety issues for adults /small children or any uncontained water leak noted in the home.
