**Fiesta Gardens HOA**  
***San Mateo, CA***

Report #: 25308-1  
Beginning: January 1, 2025  
Expires: December 31, 2025

**RESERVE STUDY**  
**Update "With-Site-Visit"**

October 28, 2024

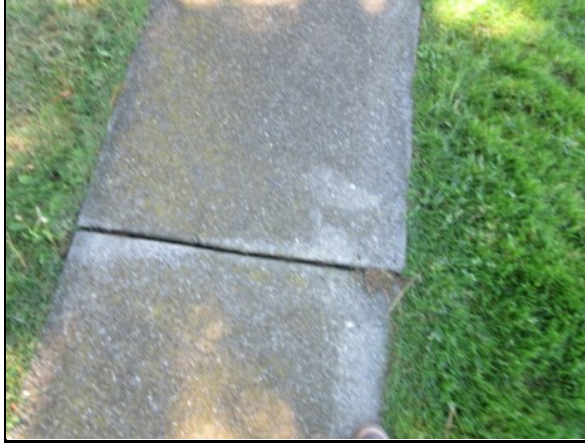
**Comp #: 205 Concrete Walkways - Repair****Quantity: Approx 650 GSF**

Useful Life:  
10 years

Remaining Life:  
1 years

Best Case: \$ 2,500

Worst Case: \$ 3,500

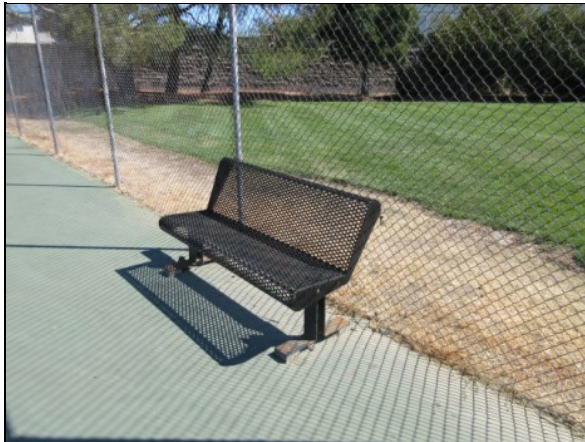
Useful Life:  
30 years

Remaining Life:  
1 years

Best Case: \$ 10,000

Worst Case: \$ 16,000

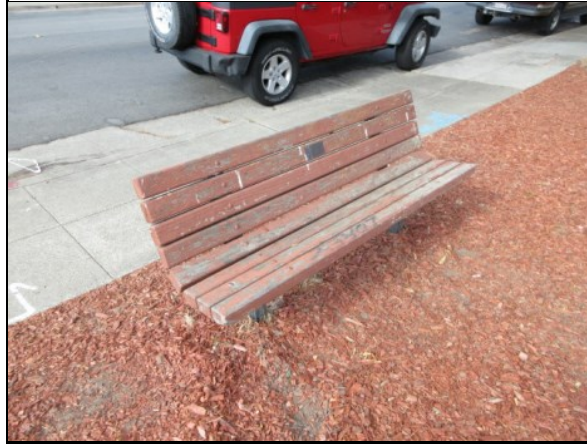
**Comp #: 416 Wood Benches - Repair/Replace**

Useful Life:  
25 years

Remaining Life:  
0 years

Best Case: \$ 10,000

Worst Case: \$ 12,000

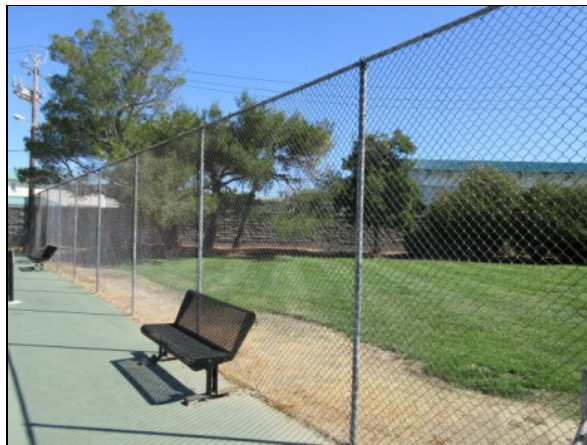
Remaining Life:

5 years

Best Case: \$ 36,000

Worst Case: \$ 45,000

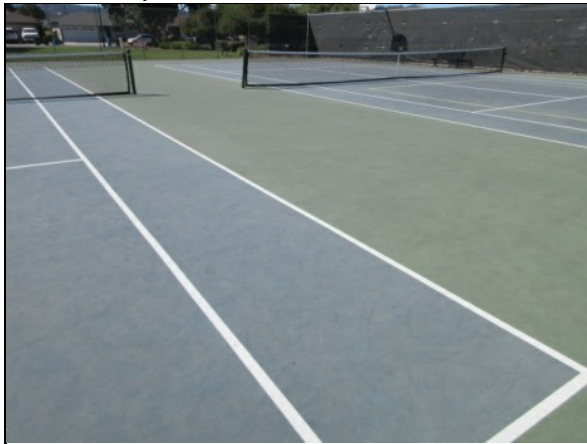
Remaining Life:

1 years

Best Case: \$ 25,000

Worst Case: \$ 35,000

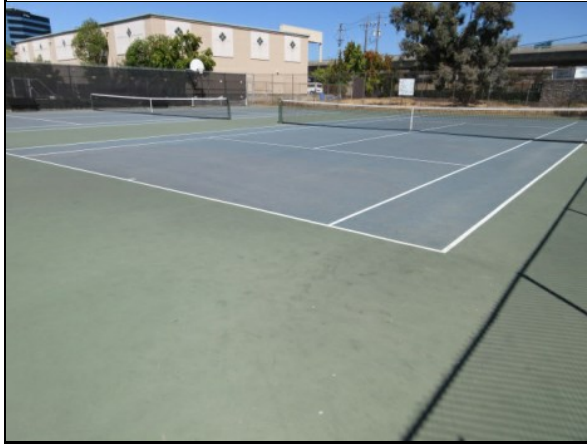
Useful Life:  
30 years

Remaining Life:  
10 years

Best Case: \$ 80,000

Worst Case: \$ 100,000

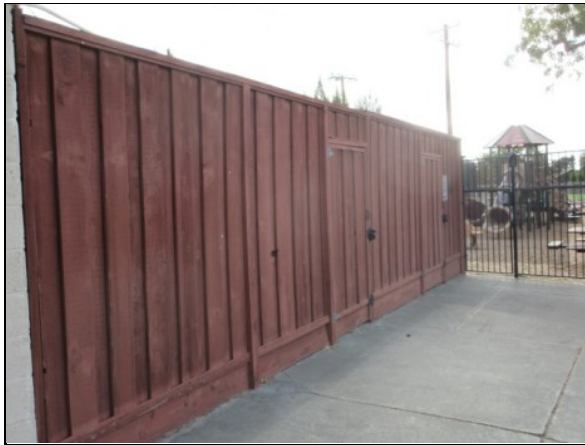
Comments: The wood fence remains upright, intact, and sturdy. No major warping, cracking, or board detachment noted. We recommend periodic staining to maximize the useful life of the wood.

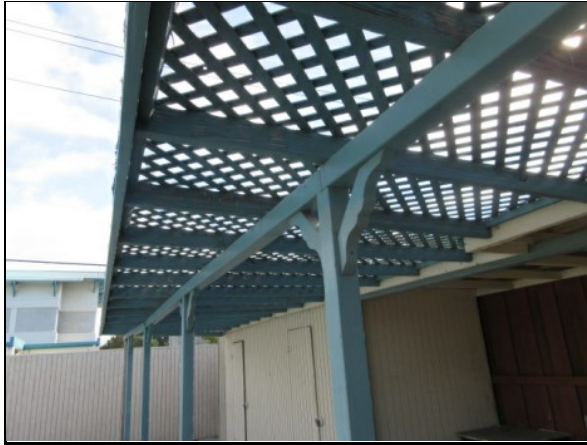
Remaining Life:

6 years

Best Case: \$ 19,500

Worst Case: \$ 26,000

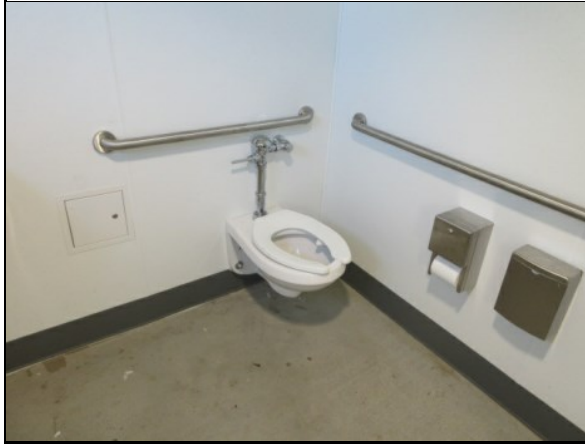
Remaining Life:

1 years

Best Case: \$ 20,000

Worst Case: \$ 30,000

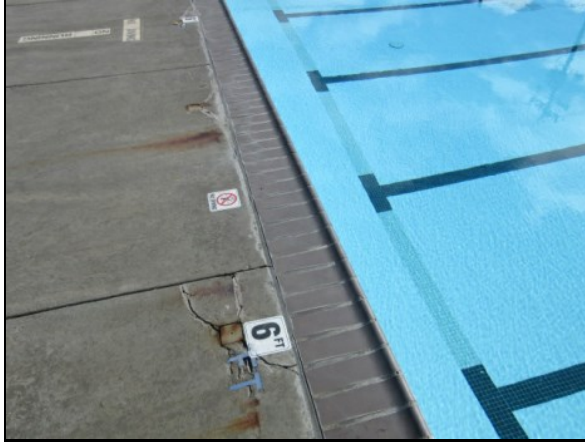
Remaining Life:

12 years

Best Case: \$ 15,000

Worst Case: \$ 20,000

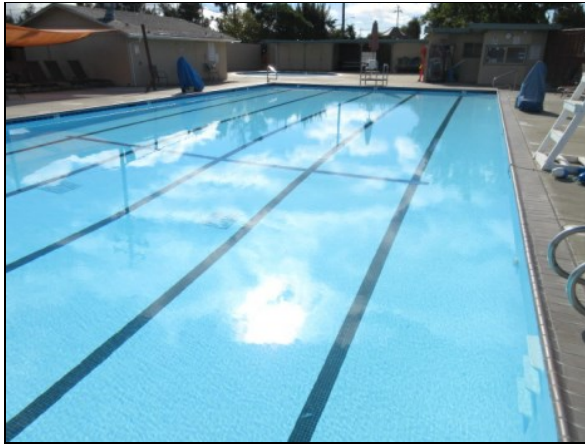
Remaining Life:

0 years

Best Case: \$ 66,400

Worst Case: \$ 79,580

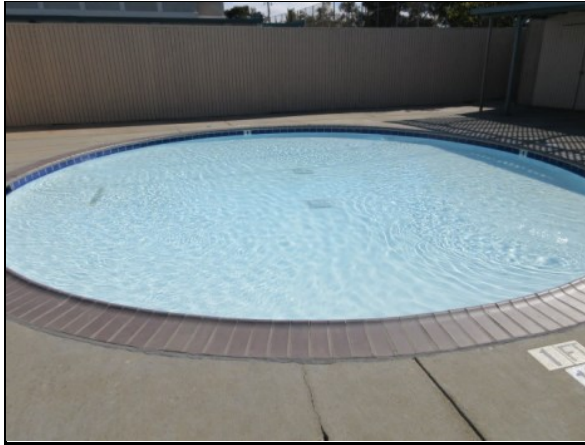
Remaining Life:

0 years

Best Case: \$ 14,200

Worst Case: \$ 16,980

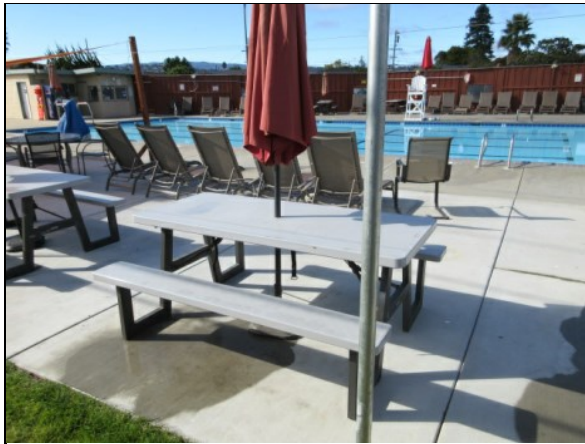
Remaining Life:

0 years

Best Case: \$ 9,000

Worst Case: \$ 11,000

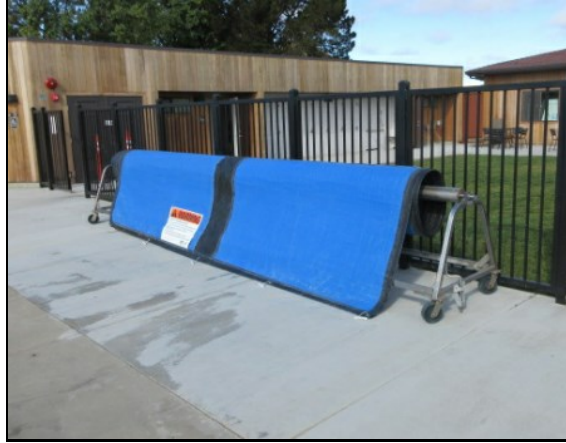
Useful Life:  
7 years

Remaining Life:  
5 years

Best Case: \$ 6,200

Worst Case: \$ 7,530

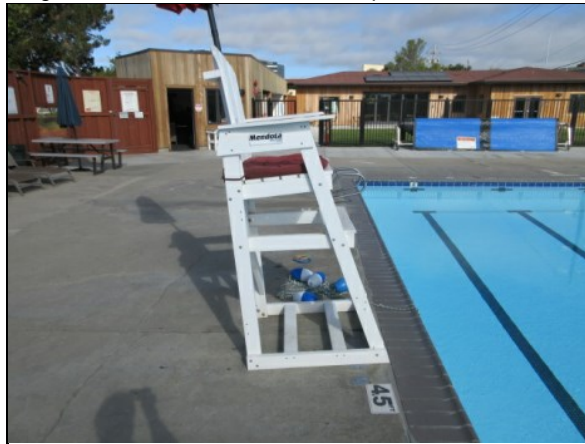
Useful Life:  
12 years

Remaining Life:  
10 years

Best Case: \$ 2,000

Worst Case: \$ 3,000

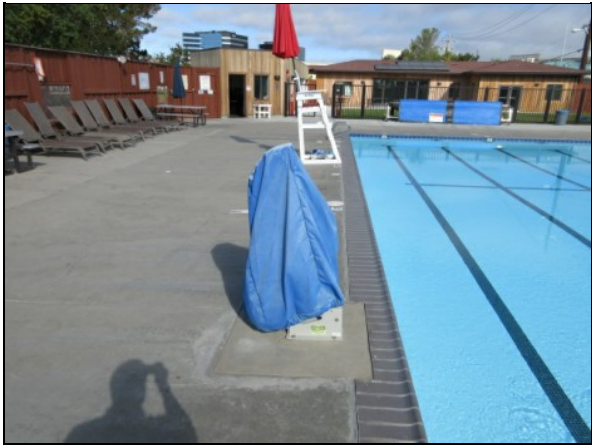
Useful Life:  
20 years

Remaining Life:  
19 years

Best Case: \$ 16,000 Worst Case: \$ 20,000

Cost Source: Client Cost History

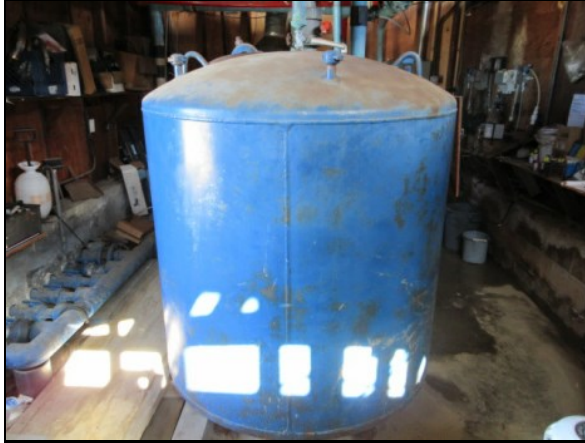
Useful Life:  
30 years

Remaining Life:  
4 years

Best Case: \$ 16,000

Worst Case: \$ 20,000

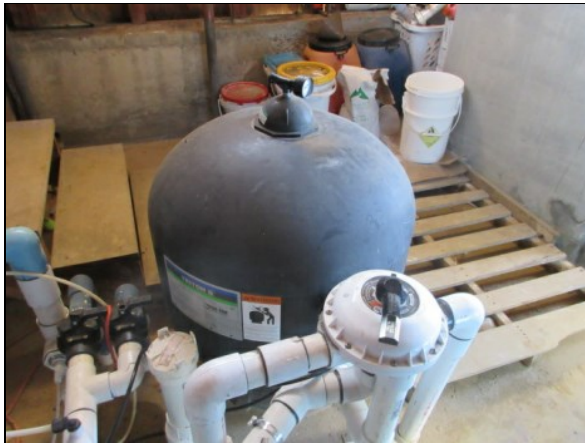
Useful Life:  
18 years

Remaining Life:  
3 years

Best Case: \$ 3,000

Worst Case: \$ 4,000

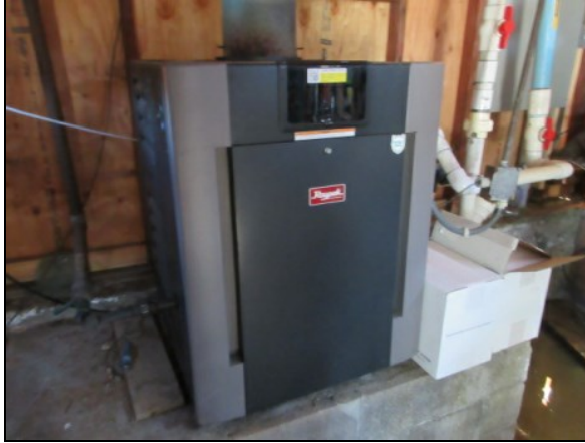
Comments: (1) Raypak Rheem Professional Heater model B-R406A-EN-X#50ASME, S/N V352200050 item #017402. No reported problems at this time. We anticipate the need for replacement in the interval outlined below.

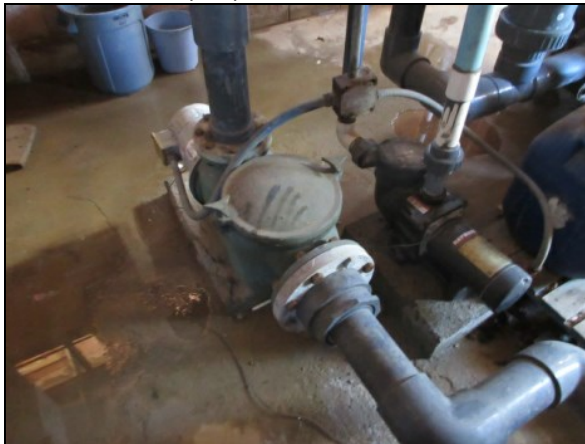
Comments: No reported problems at this time. The pump is in functional condition.

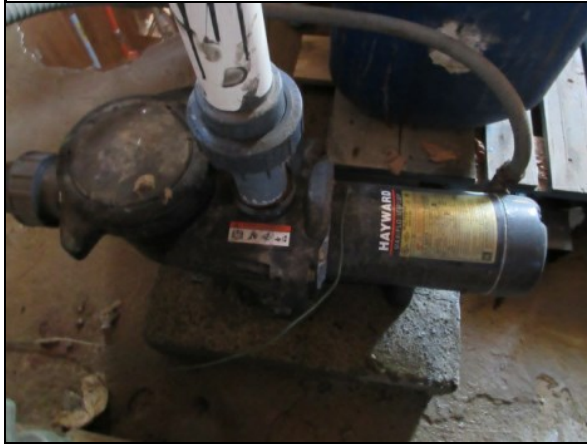
Useful Life:  
10 years

Remaining Life:  
0 years

Best Case: \$ 3,000

Worst Case: \$ 4,000

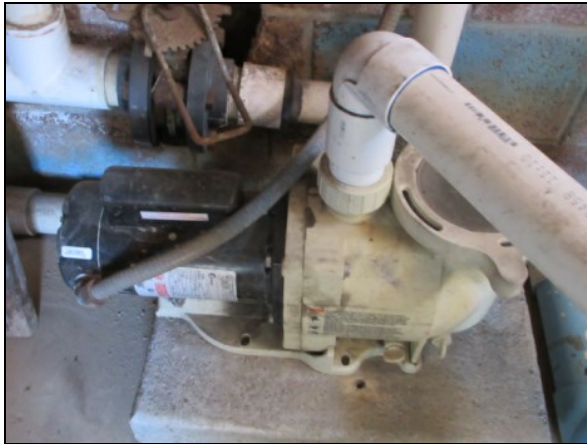
Useful Life:  
10 years

Remaining Life:  
9 years

Best Case: \$ 3,000

Worst Case: \$ 3,500

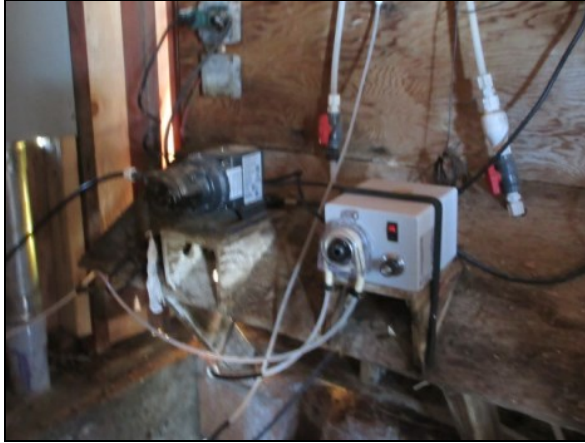
Useful Life:  
5 years

Remaining Life:  
4 years

Best Case: \$ 2,000

Worst Case: \$ 3,000

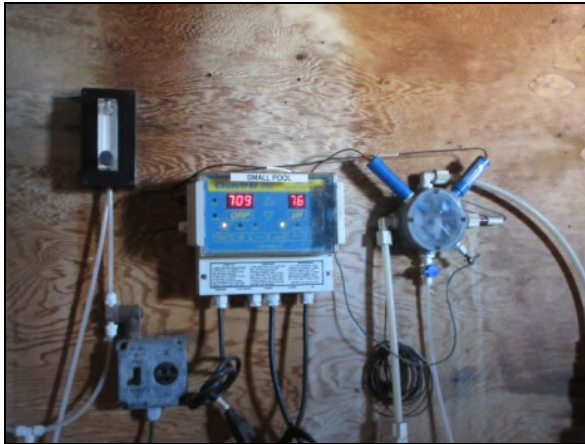
Useful Life:  
12 years

Remaining Life:  
2 years

Best Case: \$ 9,000

Worst Case: \$ 11,000

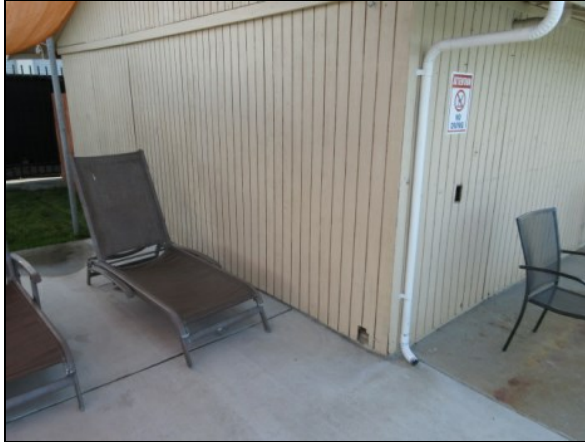
Useful Life:  
6 years

Remaining Life:  
0 years

Best Case: \$ 10,500

Worst Case: \$ 14,000

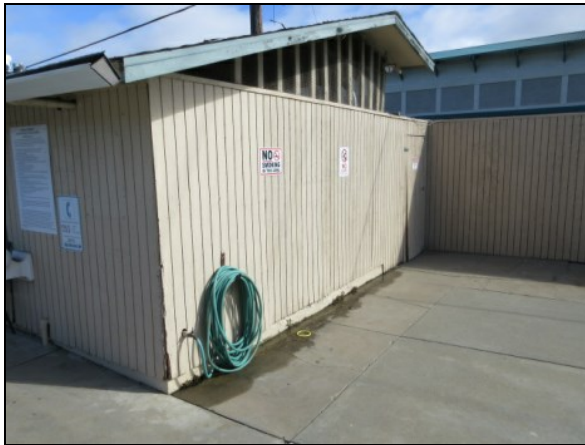
Useful Life:  
6 years

Remaining Life:  
0 years

Best Case: \$ 3,000

Worst Case: \$ 4,000

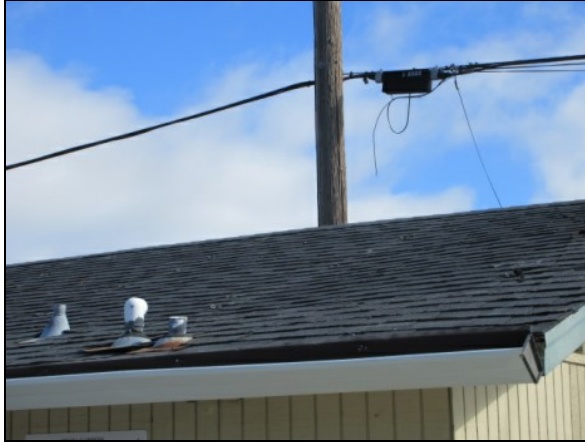
Useful Life:  
25 years

Remaining Life:  
3 years

Best Case: \$ 11,880

Worst Case: \$ 14,000

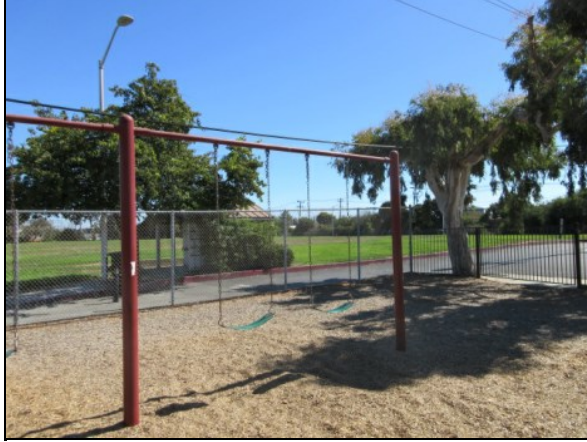
Comments: The swing set appears to be intact and in fair condition. No indications of widespread deterioration noted.

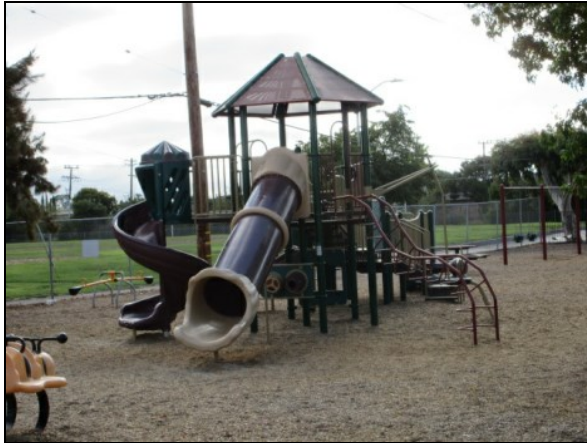
Comments: No reported problems of major deterioration noted. The play structure is intact and in fair condition at this time. We recommend setting aside funding for replacement in the interval outlined below.

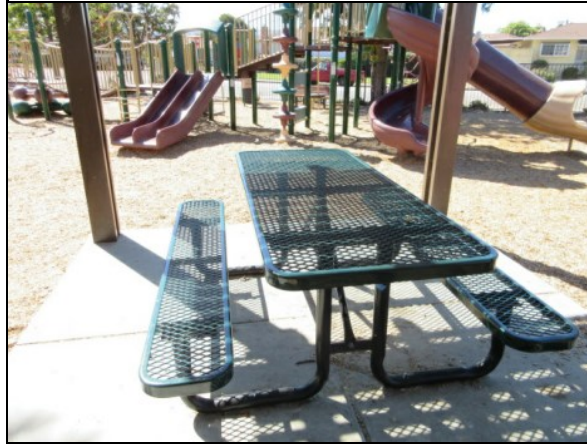
Useful Life:  
28 years

Remaining Life:  
10 years

Best Case: \$ 2,000

Worst Case: \$ 3,000

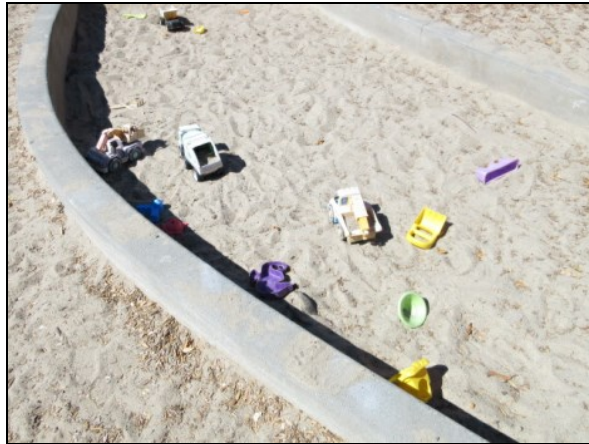
**Comp #: 414 Sandbox - Repair**

Comments: The sandbox is intact and appears to be aging correctly at this time. This component provides funding for periodic repairs.

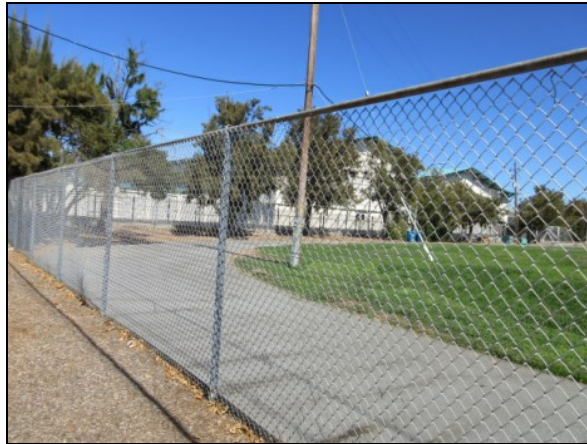
**Comp #: 503 Chain Link Fence - Replace**

Comments: The fence is upright, intact, and in fair condition at this time. No significant leaning or other indications of failure noted. We recommend setting aside funding for replacement in the interval outlined below.

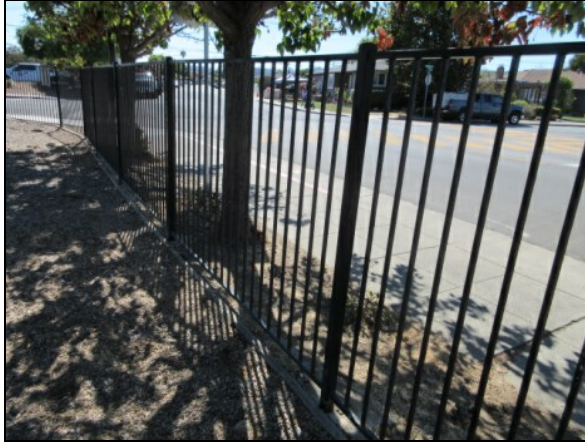
**Comp #: 504 Metal Fence - Replace****Quantity: Approx 240 LF**

Comments: The fence displays a slight lean but remains upright. We recommend regular painting to protect against corrosion, which will maximize the useful life of the metal. This component provides funding for replacement in the interval outlined below.

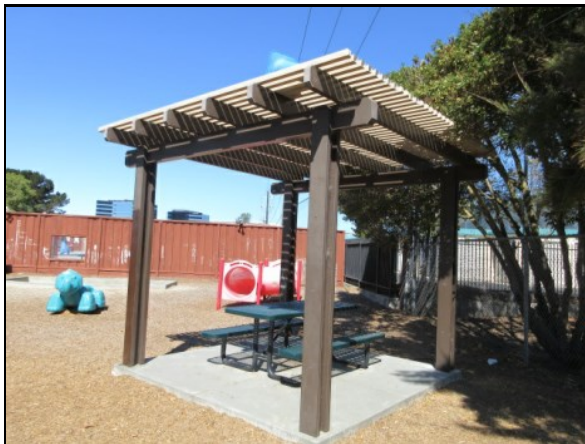
**Comp #: 512 Metal Trellis - Replace****Quantity: (1) Trellis**

Comments: No signs of widespread deterioration. Inspect regularly to ensure the stability of the structure. A durable and typically long-lived component with ordinary care and maintenance. However, we recommend setting aside funding for eventual replacement at the interval indicated below.

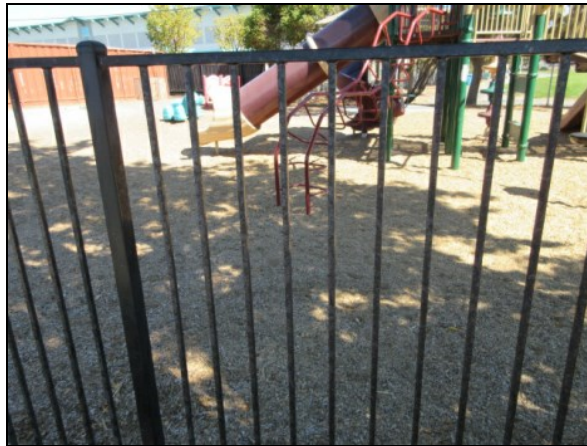
Comments: The paint is peeling and in poor condition. We recommend repainting at this time to maximize the useful life of the metal.

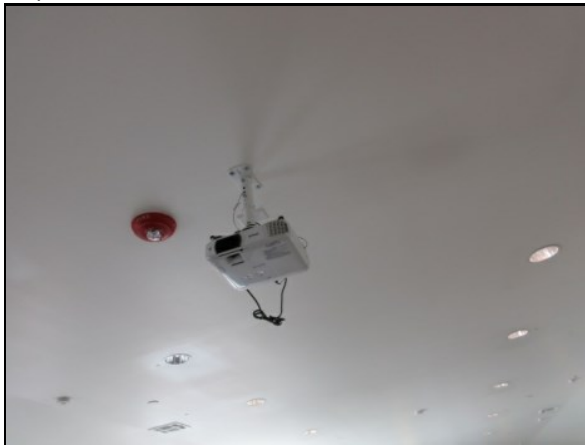
**Comp #: 314 Projection Equipment - Replace****Quantity: (1) Projector, (1) Screen**

Comments: (1) Epson projector and (1) automatic screen. The timing of replacement depends on the level of use. We recommend setting aside funding for eventual replacement in the interval outlined below.

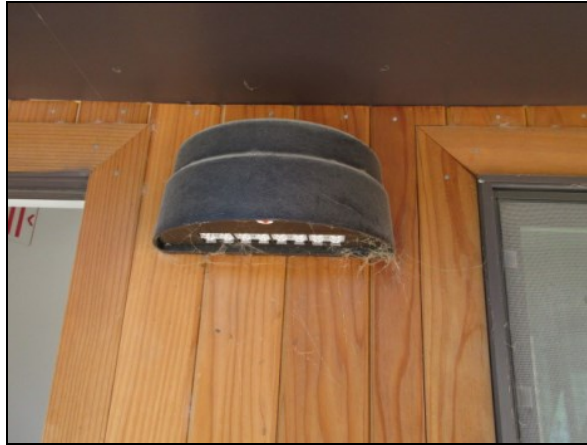
**Comp #: 324 Exterior Lights - Replace****Quantity: (16) Fixtures**

Comments: The fixtures are new and in good condition. As routine maintenance, clean by wiping down with an appropriate cleaner, change bulbs, and repair as needed. We recommend setting aside funding for eventual replacement in the interval outlined below.

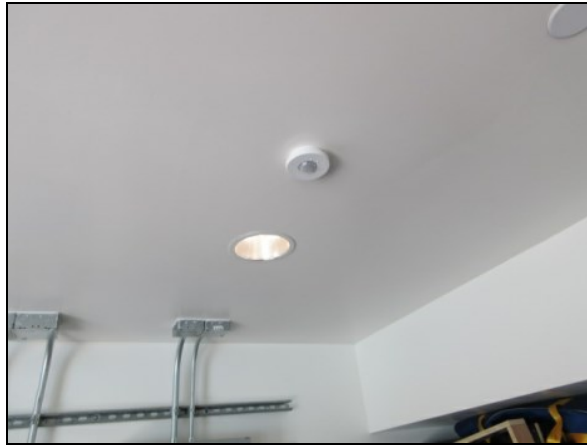
**Comp #: 325 Interior Lights - Replace****Quantity: (61) Fixtures**

Comments: The fixtures are new and in good condition. As routine maintenance, inspect, repair, and change bulbs as needed. The best practice is to coordinate at the same time as other interior projects, such as painting, whenever possible to minimize downtime and maintain consistent quality standards.

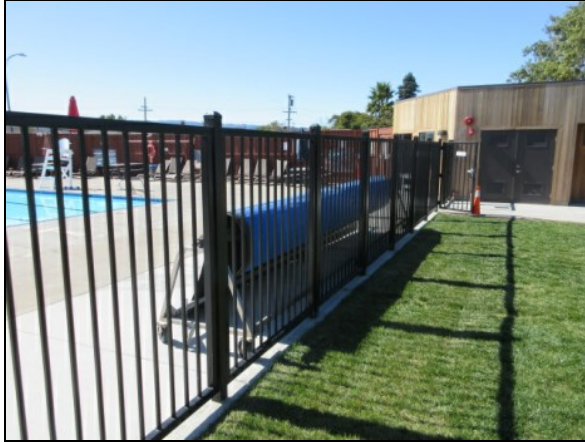
**Comp #: 503 Metal Fence - Replace****Quantity: Approx 85 LF**

Comments: Inspect regularly to ensure the stability of the fencing. A durable and typically long-lived component with ordinary care and maintenance. However, we recommend setting aside funding for eventual replacement at the interval indicated below.

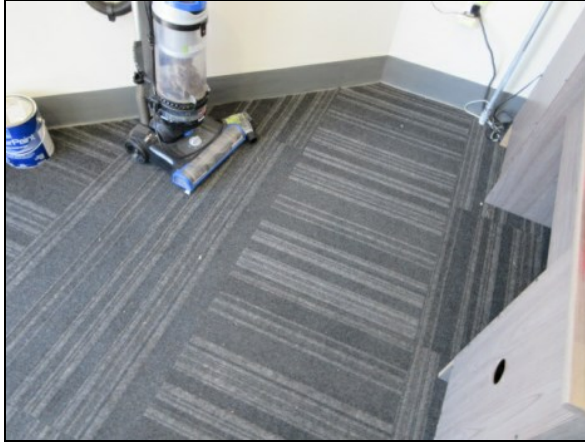
**Comp #: 601 Carpet - Replace****Quantity: Approx 20 GSY**

Comments: The carpet is intact and in good condition. We recommend periodic cleaning to maintain a uniform appearance. We recommend setting aside funding for replacement in the interval outlined below.

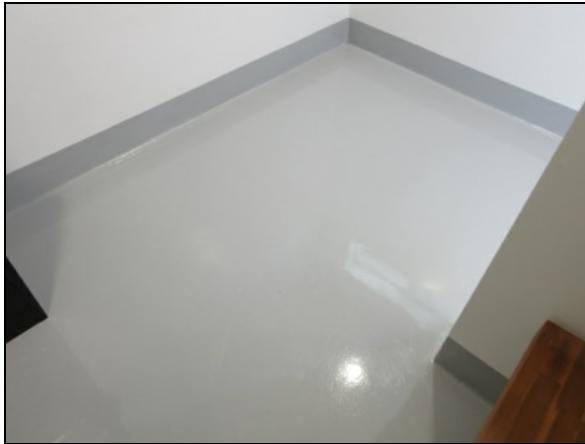
Comments: The seal is new and in good condition. No indications of premature deterioration noted. We recommend regular sealing in the interval outlined below, however the cycle might need to be adjusted based on the level of traffic and wear.

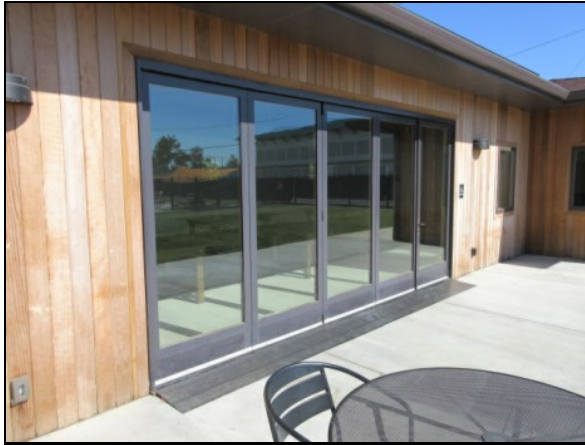
**Comp #: 712 Sliding Door - Replace**

Comments: The door is new and in good condition. No indications of premature deterioration noted.

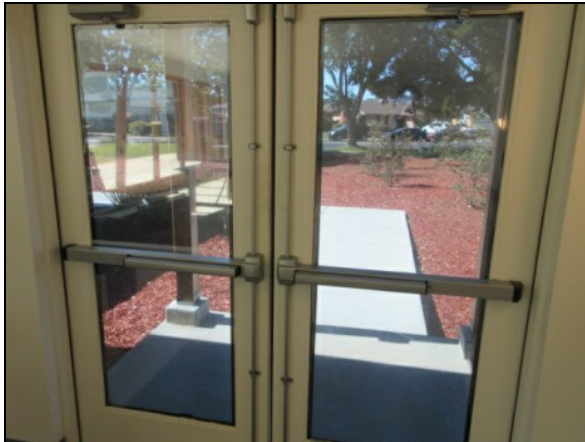
**Comp #: 740 Exterior Doors - Replace**

Comments: The doors are intact and have a satisfactory seal. No indications of premature damage or abuse noted.

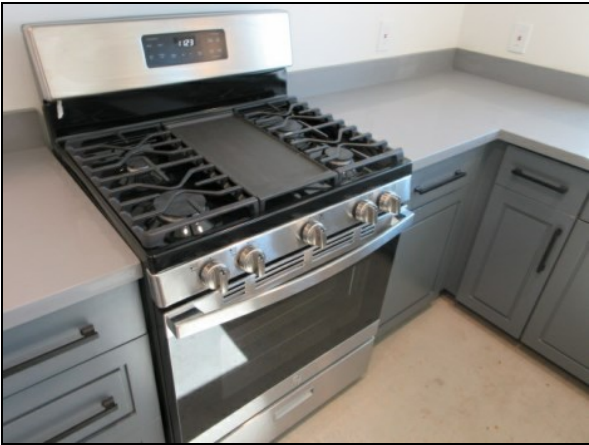
**Comp #: 901 Appliances - Replace**

Location: Cabana kitchen  
Funded?: Yes.  
History:  
Comments: (1) GE Stive, (1) GE Refrigerator, and (1) Kucht hood. The appliances are new and in good condition at this time.

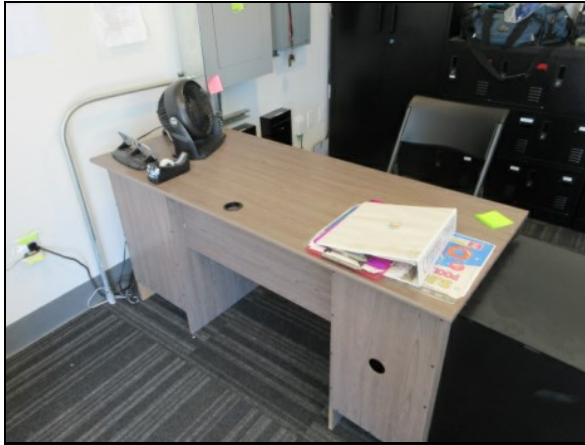
**Comp #: 901 Office Furniture - Replace**

Comments: (2) Cabinets, (1) locker unit, (1) refrigerator, (2) desks. The furniture is new and in good condition.

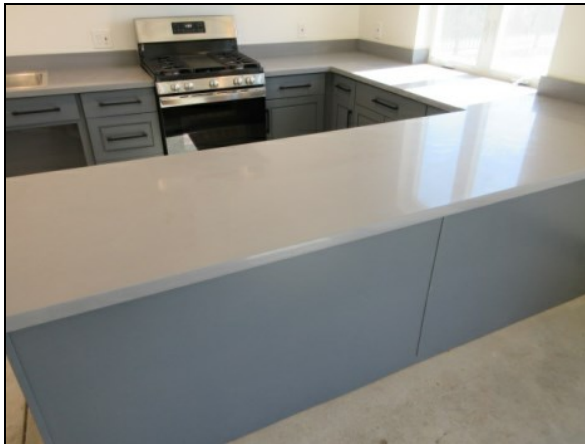
**Comp #: 902 Kitchen Counters/Cabinets - Replace**

Comments: The cabinets and countertops are new and in good condition. This component provides funding for eventual replacement in the interval outlined below.

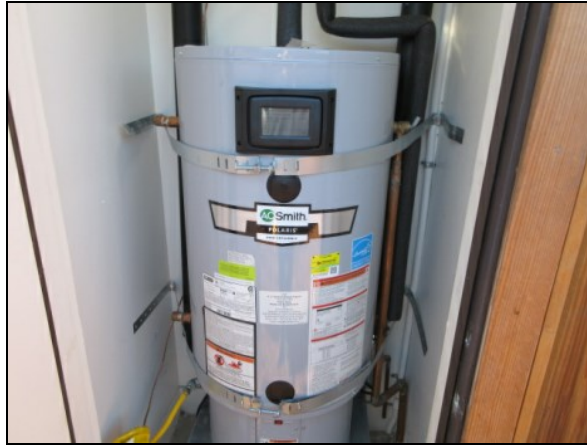
**Comp #: 803 Water Heater - Replace (Cabana)****Quantity: (1) Water Heater**

Comments: (1) AO Smith 34-gallon model BSS-130 200, serial number 2336135576643. It is best to plan for replacement within the typical life expectancy of ten to fifteen years. We recommend periodic inspections by a licensed professional to ensure the water heater is fully functional and aging correctly.

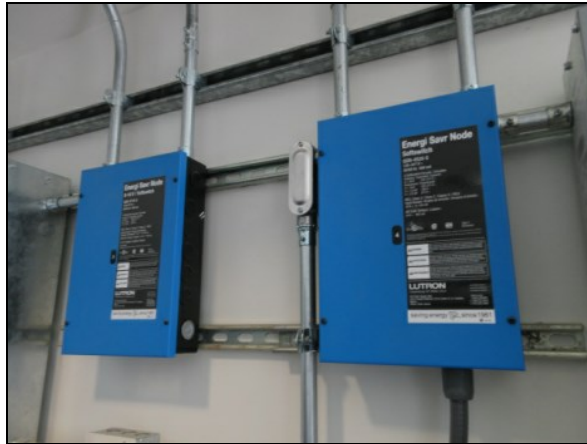
**Comp #: 1613 Lighting Systems - Replace****Quantity: (2) Systems**

Comments: (2) Lutron lighting systems. No reported problems at this time. The systems are new and in good condition.

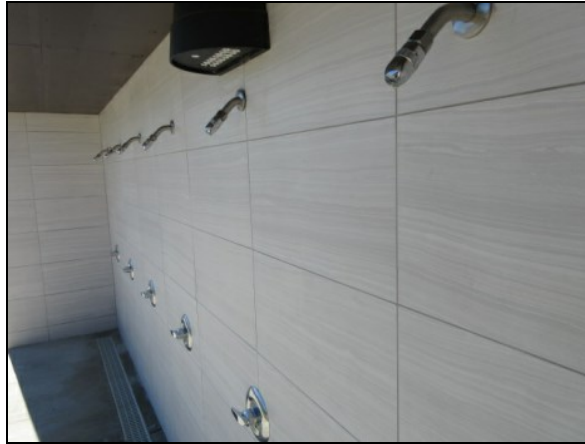
**Comp #: 1811 Plumbing - Replace/Reline/Repair****Quantity: Extensive LF**

Comments: Analysis of plumbing systems is beyond the scope of our services because the vast majority of them are hidden and not visible for review. Manufacturing defects become apparent from time to time, and certain site conditions (e.g., galvanic corrosion, dissimilar metals in contact with piping, chemical reactions, etc.) can contribute to premature deterioration of the plumbing systems. Treat minor repairs as an ongoing maintenance expense.

We highly recommend the association engage a qualified firm to evaluate the plumbing systems, including forensic wall openings and test sections of piping. Patterns of significant repair expenses, leaks, poor flow, and sediments in the lines should accelerate the need to address proactively and seek a detailed analysis to identify hidden conditions, project a remaining useful life, and make recommendations for any needed repairs, maintenance, etc. Before such an evaluation, there is no predictable basis at this time for large-scale plumbing repair or replacement expenses. Results should be included in the subsequent reserve study update.

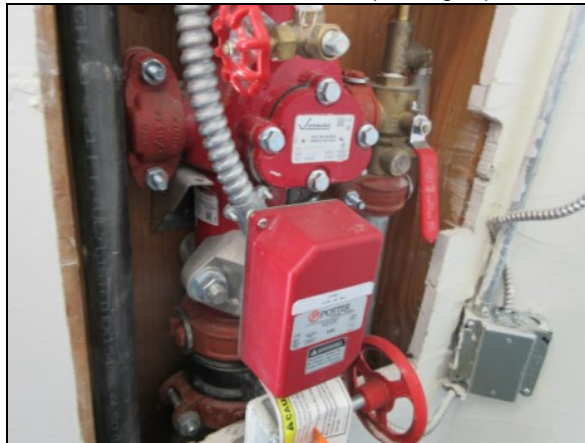
**Comp #: 1813 Fire Sprinklers/Devices - Replace****Quantity: Extensive Devices**

Comments: Unless otherwise noted, the fire sprinkler/suppression distribution system (pipes, valves, sprinkler heads, etc.) is assumed to have been designed and installed correctly and adheres to all relevant building codes. Generally speaking, repairs are minimal and infrequent and can be addressed as needed as an Operating expense, not through Reserves.

Funded?: No. Handle replacement as an operating expense. No Reserve funding allocated.

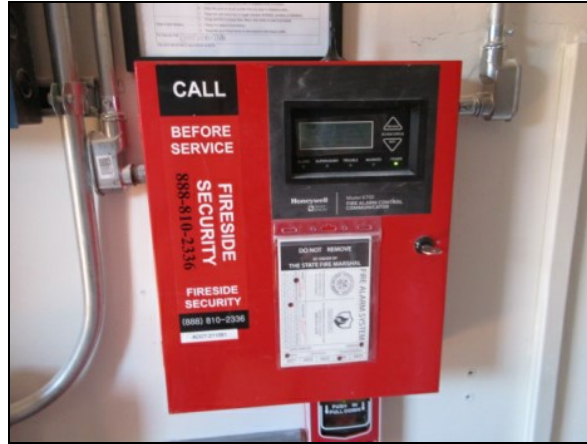
**Comp #: 1819 Fire Alarm System - Replace****Quantity: (1) System**

Comments: Fire panels and systems may last an extended period, barring unforeseen electrical incidents. In our experience, design obsolescence, parts availability, technological advances, and code changes dictate the need to plan for periodic replacement. A wide range of panels and features is available; this component provides an allowance for replacement. We recommend regular inspections by a licensed professional to ensure all fire systems are fully functional and aging correctly.

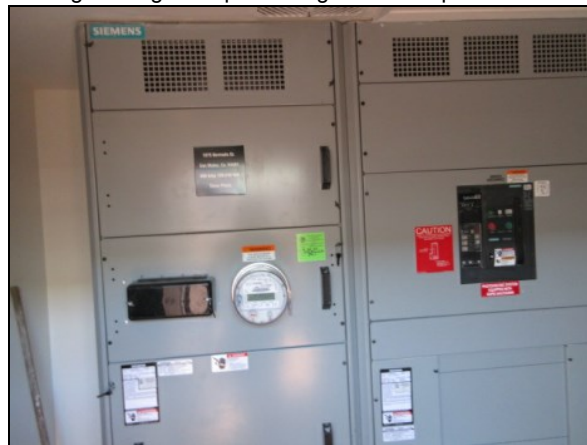
**Comp #: 1844 Electrical System - Repair/Replace****Quantity: Extensive Wiring**

Comments: Assessing the electrical systems is beyond the scope of our services. Typically, if installed per architectural specifications and local building codes, there is no predictable time frame for large-scale repair/replacement expenses within the scope of our report. Consult with an engineering firm specializing in such inspections and analysis.

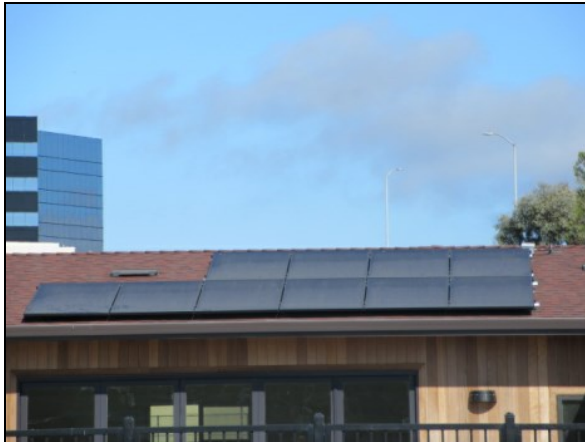
**Comp #: 1870 Solar Panels - Replace**

Comments: We recommend regular service and maintenance by a licensed professional to ensure the solar panels continue to function correctly. No reported problems at this time.
